# Effects of the Earthquake Of March 27, 1964 At Anchorage, Alaska

BY WALLACE R. HANSEN

*A description and analysis of the damage resulting from seismic vibration, ground cracks, and especially landslides in Alaska's largest city*

GEOLOGICAL SURVEY PROFESSIONAL PAPER 542-A

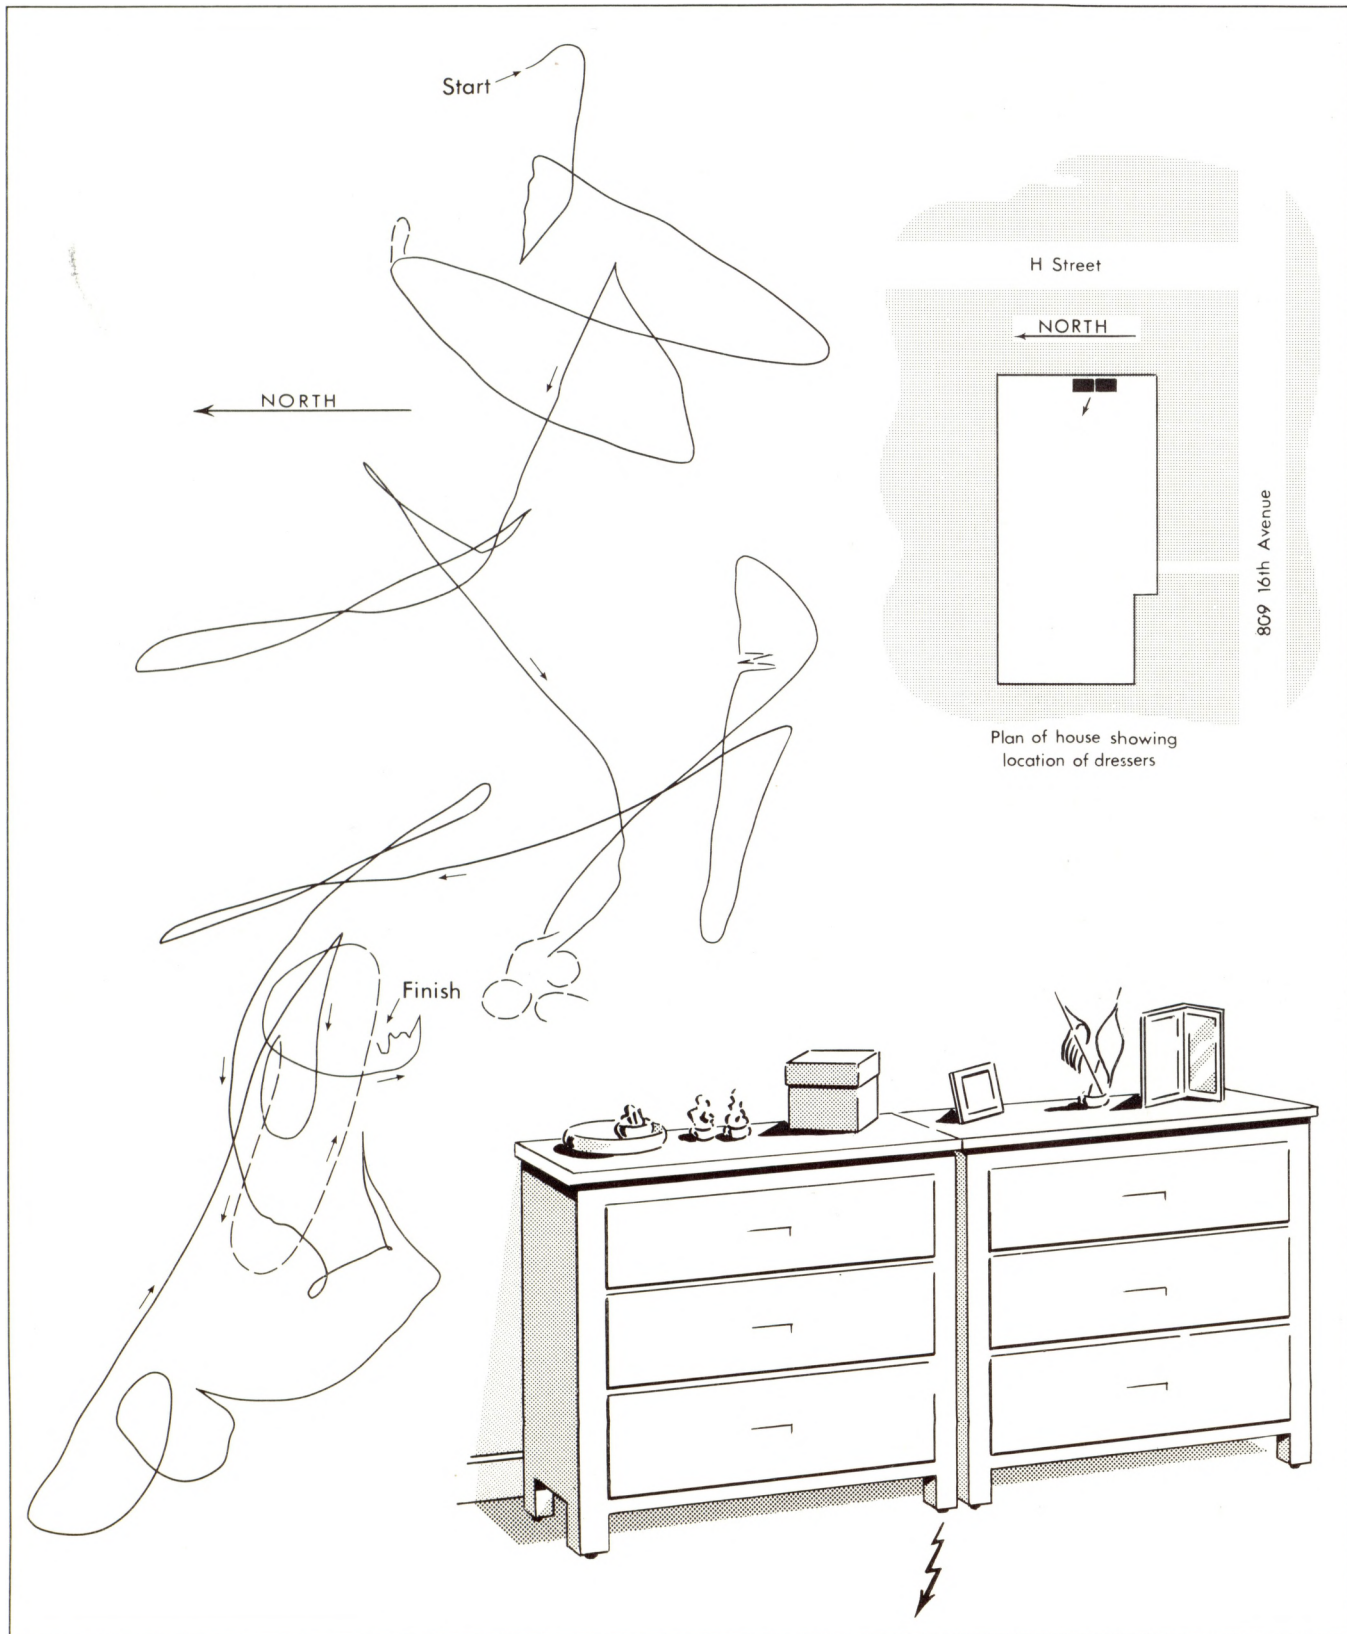
2.—Horizontal trace on asphalt tile flooring left by dresser leg during earthquake. Net movement of dresser was about N.  $75^{\circ}$  W. Other legs left nearly identical traces. Sundry items on dresser tops were little disturbed. Trace reproduced by Oliver V. Kola, published by permission of Dr. M. A. Sozen. Scale of trace,  $\times \frac{1}{2}$ .

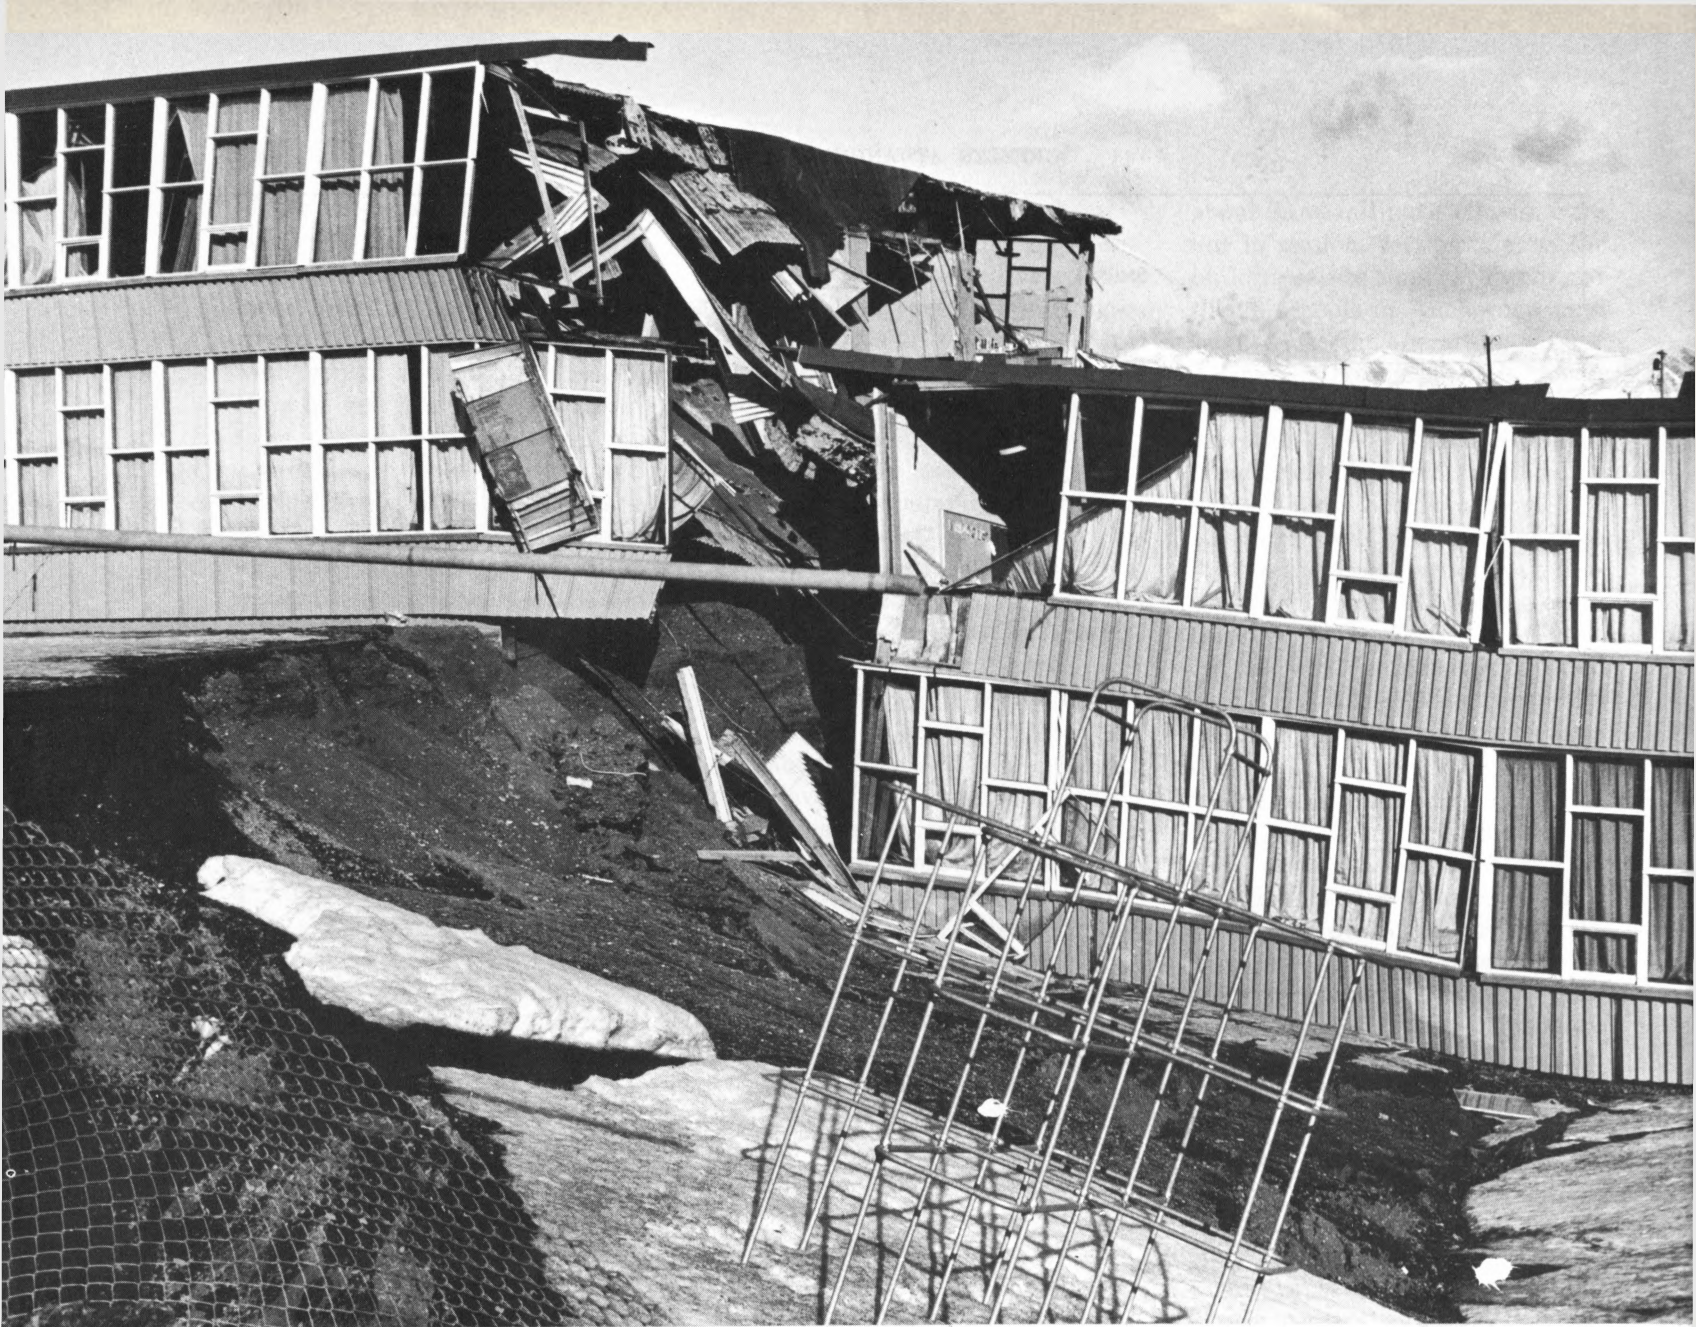
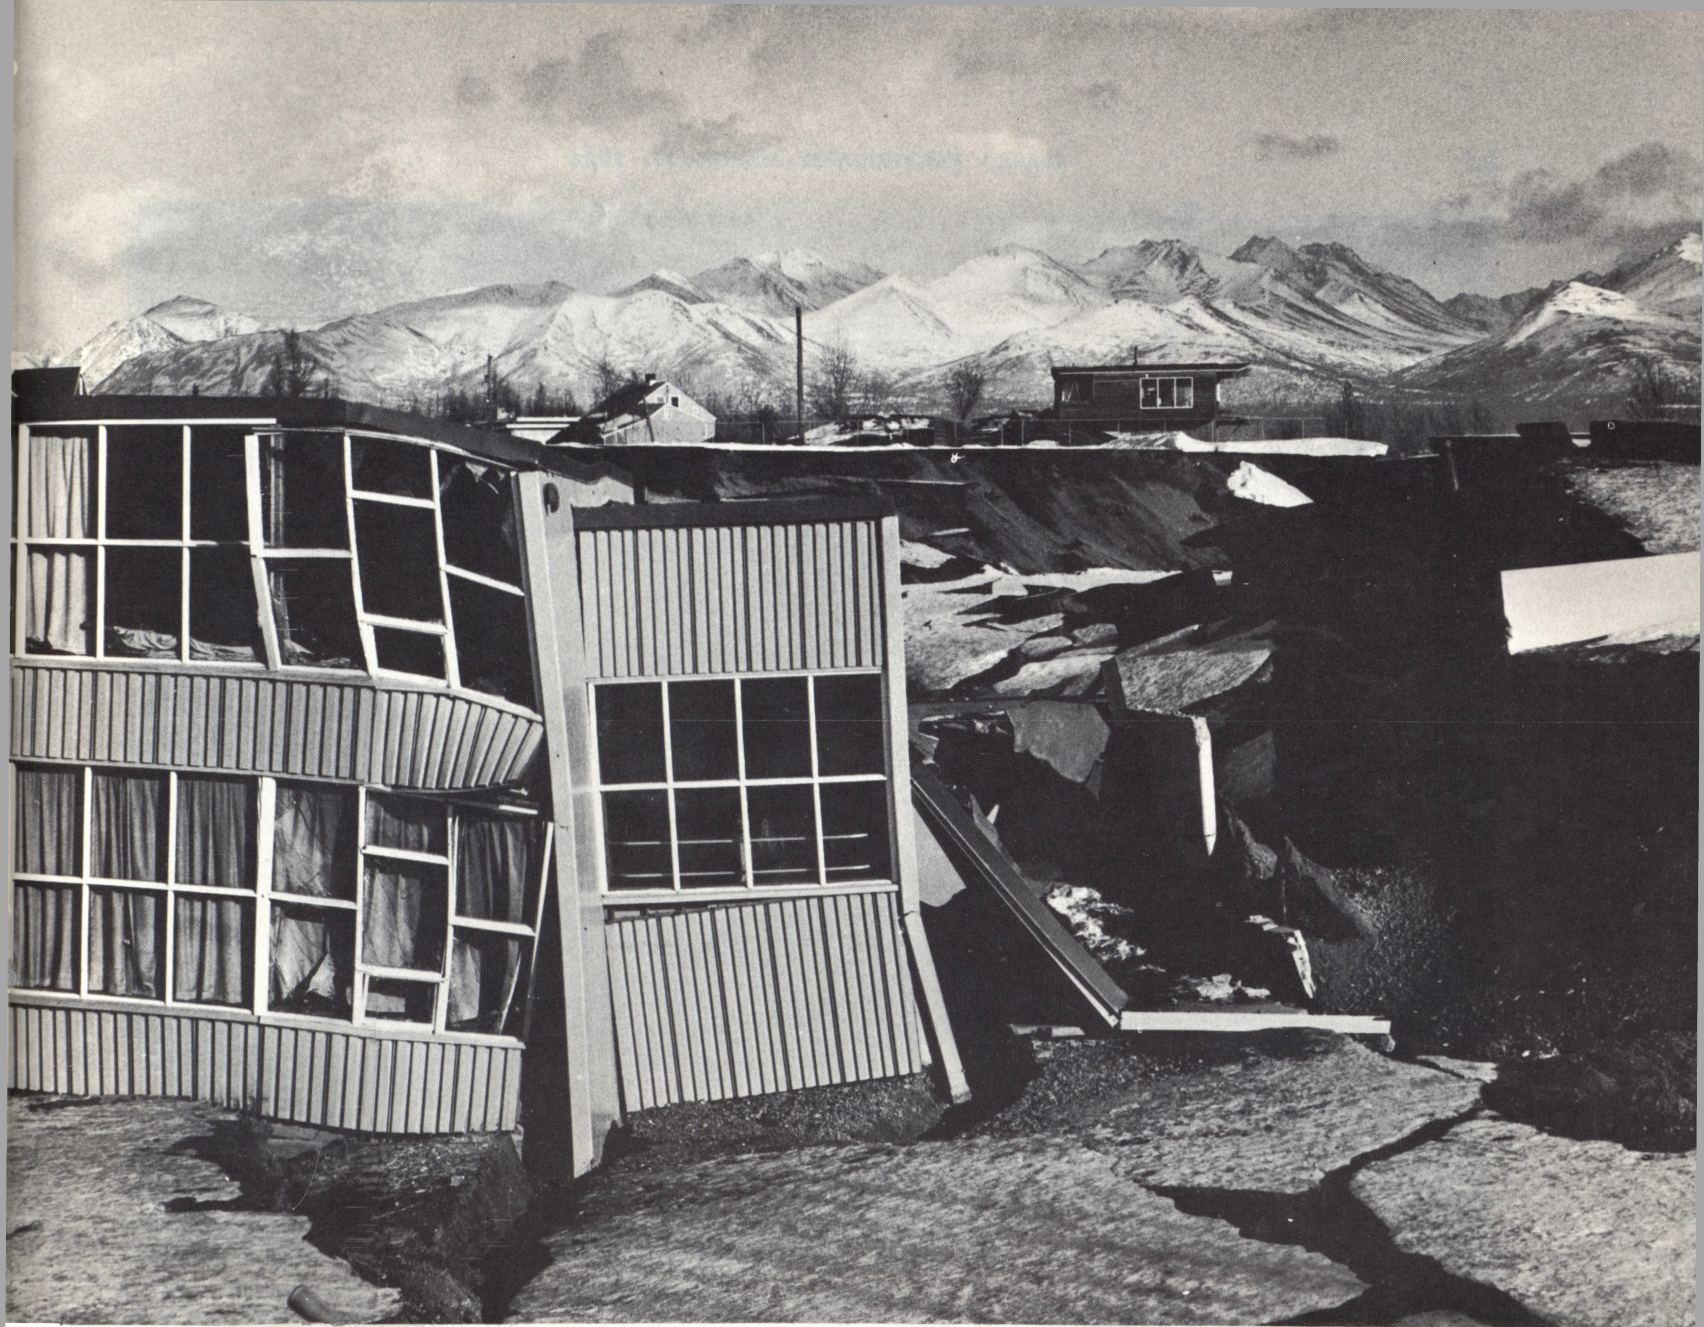
3.—Wreckage of Government Hill School. The south wing of the building, shown here, collapsed into a graben at the

head of the slide. Net slip of the graben block is shown by the displacement of the roofline. Photograph by M. G. Bonilla.

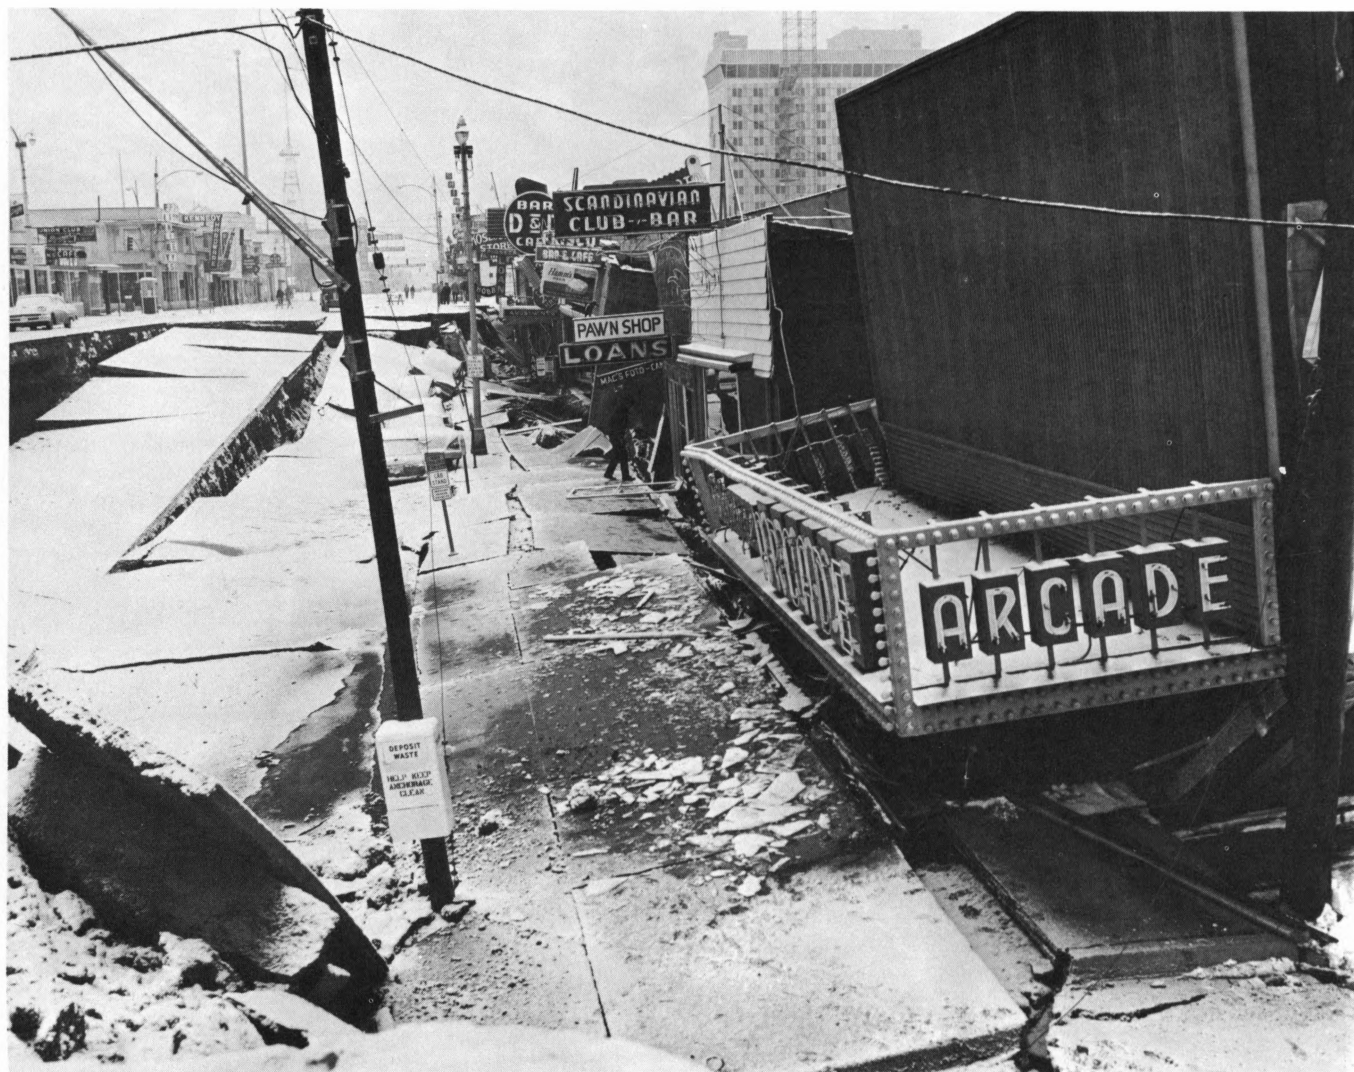
In downtown Anchorage (the L Street and Fourth Avenue landslide areas), about 30 blocks of dwellings and commercial buildings were destroyed or severely damaged (fig. 4). A new six-story apartment building, the Four Seasons, was razed. A new five-story department store (J. C. Penney Co.) was damaged beyond repair by seismic shaking and had to be torn down (fig. 5). Many automobiles in the downtown area were struck by falling debris. Twin 14-story apartment buildings, though a mile apart, sustained massive, nearly identical vibratory damage, much of it in response to vertical shearing forces caused by oscillation. Many other multistory or large-area buildings were severely damaged.

4.—View west along Fourth Avenue at head of landslide. North (right) side of street has collapsed into a graben. Vertical displacement is about 10 feet. Photograph by Mac's Foto, Anchorage, Alaska.

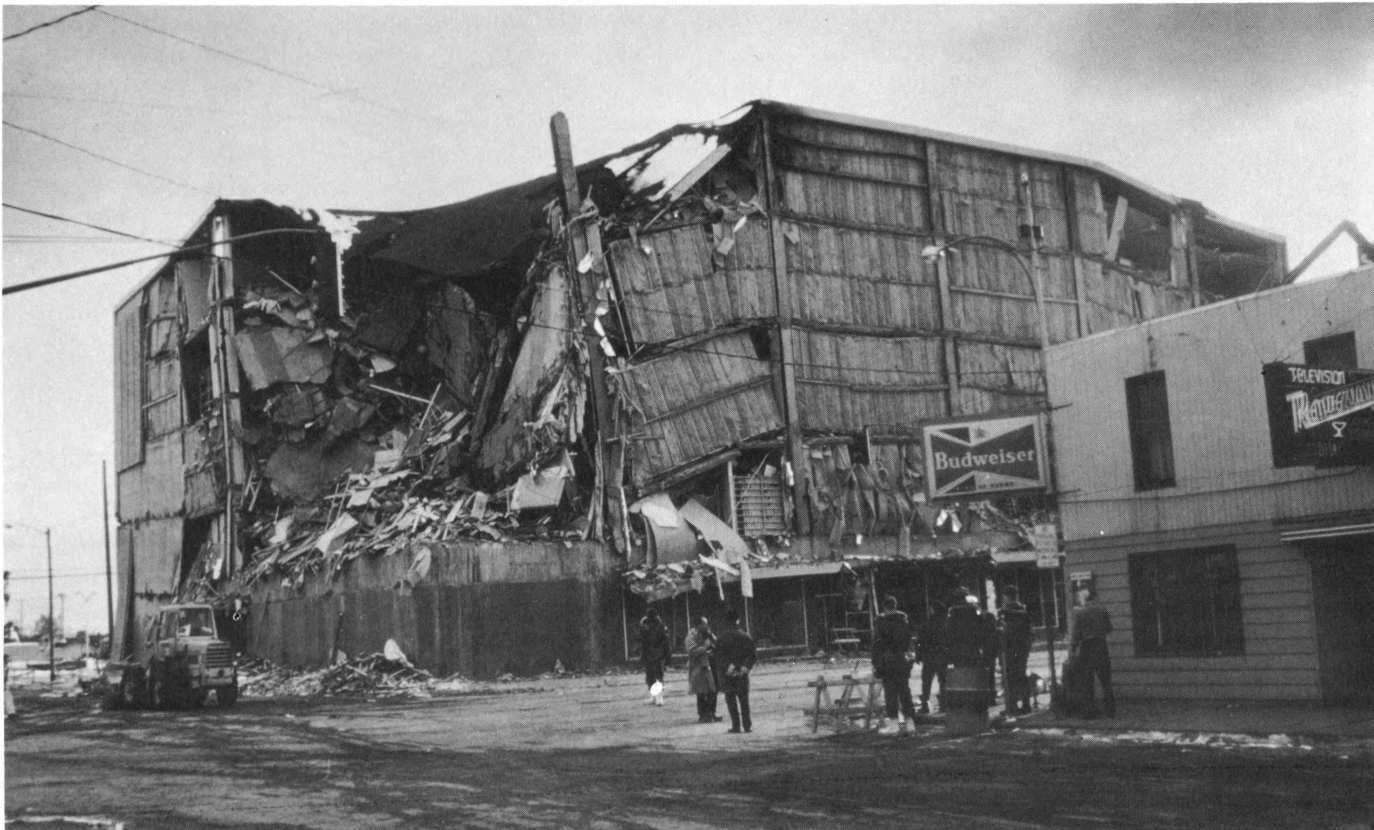
5.—Wreckage of Penney's department store, Fifth Avenue and D Street, Anchorage. Building failed after sustained seismic shaking. Most of rubble has been cleared from streets. Photograph by George Plafker.

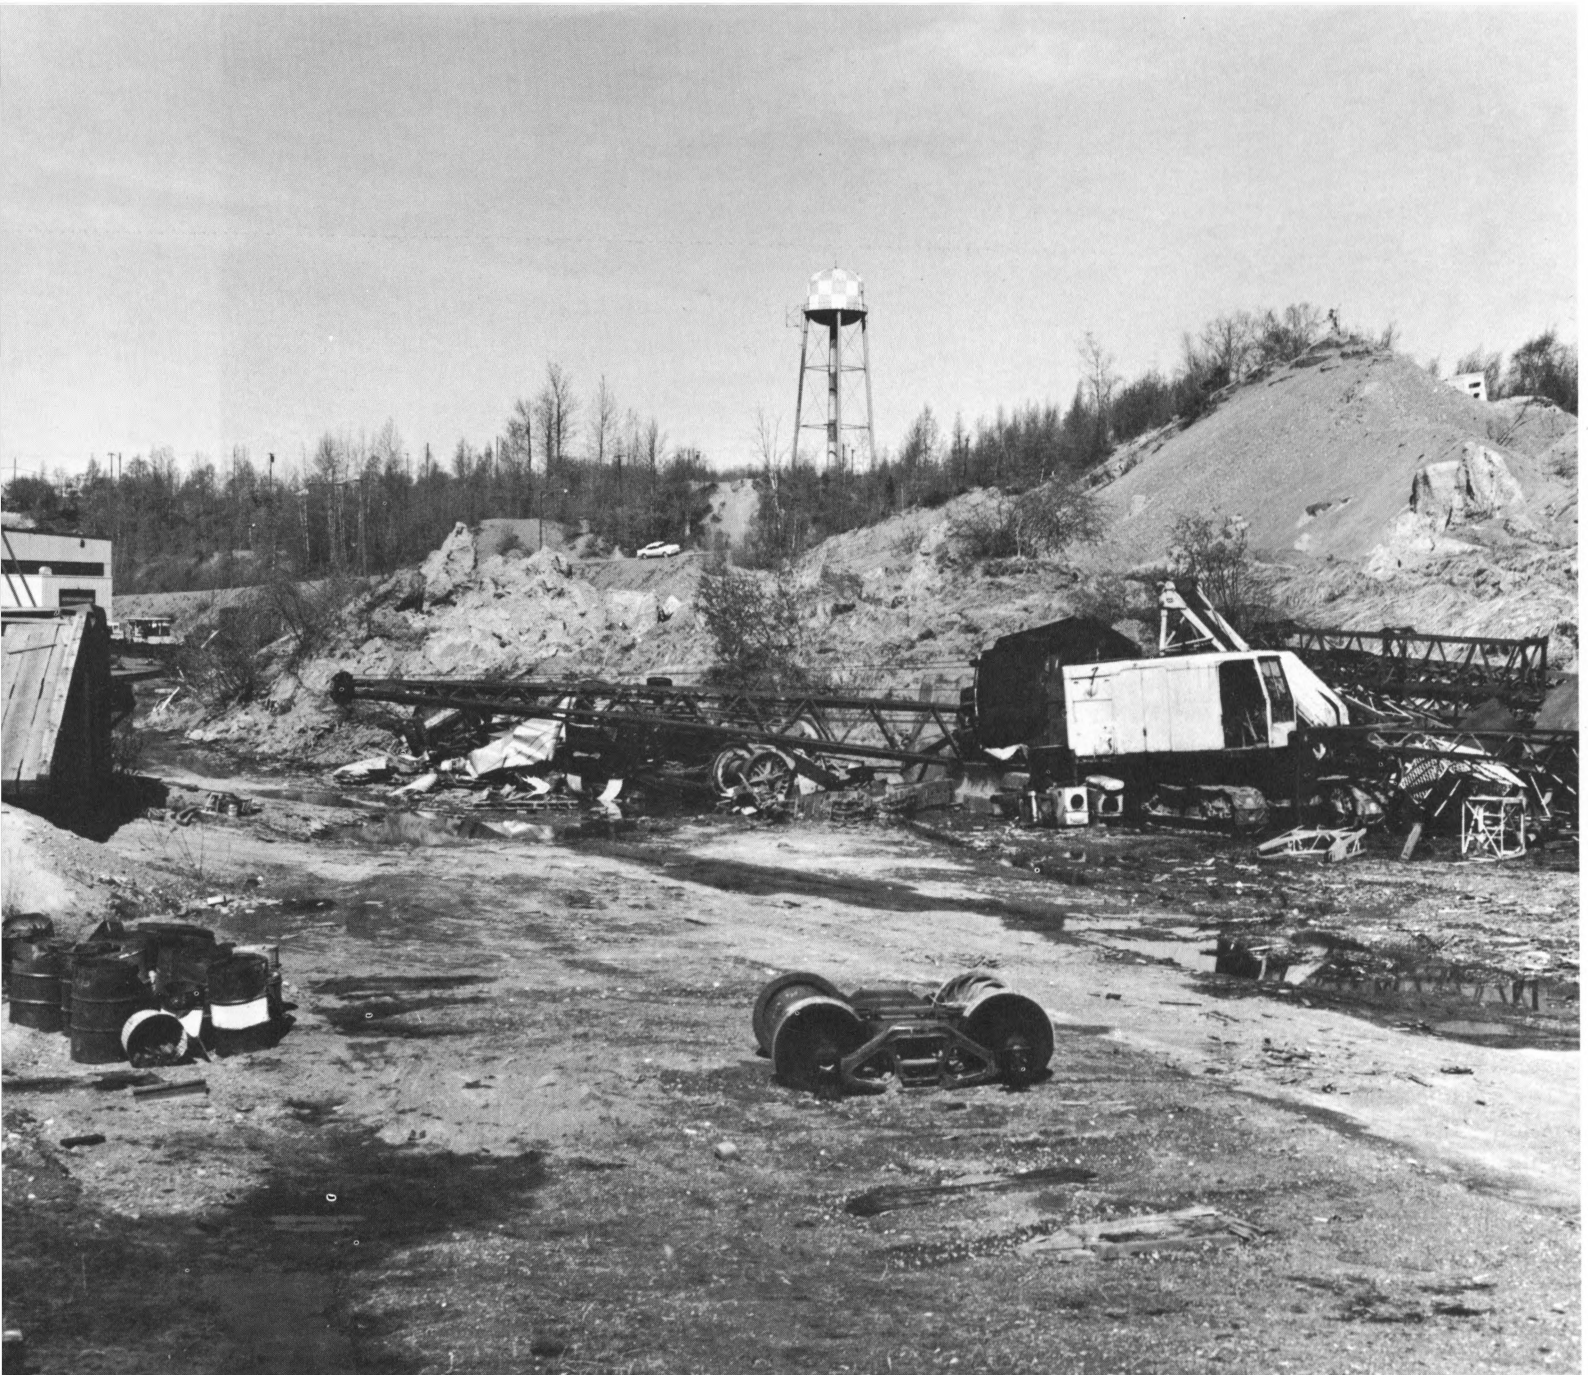
6.—Damage to yards of The Alaska Railroad, looking northwest, caused by earthflow at toe of Government Hill slide. Note undamaged water tank in background.

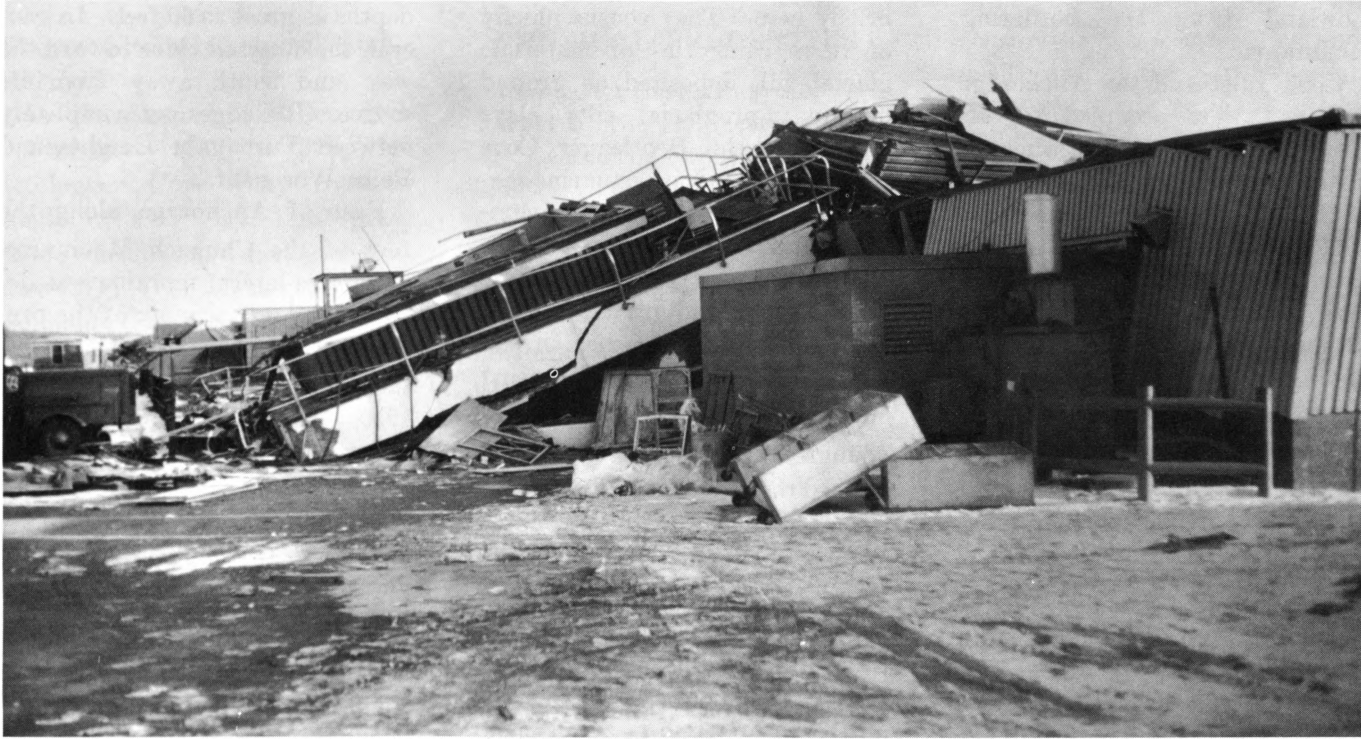
At the Anchorage International Airport, the control tower failed under seismic vibration and collapsed to the ground (fig. 7), killing one occupant and injuring another. The airport terminal building, although tied structurally to the tower, was only slightly

7.—Wreckage of control tower at Anchorage International Airport. Six-story tower failed under sustained seismic shaking. Photograph by George Plafker.

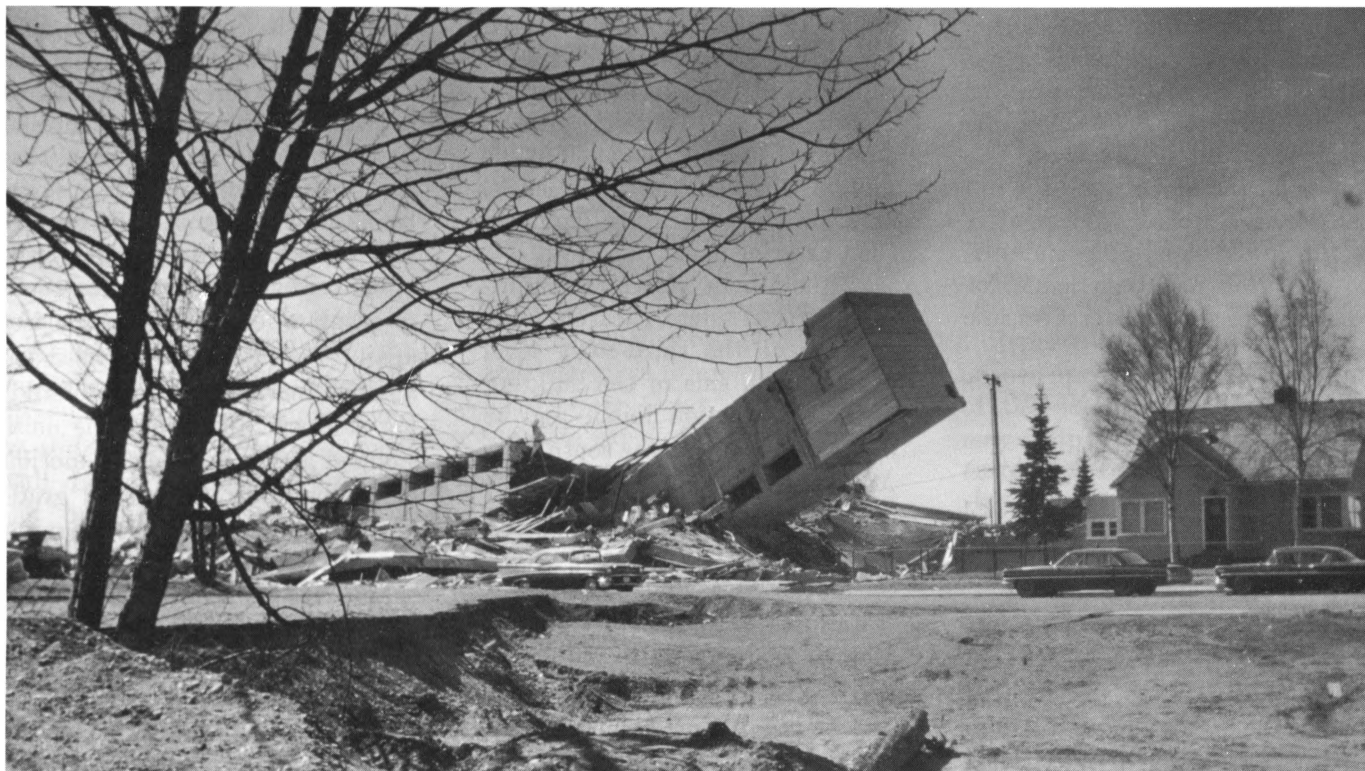
The effects of seismic vibration in areas of cracked ground cannot always be separated from the effects of ground displacement. The collapse of the Four Seasons Apartment Building (fig. 13), a case in point, has been attributed to seismic vibration. Perhaps vibration was the dominant factor in the building's failure. The building, however, was close to the L Street graben at West Ninth Avenue and M Street, and a large subsidiary fracture, trending about west-northwest, passed directly under the building. In the chaotic pile of rubble left after the

13.—Wreckage of six-story Four Seasons Apartment Building, Anchorage, Alaska. Canted elevator shaft at center. Large crack in foreground, filled in on M Street to restore traffic, passed beneath building.

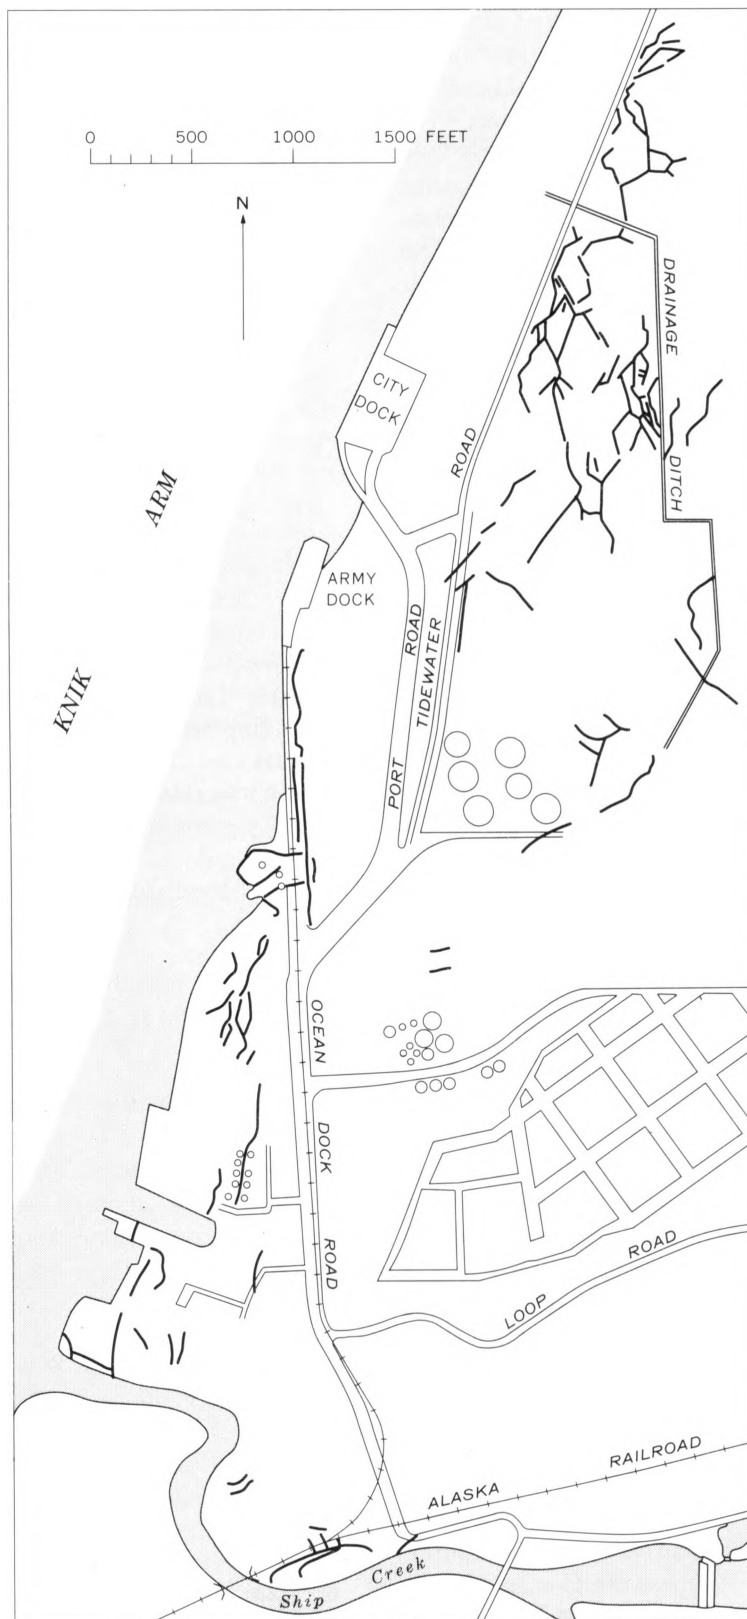
14.—Ground cracks, Port of Anchorage and vicinity. Anchorage, Alaska. Many of these cracks spouted mud, particularly those east of City Dock. Base by city of Anchorage, Office of City Engineer.

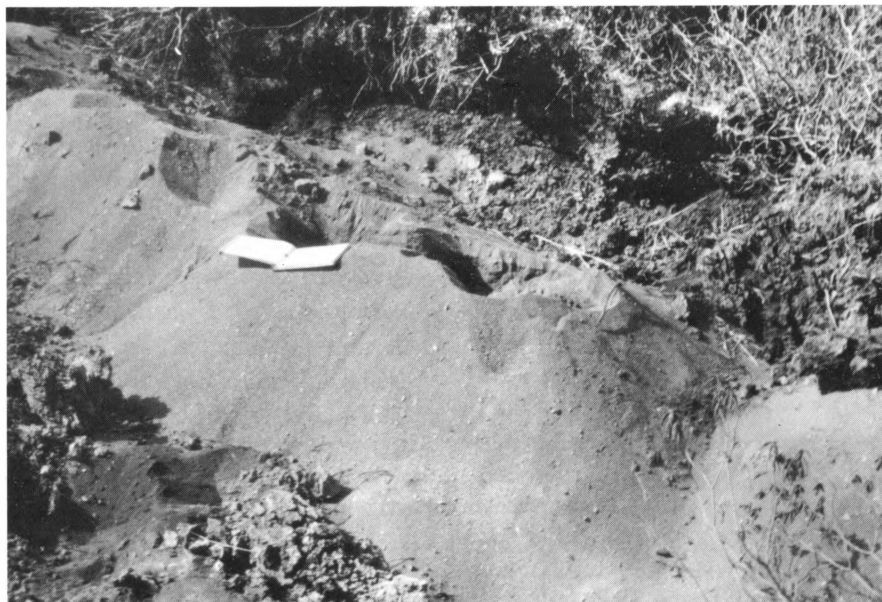
15.—Part of a sand boil, Turnagain Heights slide area. Ridges 2 to 3 feet high and 100 feet long or more were formed as fountains of water were ejected through frozen outwash.

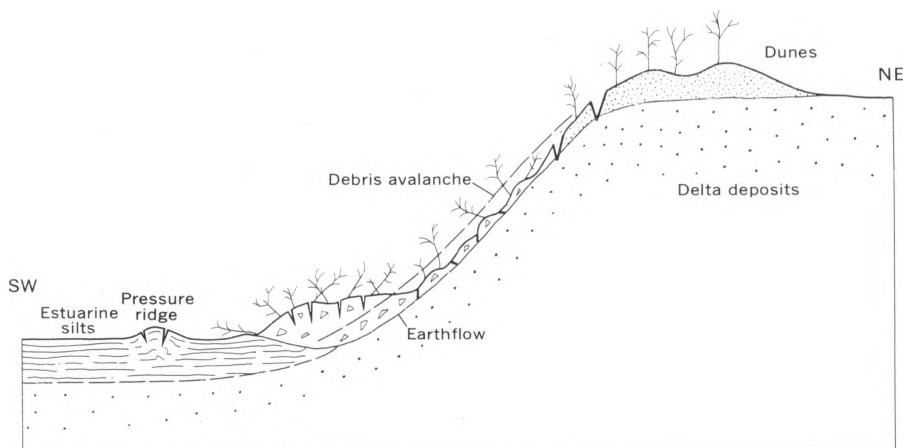
16.—Diagrammatic section near Point Campbell, showing mode of failure along bluff line overlooking Turnagain Arm.

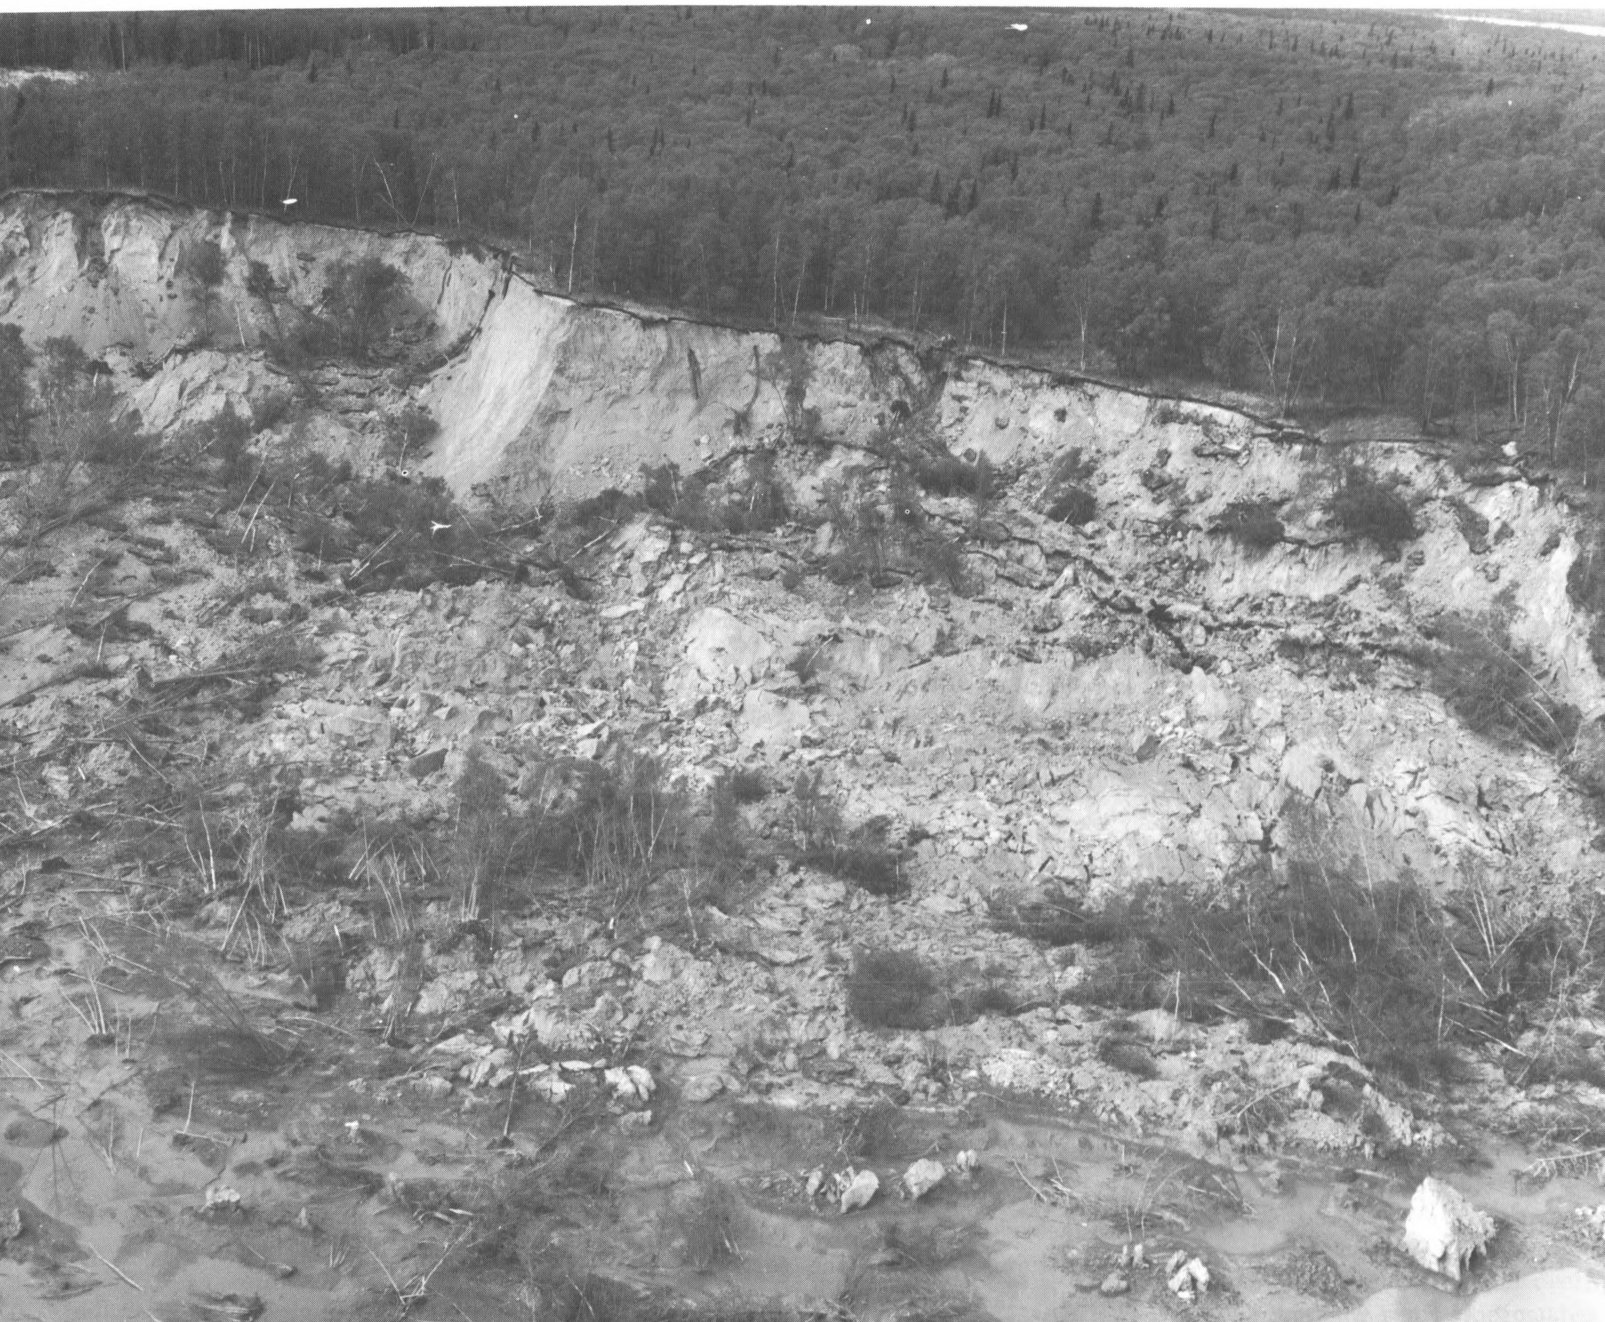
19.—Rotational slump near Sleeper landing strip, on the west side of Knik Arm opposite Cairn Point. At its foot, the slump passed into an earthflow. Tidewater in foreground. Scarp to left of upper center is about 80 feet high.

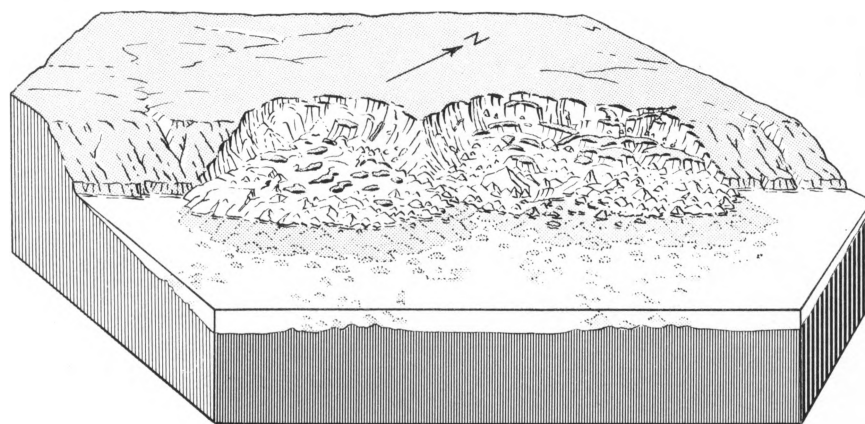
20.—Block diagram of compound slump near Sleeper landing strip. Two lobes of slide surged out onto mudflat below high tide.

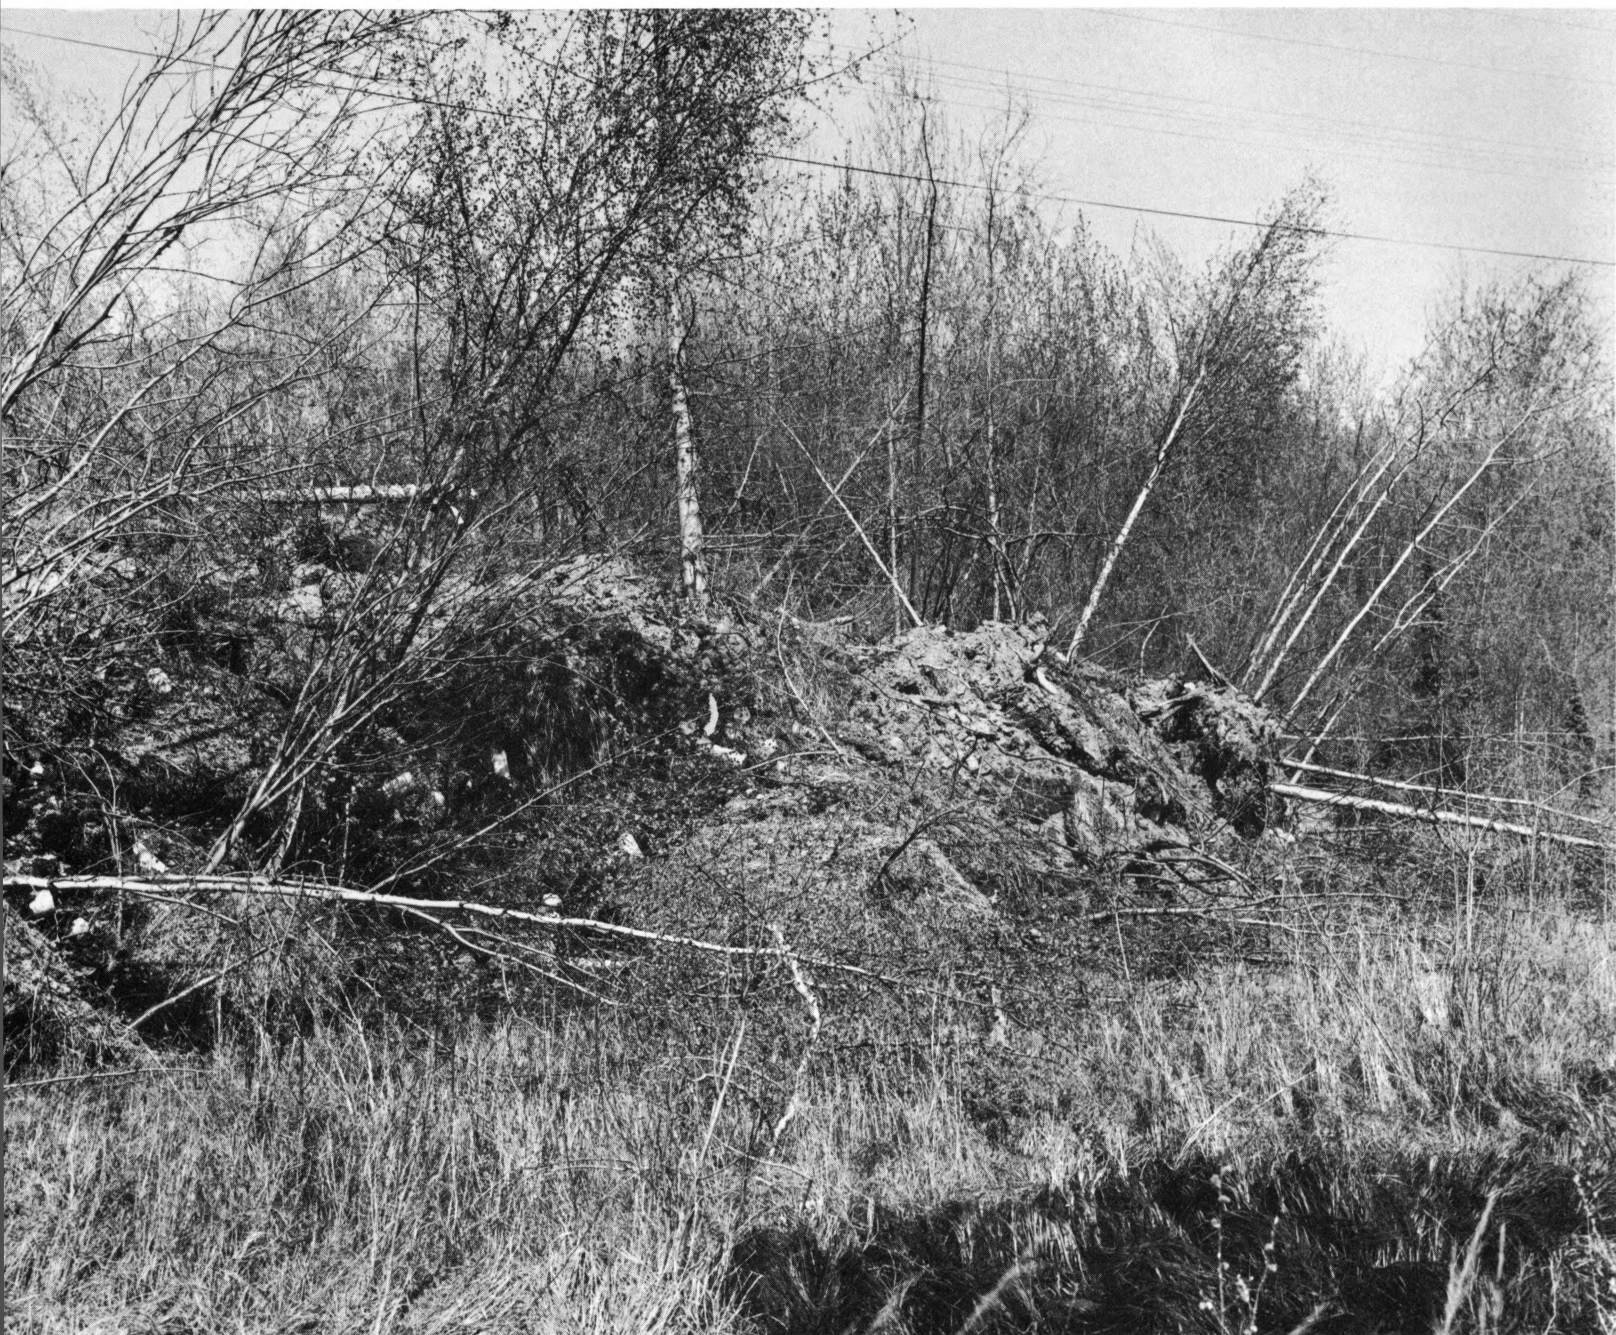
21.—Chaotic pressure ridge at toe of rotational slide, Bluff Road.. In part, toe surged forward as an earthflow. Compare with figure 22.

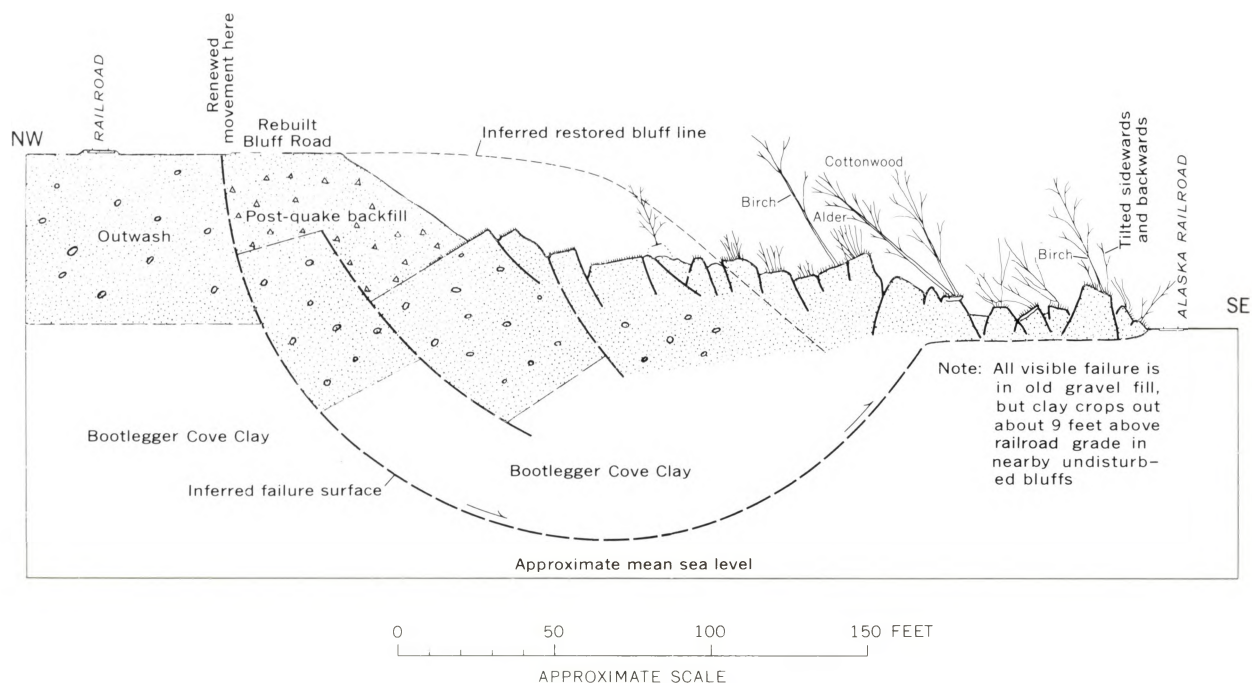
22.—Sketch section through rotational slide at Bluff Road.
