# Effects of the Earthquake Of March 27, 1964 At Anchorage, Alaska

BY WALLACE R. HANSEN

*A description and analysis of the damage resulting from seismic vibration, ground cracks, and especially landslides in Alaska's largest city*

GEOLOGICAL SURVEY PROFESSIONAL PAPER 542-A

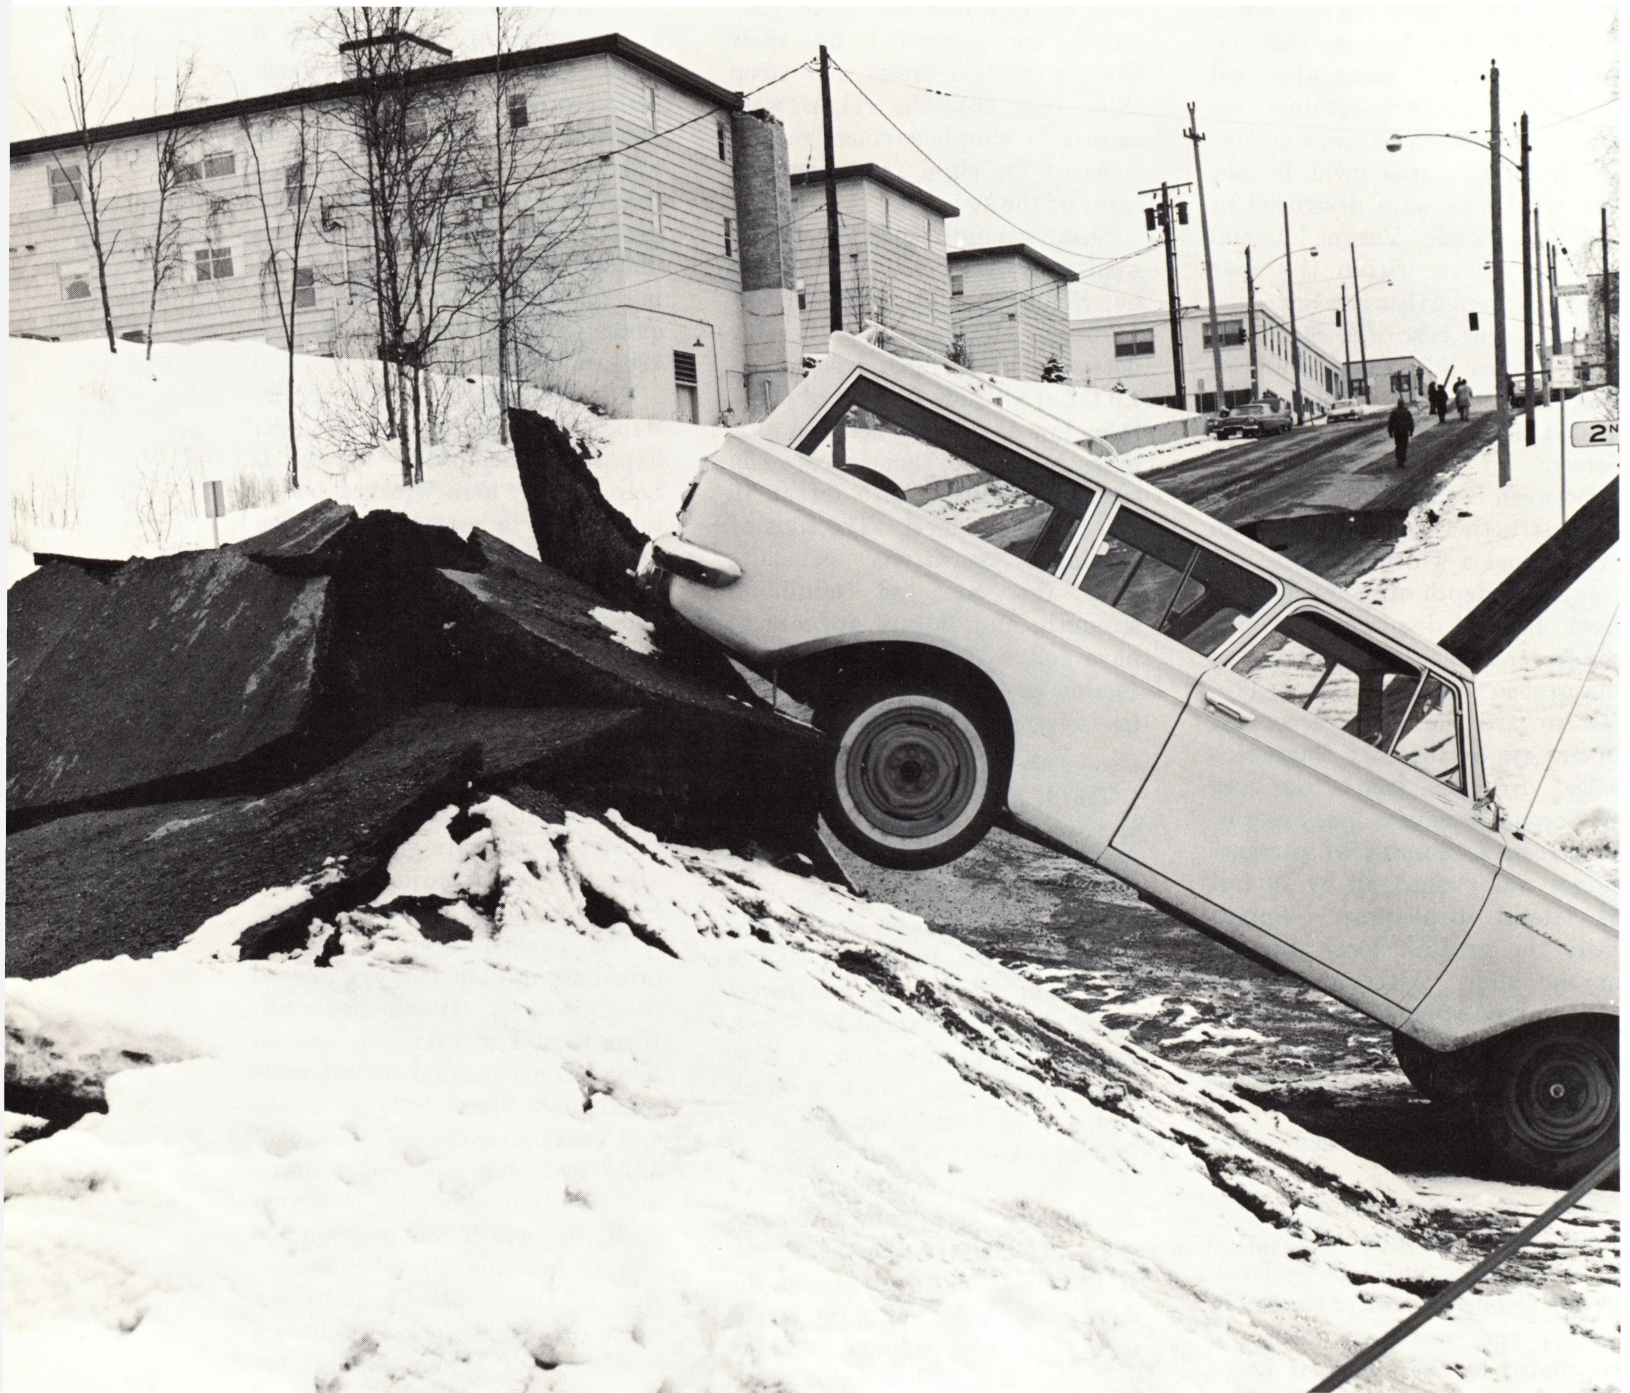
26.—Sharp-crested pressure ridge at Second Avenue and C Street, Anchorage. Probably caused by shallow translation of frozen surface layer. Note smaller pressure ridge in street part way up block and toppled chimney of building behind car. Photograph by Mac's Foto, Anchorage.

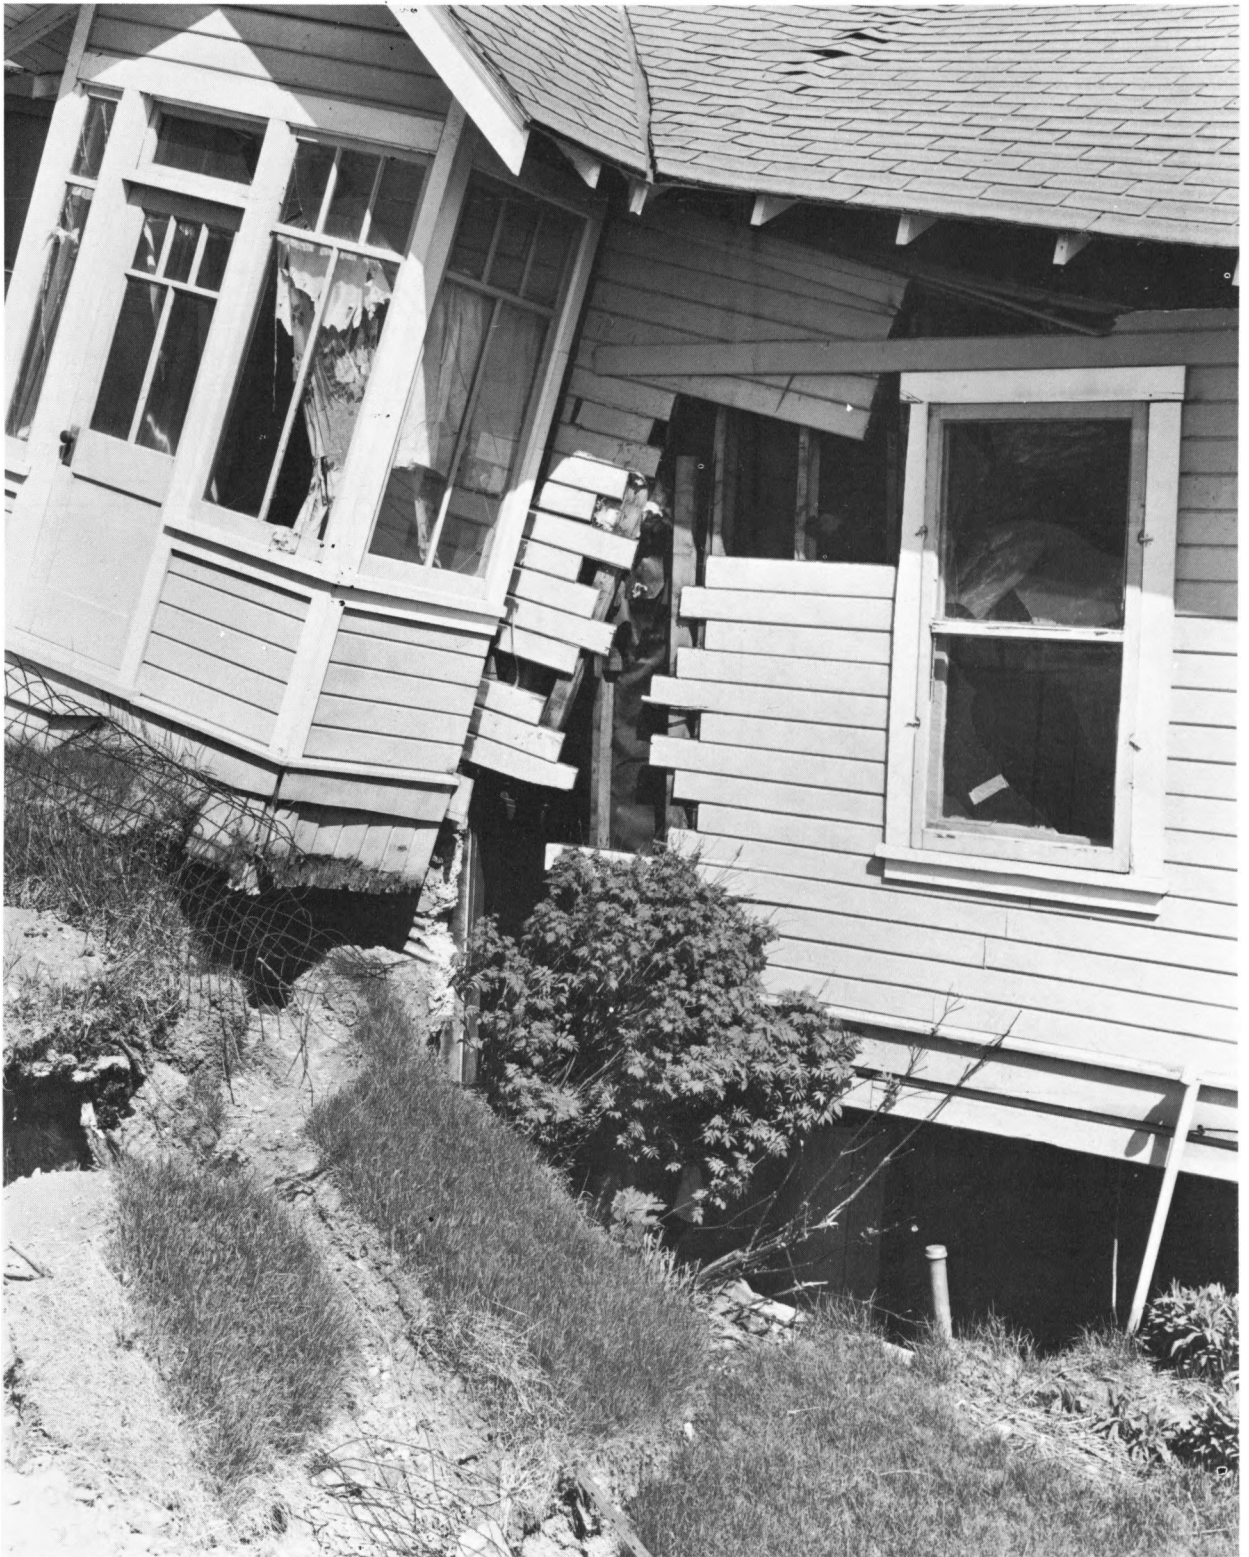
28.—Wrecked dwelling astride bounding fracture, L Street graben at Eighth Avenue and N Street. Damage caused entirely by ground displacement along fracture.

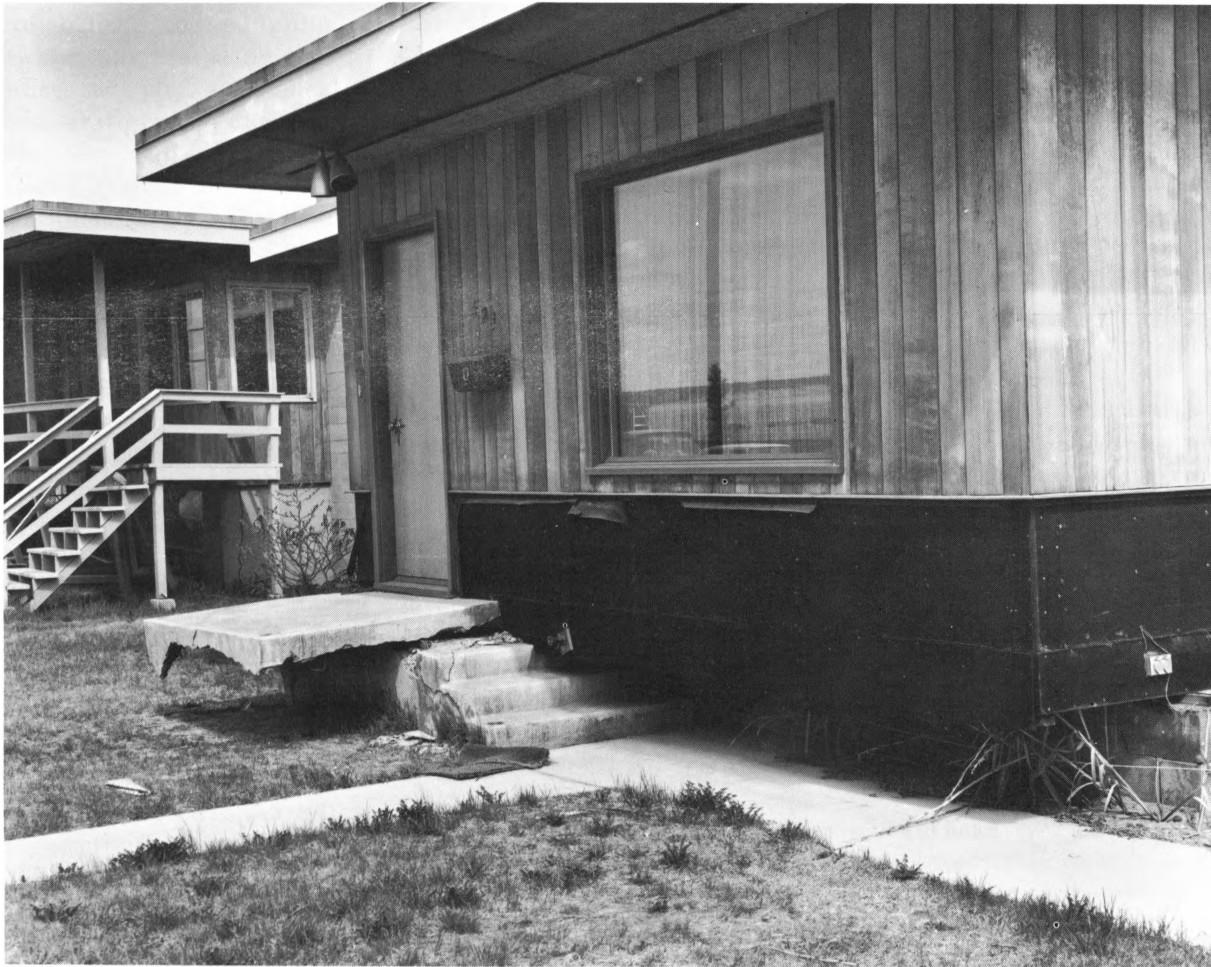
29.—House pushed off foundation by pressure ridge at toe of L Street slide. Well-framed house not otherwise visibly damaged. Push must have been shallow and nearly horizontal.

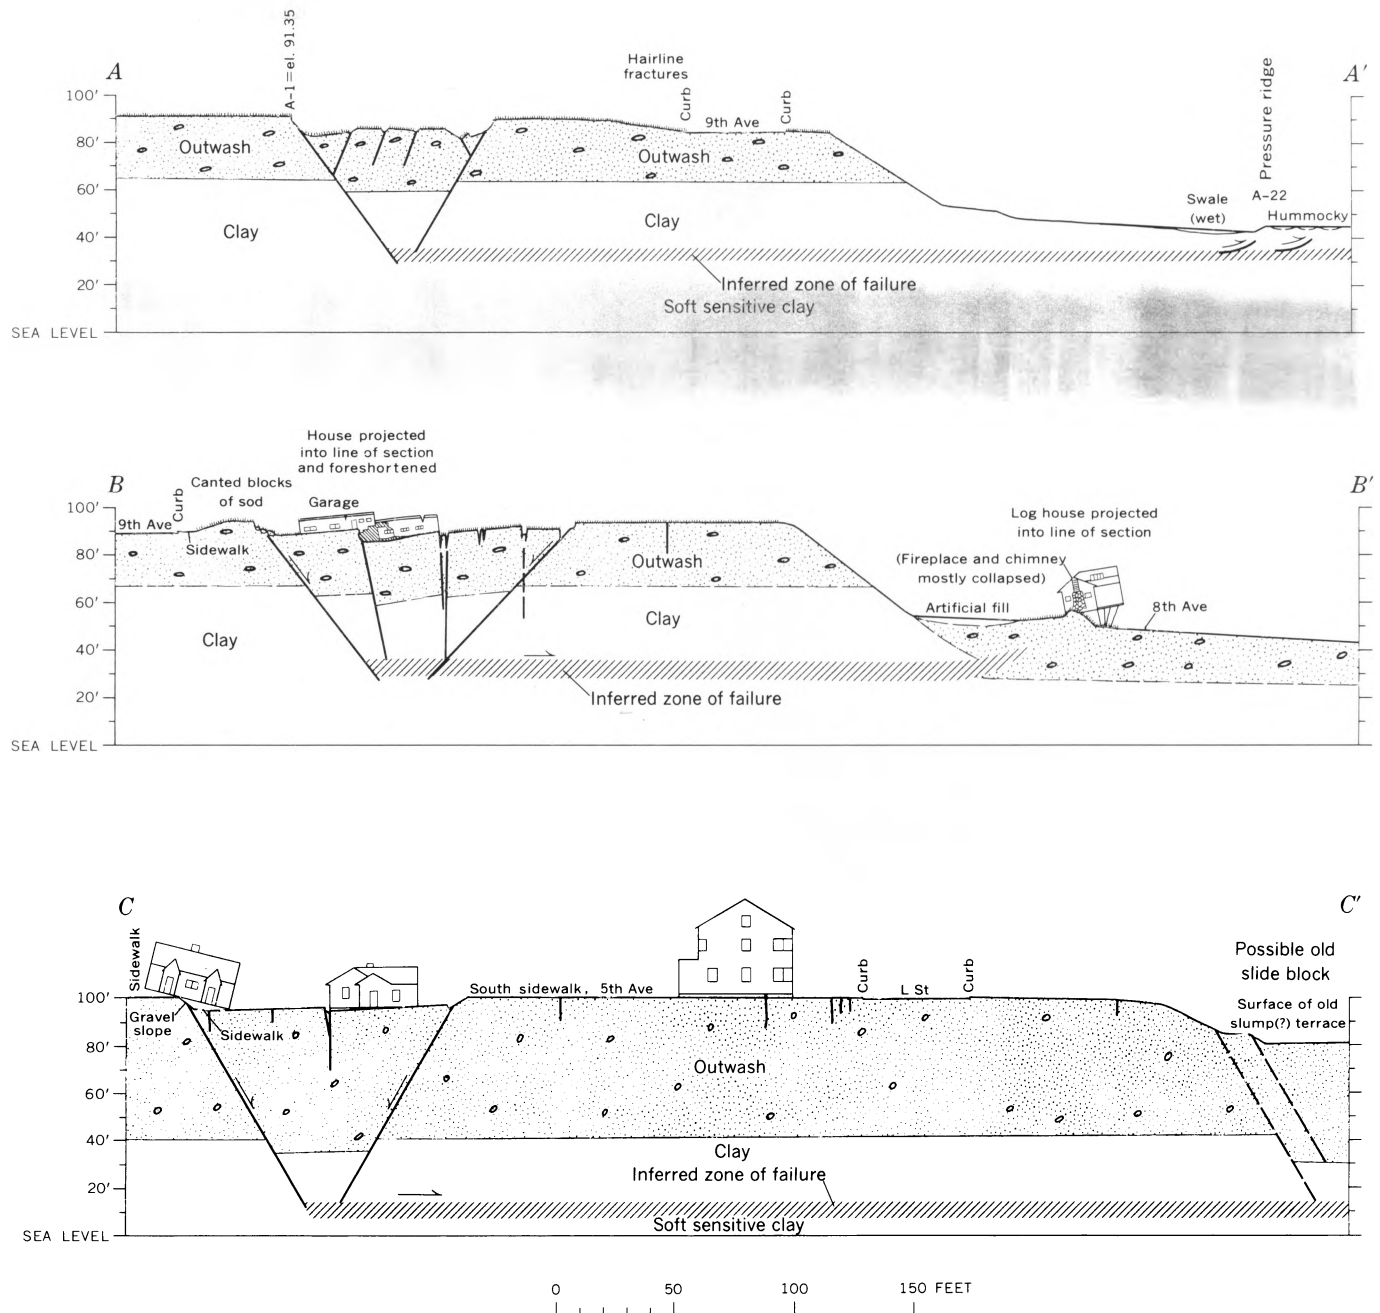
30.—Geologic section through the L Street slide. In section C-C' the toe of the slide is to the right of C'.

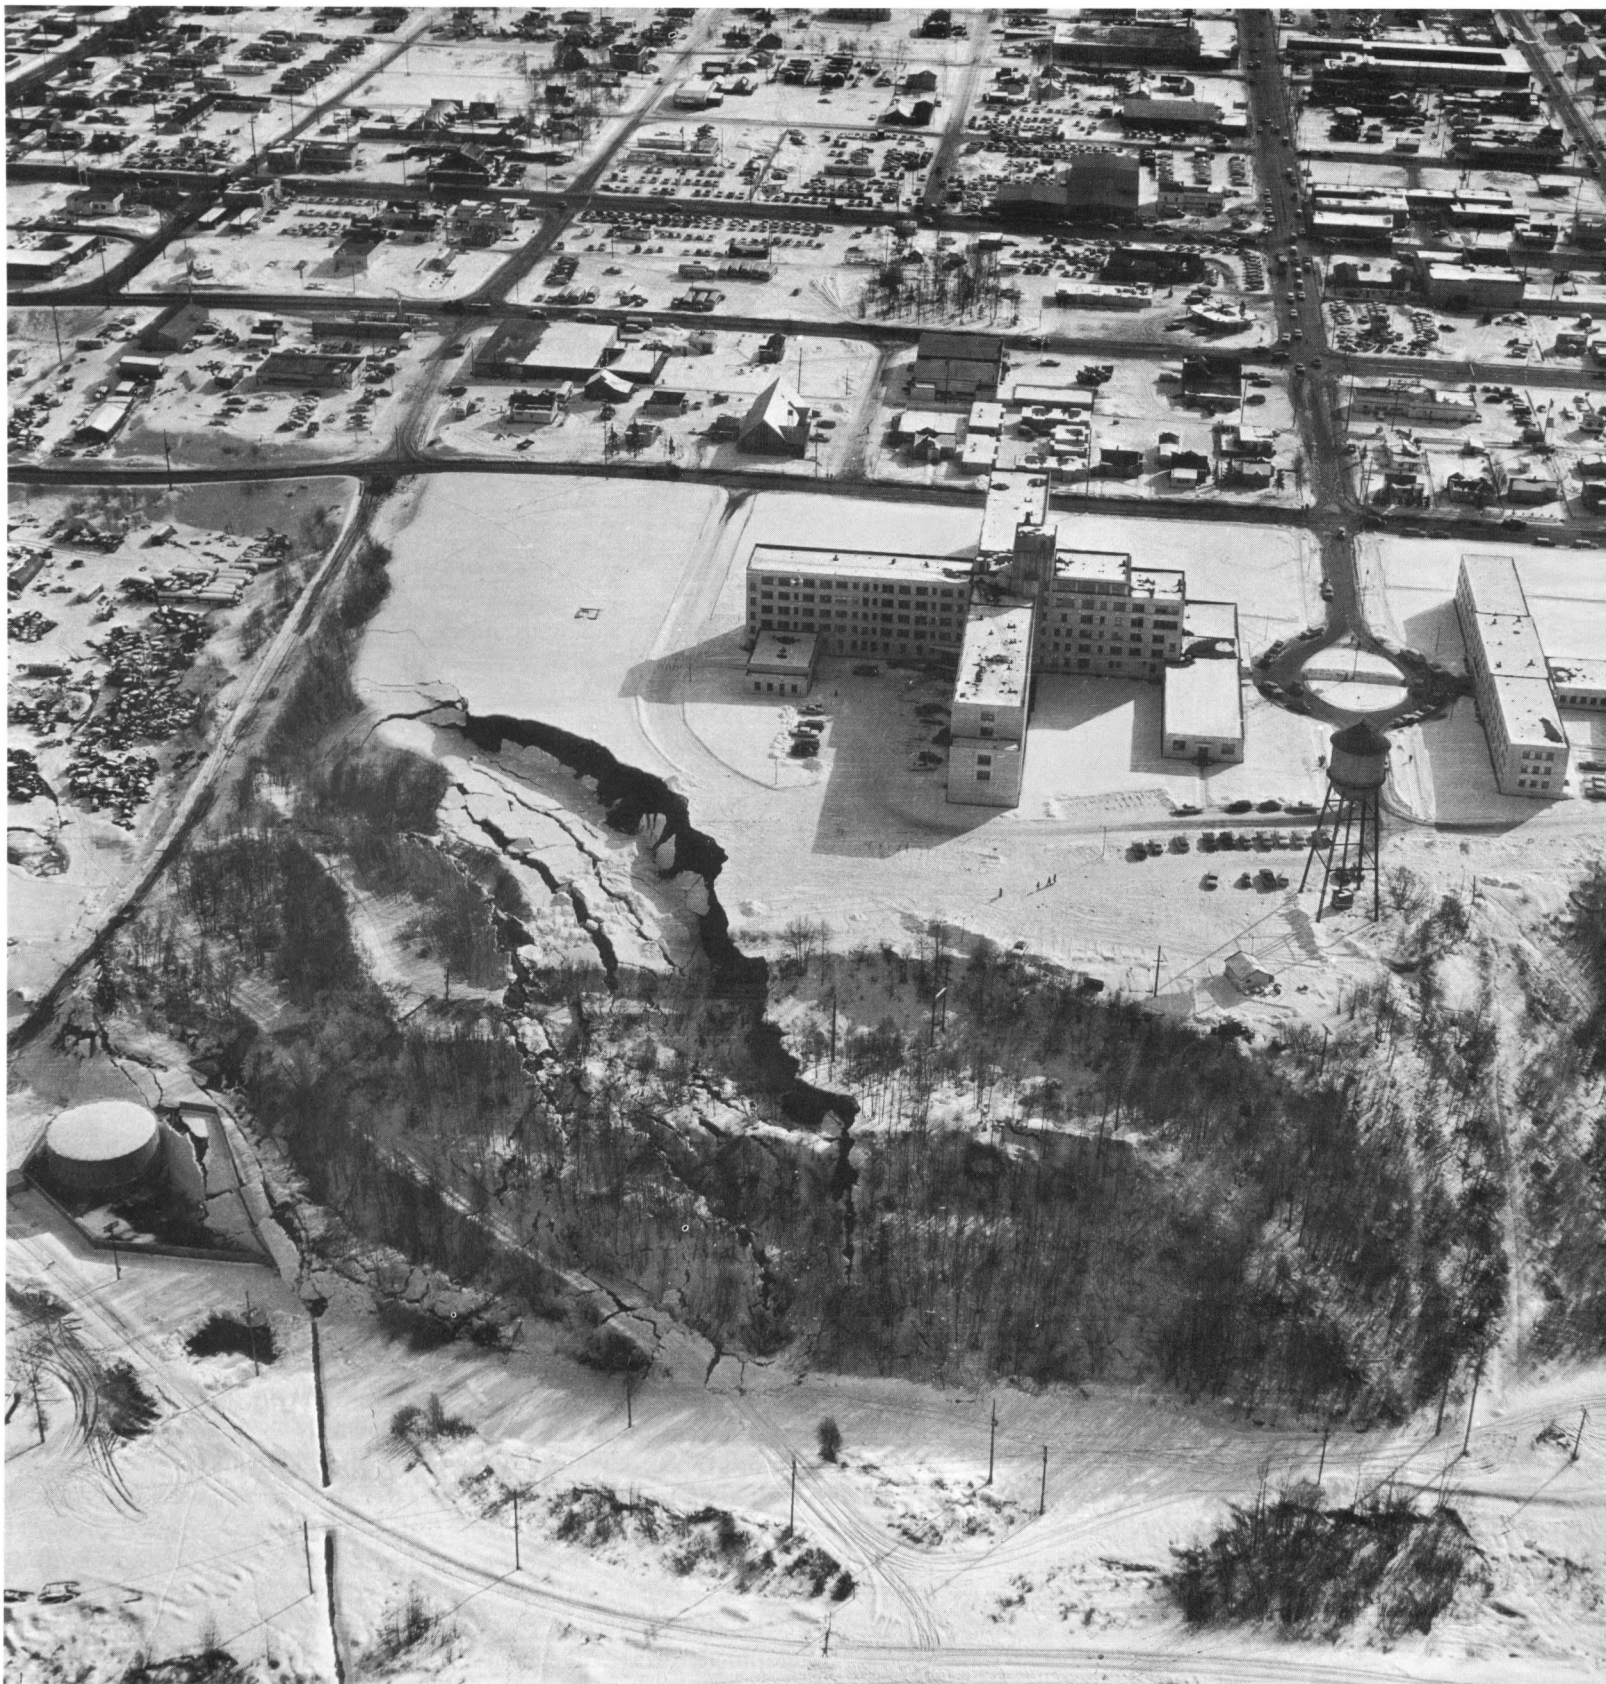
32.—Air view (looking south) of Native Hospital slide showing graben and pressure ridge. The scar of an older landslide is transected by the slide of March 27, 1964. Photograph by U.S. Army.

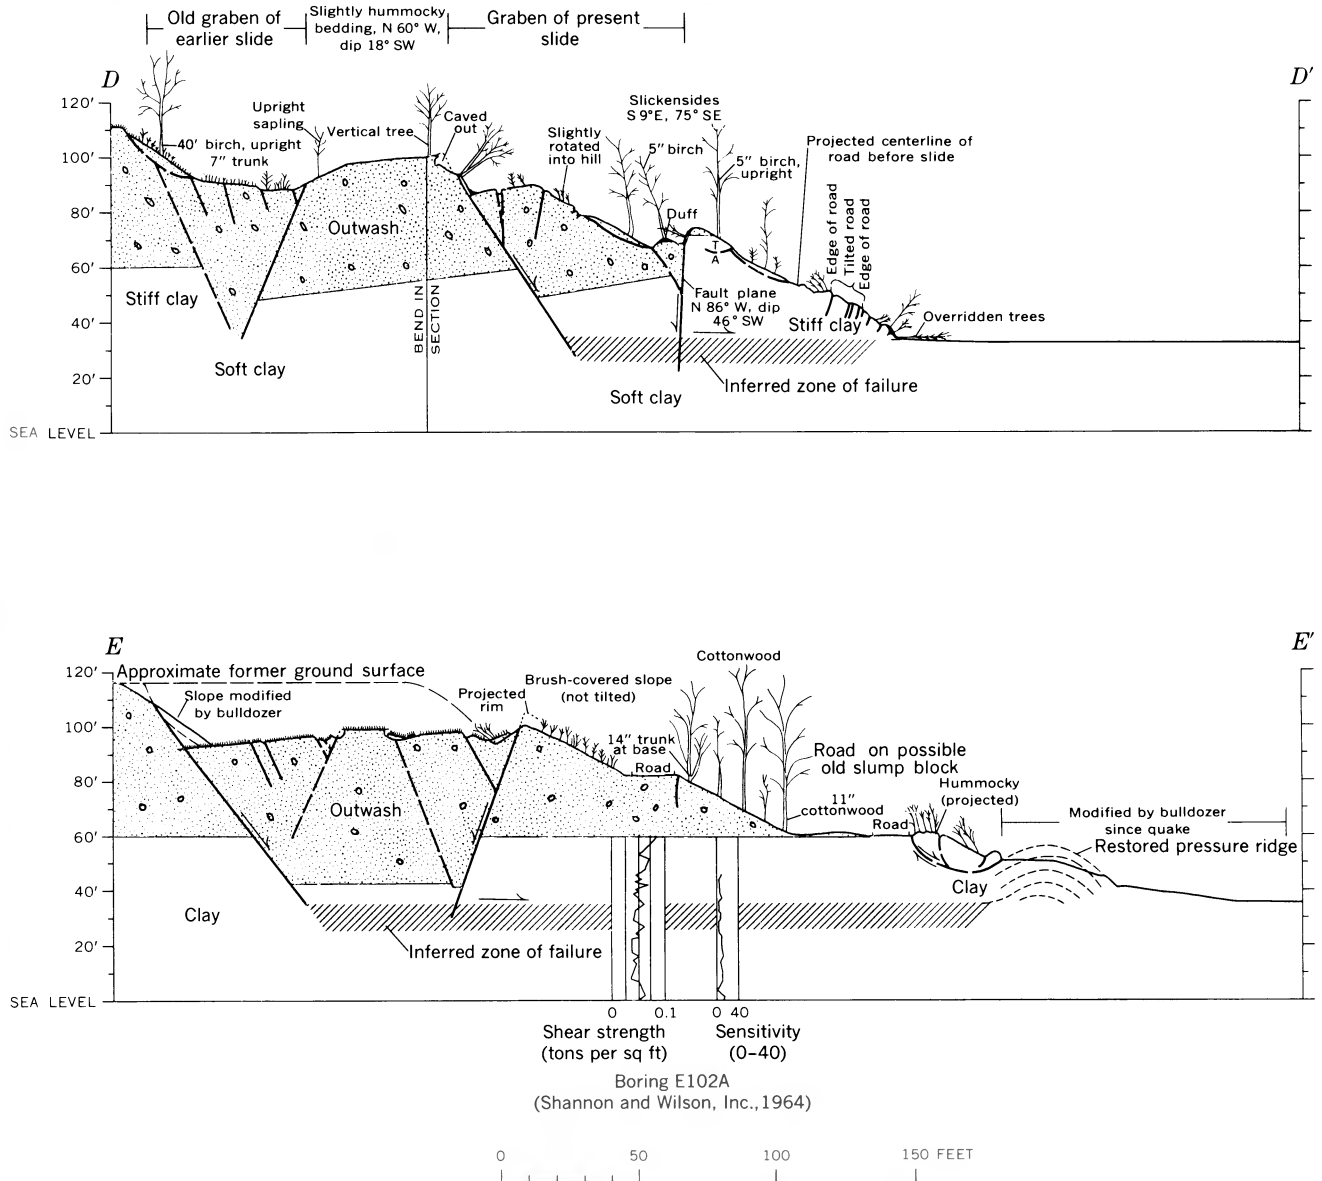
33.—Geologic sections through the Native Hospital slide, Anchorage, Alaska. Section D-D' transects the graben of an earlier landslide (upper left). Boring data from Shannon and Wilson, Inc. (1964).

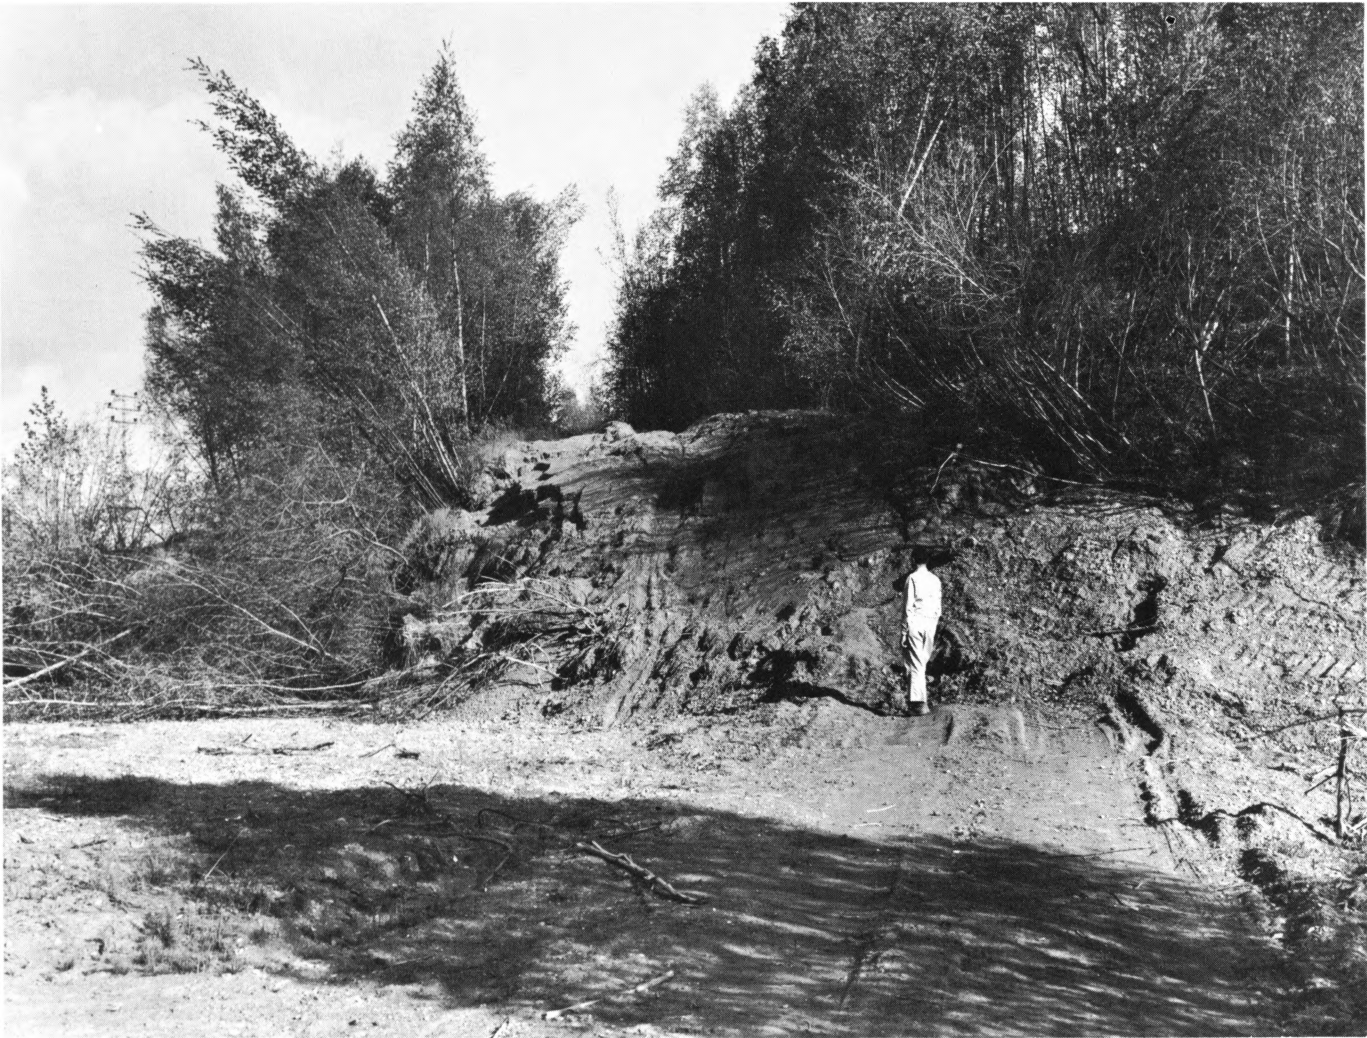
34.—Overthrust toe of Native Hospital slide. Road is bulged up and displaced about 12 feet laterally. Note overridden trees at left.

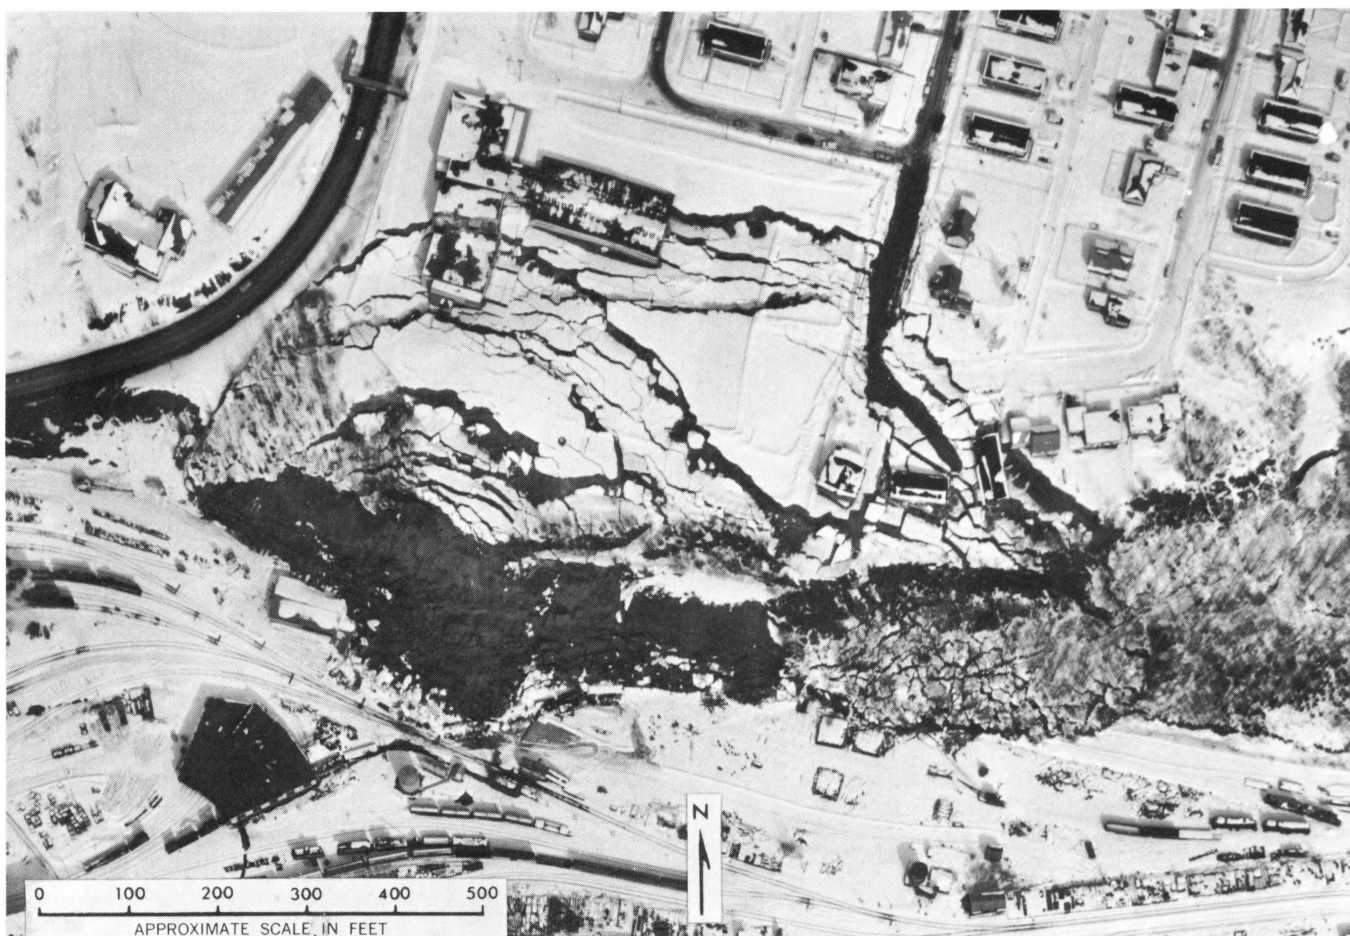
35.—Air view of Government Hill slide, Anchorage, Alaska. Graben plainly discernible. Compare with figure 38. Photograph by Air Photo Tech, Anchorage, Alaska.

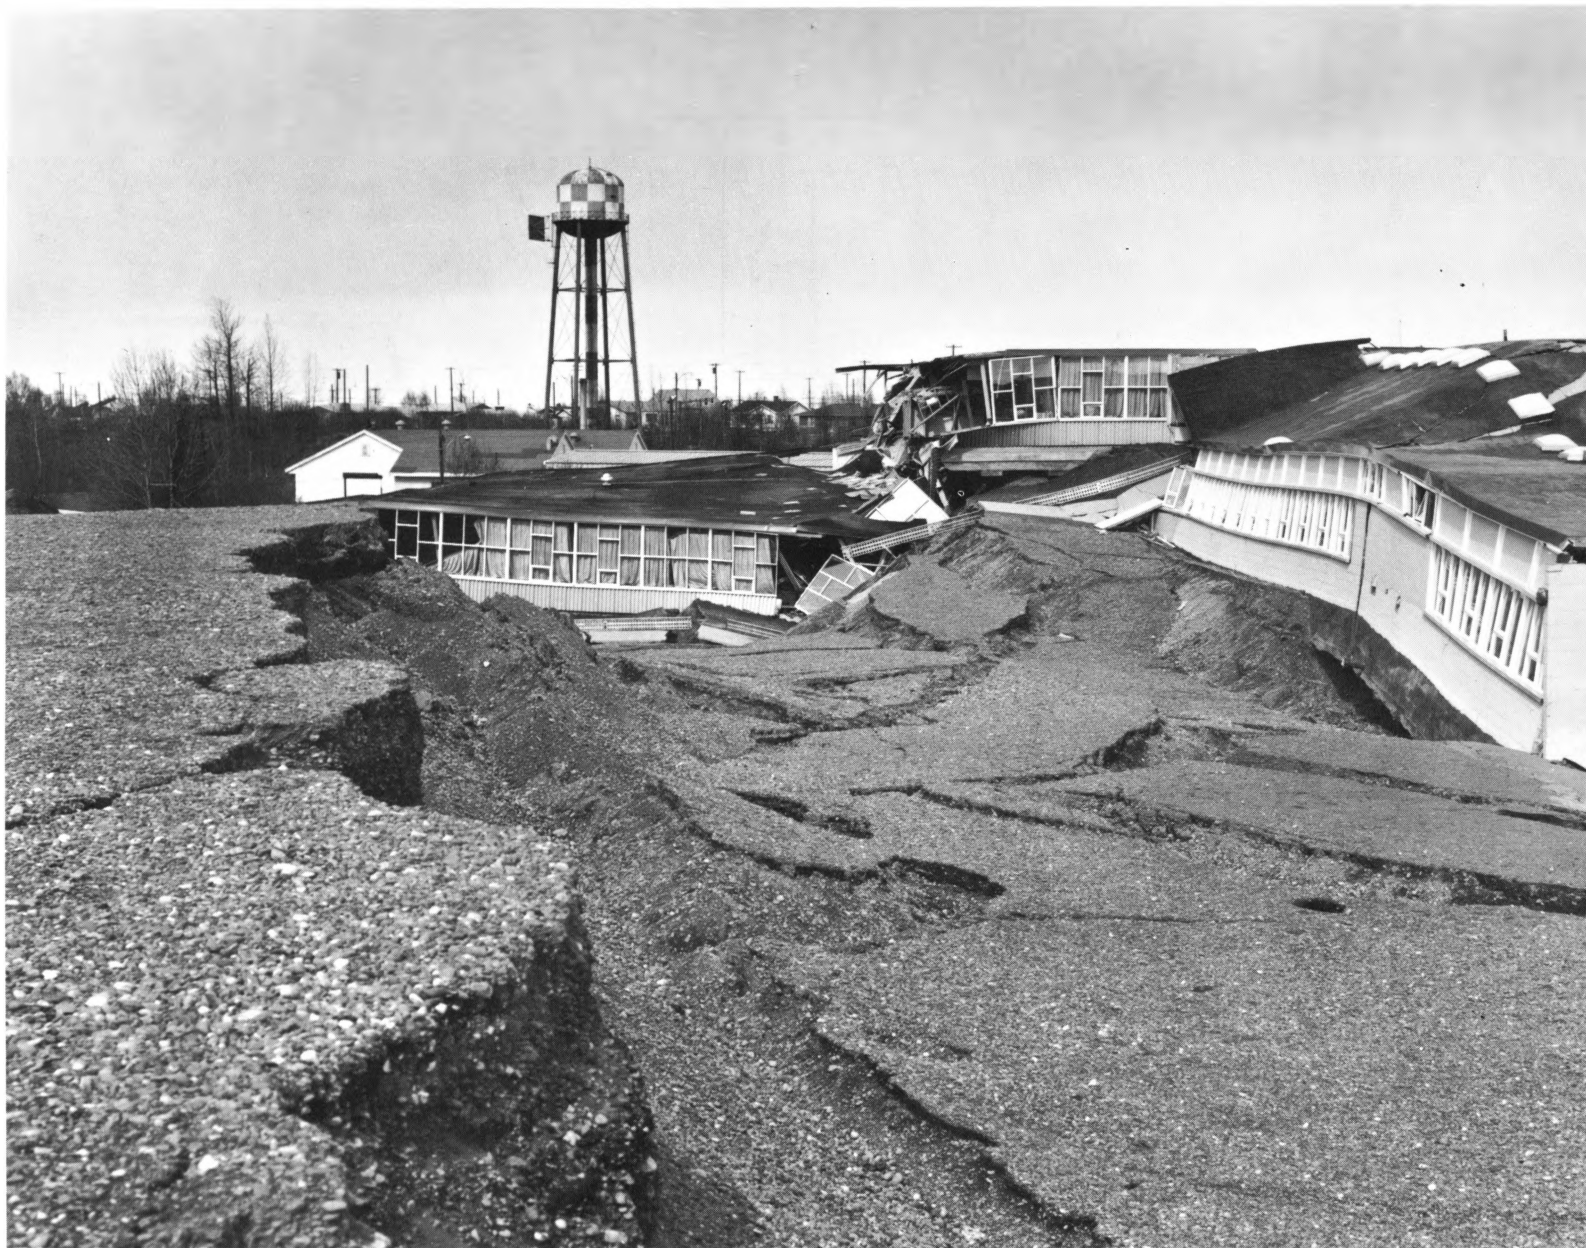
36.—Wreckage of Government Hill School as viewed from the playground, looking west. Graben in foreground is about 12 feet deep. Note undamaged water tower.

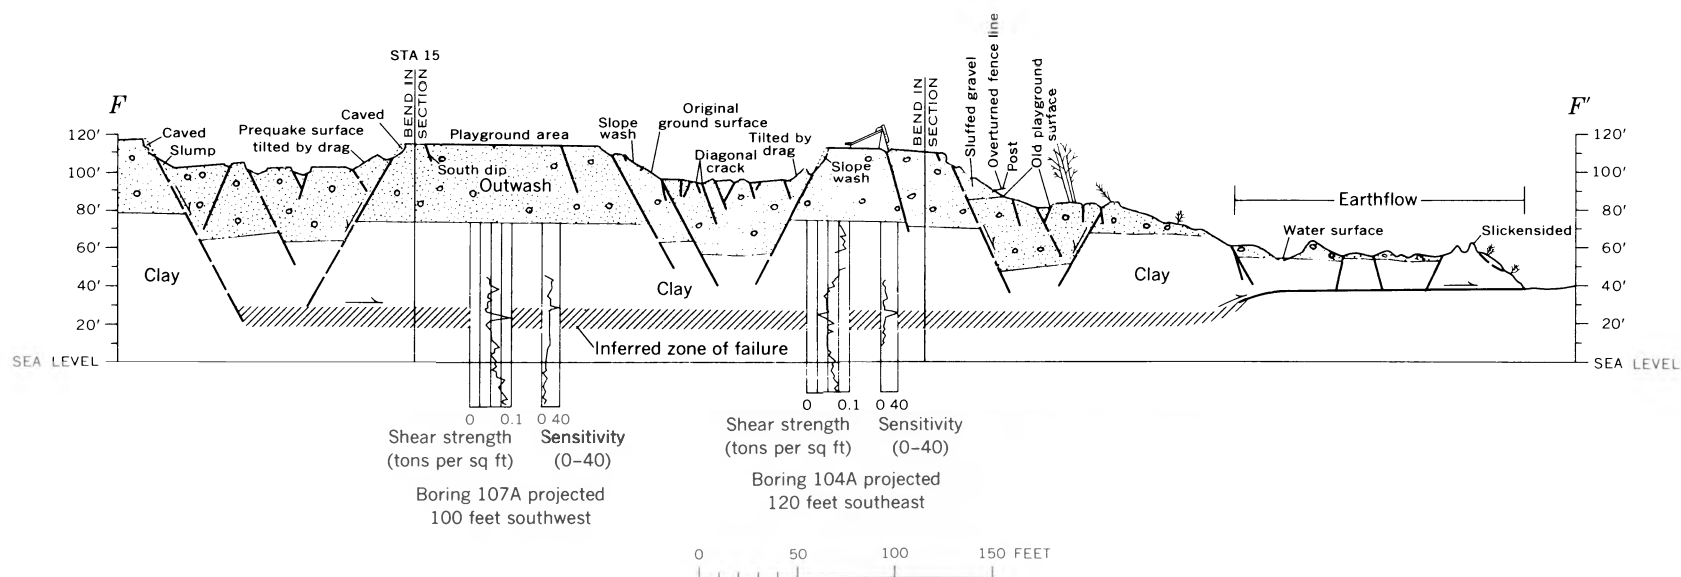
37.—Geologic section through Government Hill slide. Boring data from Shannon and Wilson, Inc. (1964).

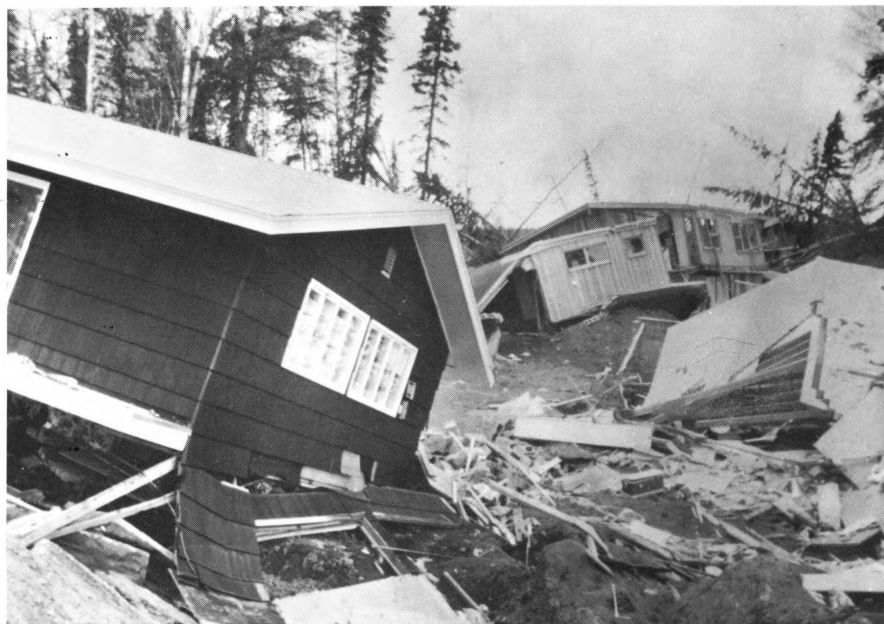
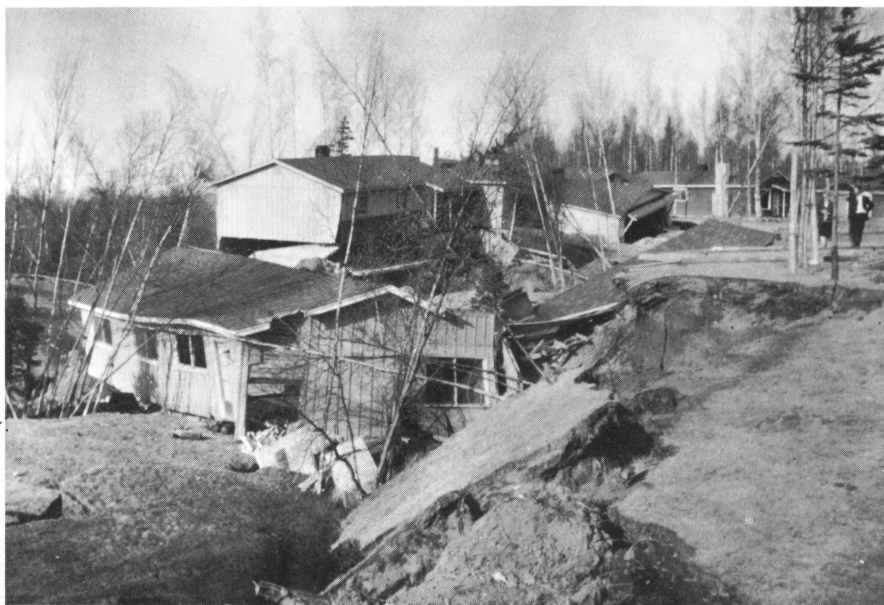
39.—Homes devastated by Turnagain Heights slide; deep within slide area, upper; at main scarp, lower. About 75 homes were destroyed.

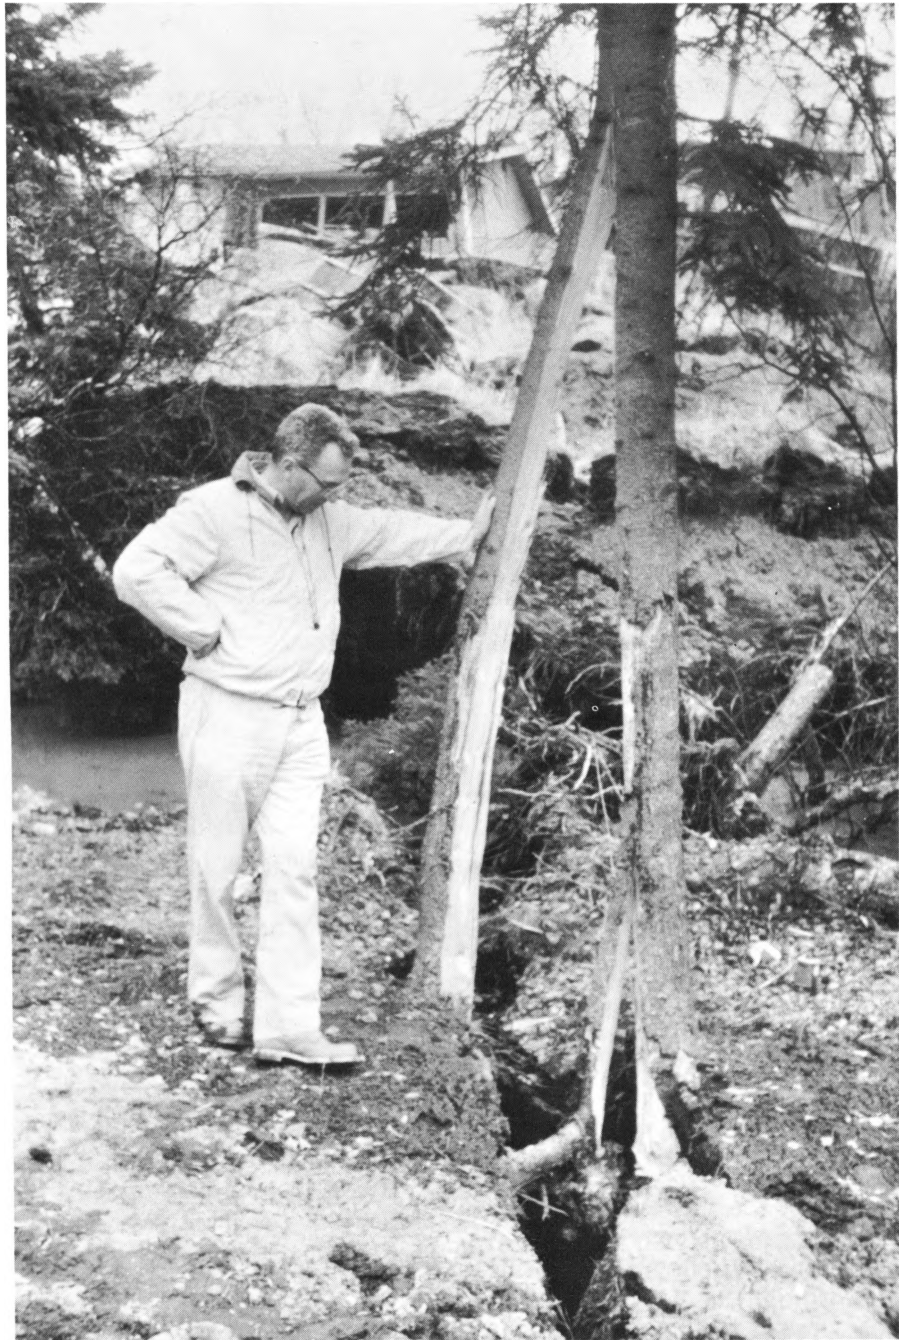
40.—Tree trunk split by tension fracture, Turnagain Heights slide. Many trees were similarly damaged because their roots were firmly embedded in the frozen ground.

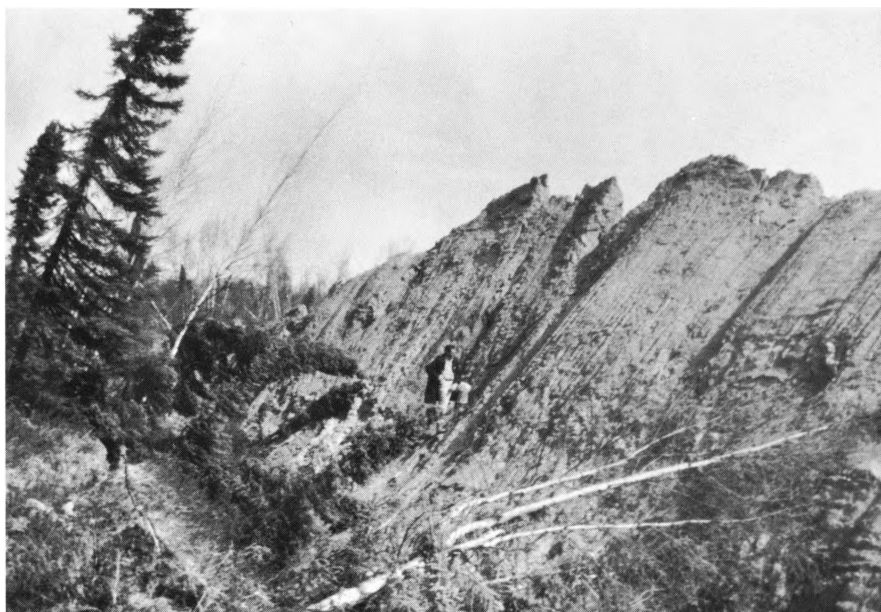
41.—Furrowed, slickensided clay ridge, Turnagain Heights slide. Ridge is about 20 feet high. Tilted collapsed block at left. Compare with figure 42.

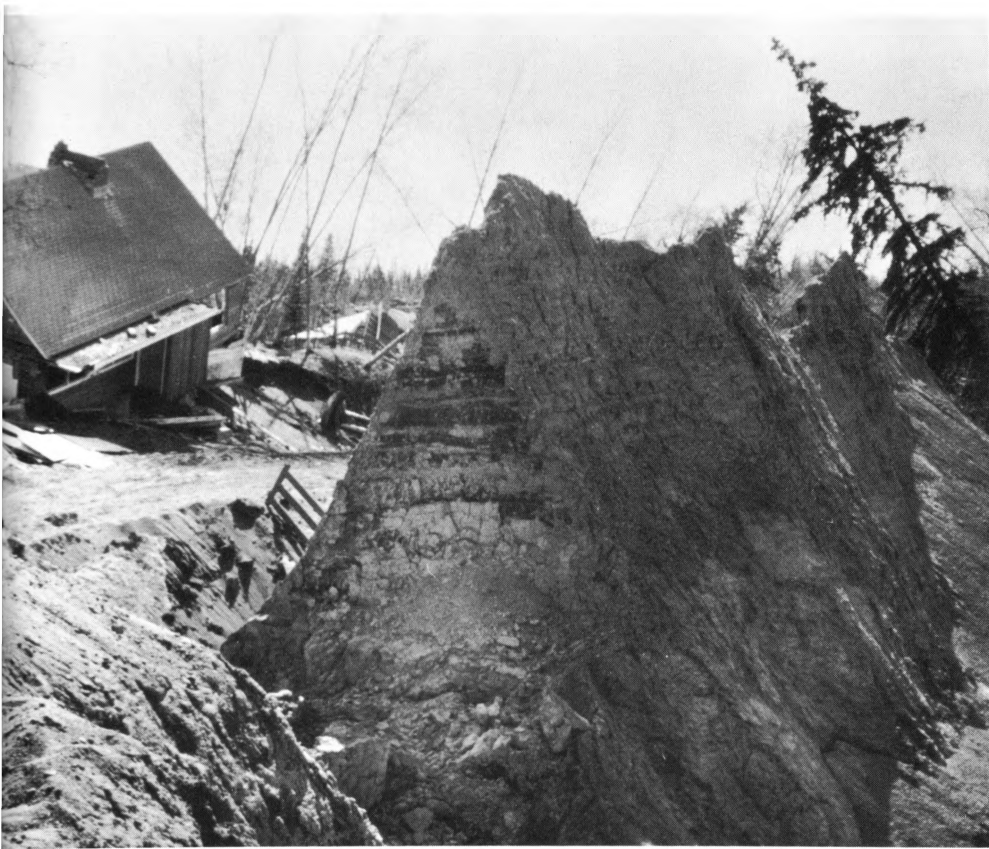
42.—Sharp-crested clay ridge, Turnagain Heights slide. Collapsed blocks tilted toward ridge on both flanks. Note horizontal stratification in ridge. Compare with figure 41.

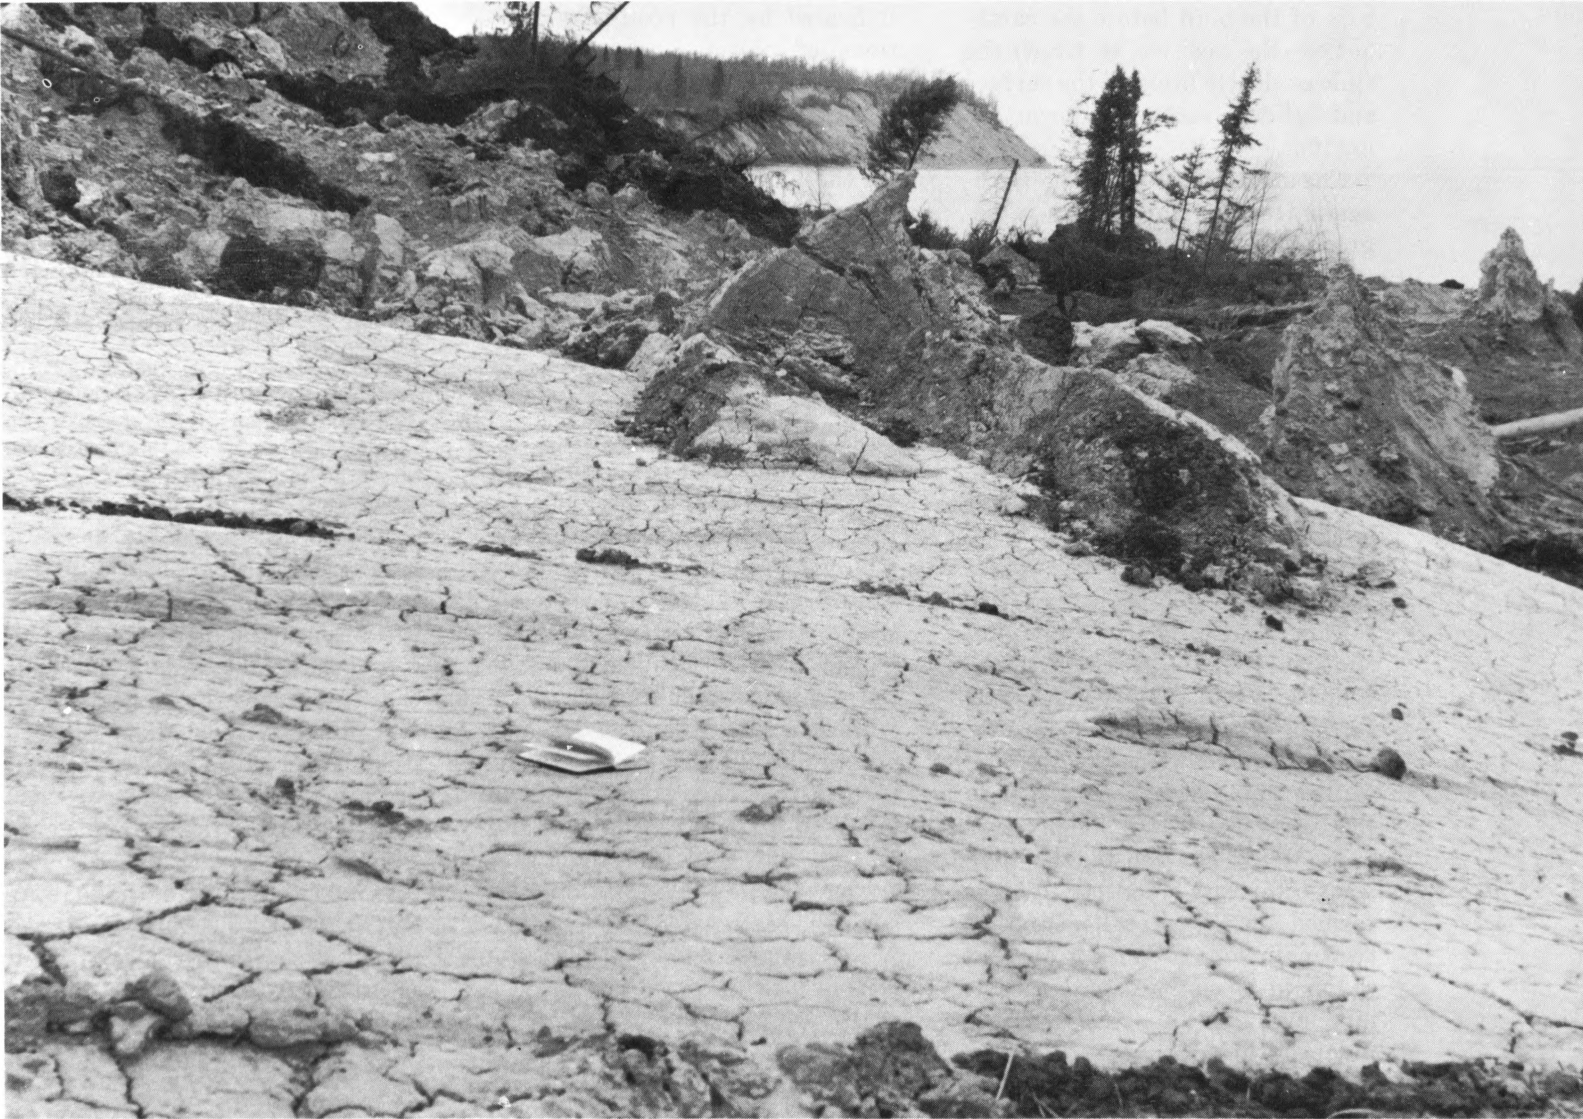
43.—Slip surface of Turnagain Heights slide exposed near west margin of slide. Furrows and welts still well preserved despite desiccation and weathering. Point Woronzof and Knik Arm in distance.
