# Effects of the Earthquake Of March 27, 1964 At Anchorage, Alaska

BY WALLACE R. HANSEN

*A description and analysis of the damage resulting from seismic vibration, ground cracks, and especially landslides in Alaska's largest city*

GEOLOGICAL SURVEY PROFESSIONAL PAPER 542-A

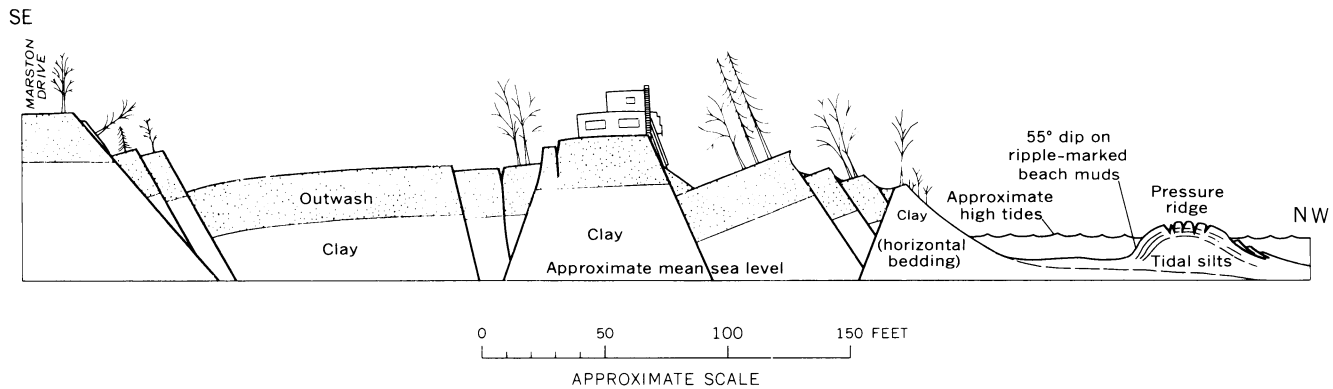
44.—Sketch section through eastern part of Turnagain Heights slide. Note pressure ridge, upright blocks at center and to left of pressure ridge, and tilted collapsed blocks between.
