THE ALASKA EARTHQUAKE, MARCH 27, 1964:
EFFECTS ON COMMUNITIES

Effects of the Earthquake Of March 27, 1964 At Whittier, Alaska

By REUBEN KACHADOORIAN

GEOLOGICAL SURVEY PROFESSIONAL PAPER 542-B

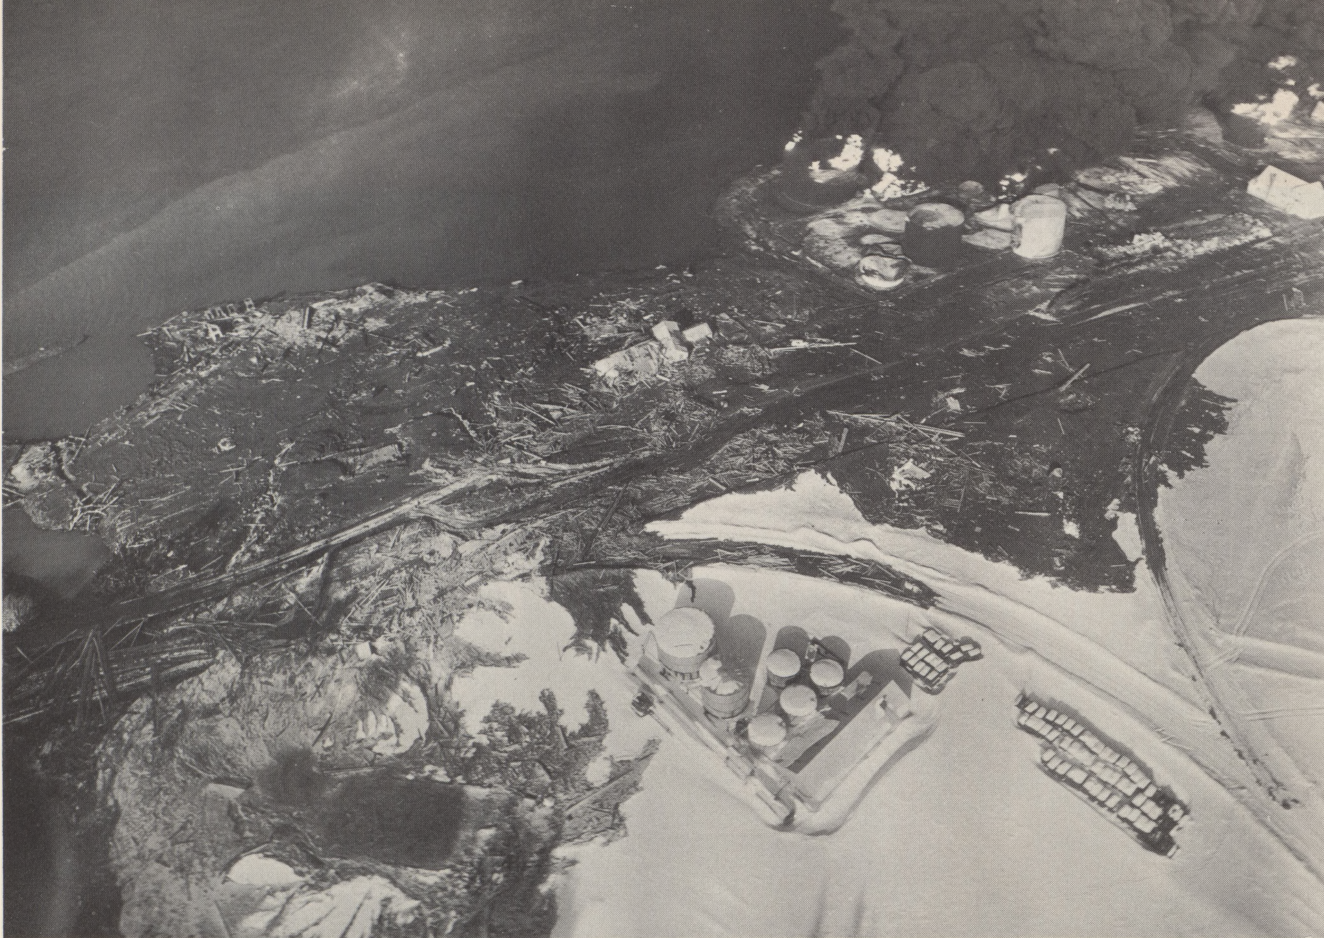
During the earthquake a fire started in the Union Oil Co. and U.S. Army tank-farm area (fig. 5) and burned until March 31; it completely destroyed the fuel-storage tanks.

5.—Aerial view, looking northeast, of Union Oil Co. and U.S. Army fuel-storage tanks burning. Note high-water mark where waves washed away snow cover. Photograph by U.S. Army, March 28, 1964.

Fire was chiefly responsible for destruction of the Union Oil Co. and the U.S. Army fuel-storage tanks at the Whittier waterfront. Fire, together with damage by wave and seismic action, completely destroyed the tanks. The

cause of the fire is not known, but there are at least two possible explanations: (1) seismic motion may have snapped a live power-line in the area, or (2) fuel from a damaged tank may have flowed into a boiler that was operating in the area.

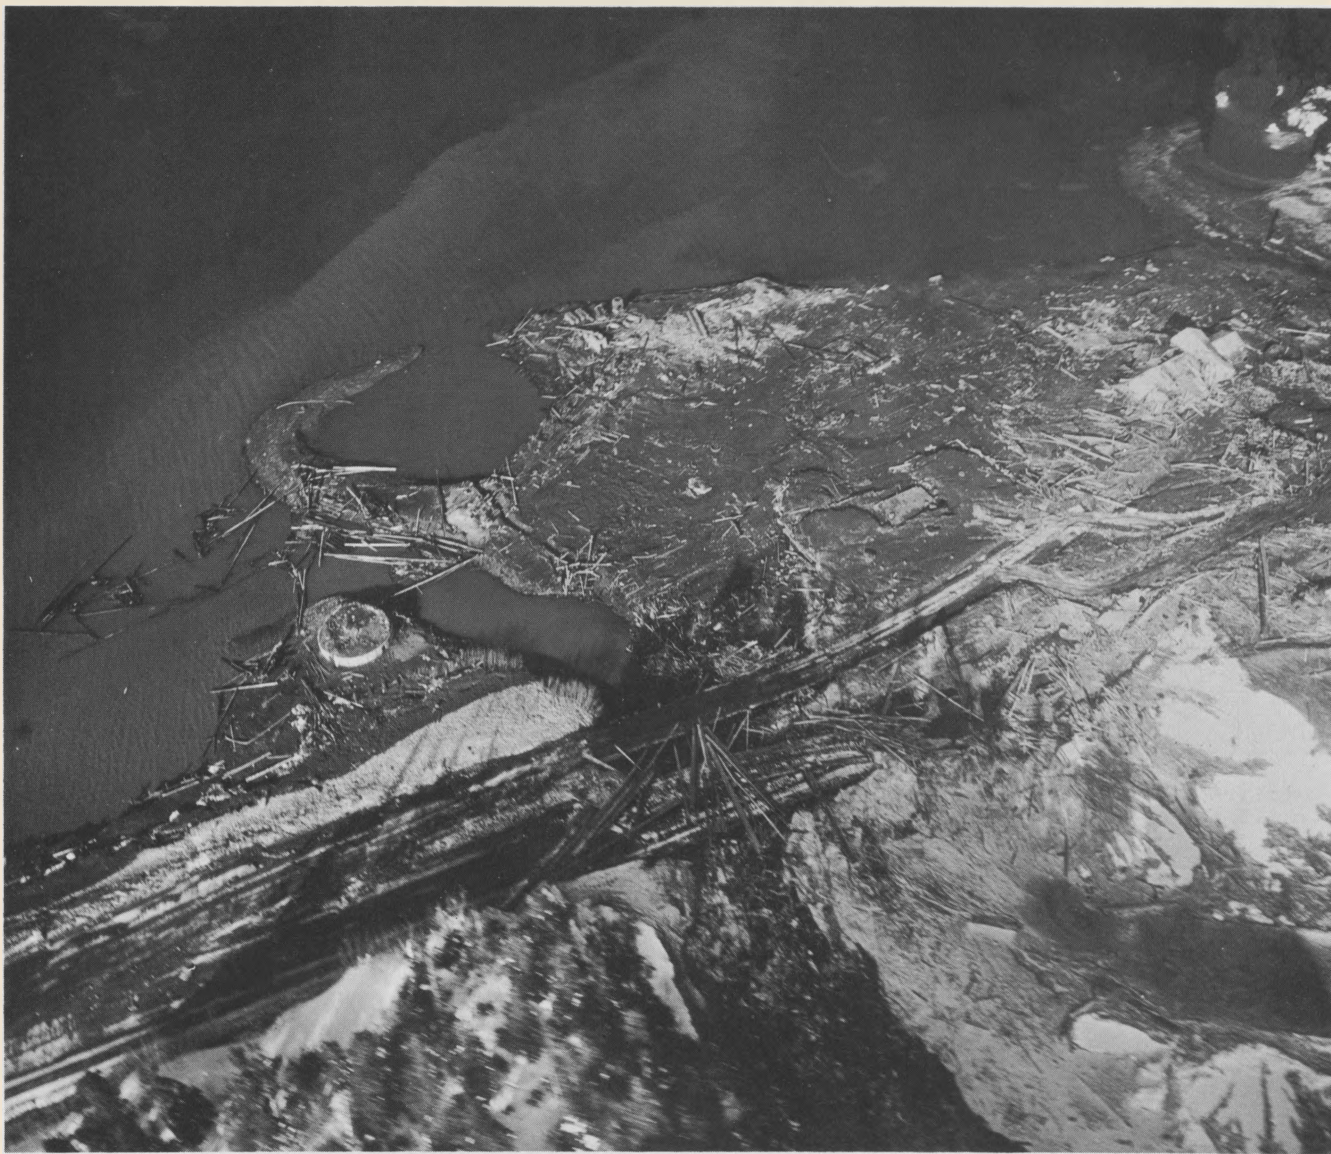
Thirteen lives were lost at Whittier as the result of wave action. Eyewitnesses state that 10 of the persons lost and presumed dead had gone into the home of one of the Columbia Lumber Co. workers a few minutes before the earthquake struck. The waves totally destroyed both the company's industrial buildings and the homes of the workers (figs. 6 and 7). Two other persons associated with the company are missing and presumed dead. None of the 12

7.—Postearthquake aerial view, looking north, of destruction of Columbia Lumber Co. Photograph by U.S. Army, March 28, 1964.

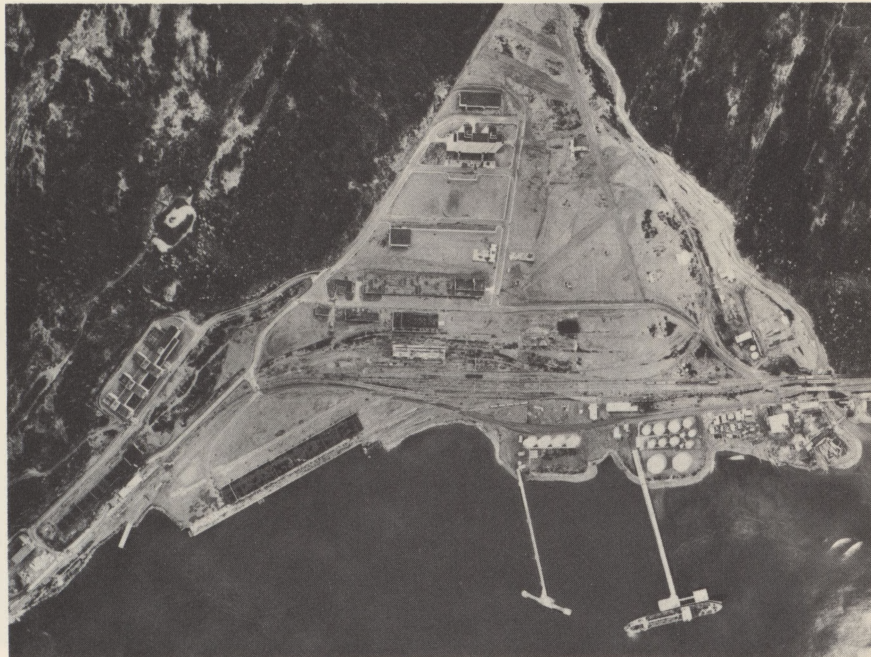
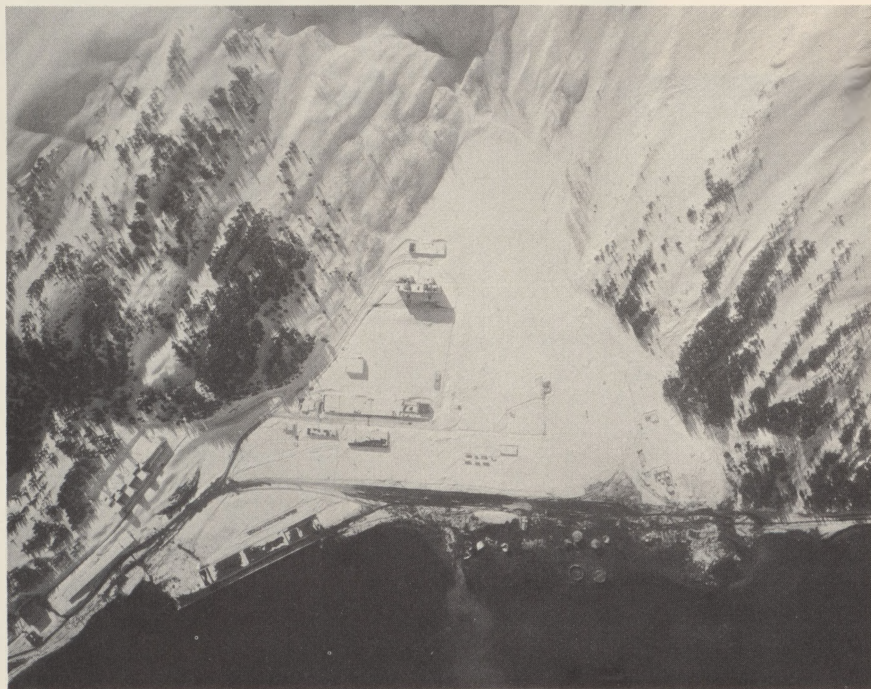
Studies by the U.S. Geological Survey and the U.S. Coast and Geodetic Survey determined that tectonic subsidence of the land-mass at Whittier was 5.3 feet during the earthquake. Residents of Whittier estimate that only 20 percent of the prequake tidal zone is now exposed during low tides (compare pls. 2 and 3). High tides now inundate some of the delta area at the head of Passage Canal, much land leased by the Two Brothers Lumber Co., and about 350 feet of the eastern end of the airstrip (fig. 10). The 5.3-foot subsidence is not wholly responsible for the change in exposure of the tidal zone; landslides

8.—Vertical aerial photographs of Whittier. Top, Prequake; composite of photographs by Bureau of Land Management, September 23, 1963. Bottom, Postquake; photograph by U.S. Army, March 28, 1964.

The most pressing problem at Whittier was to put back into service the port and railroad facilities that were destroyed or damaged by land subsidence. Much of the reconstruction in Alaska depended on immediate use of the car-barge slip dock, which was the only connecting link for transferring supplies and equipment from ships to The Alaska Railroad after the earthquake. To permit maximum use of the dock, which is stationary at the

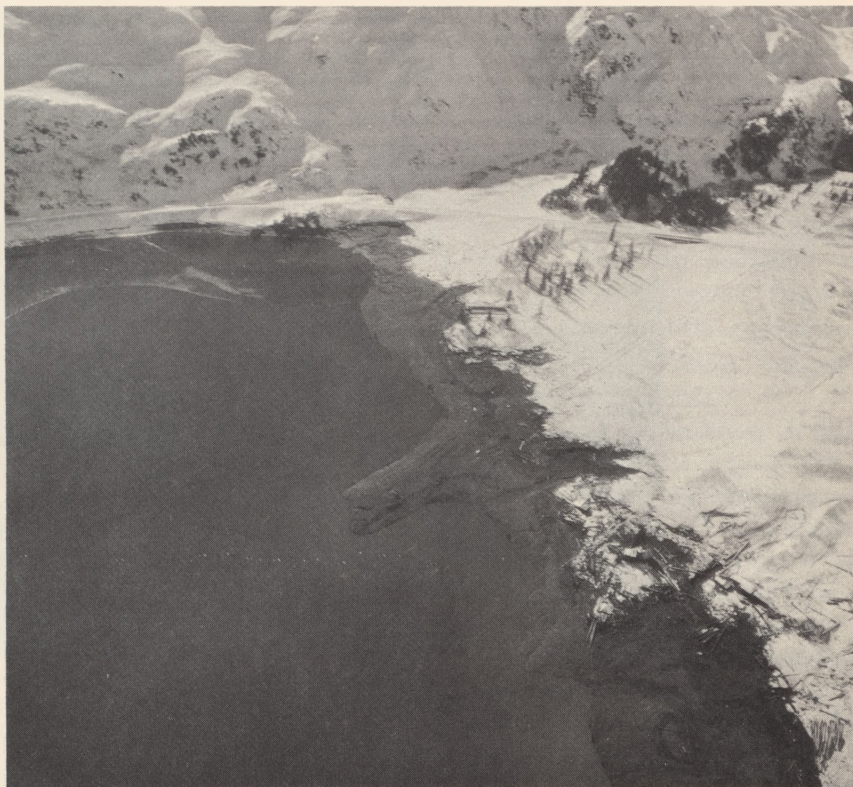
10.—Aerial photograph, looking south, of delta at head of Passage Canal. Remains of Two Brothers Lumber Co. in right foreground. Projecting into the water is the airstrip. Note high-water mark indicated by snow. Photograph by U.S. Army, March 28, 1964.

The only structures damaged by landslides (pl. 1) were the FAA station (fig. 17), a section of the railroad, a small pier near the FAA station, and the extreme eastern end of the airstrip (fig. 10). The slip tower at the car-barge slip dock may have been destroyed by the landslide at the marginal wharf.

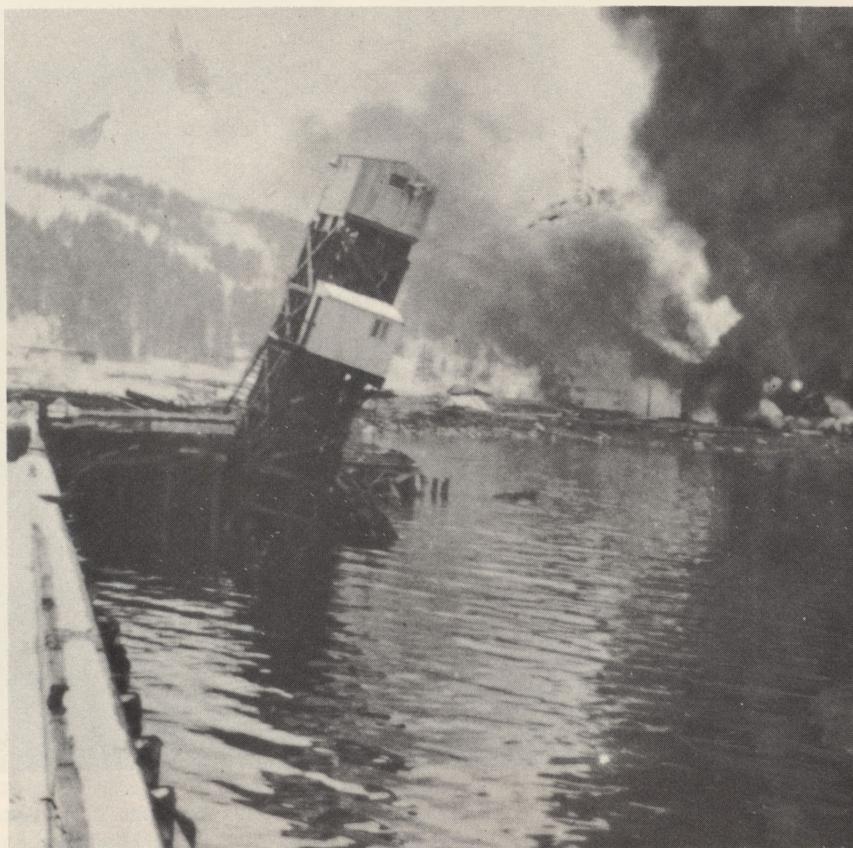
11.—View, looking west, of remains of car-barge slip dock. Slip tower only part of structure left. Photograph by The Alaska Railroad, 1964.

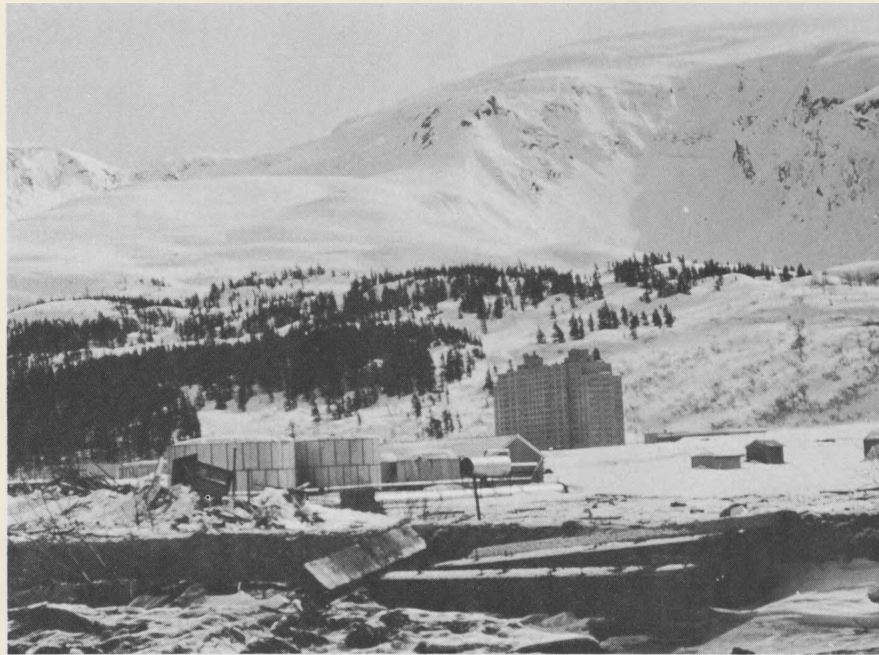
12.—View, looking southeast, of Hodge Building. Photograph taken April 4, 1964.

road bridges crossing Whittier Creek. Beyond the inundated zone there was moderate damage to the Hodge Building (fig. 12), the composite shop, and part of the station storage warehouse (fig. 13). The Buckner Building (fig. 14), gymnasium, fire station, telephone building, ACS (Alaska Communication System) building, powerhouse, and the railroad bridge near the airstrip were slightly damaged.

the expansion joints were perpendicular to the motion. During the earthquake the individual units banged against each other, the weather seals popped out, and the jumper plates were curled. Damage to the structural connections (weather seals, jumper plates, and spandels) was progressively more intense upward in the structure owing to the larger horizontal component of movement. Jumpers on the top floor were shortened 4 inches by curling, whereas on the third floor they curled only a quarter of an inch.

The interior partition walls of the Hodge Building were constructed of concrete block. Damage to the walls was also greater in the upper floors. The walls on the 13th and 14th floors either collapsed or were cracked. On the fourth floor the blocks were loosened, except near the expansion joints where some of the blocks were dislodged. The exterior of the building was not substantially damaged, even where the units

Not only is there a correlation between damage and the underlying bedrock or unconsolidated deposits, but damage appears to be controlled also by the type, size, and thickness of the unconsolidated sediments. The Hodge Building, a 14-story reinforced-concrete structure which rests on coarse sandy gravel, was just moderately damaged by seismic activity. The Whittier delta at this point is only 1,200 feet wide, and the east end of the building is within 300 feet of bedrock. Therefore, the thickness of the sandy gravel that underlies the structure is probably not more than 150 feet.

The Hodge Building received substantially less damage than buildings of comparable height at Anchorage—a city about twice as far from the epicenter as Whittier. At least three geologic factors are responsible for this marked difference of damage: (1) the Hodge Building rests on a small area of unconsolidated deposits as compared to the structures at Anchorage, where a plain several miles wide is underlain by at least several hundred feet of clay, silt, sand, and gravel; (2) the deep fine-grained sediments that underlie Anchorage magnified the seismic amplitudes substantially more than the shallow coarse-grained sediments that underlie Whittier; (3) because the higher frequency components of ground motion attenuate with distance

more rapidly than the lower frequency components, the tall structures at Anchorage were more nearly attuned to long-period ground motion. Thus, these structures suffered a proportionately greater degree of damage than the 14-story Hodge Building at Whittier.

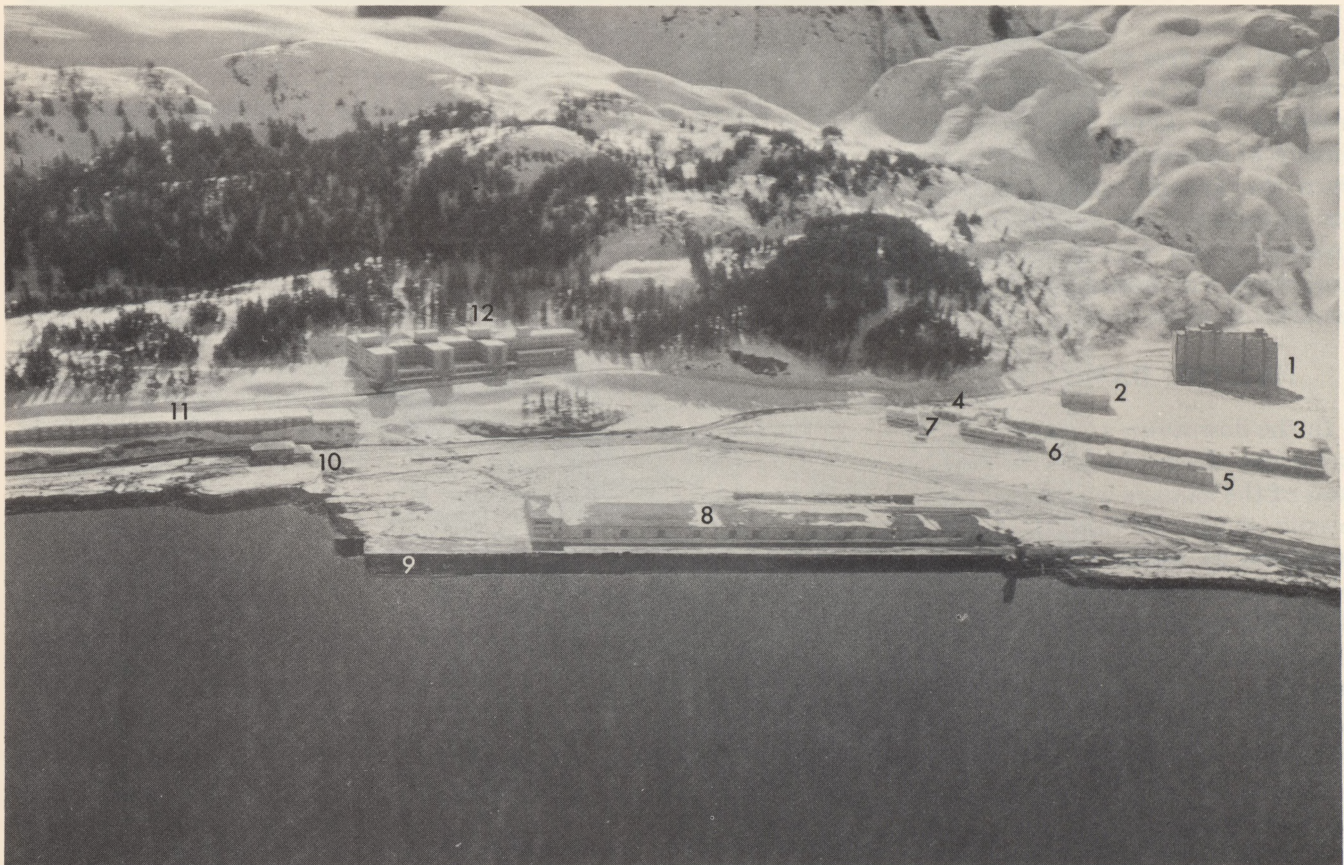
13.—Aerial view, looking south-southeast, of part of postquake Whittier. 1 Hodge Building, 2 gymnasium, 3 composite shop, 4 fire station, 5 station storage warehouse, 6 telephone building, 7 ACS building, 8 intransit storage shed, 9 marginal wharf, 10 The Alaska Railroad depot, 11 FHA housing, and 12 Buckner Building.

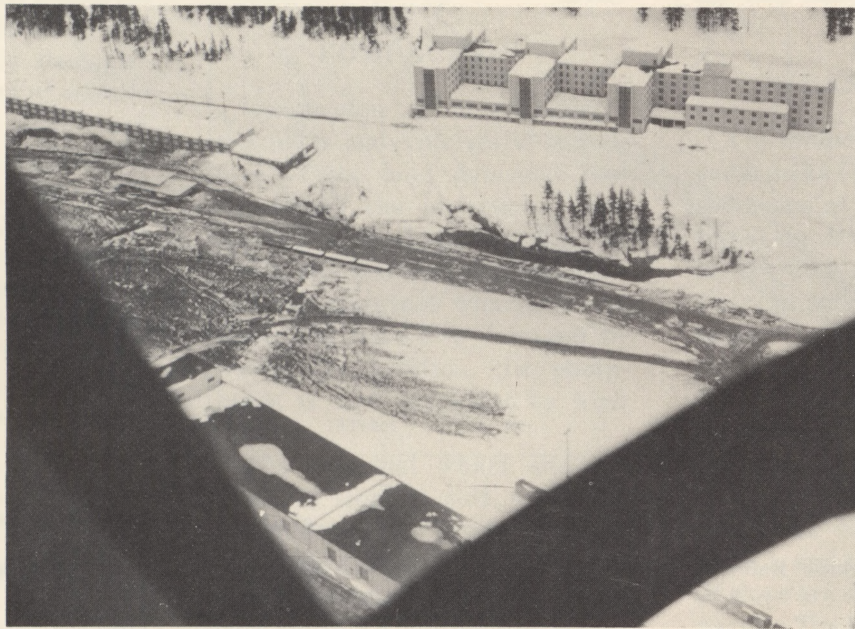
The largest building in Whittier, probably the largest in Alaska, is the Buckner Building (figs. 14, 15, and 16). It is a six-story reinforced-concrete structure about 500 feet long and 50–150 feet wide. The long dimension of the structure runs northeast-southwest, oblique to the seismic motion of the earthquake. The building rests on bedrock and did not receive any significant structural damage. The steam powerhouse near The Alaska Railroad depot also rests on bedrock and was not damaged by seismic motion.

14.—Aerial view, looking southeast, of Buckner Building; building in foreground is intransit storage shed; long structure at left of photograph is FHA housing; structure north of FHA housing is depot. Note high-water mark of wave on snow. Photograph taken April 4, 1964.

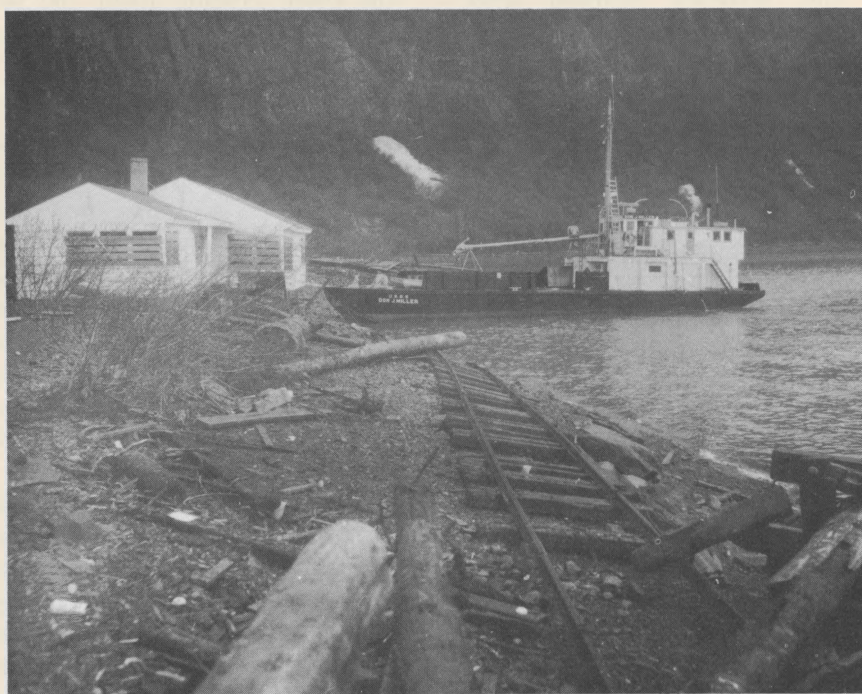
17.—View, looking north, of FAA station. Track destroyed by landslide. Bow of boat resting on scarp. Photograph by G. D. Hanna, 1964.

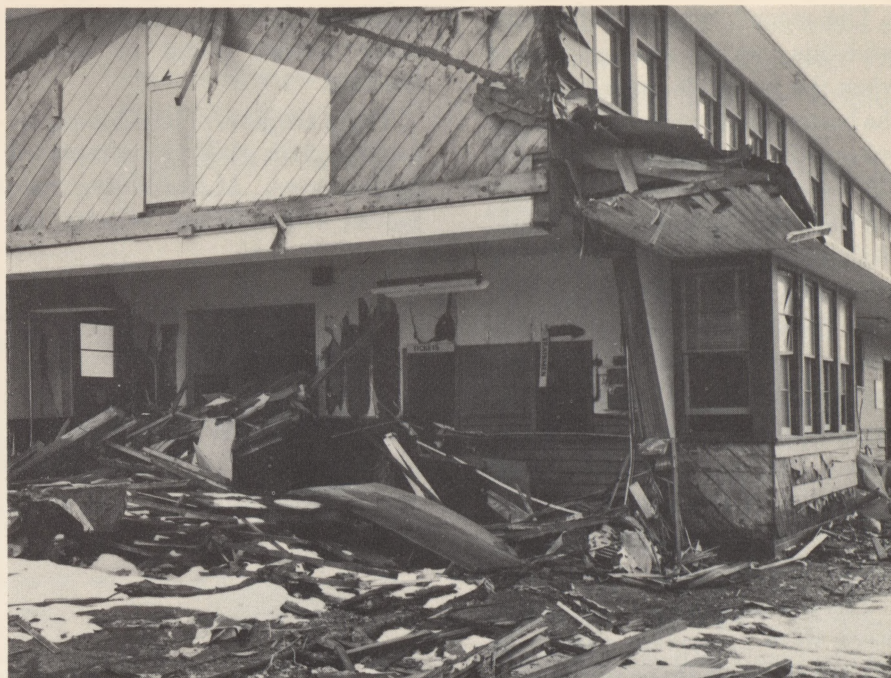
19.—View, looking south, of The Alaska Railroad depot. Wave destroyed waiting room of the depot. Photograph taken April 7, 1964.

Wave damage in the Whittier area is shown on plate 1. The wave completely destroyed (1) the small-boat harbor, (2) the stub pier, (3) the car-barge slip dock, (4) the waiting room of The Alaska Railroad depot (fig. 19), and (5) the Columbia Lumber Co. structures (fig. 5 and 7). Many facilities were damaged by a combination of destructive forces: (1) the Army tank farm by fire, seismic shaking, and waves, (2) the Union Oil Co. fuel tanks by fire

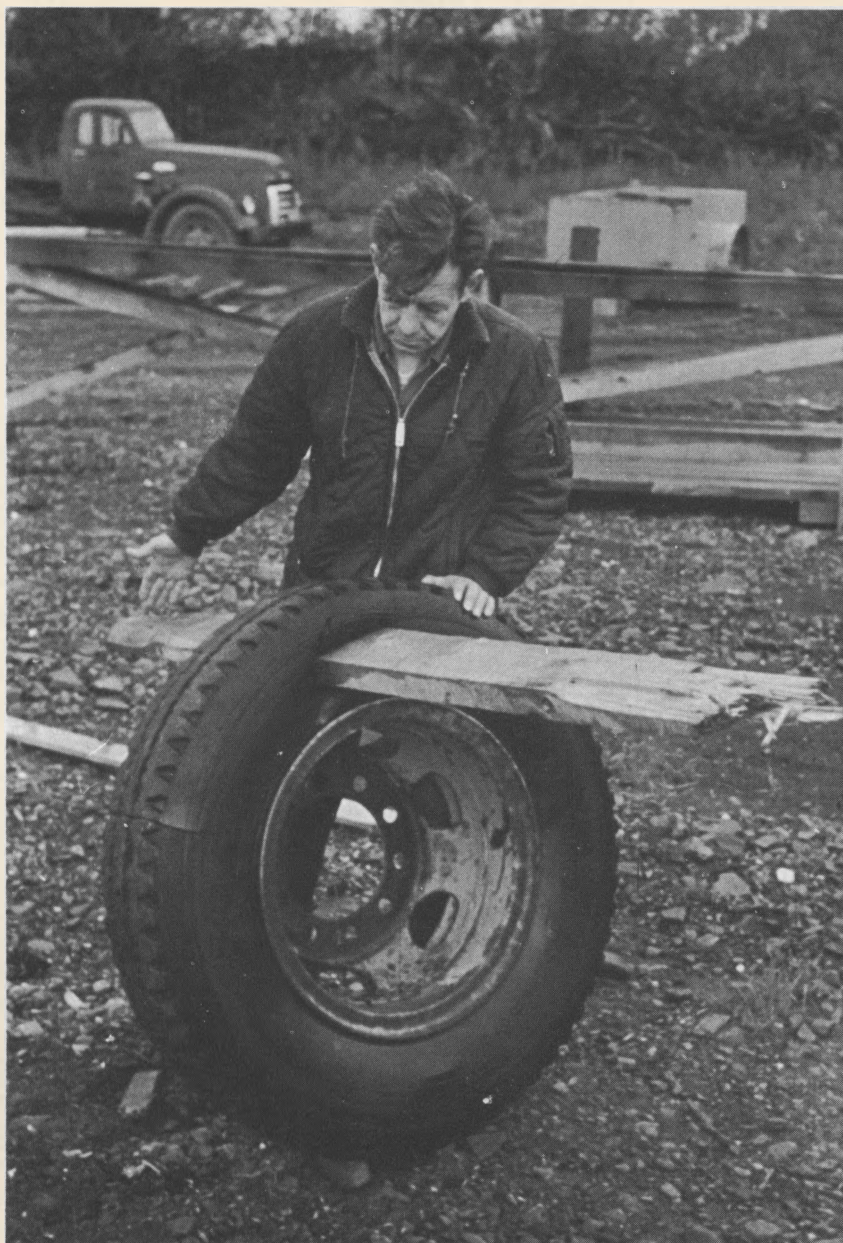
The waves that struck Whittier had sufficient force to carry heavy objects many feet inland. A 4-cubic-yard barnacle-covered boulder was carried about 125 feet and deposited on The Alaska Railroad track near the depot at an altitude of about 26 feet. Boulders as much as 6 feet across were strewn on the road between the small-boat harbor and the Union Oil Co. fuel tanks. One of the Union Oil Co. fuel tanks containing ballast was moved at least 40 feet south by waves, and another tank containing 1 million gallons of fuel was moved 15 feet south (fig. 5).

20.—Photograph of 2- by 6-inch plank driven through a 10-ply tire by wave.
