The Alaska Earthquake

Effects of the Earthquake Of March 27, 1964 In the Homer Area, Alaska

*A description of the damage caused by landmass
subsidence, earthflows, landslides, seiche waves,
and submarine landslides resulting from the
earthquake in the Homer area, Alaska*

GEOLOGICAL SURVEY PROFESSIONAL PAPER 542-D

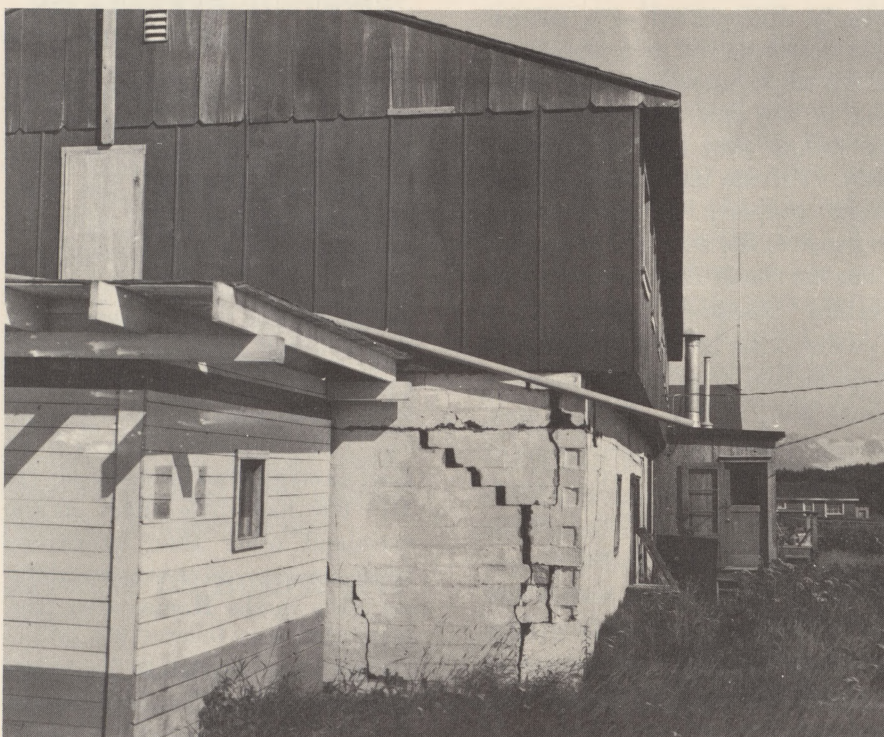
(fig. 3) and concrete-slab floors were cracked or fissured. Dishes and glassware were broken in many homes and business estab-

3.—Damage to foundation walls of the Inlet Inn Hotel. Unreinforced concrete-block construction.

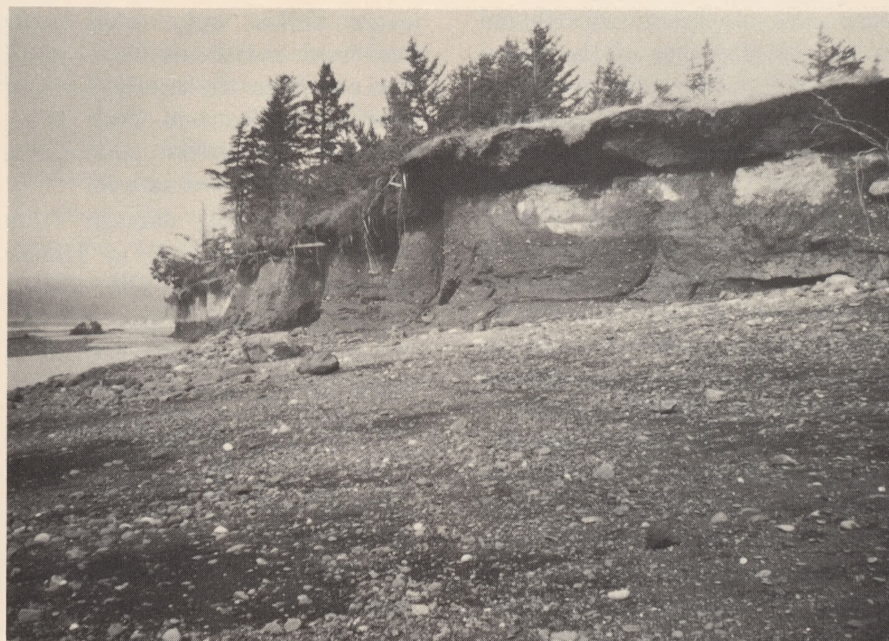
4.—Postearthquake erosion at Munson Point as of April 13, 1964. About 5 feet of the overhanging vegetal mat attests to recent erosion of the underlying glacial till as a result of higher water levels relative to land.

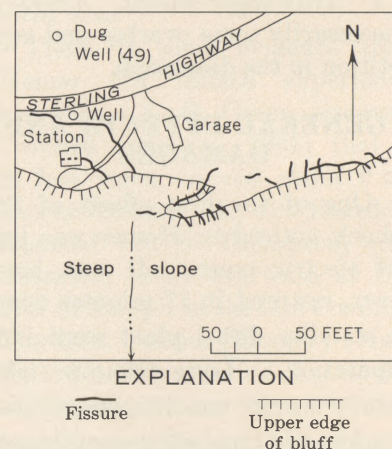
The landslide (easternmost in sec. 1, fig. 2) debris covers an area about 600 feet long and 100 feet wide. The material that slid stood previously as a promontory along a bluff eroded into the Kenai Formation. The slide area is near a fault in sec. 2 mapped by Barnes and Cobb (1959, pl. 18), but there is no evidence that this fault moved in 1964. Landslide hazards exist in comparable situations near Homer—and indeed anywhere that promontories extend out from precipitous bluffs and cliffs. Bluff Point, north of Homer (fig. 2) is an example. A field station of the U.S. Bureau of Land Management is situated about 50 feet from the edge of a 700-foot bluff. Numerous fissures (fig. 5) developed during the

5.—Sketch map of the ground-fissure pattern at the U.S. Bureau of Land Management field station near Homer. Traced from field compilation on aerial photograph by K. A. Roddy, U.S. Bureau of Land Management, May 1, 1964.

earthquake on the surface above the bluff, some of them several inches wide. A few could be traced about 20 feet down the bluff face. One earth fissure extended across the area of a field-station building and cracked the basement floor of the structure. Areas above and close below promontories where earthslides might occur must remain suspect as sites for any building.

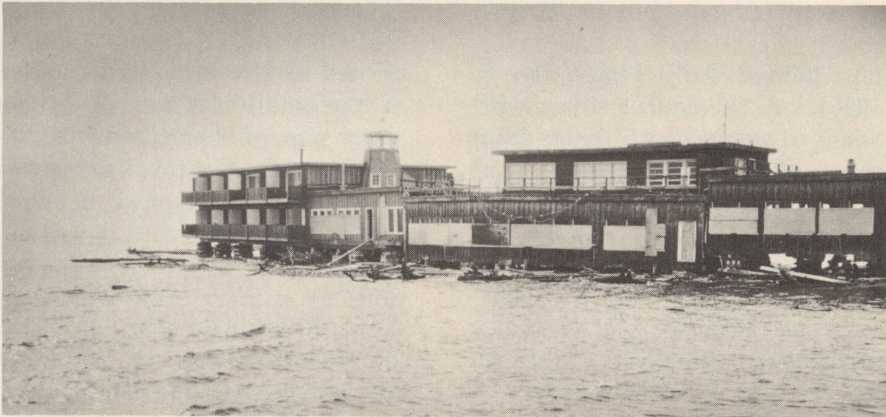
Some of the specific damage to structures caused by the flooding may be seen in figure 8 (on next page), which shows the Land's End Hotel elevated on jacks to raise it above the postearthquake high-tide level. Figure 9 (p. D10) shows other scenes of the effects of the high tides. During the high tide of about 19 feet that occurred the night following the earth-

quake, material salt-water damage was done to the hotel, to the Porpoise Room, the Salty Dawg Saloon, two seafood-processing plants, and the Standard Oil Co. tank farm.

8.—Land's End Hotel jacked up 8 feet to avoid inundation by high tides. View from Homer dock looking west. View during first 20-foot tide. Middle part of hotel not yet raised.

It was apparent that, in addition to repairs, remedial measures were needed to avoid future storm-wave damage as well as damage from normal high tides. Such measures were started immediately by some concerns, whereas others awaited aid from the Government, through the Federal Disaster Act, authorized under Public Law 81-875. As of August 30, 1964, the Office of Emergency Planning had authorized reconstruction projects totaling \$1,565,000 to replace or rehabilitate public facilities damaged by the earthquake and tides

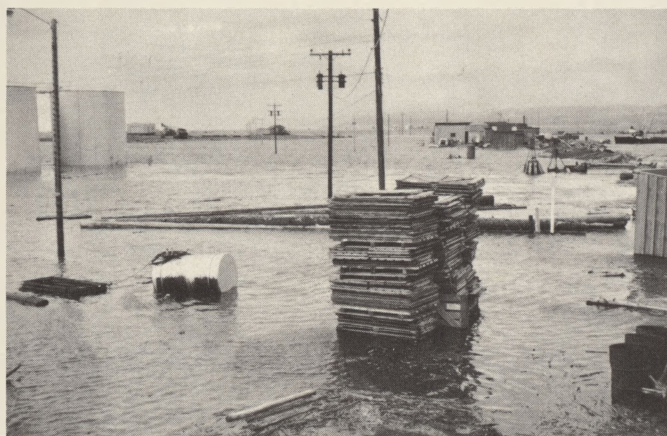
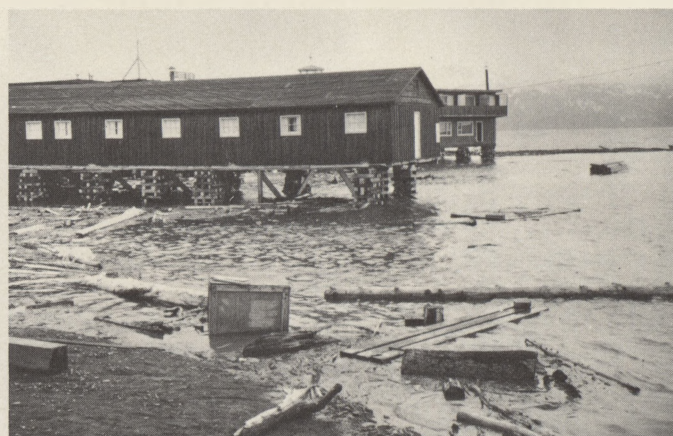
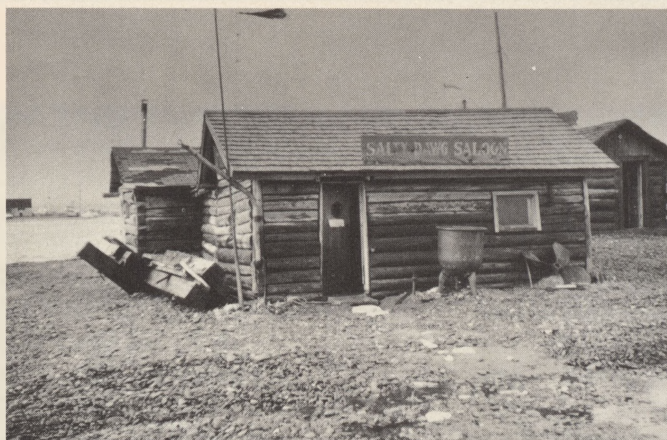
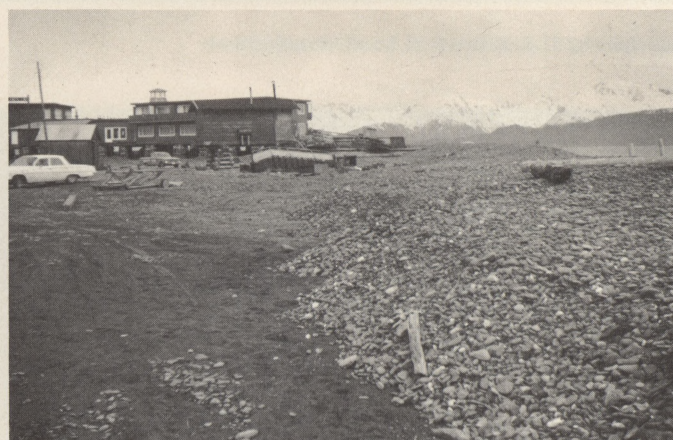
9.—Effects of the high tides submerging the end of Homer Spit on April 12, 1964. A, Standard Oil Co. tank farm awash in as much as 6 feet of water. B, Lands End Hotel raised on jacks. C, Water rose high enough to flow through the windows of the Salty Dawg Saloon. D, New storm berm encroaching on spit southwest of the Land's End Hotel.

covered in a matter of days by a new berm (fig. 9D) that prevented observation.

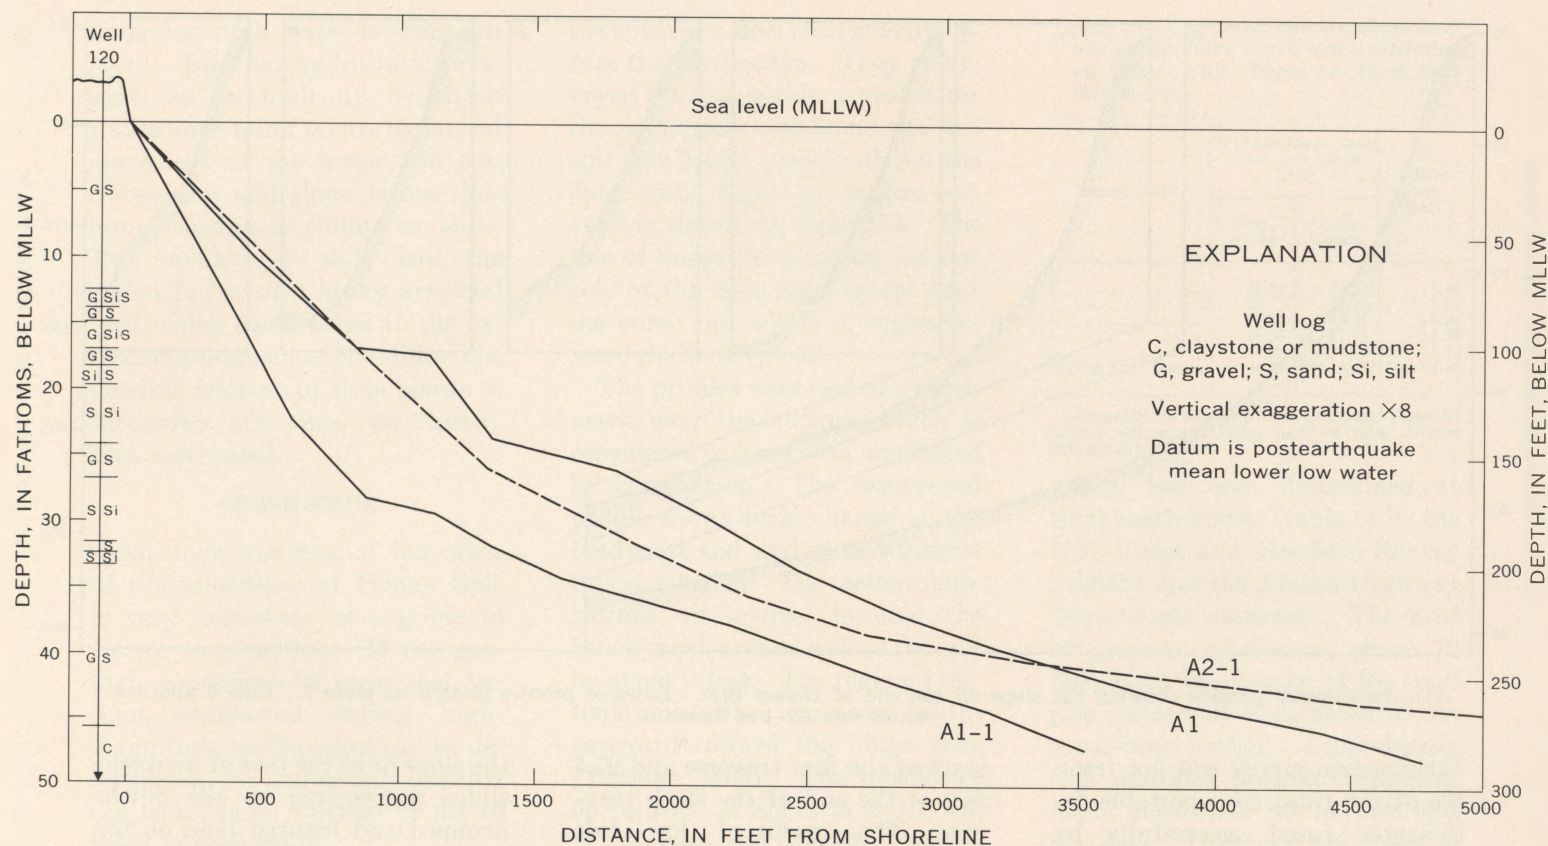
10.—Offshore profiles showing the slope off the end of the Homer Spit. Lines of profiles plotted on plate 1. Data from U.S. Army Corps of Engineers. Profile A1 is the easternmost of the two shown on plate 1.

is also shown (fig. 10) to indicate the seeming coincidence of silty zones beneath the spit with offshore bulges or plateaus on the bathymetric profiles.

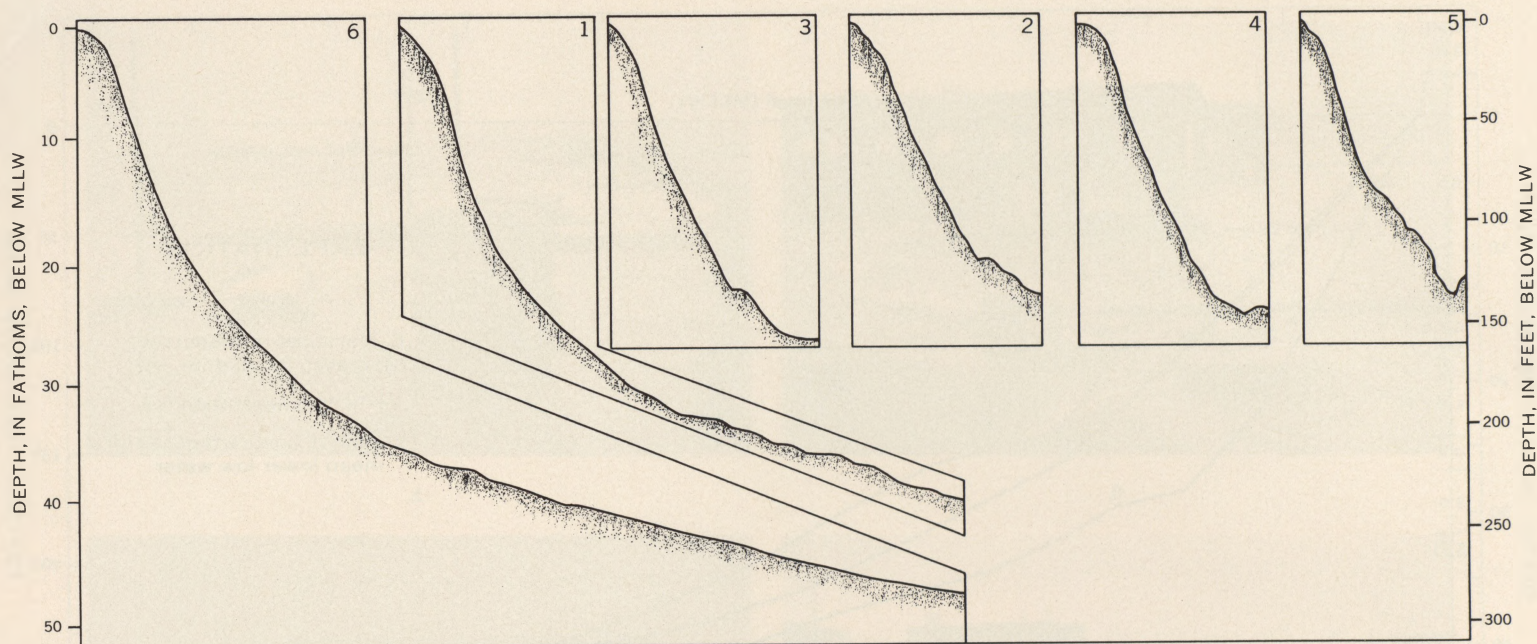
11.—Fathometer profiles showing the slope off the end of Homer Spit. Lines of profiles plotted on plate 1. Line 6 approximates line A2-1 of figure 10.

bathymetric survey was not feasible at the time, so a portable fathometer (used successfully by other Survey geologists in determining subaqueous slides in Kenai Lake and elsewhere) was used to run a few continuous profiles offshore to try to determine slide areas (locations on plate 1). Although the runs were hampered by the writer's inexperience with the instrument, the results are believed to confirm the presence of another slide west of the Land's End Hotel.

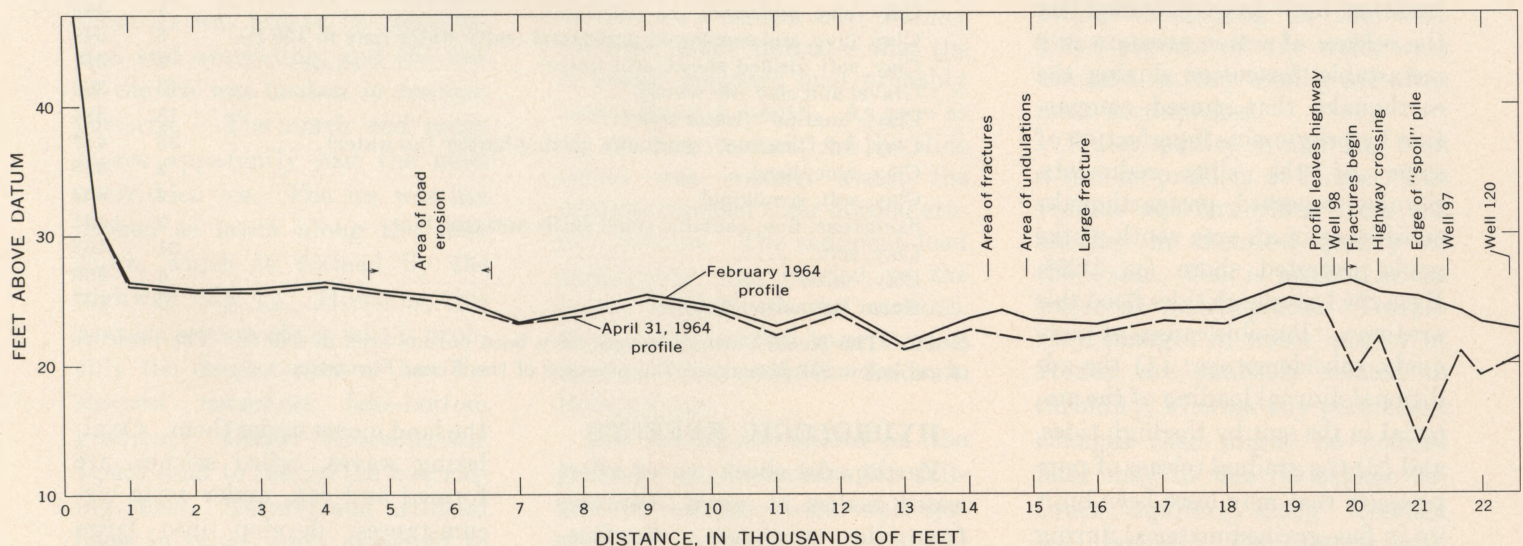
12.—Profiles of Homer Spit surveys by the Alaska Highway Department. Datum is U.S. Bureau of Public Roads temporary bench mark 20, 70.25 feet above (preearthquake) datum. Vertical exaggeration $\times 200$.

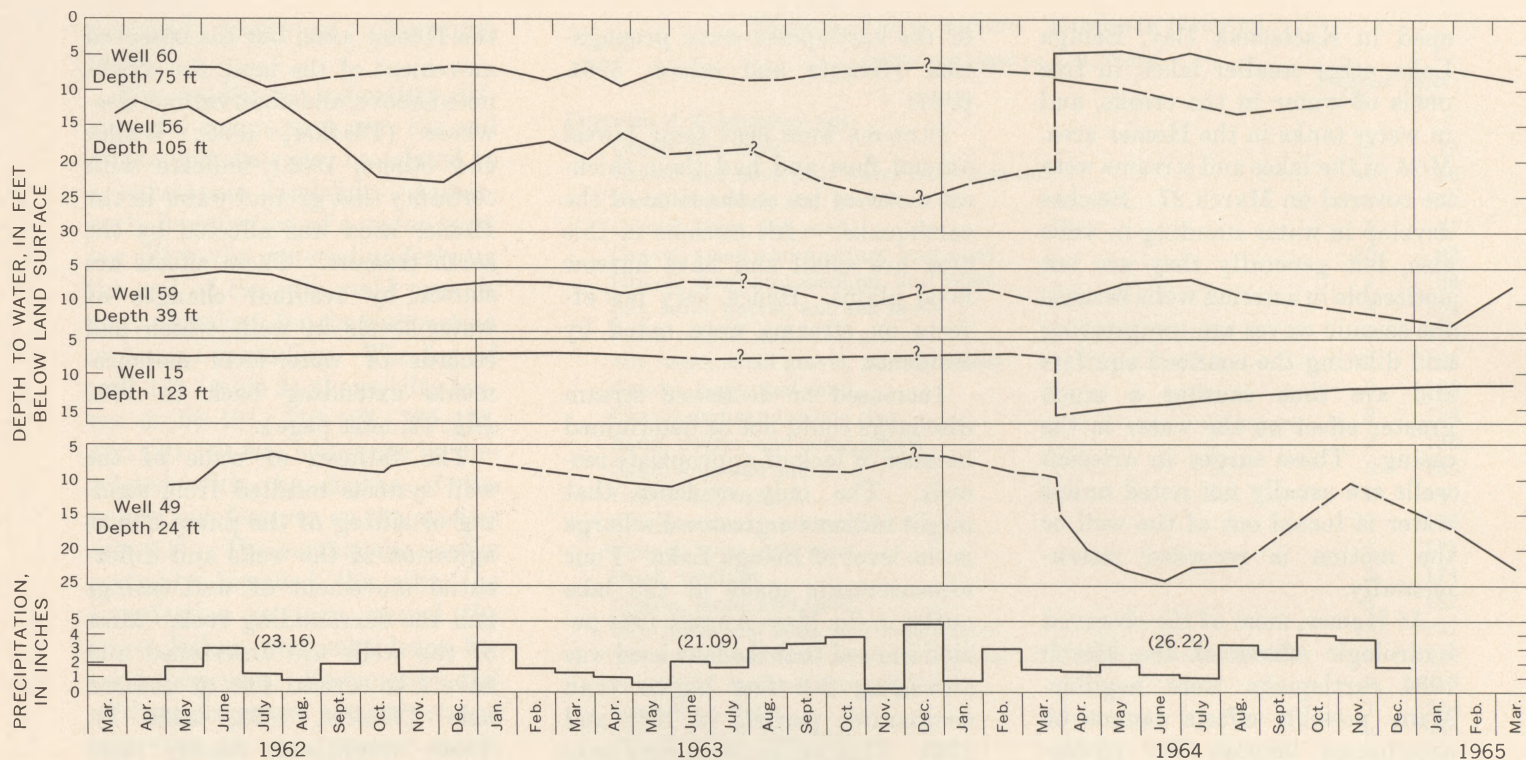
13.—Hydrographs of five Homer wells showing long-term effects of the earthquake. Locations of wells shown on figure 2.

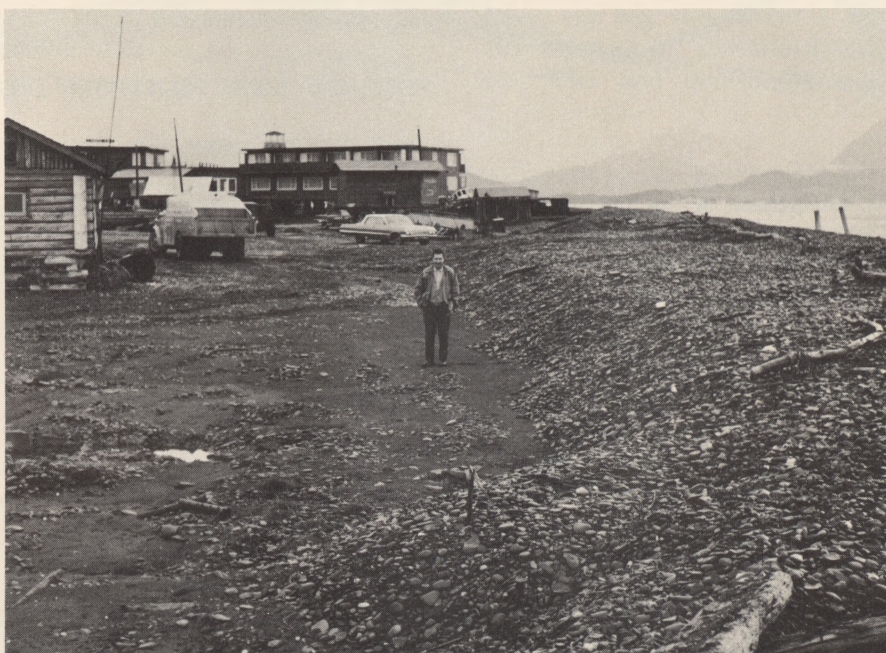
18.—Storm berm developed along spit within 6 months after subsidence. Berm before subsidence was less than 3 feet high and 4–5 feet wide at the base.

As an illustration of berm growth, the preearthquake berm at the distal end of the spit was less than 3 feet high, and 4-5 feet wide at the base. Six months after the earthquake, the berm, as shown by figure 18, had built up to 6 feet in height and had widened to nearly 60 feet. The same berm after another 6-month period had widened an additional 20 feet. Elsewhere the berm has migrated around buildings and covered and blocked roads.

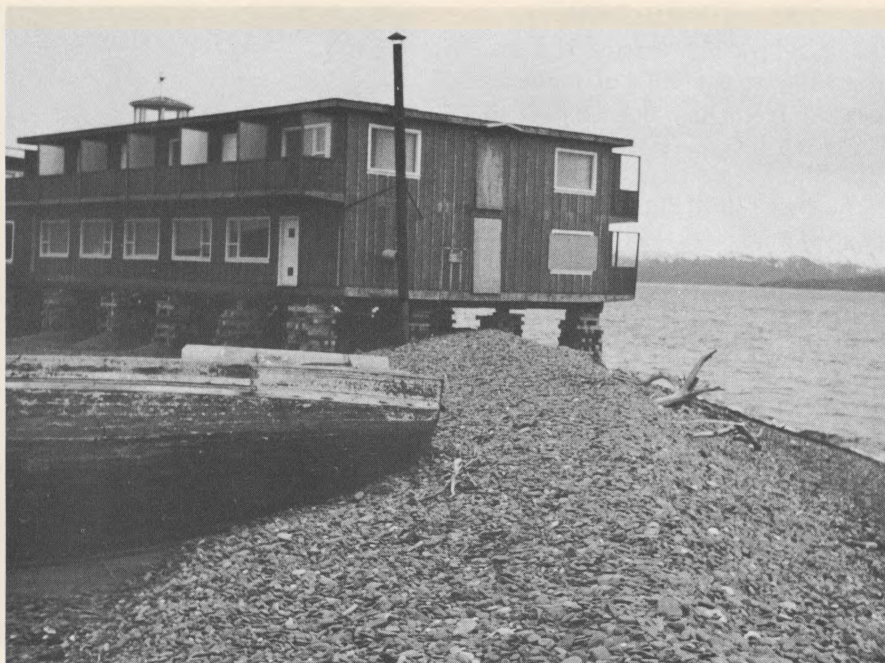
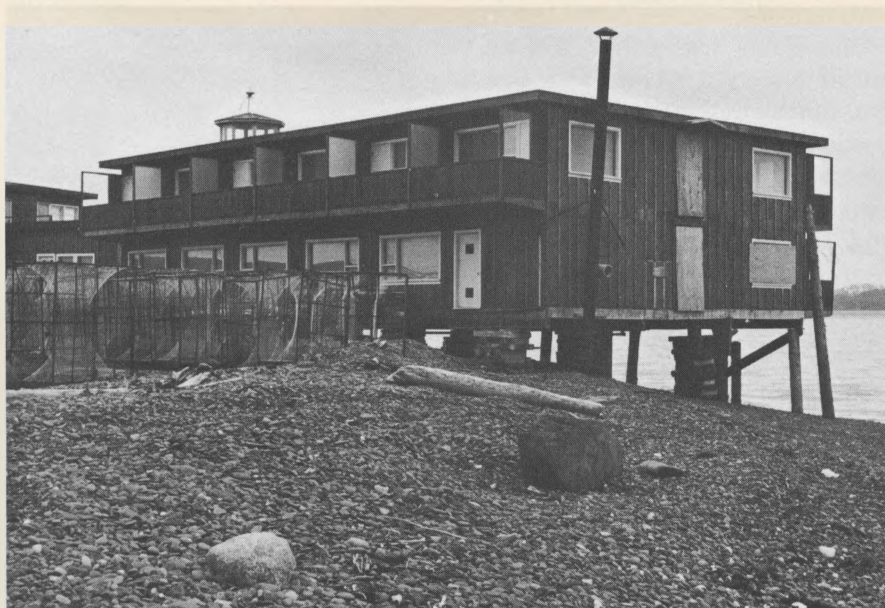
The size of the new berm is not in proportion to material lost from, nor to the recession of, the adjacent beach face. Figure 19

19.—Photographs taken 6 months after subsidence (top) and a year after subsidence (bottom) show that the size of frontal berm is not proportional to the recession of the beach face.

shows an example of this disparity. Such examples show that a large part of the material scoured from the beach face was not carried onto the spit and deposited as part of the berm. According to King (1959, p.

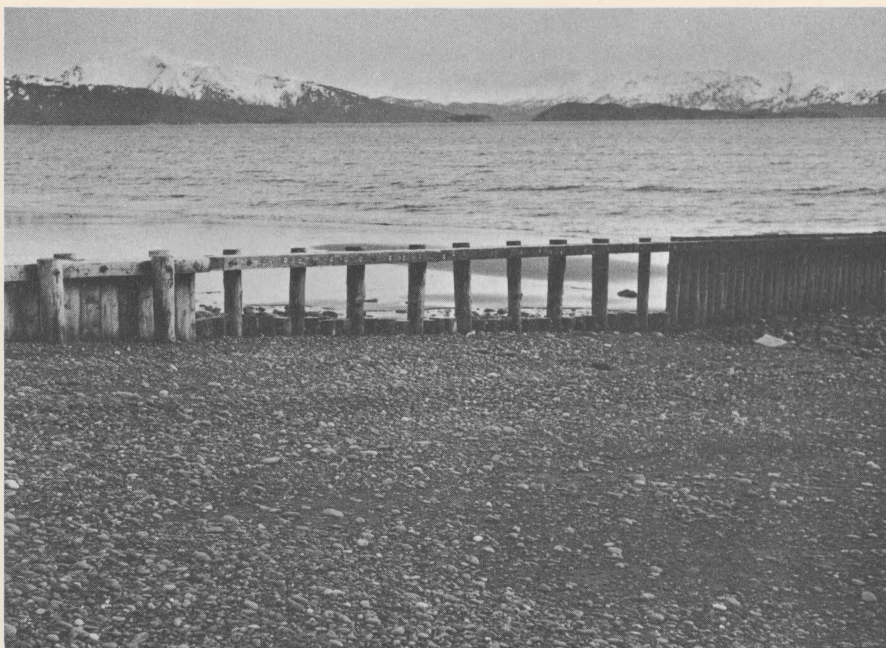
20.—Section removed from seaward end of groin to allow bypassing of material.

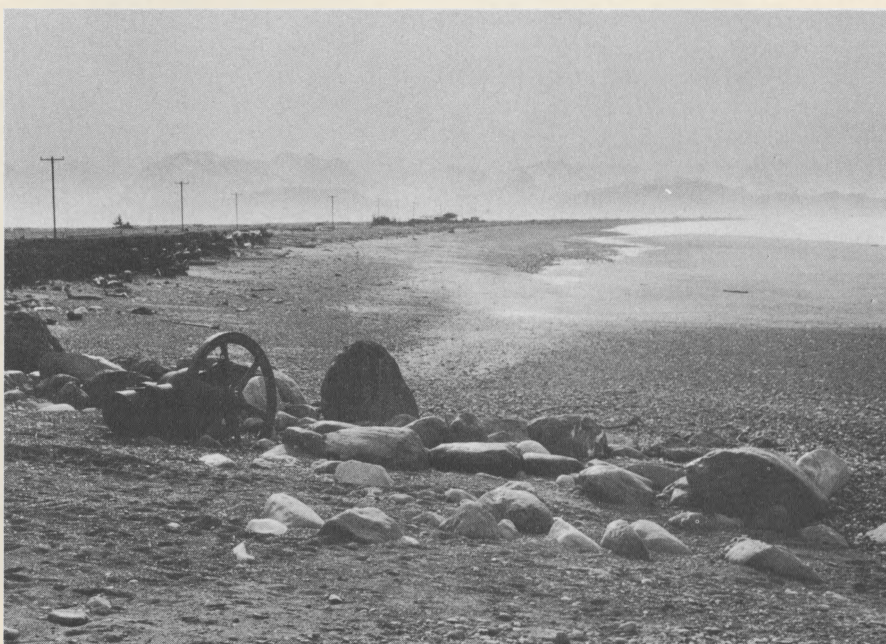
21.—Erosion on the lee side of the last of a series of four groins, a few days after the earthquake.

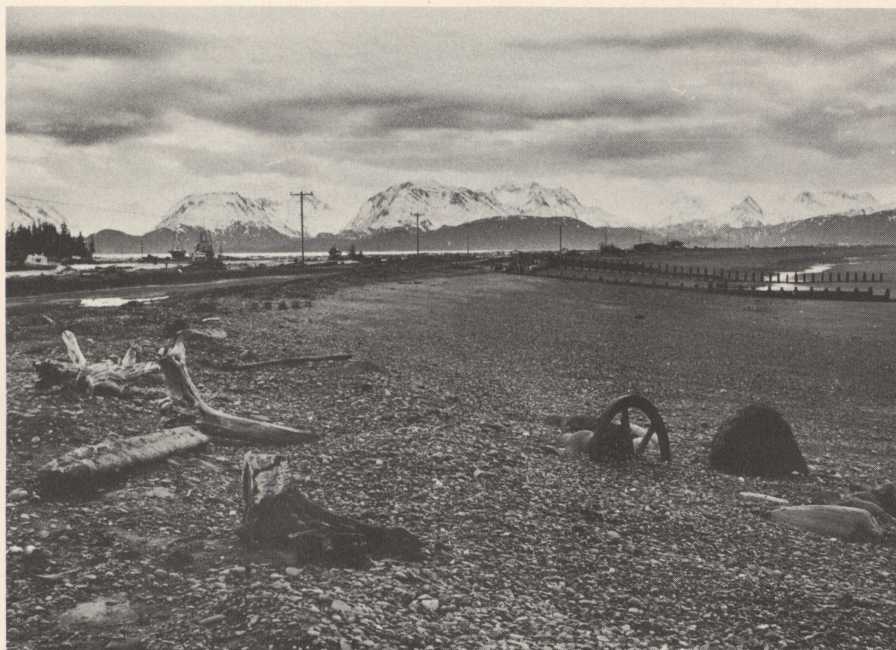
22.—The same area as shown in figure 21, 1 year later, after construction of two new groins (right background).

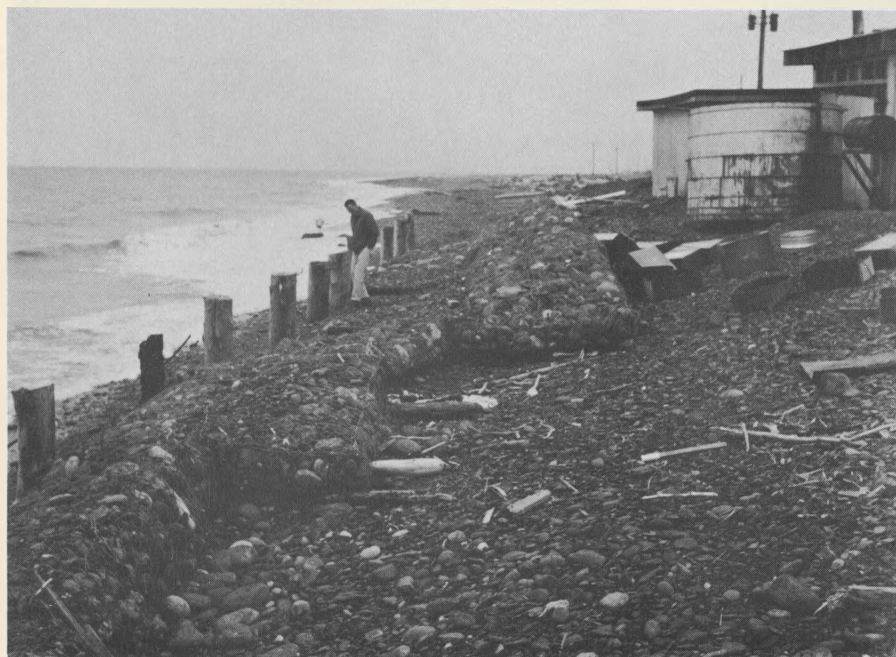
23.—Cobble-filled baskets placed on beach face to prevent erosion.

At one location a small cannery was endangered by undermining. Specially manufactured and prefabricated wire baskets were filled with cobbles and placed along the beach face (fig. 23). After 1 year the beach has built up and has shown no tendency to scour in front of the cobble-filled baskets.

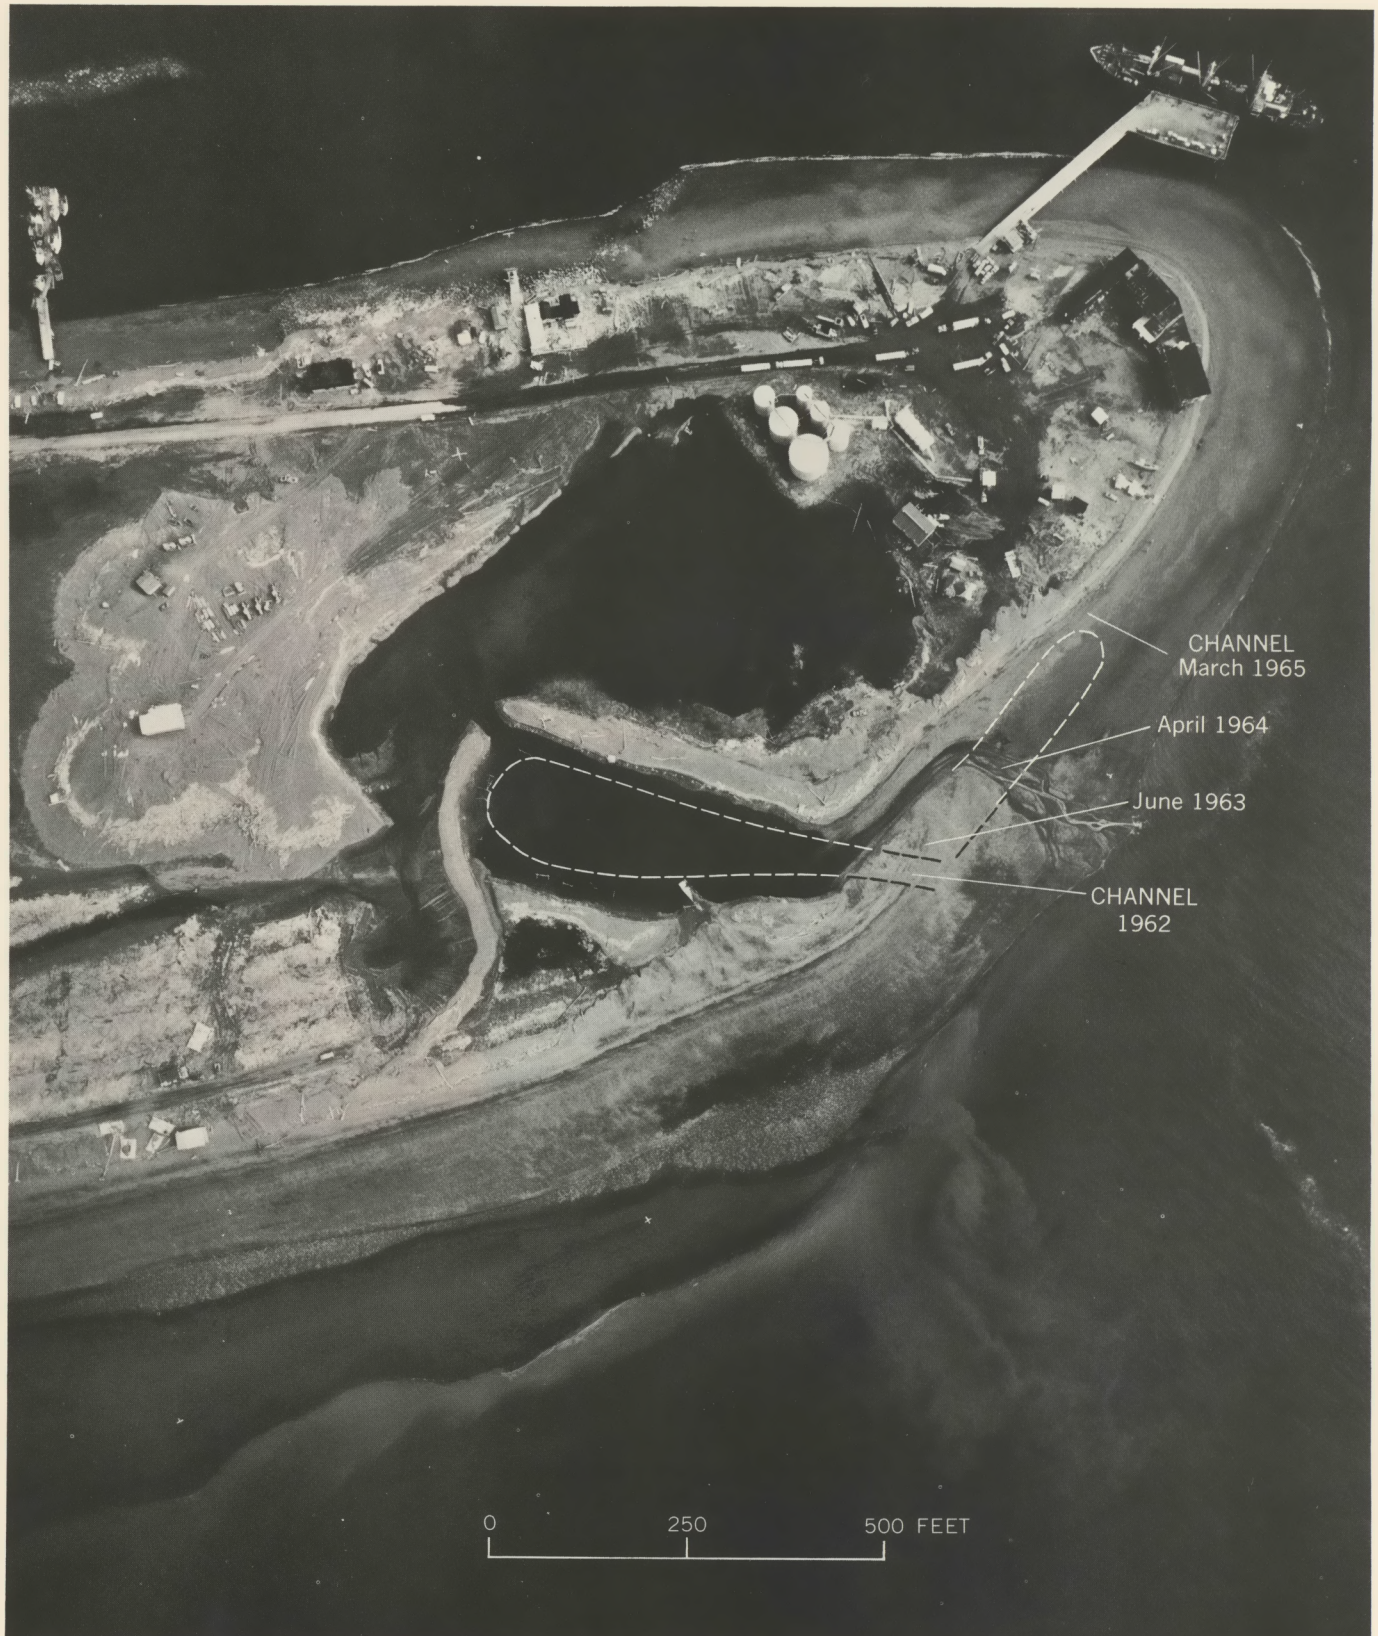
24.—Bar being built across the entrance of a tidal inlet at distal end of Homer Spit. Photograph by U.S. Army Corps of Engineers, April 30, 1964.

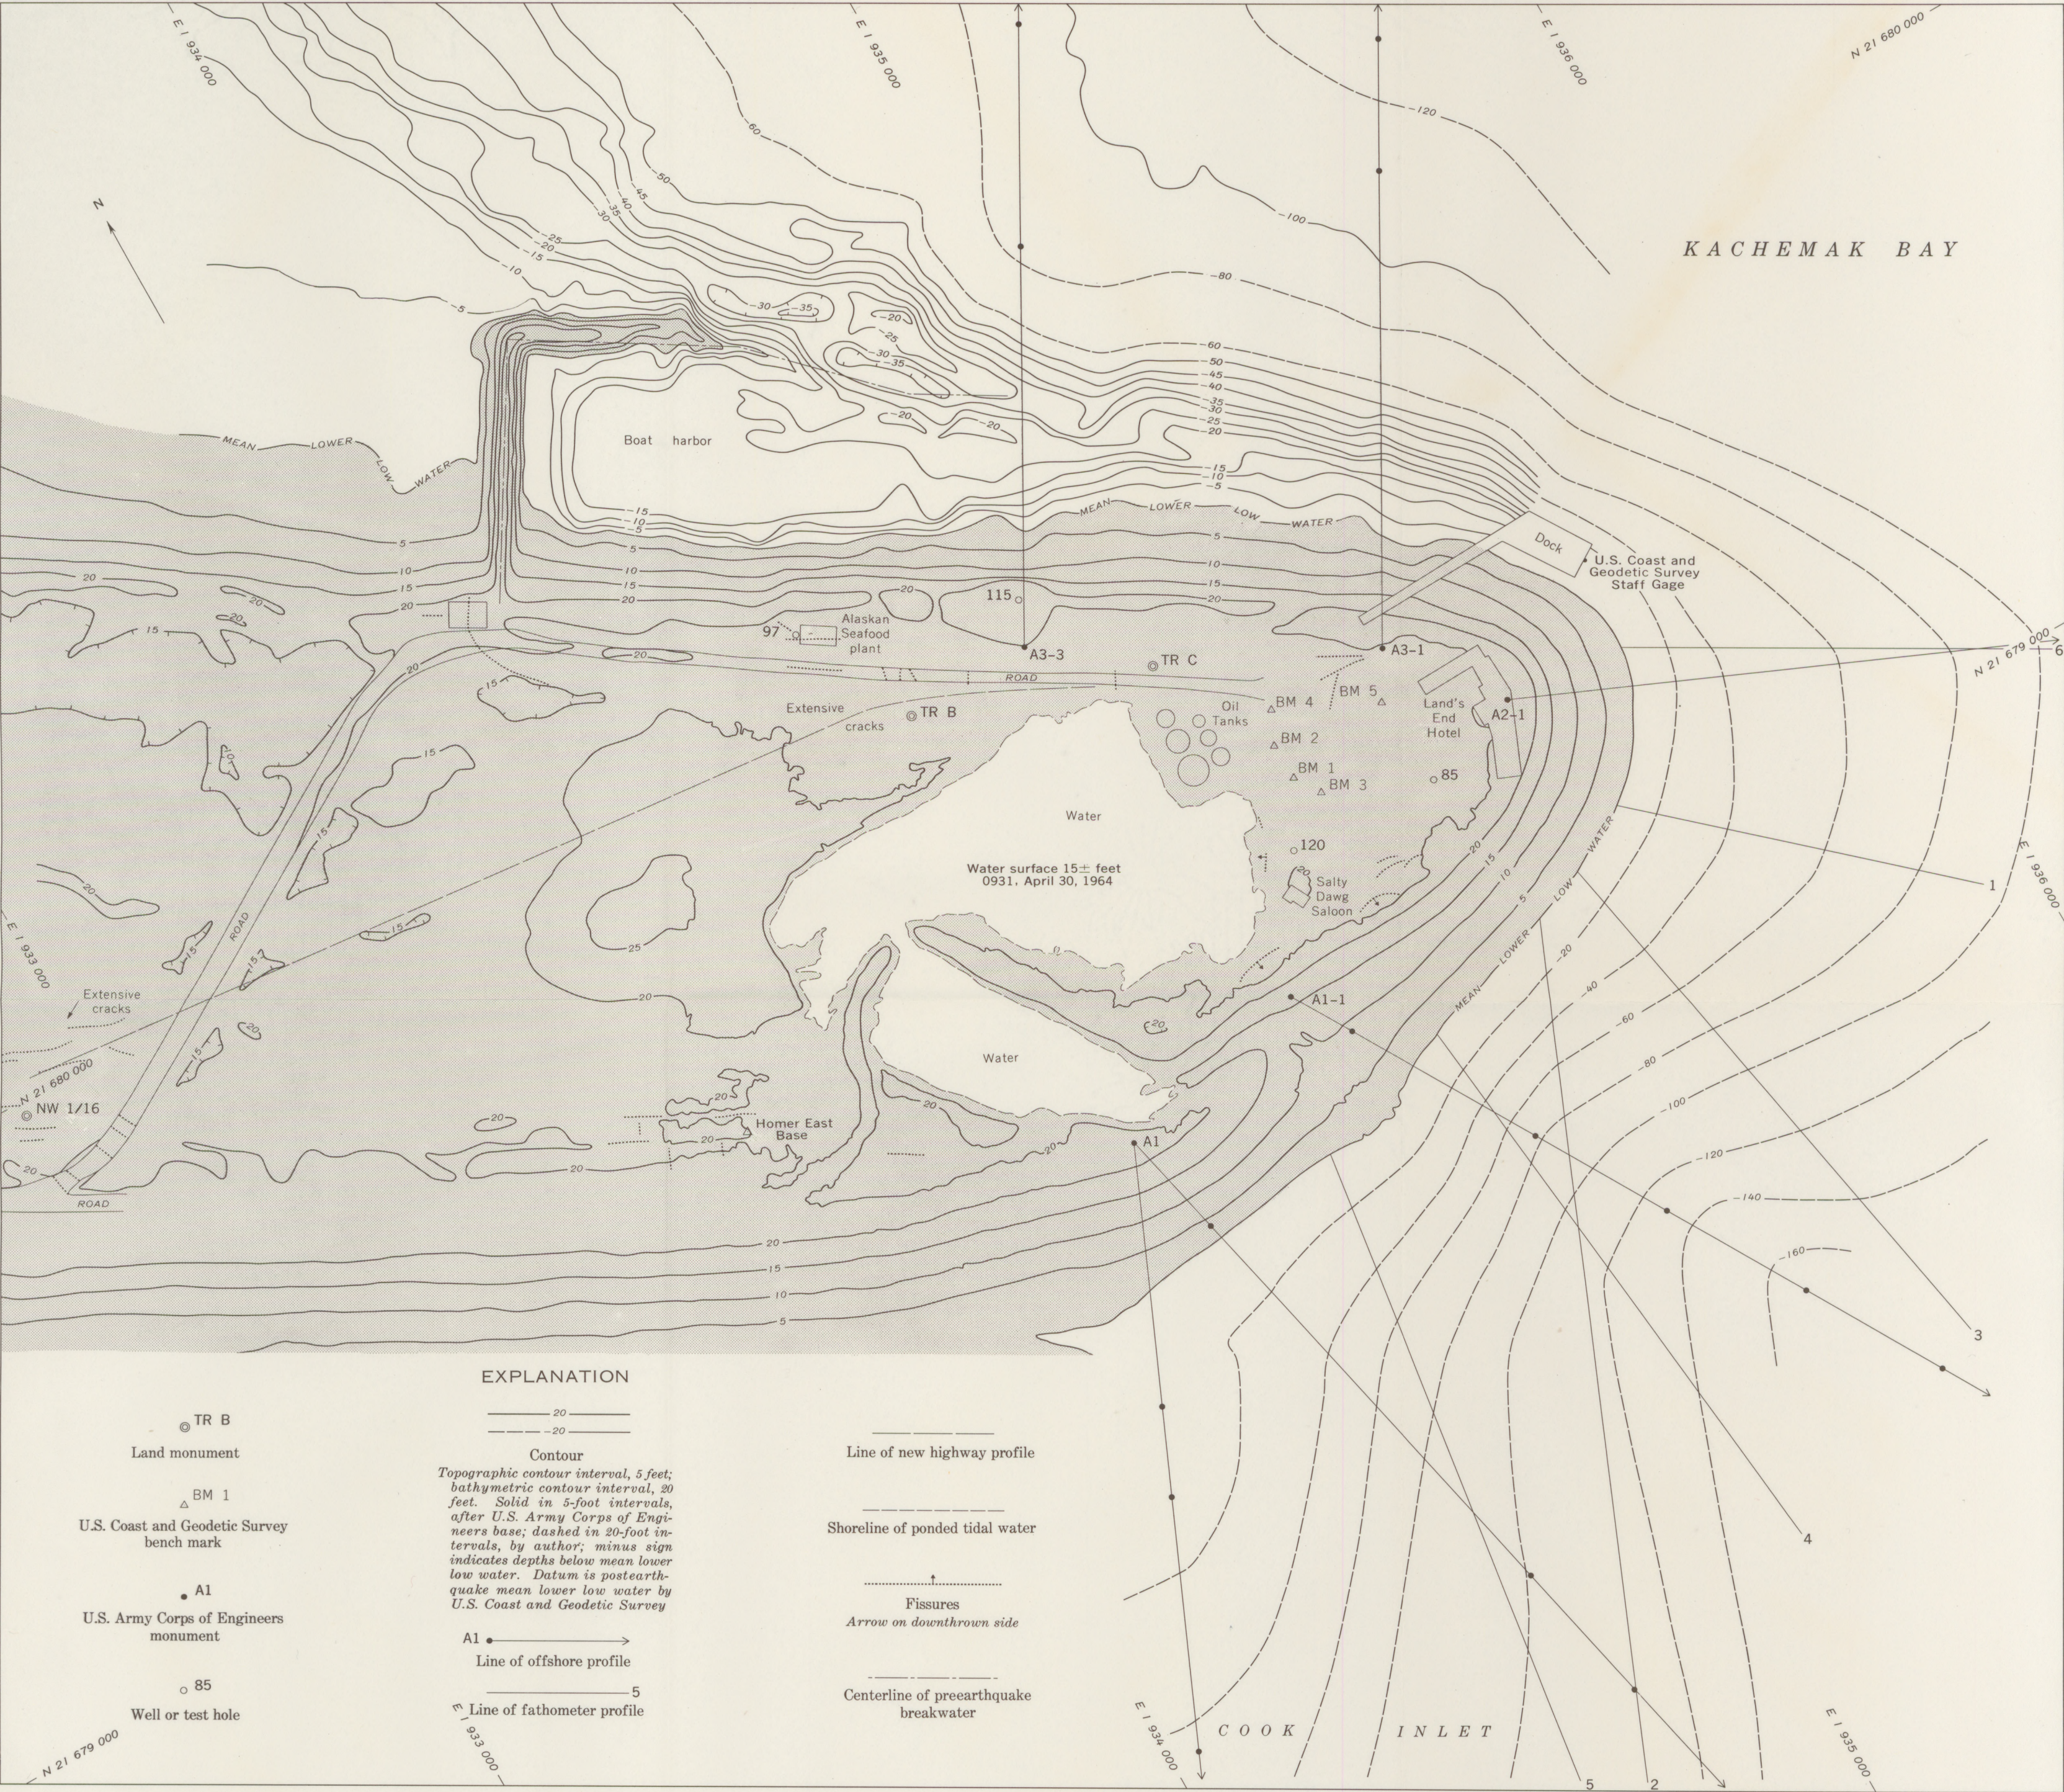
MAP OF END OF HOMER SPIT, ALASKA, SHOWING LOCATIONS DESCRIBED IN TEXT
FISSURE PATTERNS, TOPOGRAPHY, AND OFFSHORE BATHYMETRY

The fissures on Homer Spit were plotted (pl. 1) in their approximate locations. Many fissures were somewhat obscured by repeated inundation but, surprisingly, those in vegetated (dune grass) areas were still noticeable several months later. Grantz and others (1964, p. 24) reported that "Many of the fractures had vertical displacement, some as much as 8 inches, with the downdropped side toward the coast," presumably meaning both the bay and the ocean shoreline; hence the material was displaced downward between the fissures and the closest shoreline, a fact which suggests lateral spreading.
