EFFECTS OF THE EARTHQUAKE
OF MARCH 27, 1964
AT SEWARD, ALASKA

Effects of the Earthquake Of March 27, 1964, At Seward, Alaska

BY RICHARD W. LEMKE

GEOLOGICAL SURVEY PROFESSIONAL PAPER 542-E

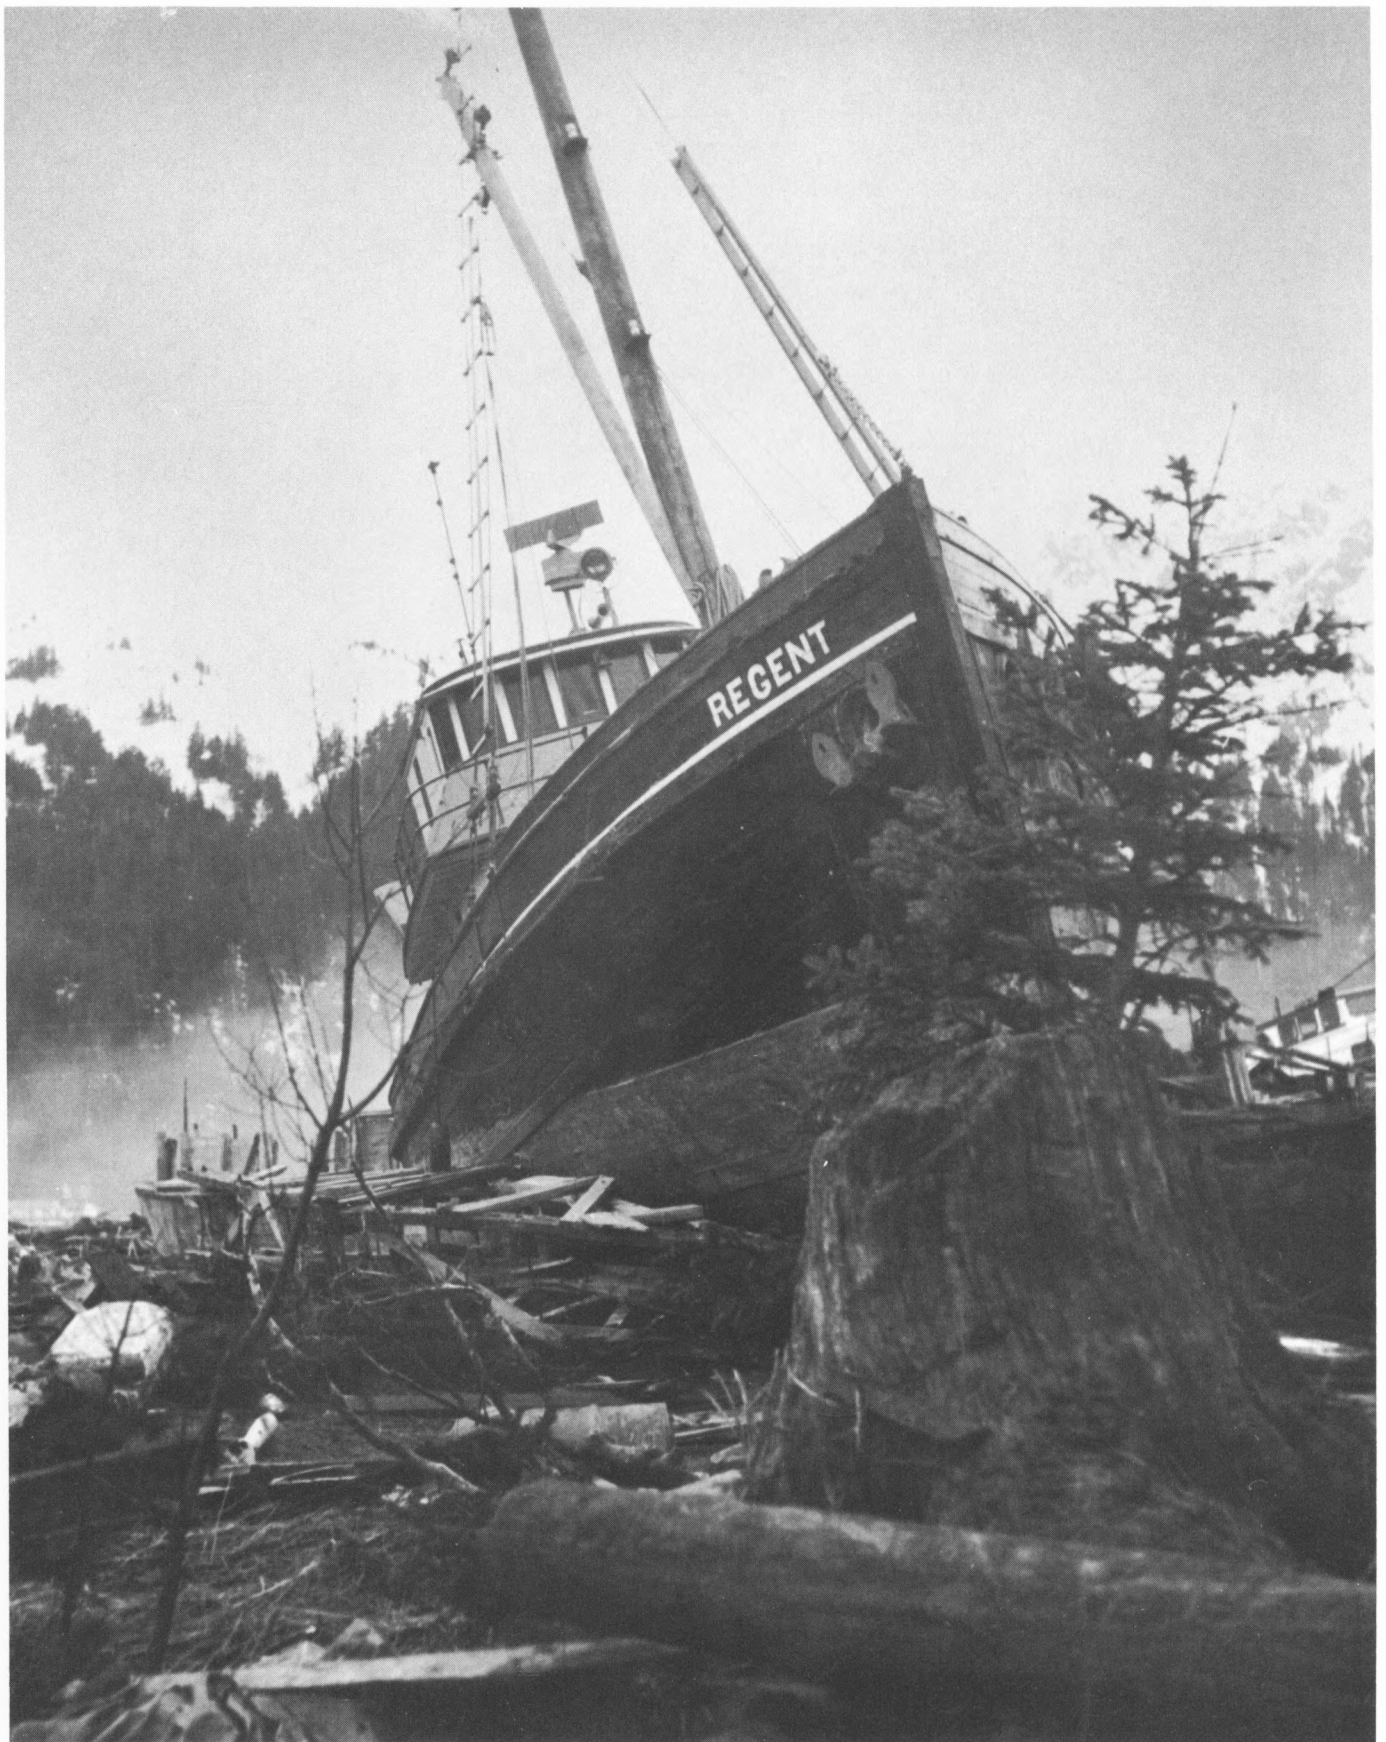
Fishing boat beached several hundred feet inland from the head of Resurrection Bay by seismic sea waves.

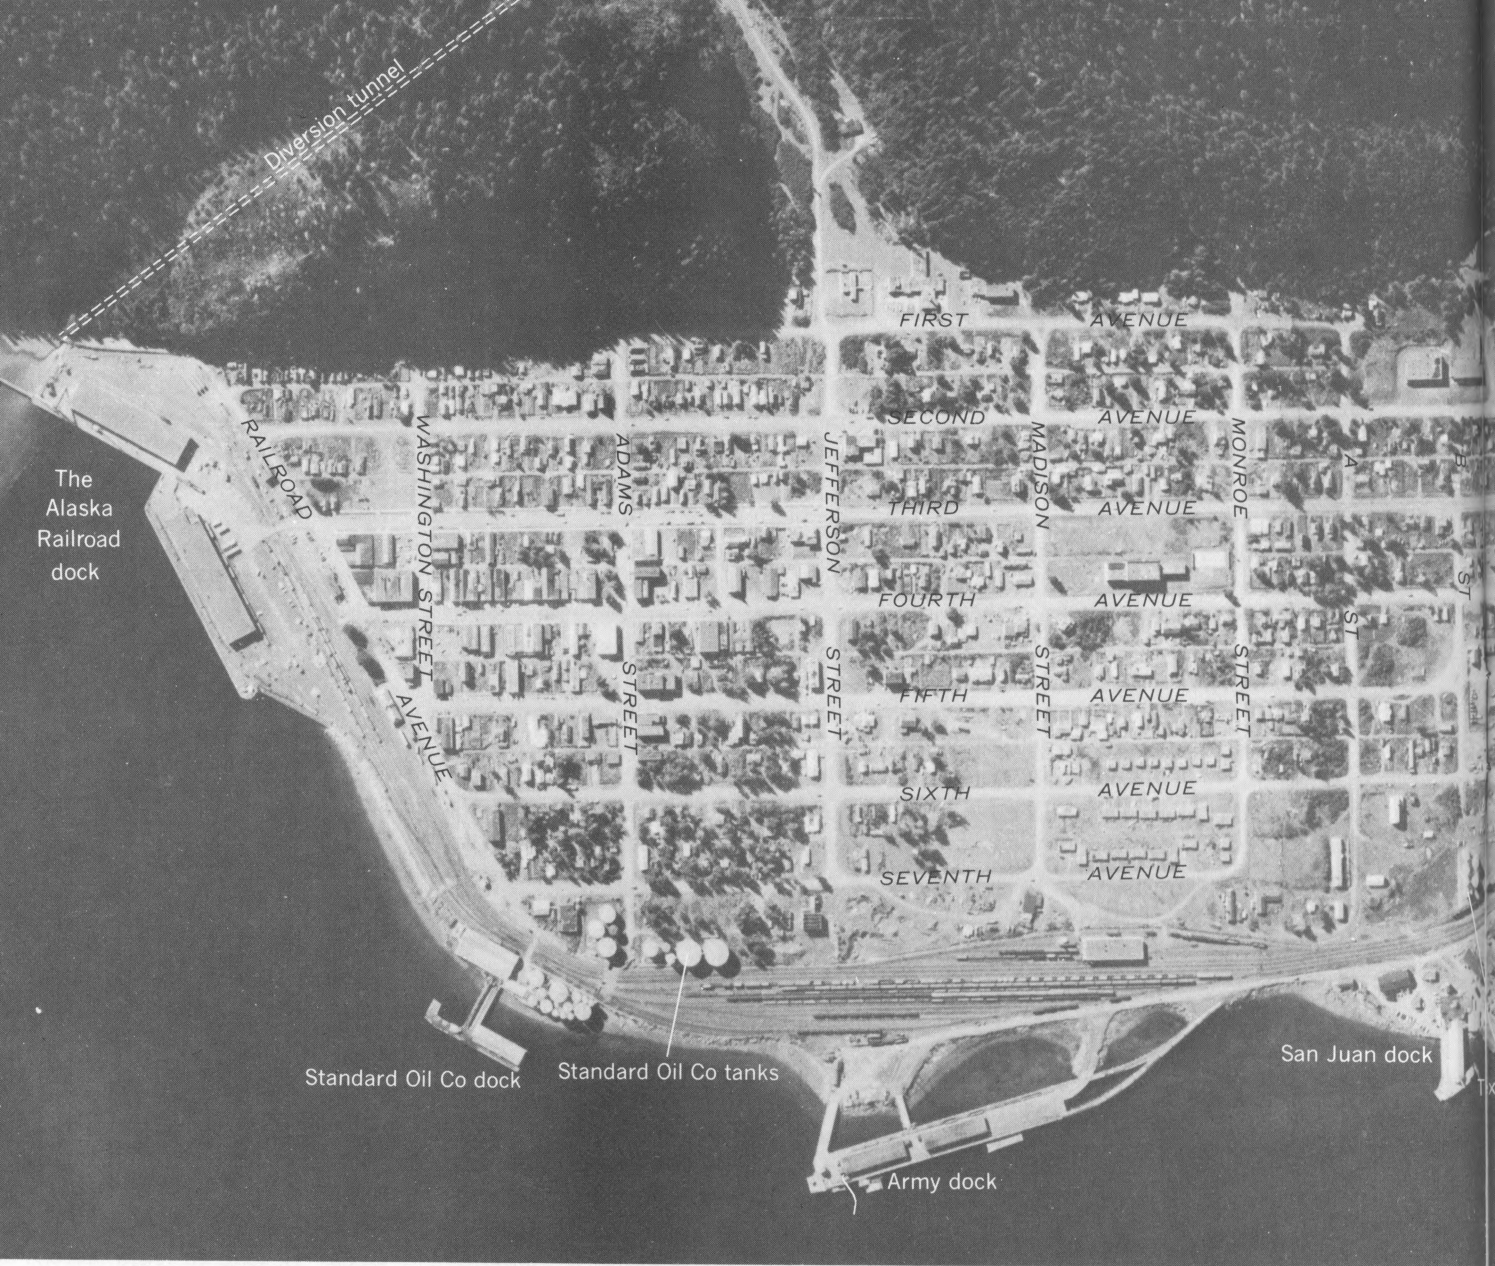
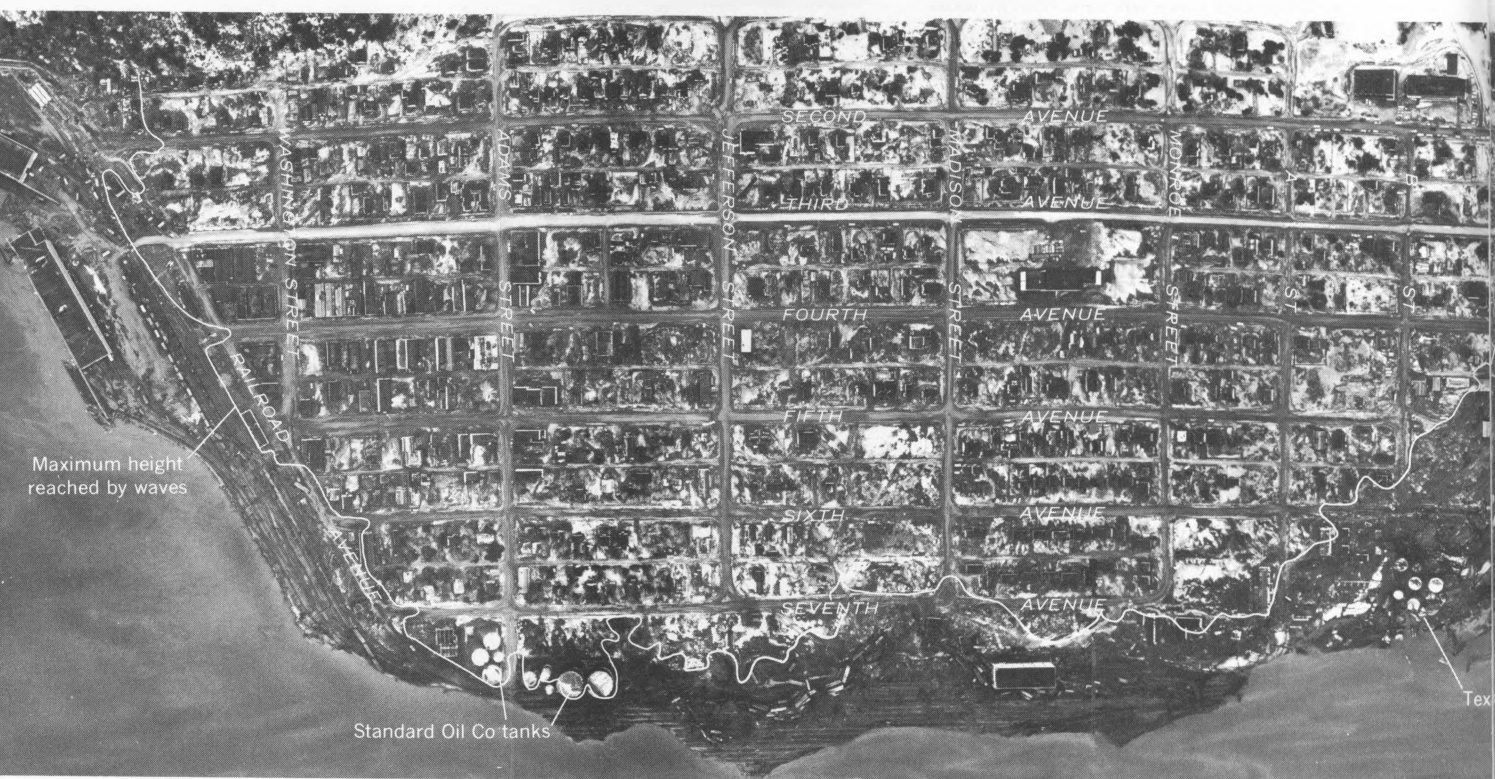
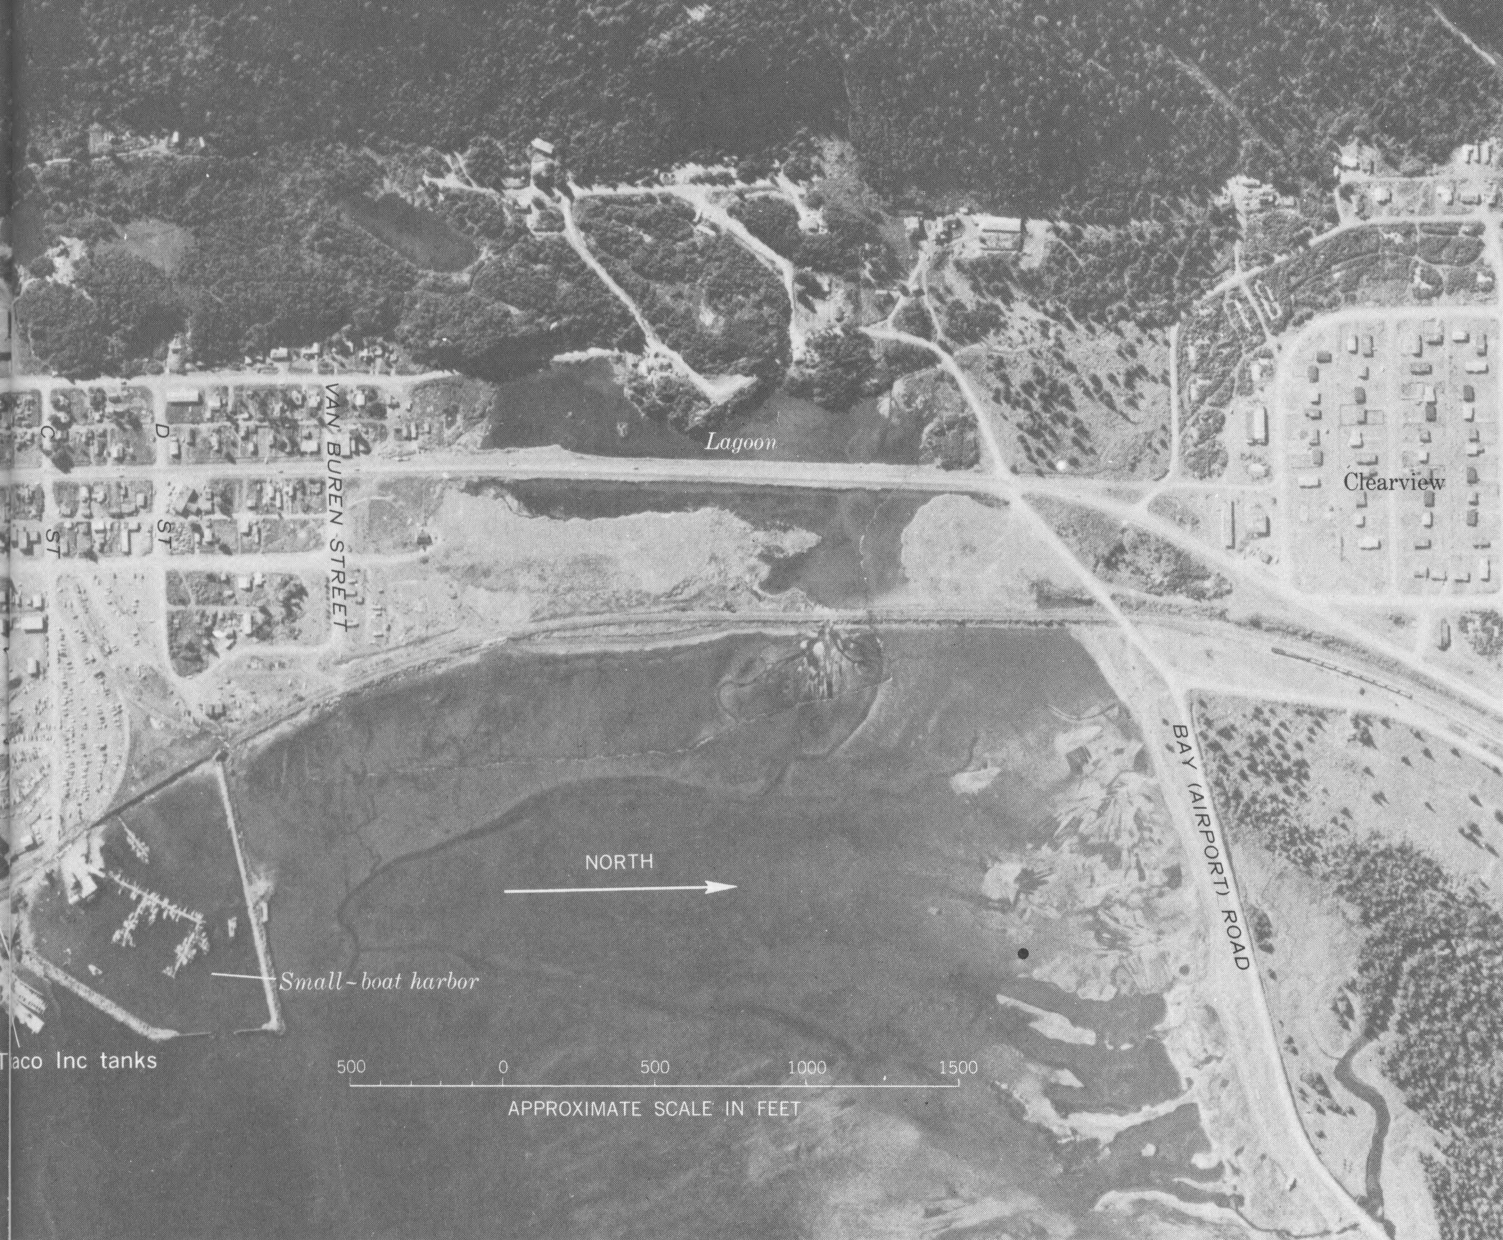
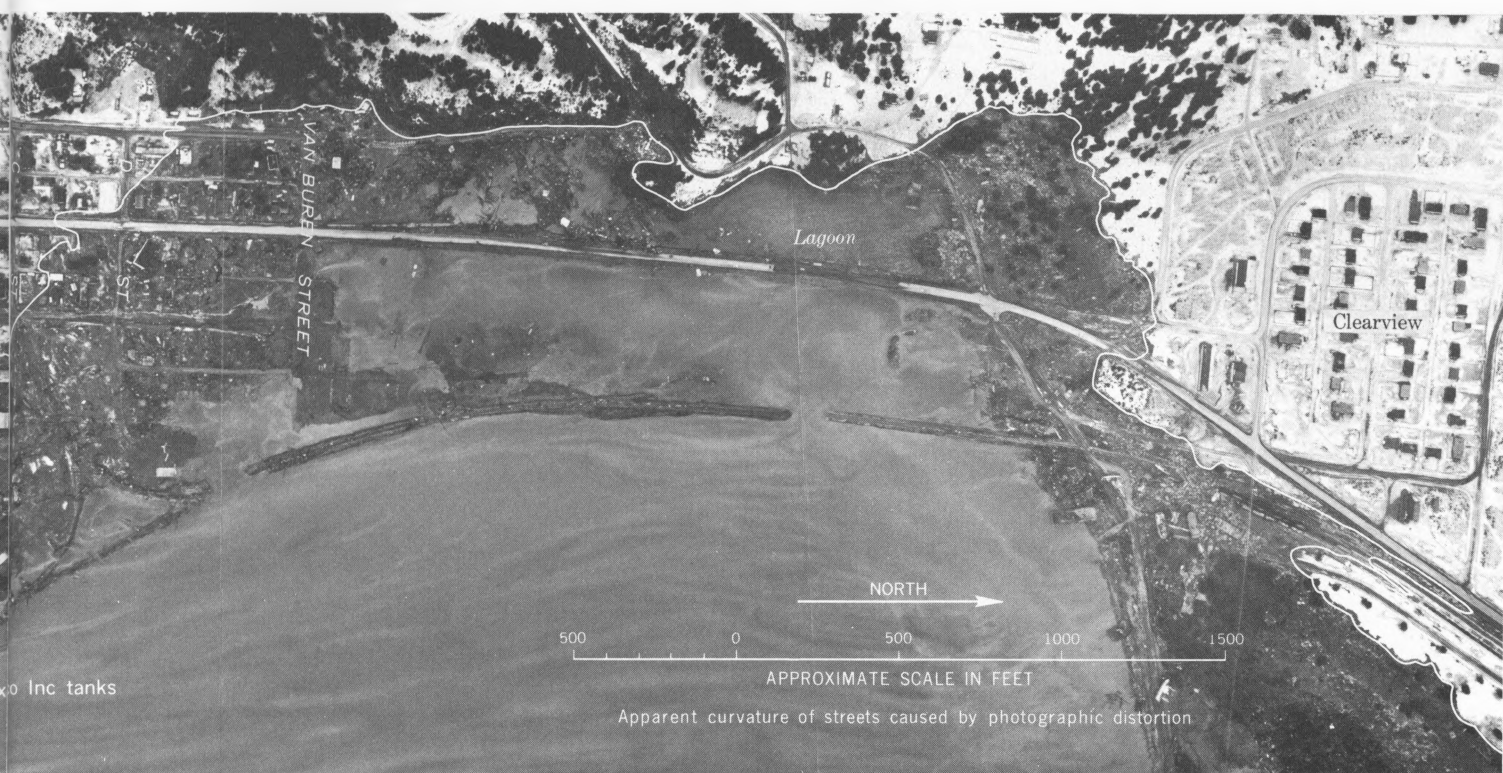
gressively as shaking continued, until a strip of harbor area 50–500 feet wide had disappeared into the bay (fig. 2, p. 6). Large fractures broke the ground surface behind the slide area and extended several hundred feet inland as shaking continued (figs. 3, 4, p. E8, E10). Some fractures near the Texaco tanks reportedly opened and closed repeatedly during the shaking; some were at least 20 feet deep. They filled quickly with water and, as the shaking continued, spewed muddy water at intervals. When the shaking ceased, fracturing had reached its maximum extent and the shoreline had receded to the position shown in figure 2 (bottom).

2. Seward before and after the earthquake. Top, before the earthquake of March 27, 1964. Bottom, 1 day after the earthquake

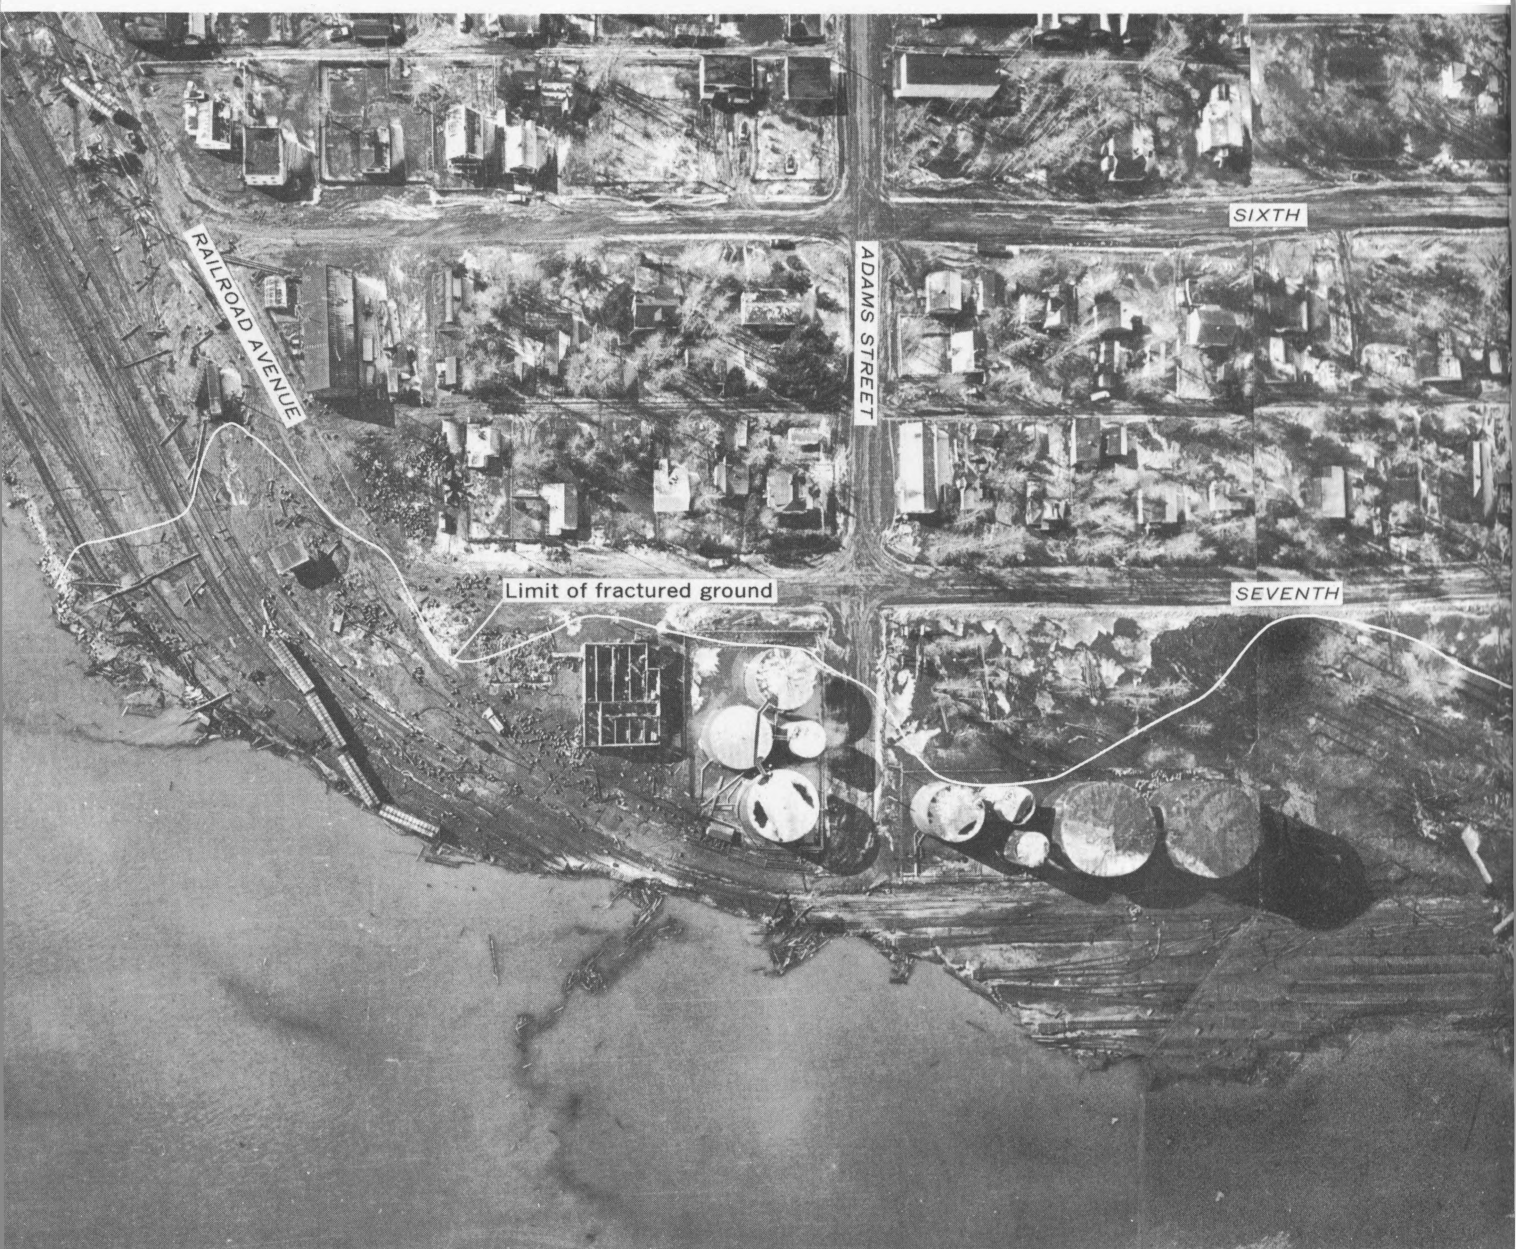
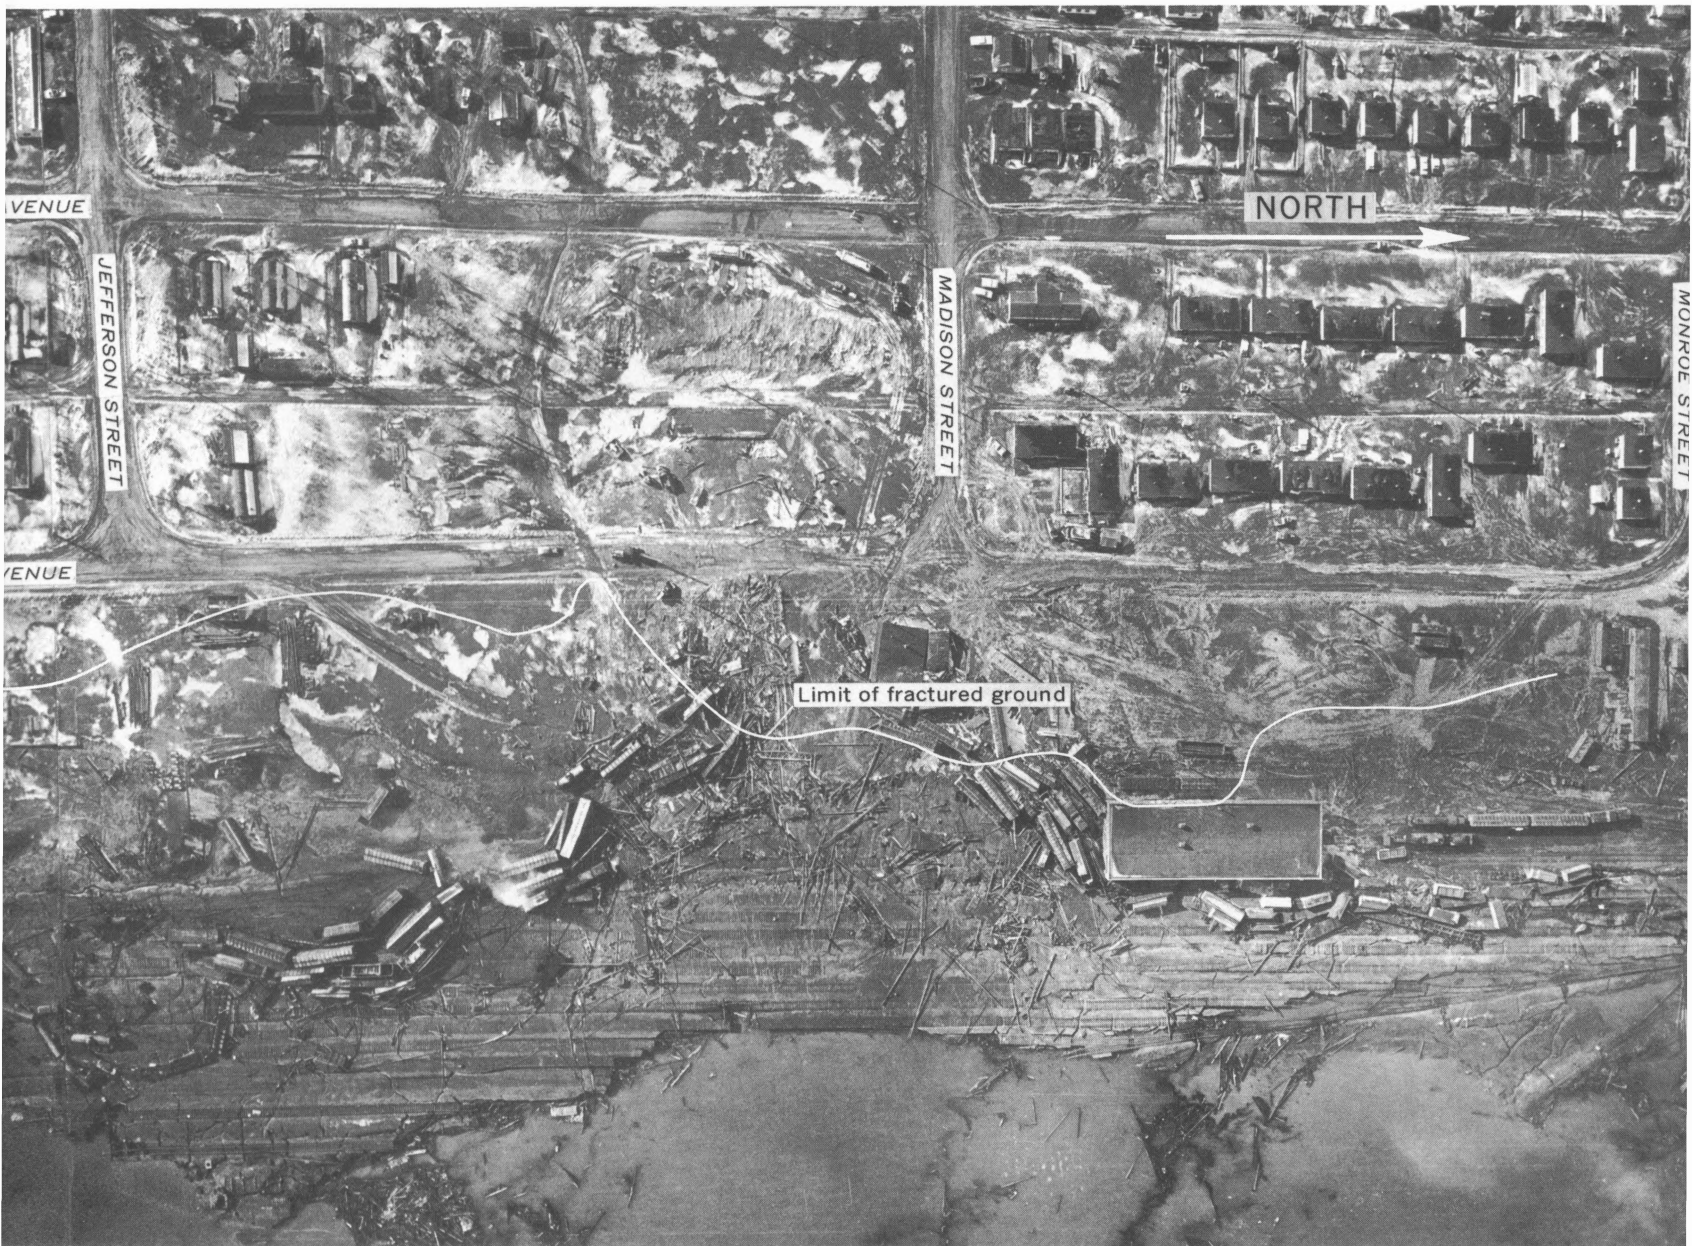
3. Aerial view of the southern part of the Seward waterfront showing extent of ground fracture and earthquake damage. Photographs

Ground fracturing along the Seward waterfront (figs. 3, 4) is believed to be closely related to onshore and offshore landsliding in that area. Horizontal translation and vertical displacement of the ground seaward, as sliding progressed, apparently was the dominant cause of fracturing.

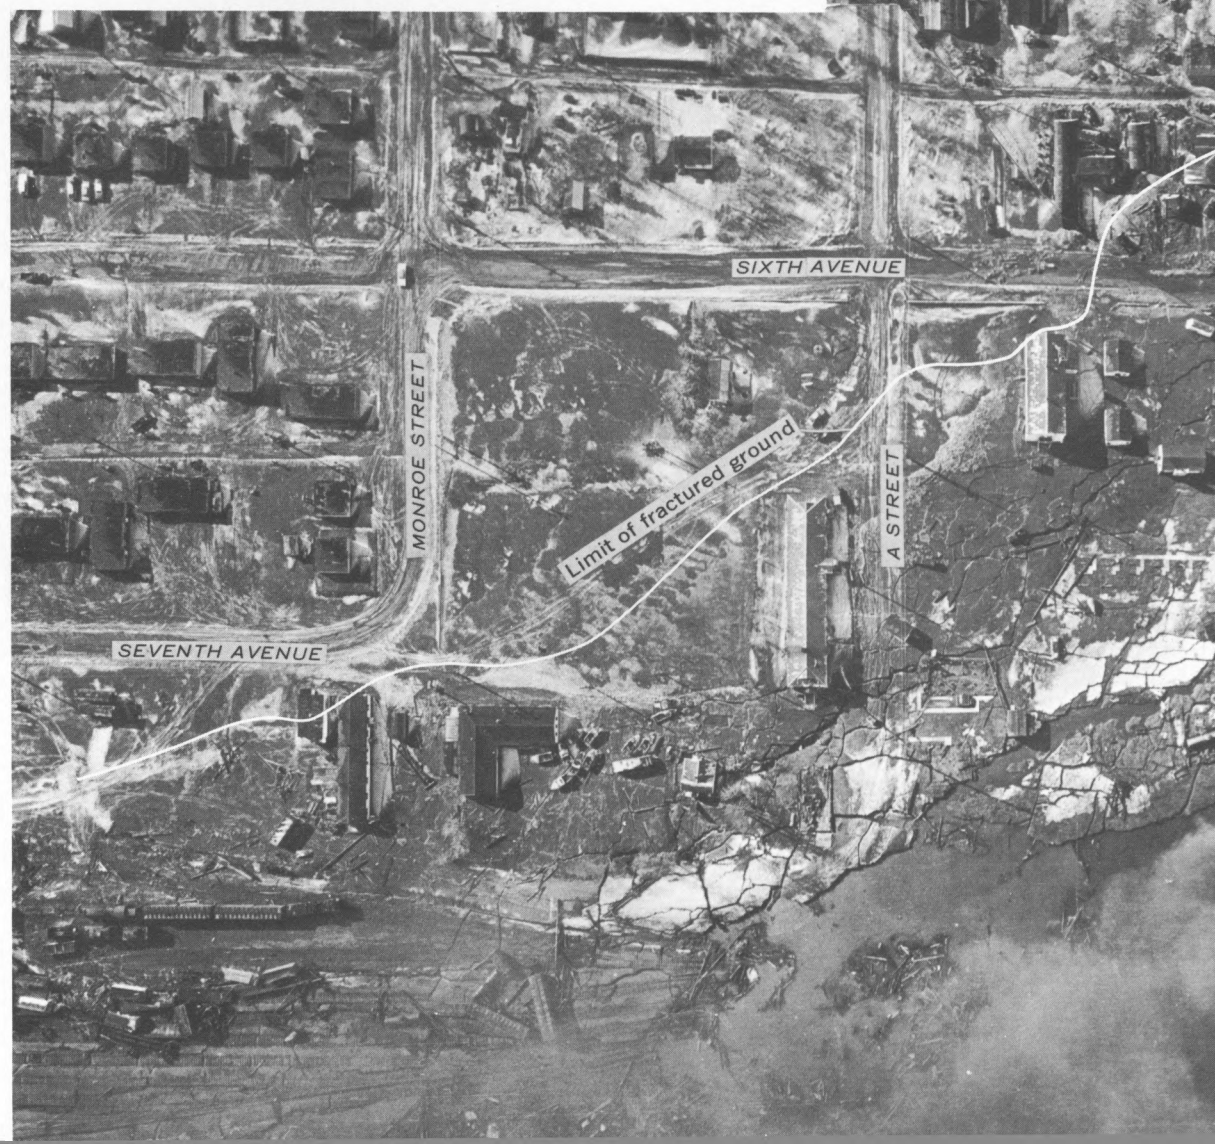
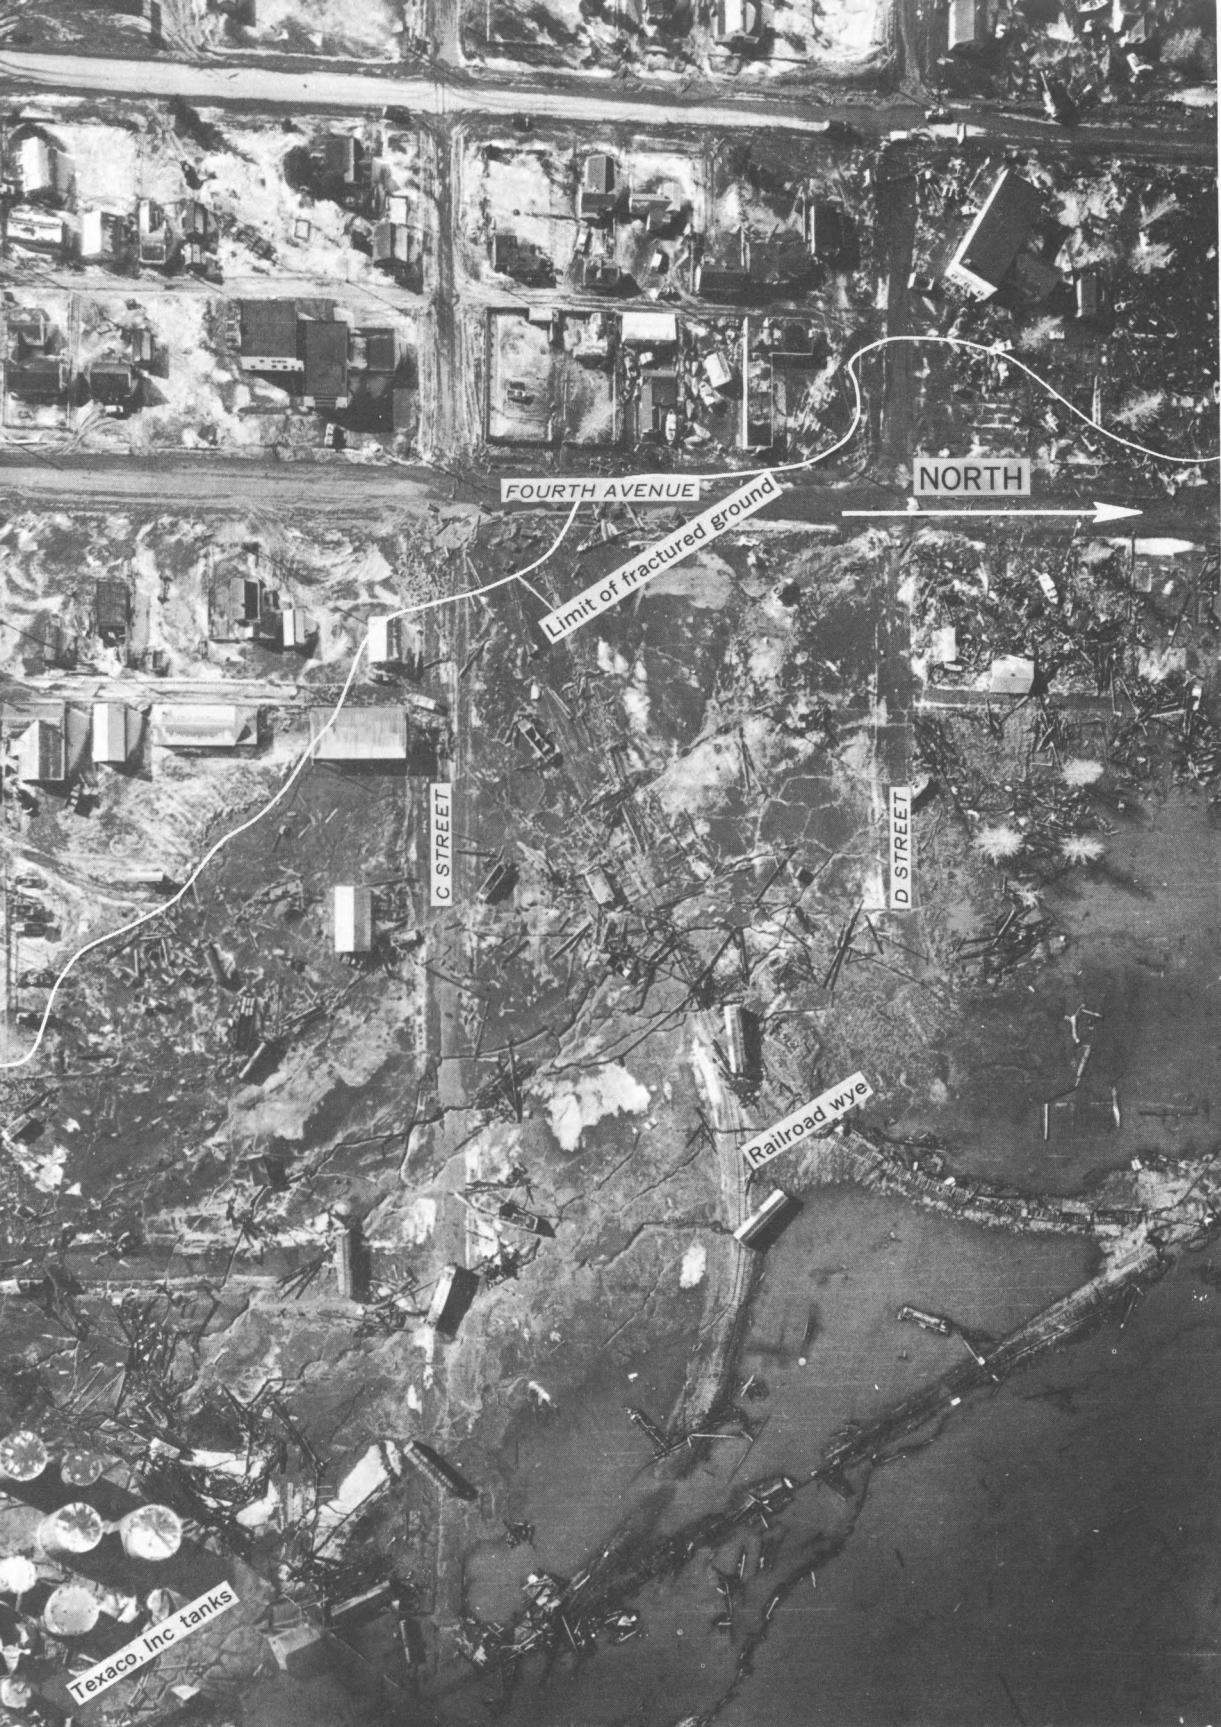
4. Aerial view of the northern part of the Seward waterfront showing extent of fractured ground and earthquake damage. Photograph by U.S. Army; mosaicked by U.S. Geological Survey. Index map (upper left) shows relation of figures 3 and 4.

The total amount of horizontal and vertical displacement in the area of fractured ground could not be determined accurately. It undoubtedly was greatest in the area of the Texaco tanks and became progressively less toward the Standard Oil Co. tanks. Two weeks after the earthquake, the fractures in the area of the Texaco tanks were commonly 0.5–2 feet wide, and a few were as wide as 4 feet. In general, the dominant fracture systems were roughly parallel to the shore. Intersecting transverse fracturing commonly produced a roughly polygonal pattern (fig. 4). In most places, the decreasing width of the fractures

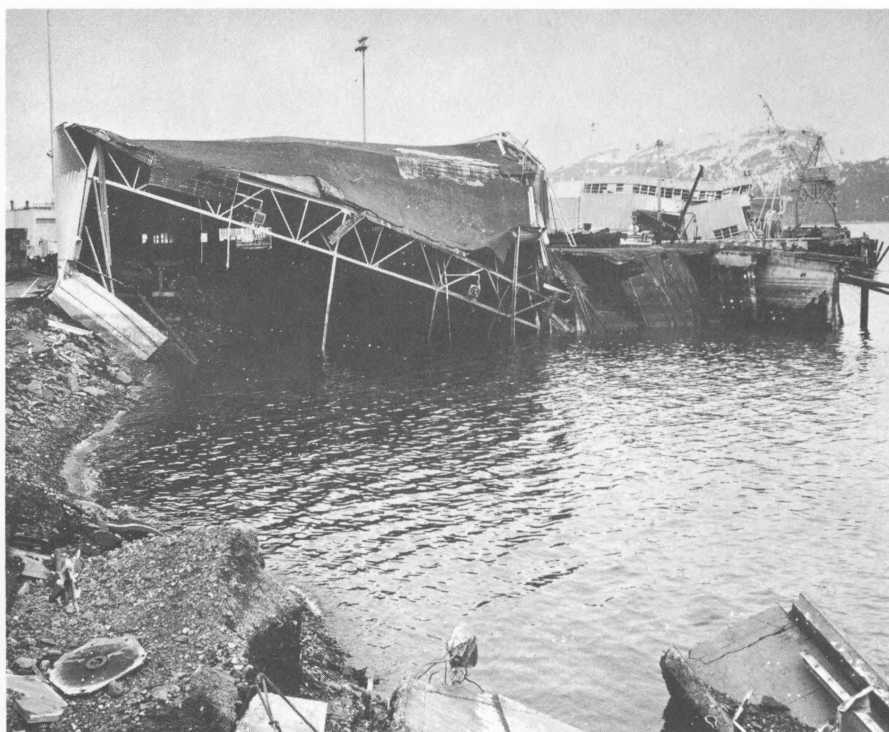
The water surged back from the mound toward the southwest part of the Seward waterfront also. A large swell broke over The Alaska Railroad dock area (fig. 5, p. 12), lifting flat cars off the tracks and picking up several vehicles. Its crestline at Railroad Avenue was nearly as high as that of any later wave. As this wave hit the shoreline at the Standard Oil Co. tanks, burning oil was carried back onto shore. An 80-car freight train on the tracks between the Standard and Texaco tanks was just ready to start moving north. Its last 40 cars were filled oil tankers and as the fire swept onto shore, the tankers caught fire in a chain reaction of exploding cars down the track toward the Texaco yard. Reportedly several minutes elapsed before the Texaco tanks caught fire, even though oil from ruptured

5.—Damage caused by water waves to old Alaska Railroad dock and facilities.
Photograph by U.S. Army.

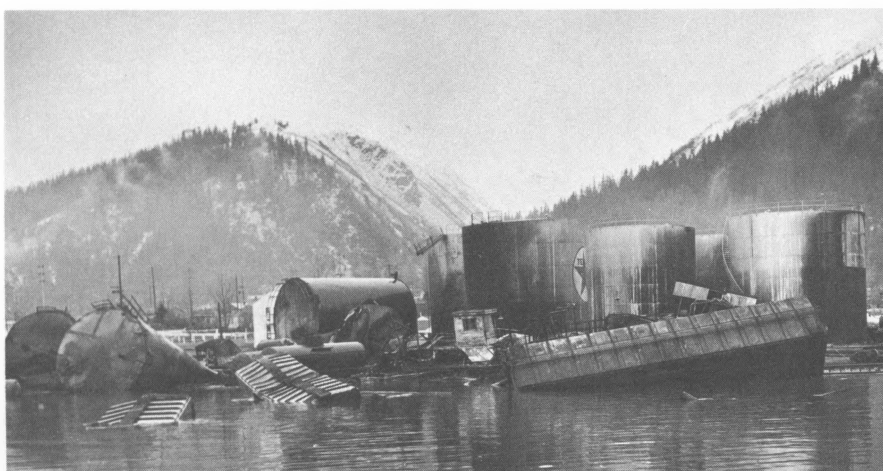
6.—Earthquake damage along Seward waterfront in area of Texaco, Inc., tanks. Photograph by U.S. Army.

Harbor facilities in the waterfront area between the Standard Oil and Texaco tanks were almost completely destroyed, and other parts of the waterfront were heavily damaged (fig. 6). The Standard Oil dock, 13 oil tanks, the Army dock, and the San Juan dock, on which a cannery was located, disappeared completely into the bay. Several Texaco tanks were destroyed by fire.

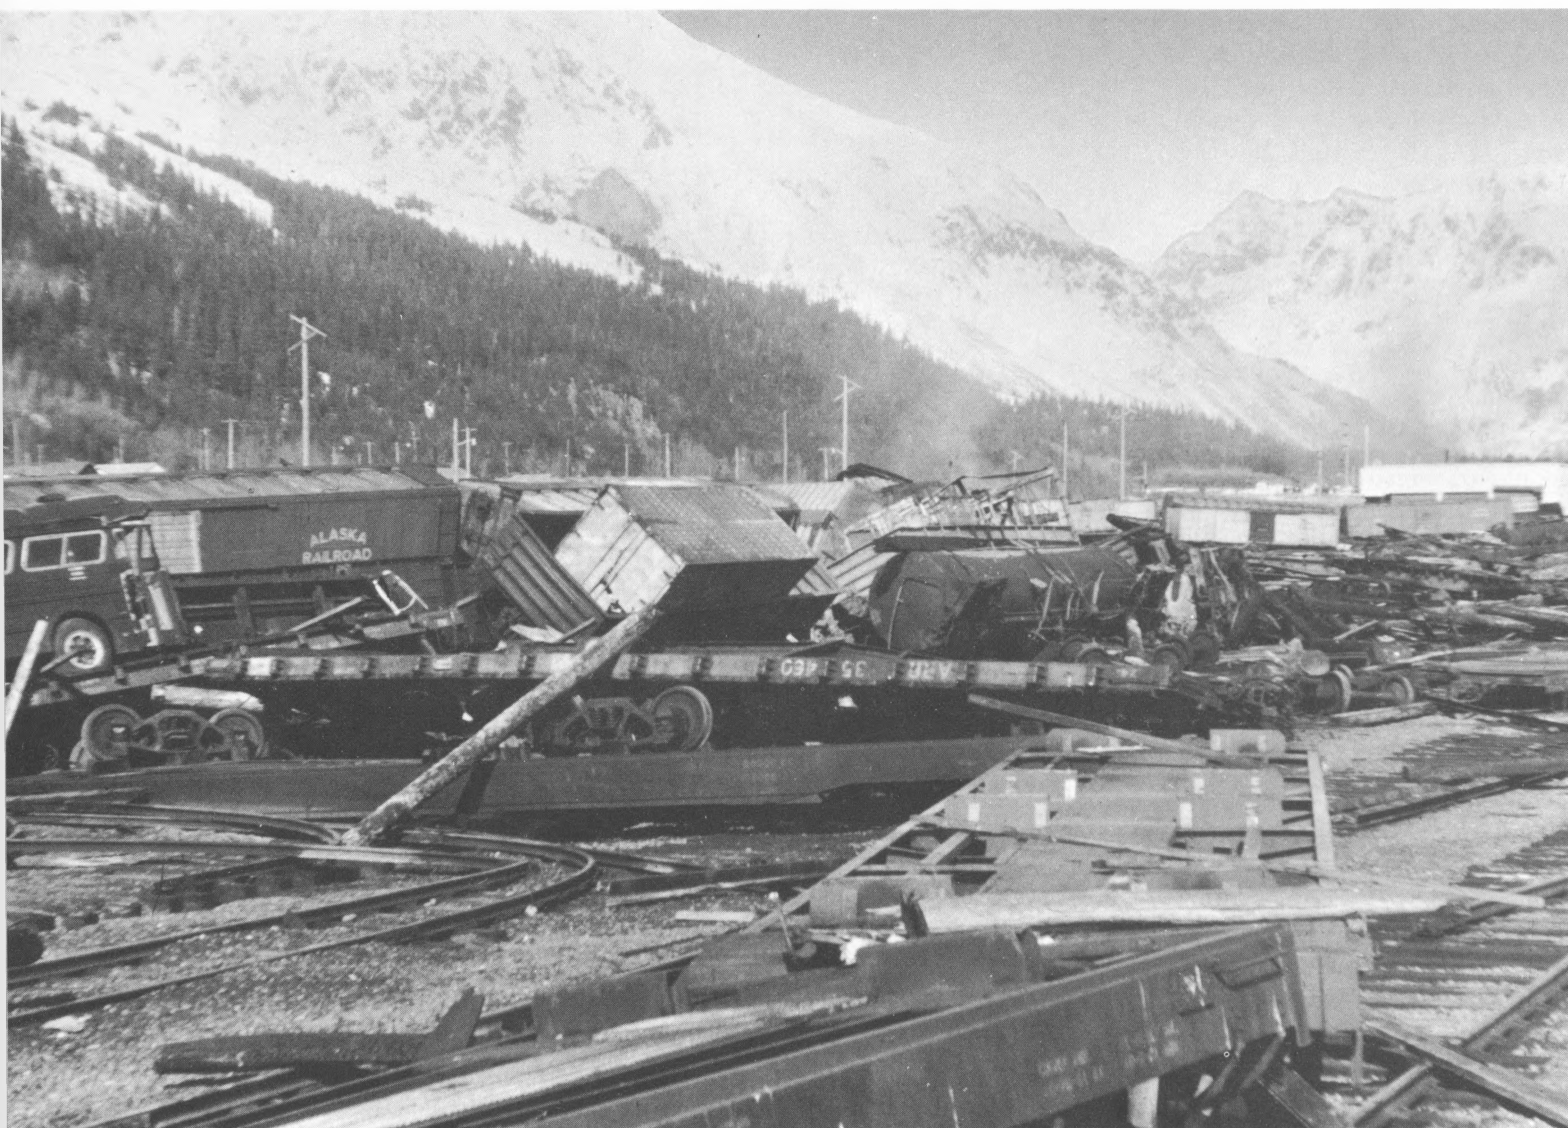
7.—Wave damage in the area of railroad marshalling yards.

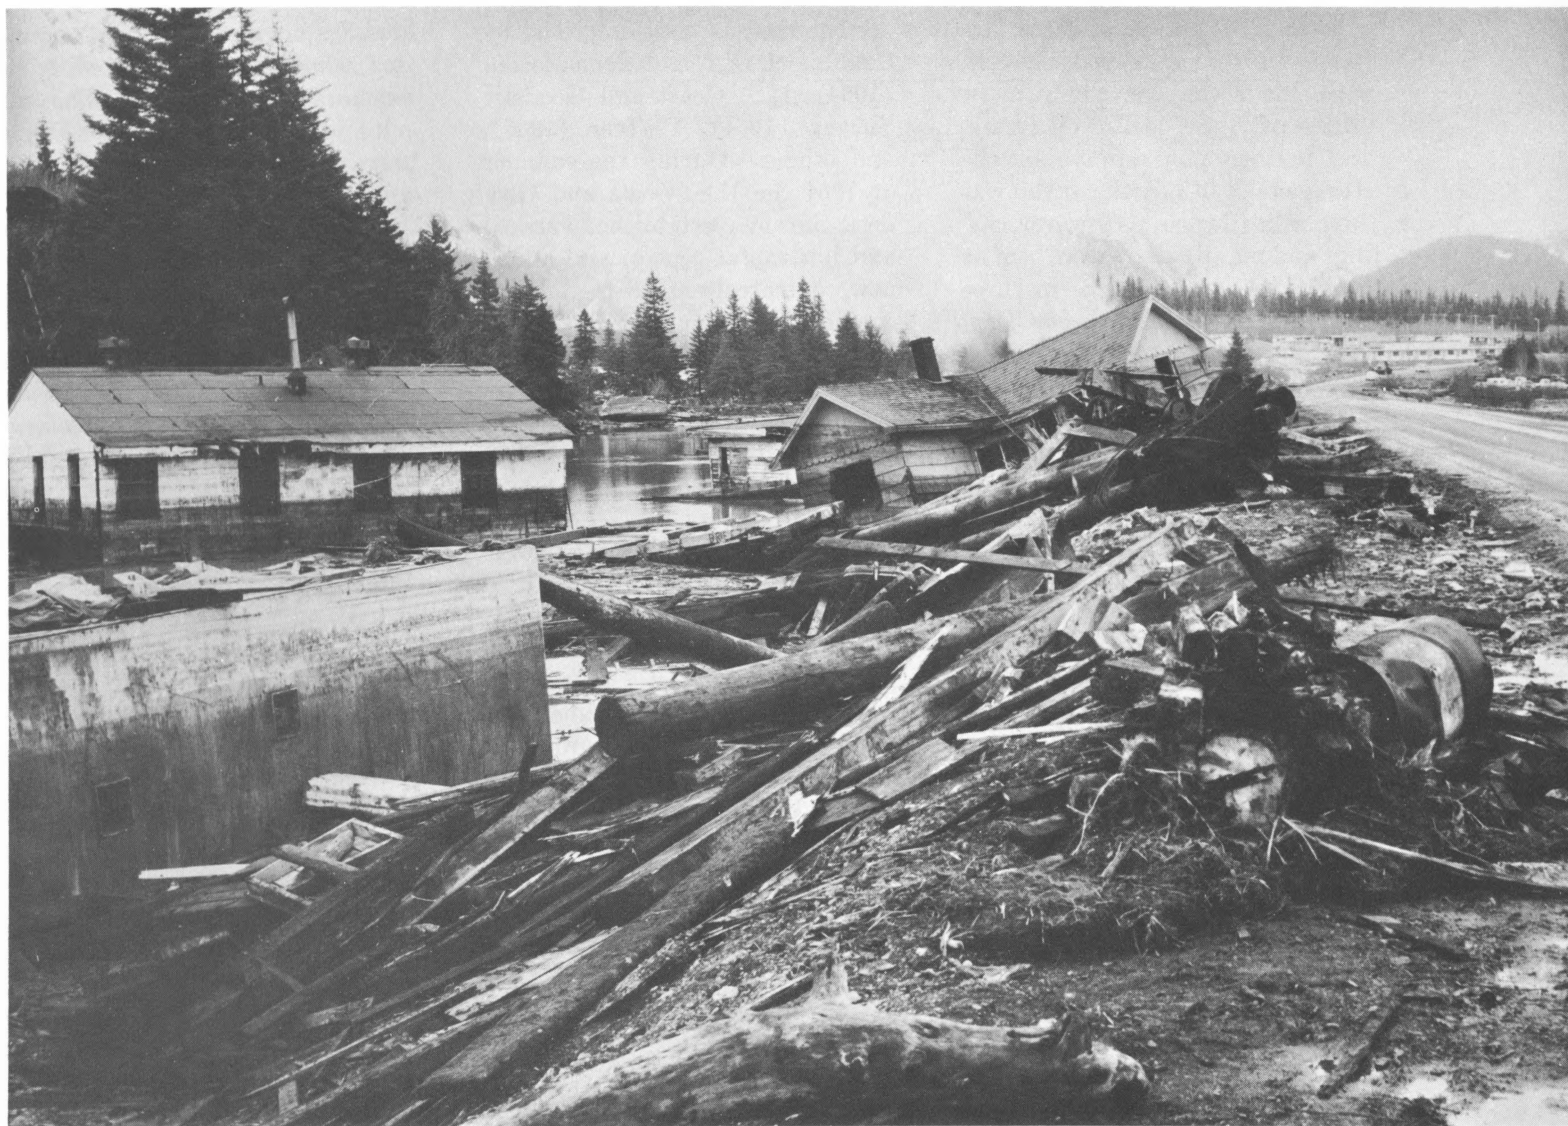
Eighty-six houses were totally destroyed and 269 were heavily damaged (James W. Harrison, Mayor, oral commun., 1964); water waves caused nearly all the destruction. Homes in the area between the Texaco tanks and the lagoon were swept completely off their foundations, and most were washed into the lagoon (fig. 8, p. 15).

8.—Houses and other debris carried by waves into the lagoon area at the north end of Seward. Main road leading north out of town shown in right-hand part of photograph. Photograph by U.S. Army.
