EFFECTS OF THE EARTHQUAKE
OF MARCH 27, 1964
AT SEWARD, ALASKA

Effects of the Earthquake Of March 27, 1964, At Seward, Alaska

BY RICHARD W. LEMKE

GEOLOGICAL SURVEY PROFESSIONAL PAPER 542-E

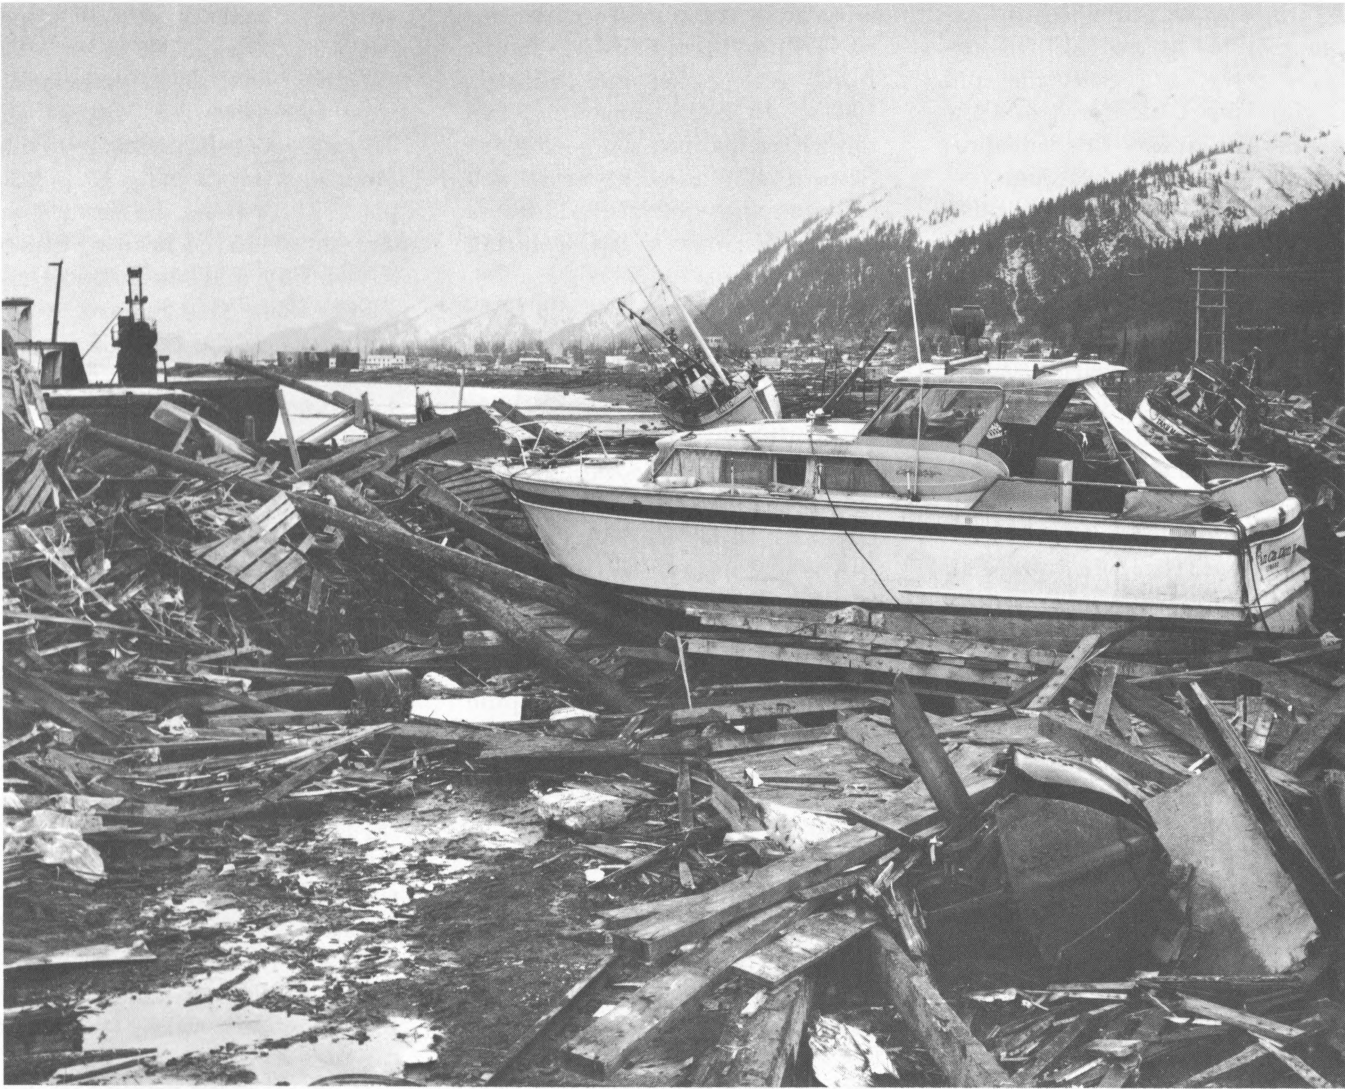
10.—Wrecked boats and other debris beached by waves at the northwest corner of Resurrection Bay. Photograph by U.S. Army.

One of the first large programs started by the Corps of Engineers after the earthquake was the massive cleanup job along the Seward waterfront, at the head of the bay (fig. 10), and in the bay itself. Onshore, what was salvageable was

saved; the rest of the debris was burned or otherwise disposed of. In the bay, hazards to navigation, such as boxcars, tankers, oil tanks, piling, rails, and remains of buildings, were removed to a minimum depth of 40 feet; this work was done in two stages: (1) cleanup of the lagoon area and the land area at the head of the bay and (2) cleanup of the railroad area and the bay. Not long after the initial cleanup was completed, reconstruction of public facilities was undertaken by the Corps of Engineers (George and Lyle, 1966).

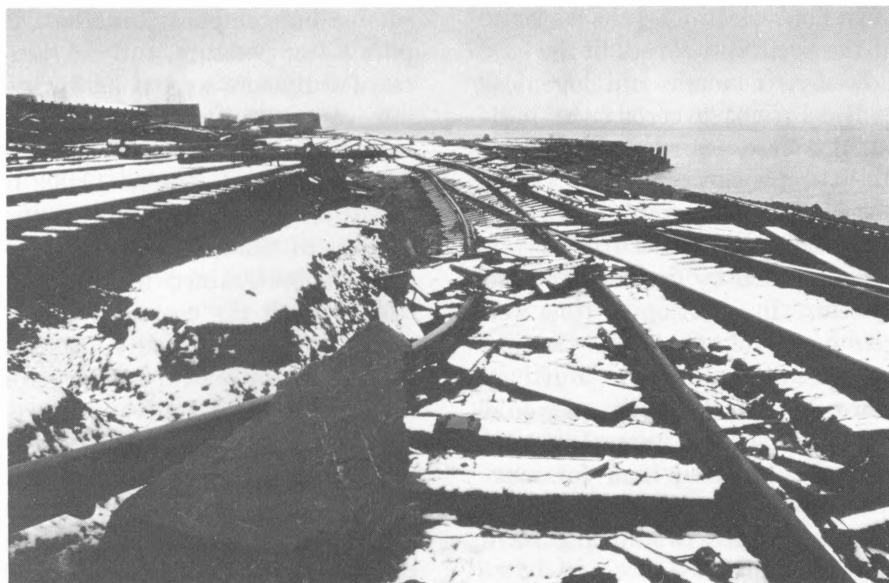
Along the Seward waterfront, a strip of land approximately 4,000 feet long and 50–500 feet wide slid into the bay concomitantly with offshore submarine landsliding. Behind the scarp marking this large submarine slide, the ground was intricately fractured for distances of 100–800 feet (figs. 3, 4). Near the northern end of the landslide scarp, some of the fractured ground subsided several feet and rotated as landslide slump blocks (fig. 12).

12.—Incipient landsliding along northern part of Seward waterfront. Fractured ground has subsided and rotated as landslide slump blocks.

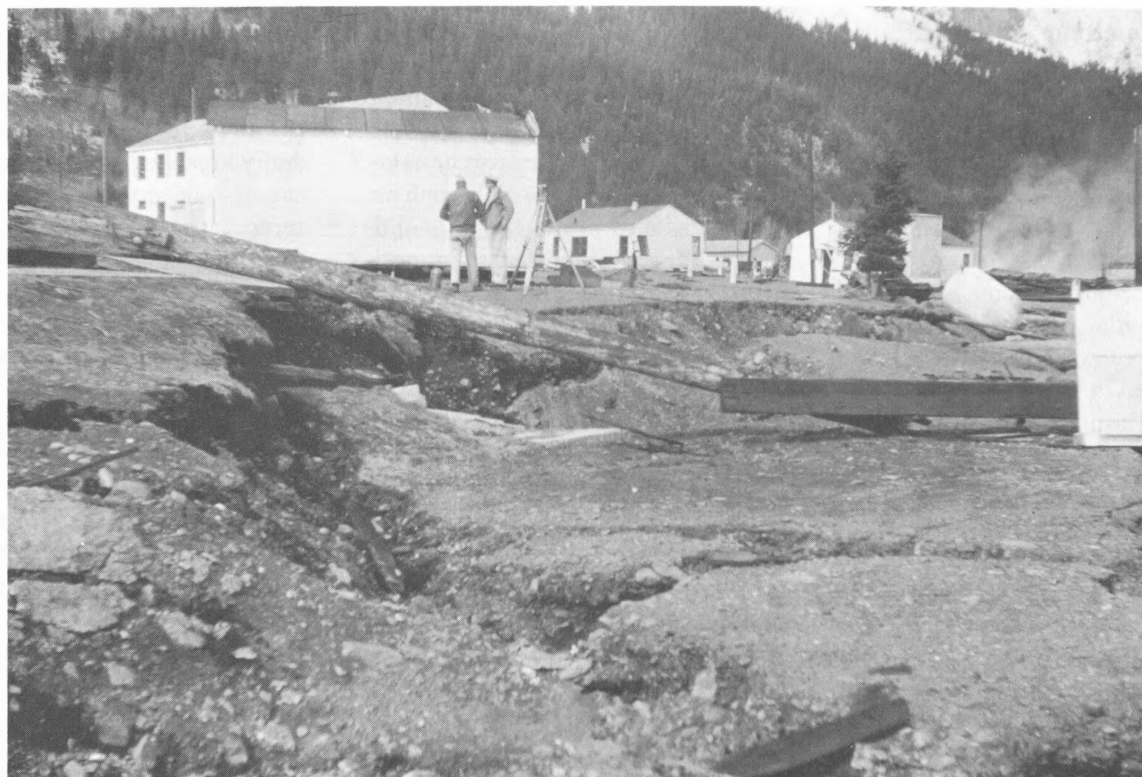
13.—Ground fracture near east end of A Street, about 100 feet from present shoreline, showing vertical displacement of about 4 feet. Downthrown side is toward Resurrection Bay.

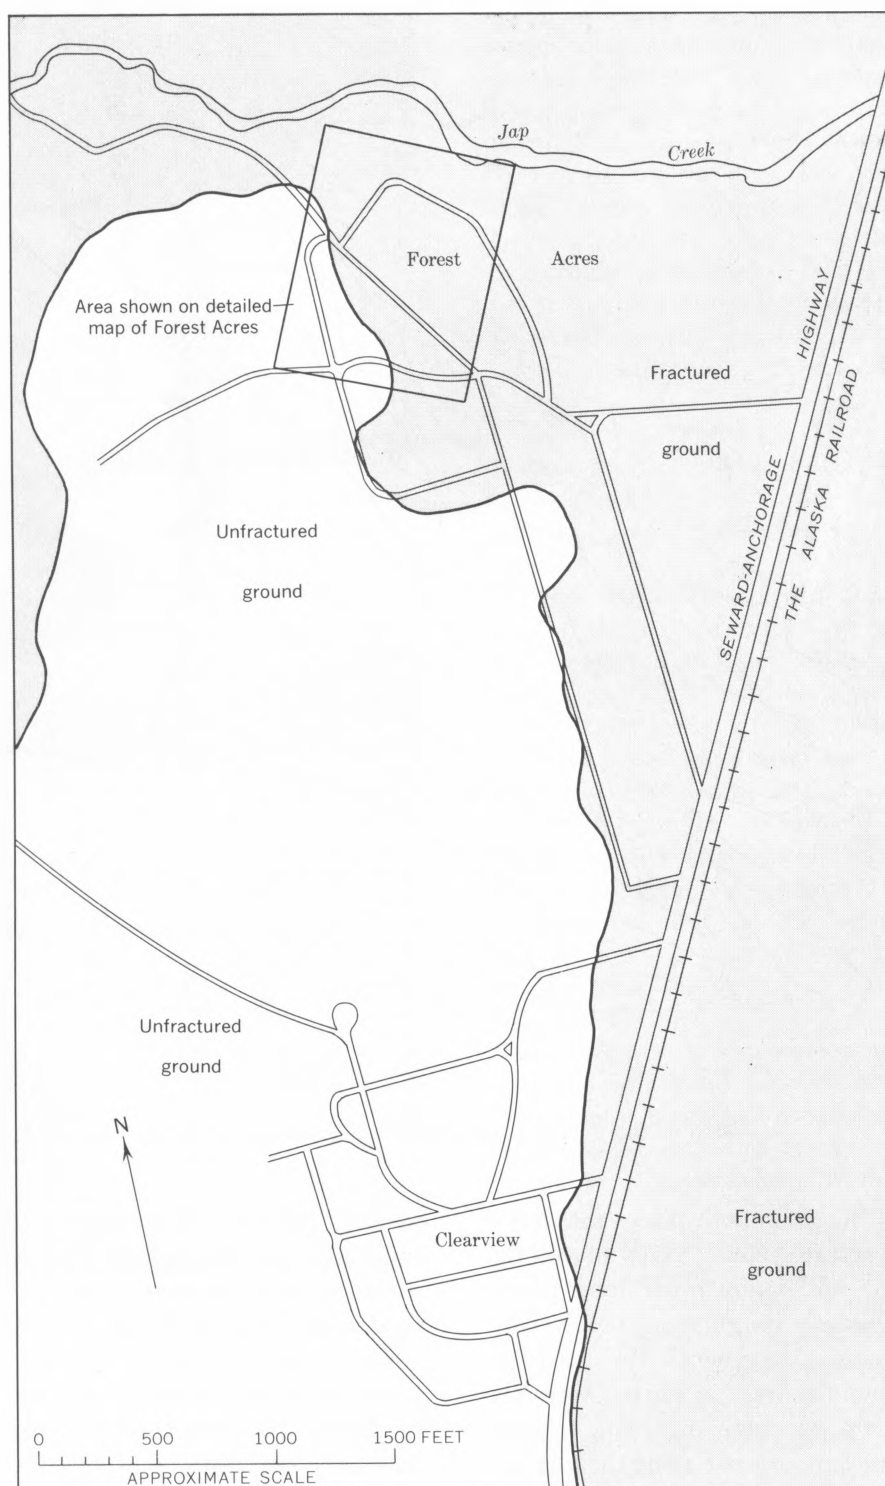
14.—Map of general area of Forest Acres and Clearview subdivisions of Seward showing extent of ground fractured as a result of the earthquake of March 27, 1964.

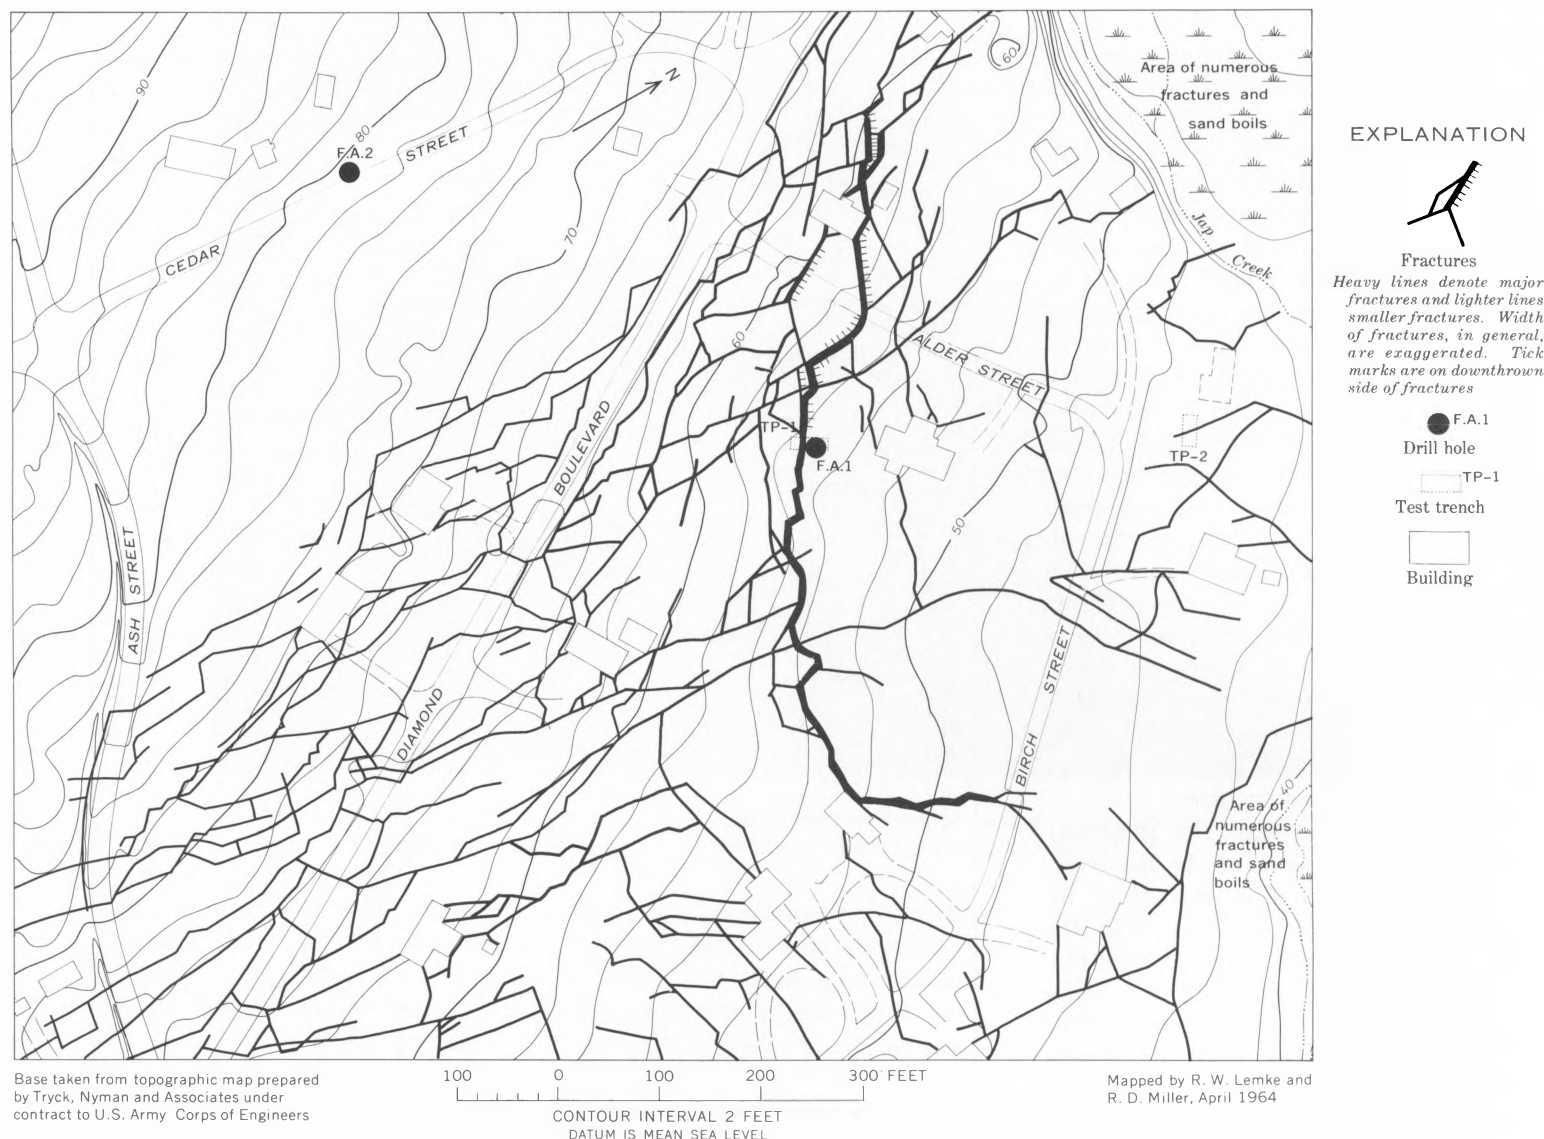
15.—Map of the Forest Acres subdivision showing fractures induced by the earthquake of March 27, 1964.

although in both places the major fracture system (heavy line on fig. 15) and many other long linear fractures roughly parallel the contours. In general, the fracture-bounded areas in Forest Acres are more elongate in plan. Many fractures die out along their extensions (fig. 16). Several fractures intersect at right angles to each other, and otherwise remarkably linear fractures commonly make right-angle turns. Only a few are arcuate in plan. Many fractures

Along the main fracture system shown on figure 15, the fractures commonly were 2-3 feet wide at the surface at the time of mapping

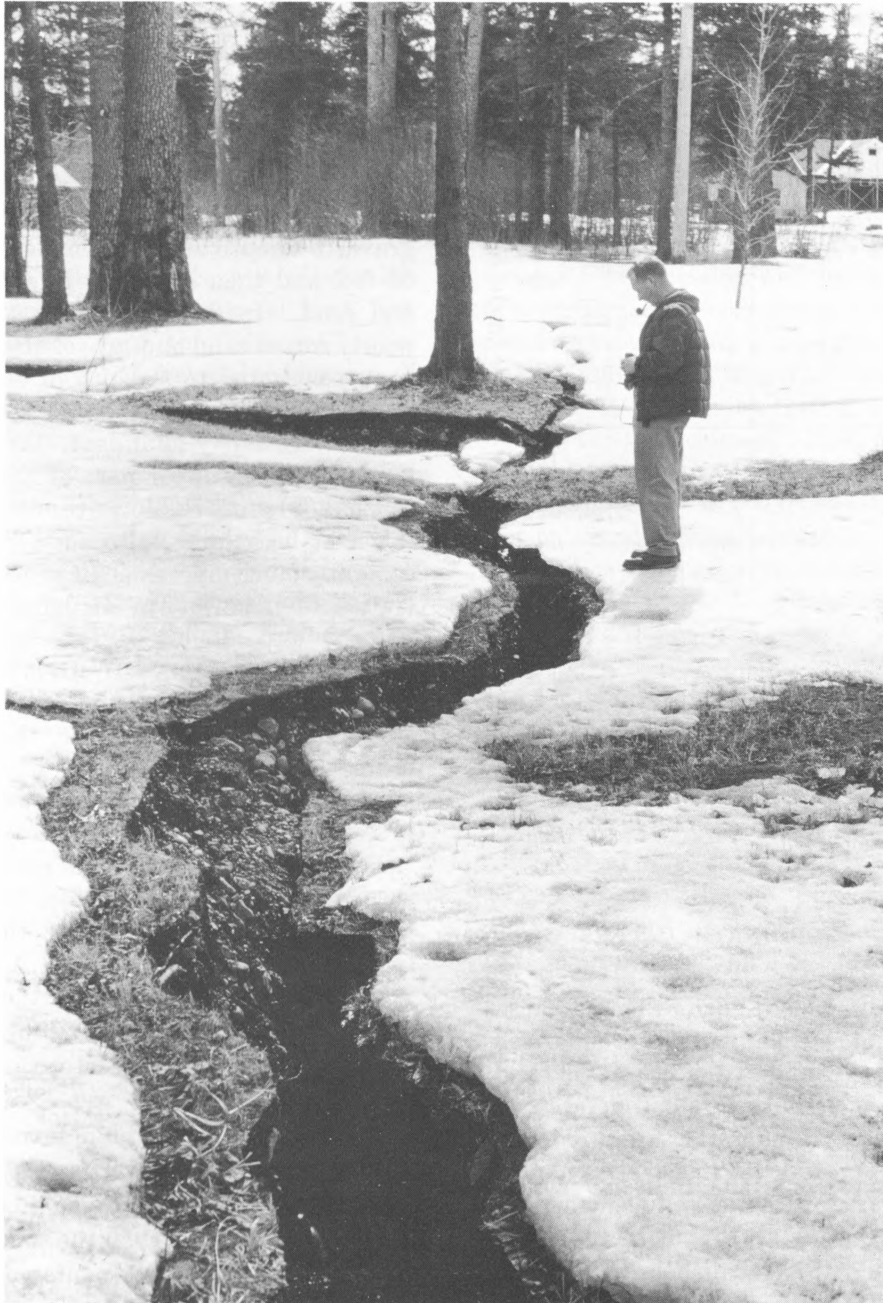
16.—Ground fracture in Forest Acres area. Fracture is about 2 feet wide in the foreground. Photograph by R. D. Miller. April 1964.

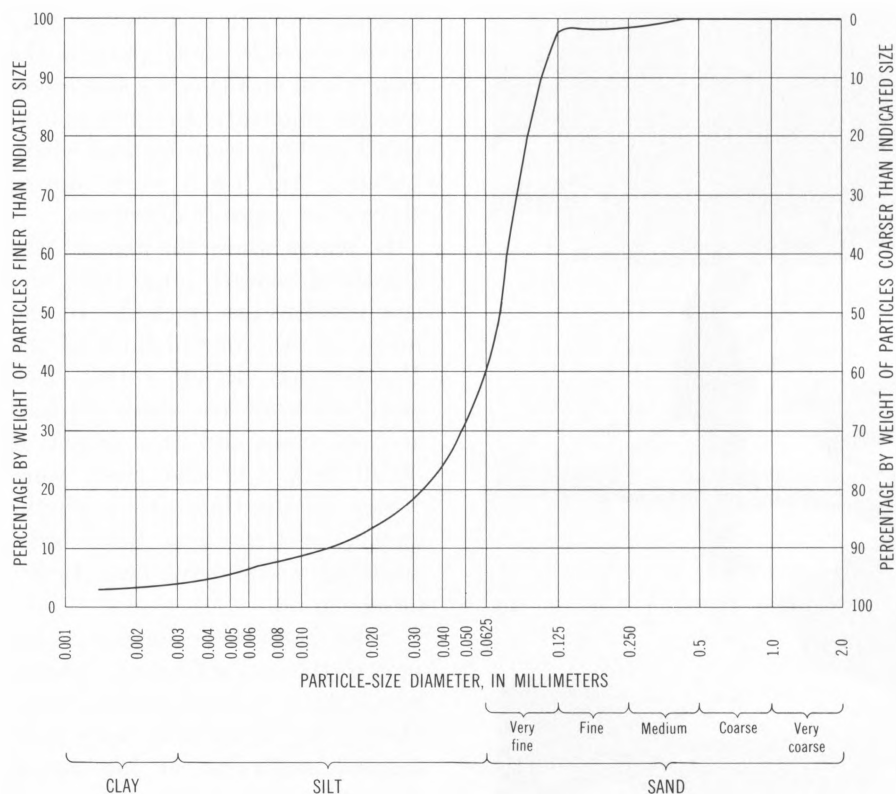
The ejected material was everywhere remarkably uniform in size and consisted of a dark-gray, very fine sand (0.0625–0.125 mm),

17.—Grain-size analysis of material from a sand boil, Forest Acres area. Analyst George S. Erickson; sample 4-346.

lesser quantities of silt, and minor clay. Figure 17 shows a grain-size analysis of a typical sample taken near trench TP-2.
