THE ALASKA EARTHQUAKE, MARCH 27, 1964:
EFFECTS ON TRANSPORTATION, COMMUNICATIONS, AND UTILITIES

Effect of the Earthquake Of March 27, 1964, on The Eklutna Hydroelectric Project, Anchorage, Alaska

GEOLOGICAL SURVEY PROFESSIONAL PAPER 545-A

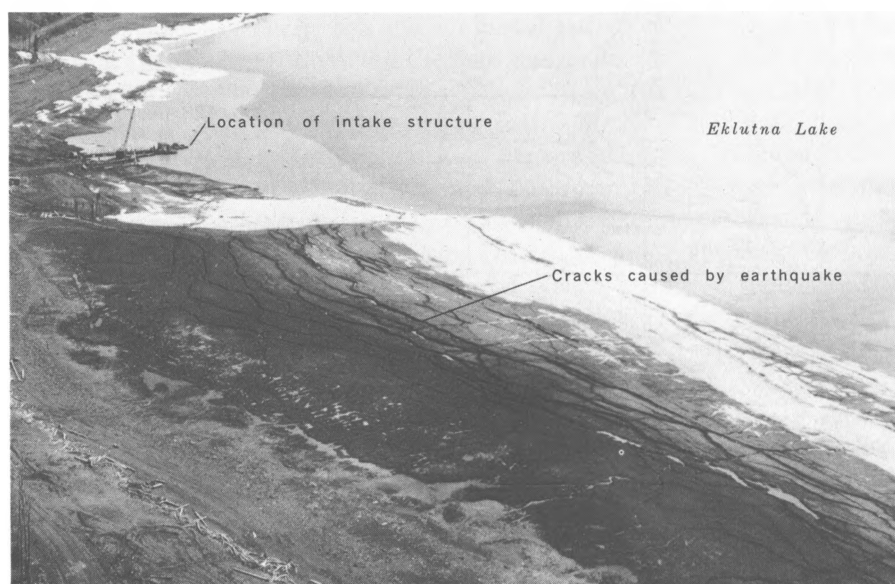
6.—View of Eklutna intake area, showing intricate network of cracks caused by the earthquake along the shore of the lake.

Earthquake-induced densification of materials in Eklutna Lake (fig. 6) caused the intake structure to move approximately 44 inches toward the lake. Principal movement was in a horizontal direction, but was accompanied by a lesser amount of vertical displacement.

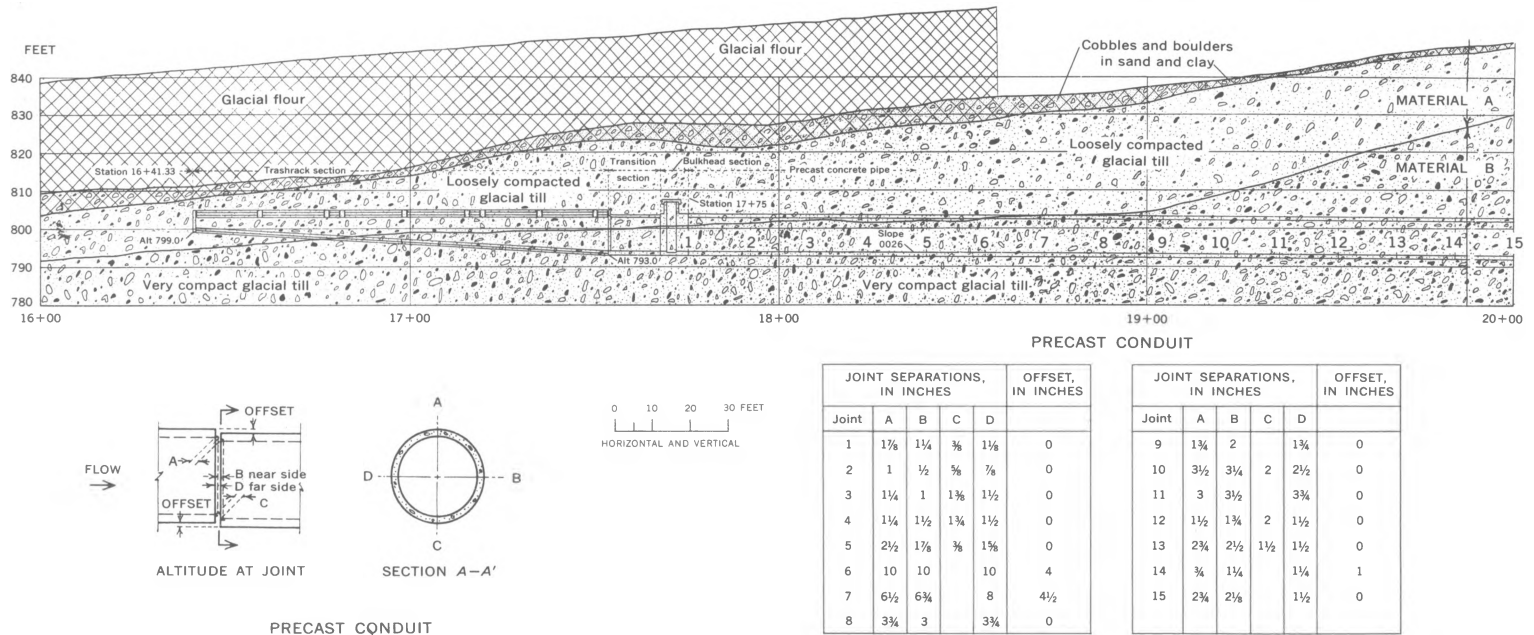
Tensional forces produced by the horizontal shift caused separation along joints in the precast conduit, as shown in figure 7. Unconsolidated sediments, ranging in size from fine sand to cobbles the size of a football, funneled through these ruptures. An elliptical cone-shaped depression, approximately 40 feet in maximum dimension, formed at the edge of Eklutna Lake over the conduit alignment near station 18+55, and numerous cracks were present along the lakeshore on either side of the conduit.

7.—Geologic section showing location of earthquake damage to intake structure. Rupturing of joints in the precast conduit occurred at the numbered locations. Amount and direction of movement is shown in the table. Failure on or within the bedding material, induced by the earthquake, is believed to have caused the damage to the intake structure. No earthquake damage in the glacial till foundation was detected.

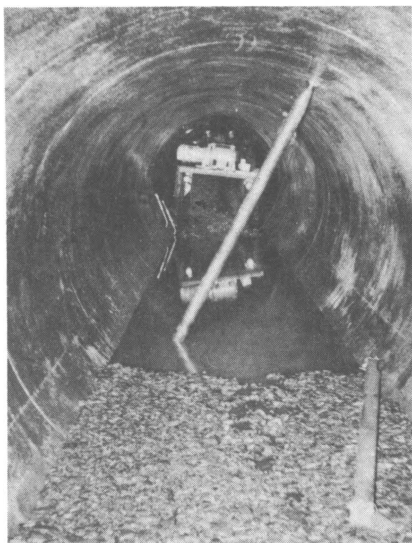
9.—Debris in Eklutna tunnel, typical of that deposited throughout the initial 3½ miles of tunnel as a result of the earthquake.

tunnel invert. The debris consisted predominantly of rock fragments 1 inch in diameter, but ranged in size from sand to an occasional fragment 14 inches across. The debris (fig. 9) was 12–18 inches deep and was uniformly distributed from the gate shaft at station 27+25 to near Station 103+00. From station 103+00 to station 235+00, debris was deposited in gravel bars of varying depths. The last mile of tunnel was relatively free of material. No structural damage to the tunnel was found.

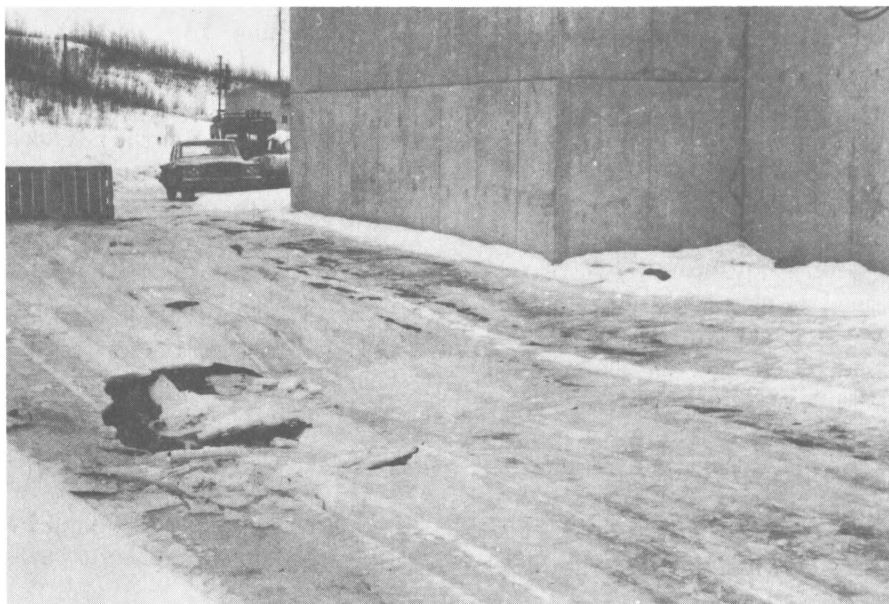
The penstock, surge tank, pile-supported anchor block, and powerhouse evidently oscillated as an integral unit during the earthquake. Very little relative movement occurred between these features although backfill in the anchor-block area subsided (fig. 13).

13 (left).—Earth settlement over the penstock anchor block directly behind the powerhouse. This settlement did not appear until 2 weeks after the earthquake. Presumably, the bridging effect of the blacktop and ground frost concealed the settlement during this period.

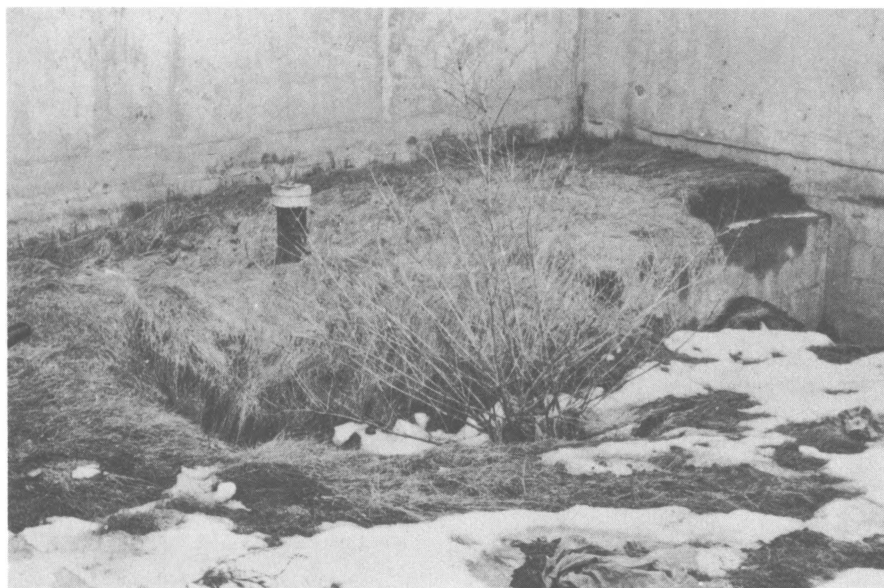
The principal area of damage occurred between the powerhouse and machine shop along the 1-inch cork-filled expansion joint. The two structures oscillated at different intensities, and the interconnecting drainage and electrical systems were sheared. The differential horizontal displacement between buildings was three-fourths of an inch, but the vertical displacement was negligible. Back-fill around the entire periphery of the plant and under the machine shop settled erratically from a few inches to a few feet (figs. 17-19).

17.—Typical ground settlement resulting from the earthquake. Settlement is near the northeast corner of the powerhouse at the location of the septic tank.

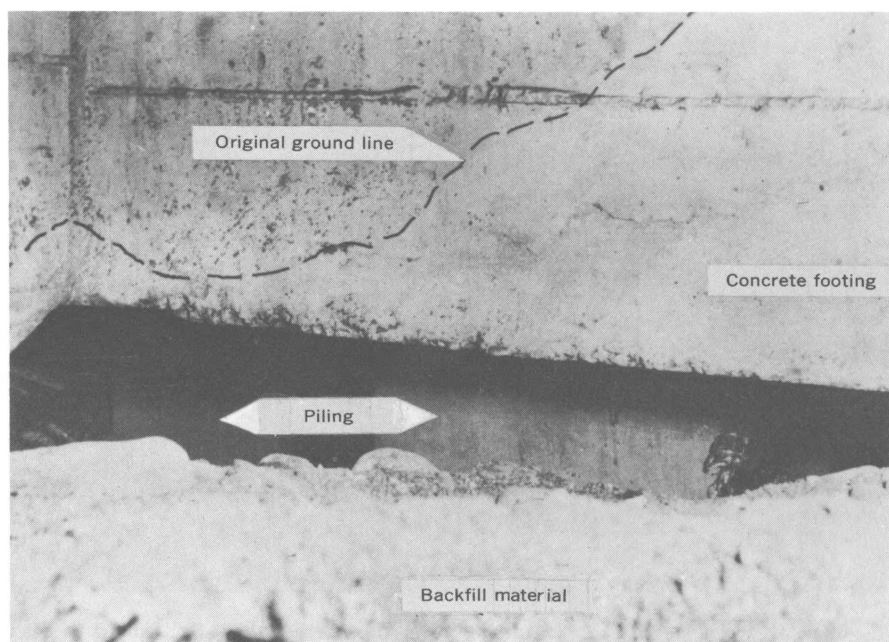
19.—Machine-shop foundation showing the separation of backfill material from the concrete footing. Approximately 1.5 feet of H-section pile is now exposed as a result of settlement caused by the earthquake.

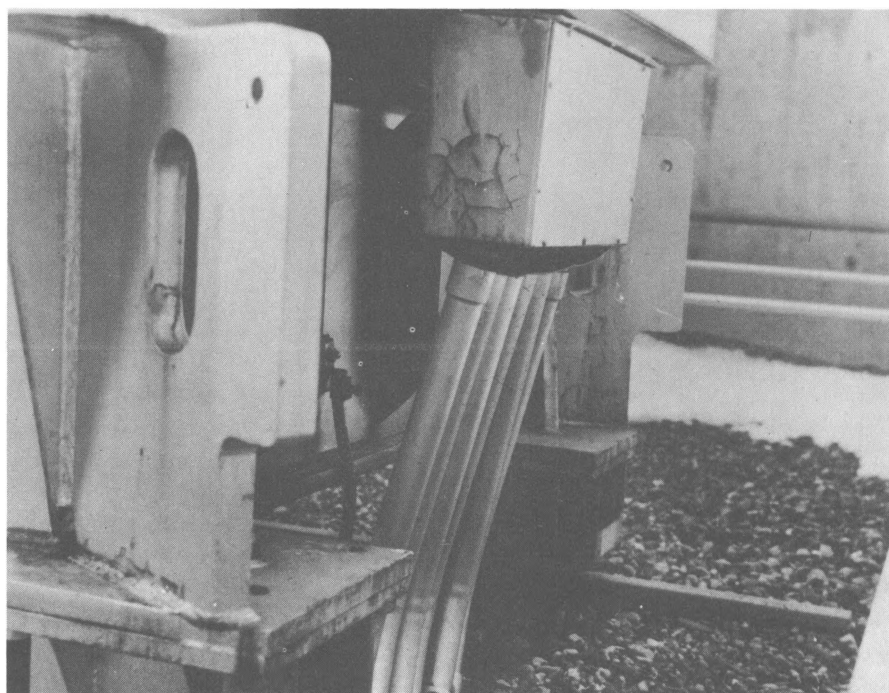
20.—The 20,000-kva transformer conduit and terminal box damaged by movement of the transformer during the earthquake. Rail stops consisted of a $\frac{1}{4}$ - by 1-inch-wide bar tack-welded to the rail. The tack-welds broke and allowed the transformer to move on the rails.

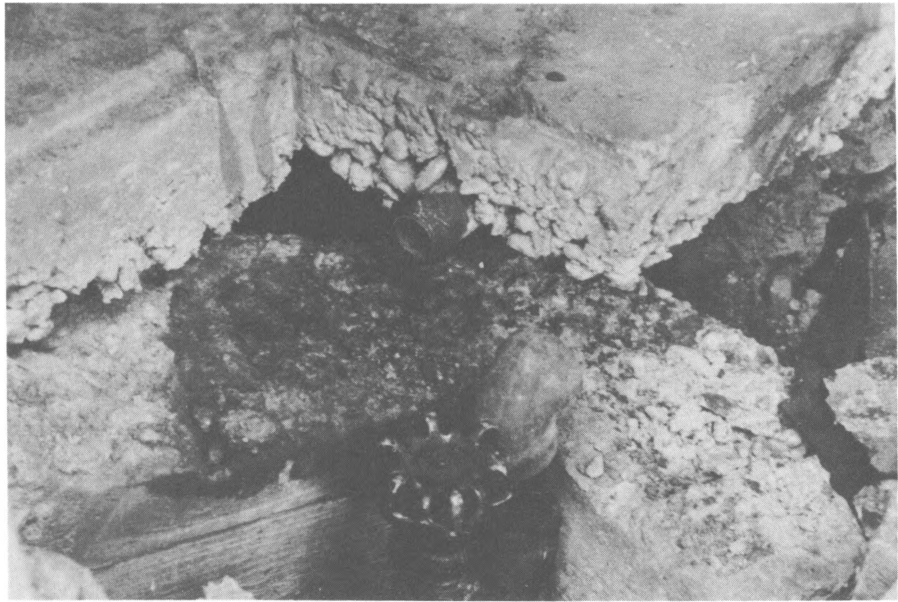
21.—Damage to the heating-system piping in the floor of the automotive repair shop caused by the earthquake.

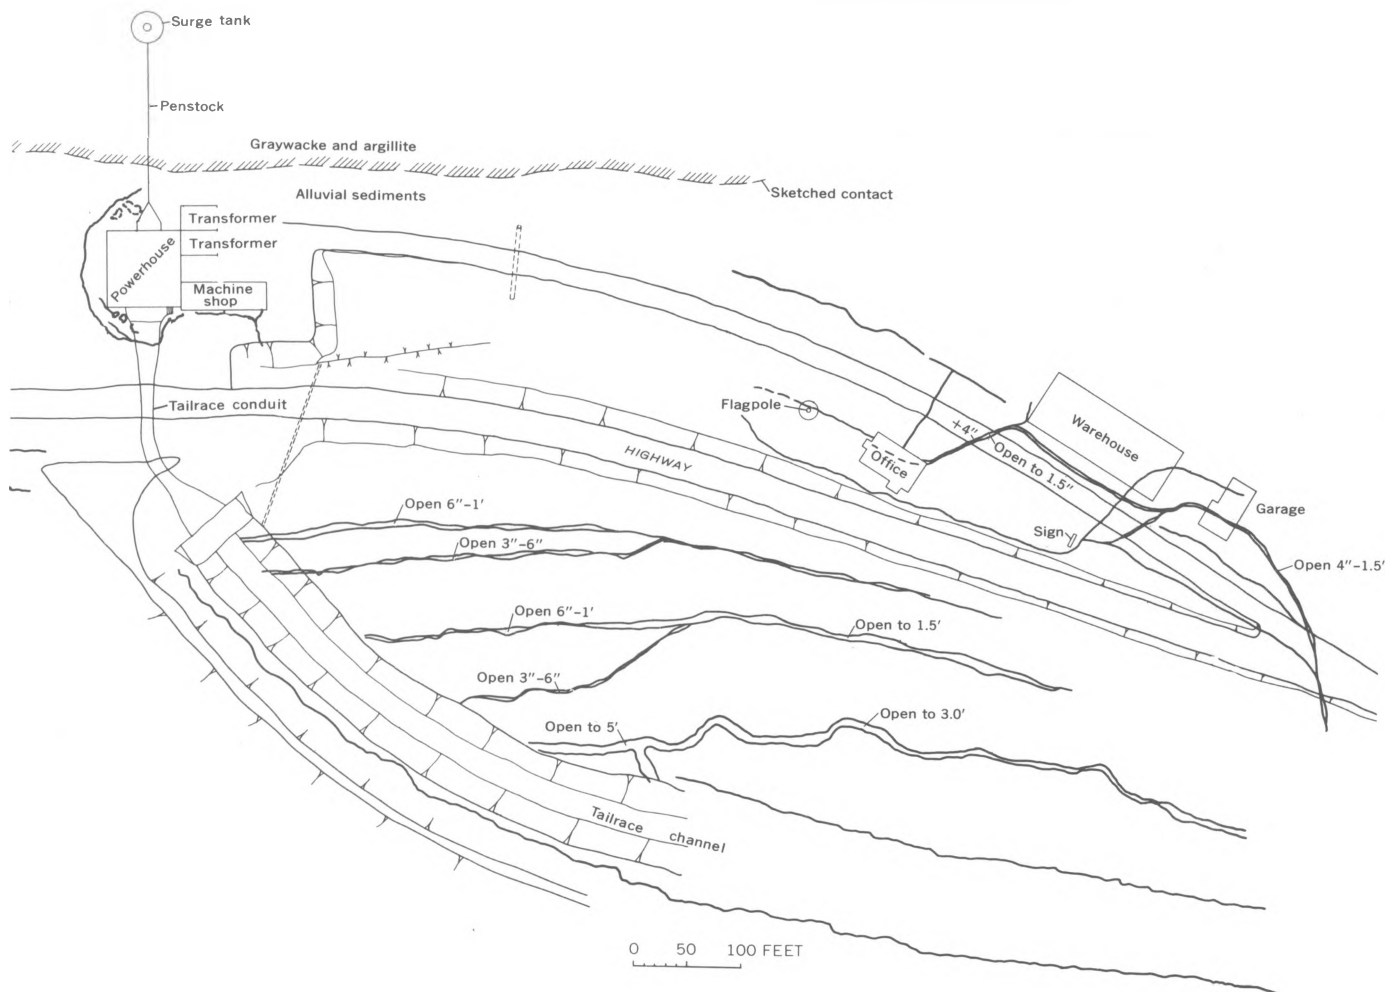
From a point west of the garage, cracks as much as a foot wide and several feet deep (figs. 22, 23) extended eastward adjacent to the north wall of the warehouse and crossed the roadway to the project office building. Cracks also extended from the garage to the southwest corner of the warehouse.

22.—Location of major earthquake cracks in the powerplant area.

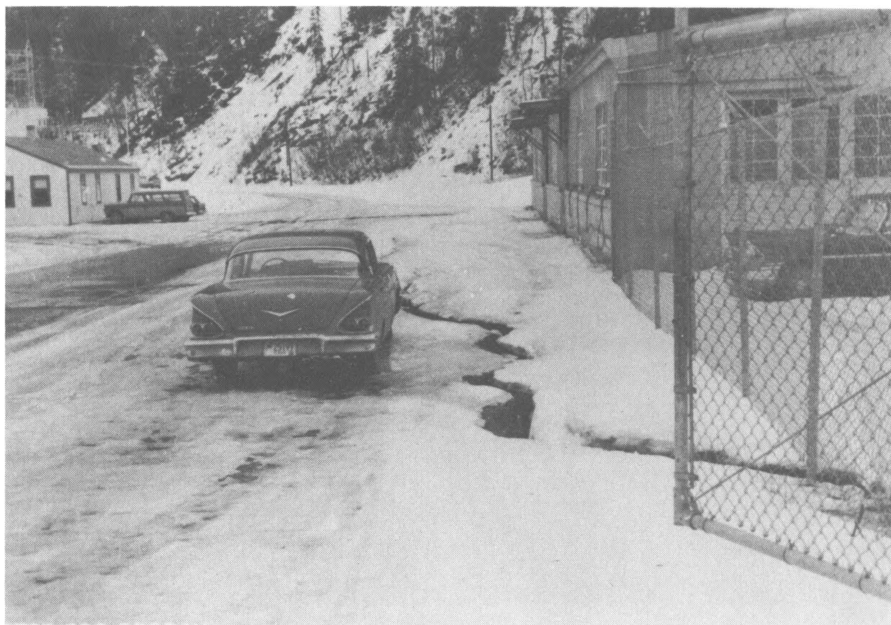
23.—Pavement damage caused by the earthquake. Cracks extend from the garage east along the north wall of the warehouse (right of photograph) and thence across the road to the project office (left of photograph).

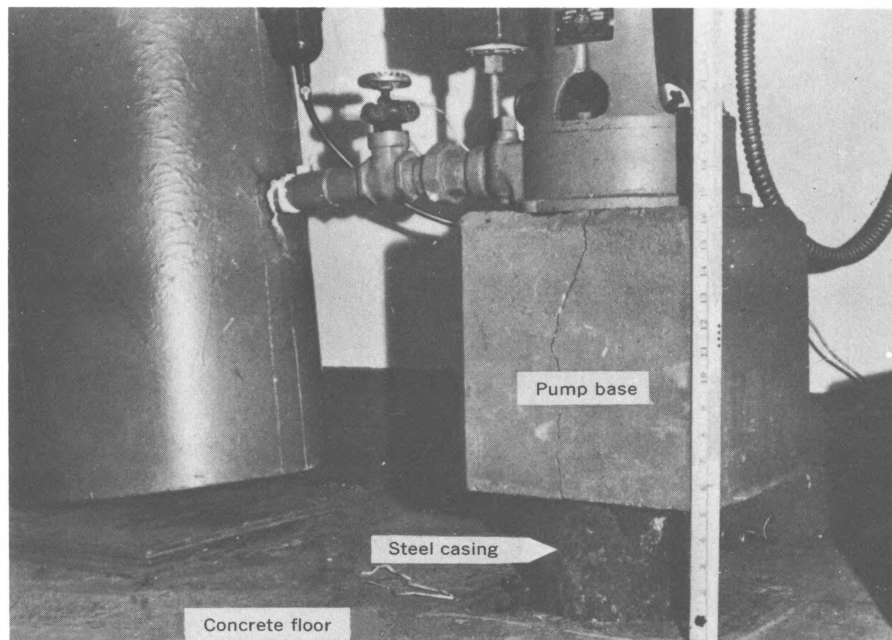
24.—Pump in Eklutna project office showing the effect of the earthquake. Base of pump is now approximately 5 inches above the floor.

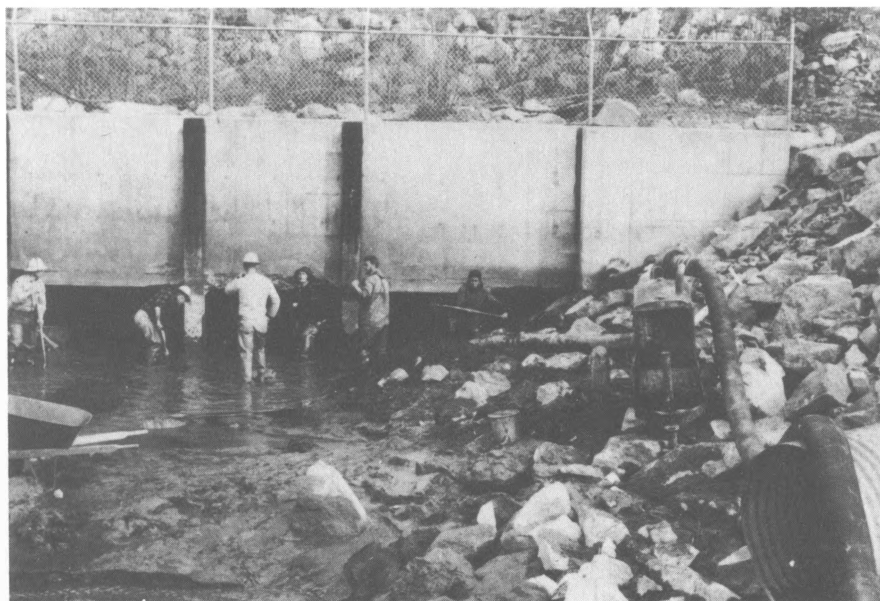
When the powerplant was shut down for repair of the intake (fig. 26), the 209-foot-long pressure tailrace conduit was inspected and cleaned. About 110 cubic yards of rock and mud had been deposited in the conduit, presumably after the break in the precast pipe section of the tunnel intake. The inspection also revealed considerable shifting of the sections nearest the powerplant (fig. 27). Regional subsidence raised the high-tide water level approximately 3 feet.

26.—Cleaning-up operation at the outlet of the tailrace conduit. Debris was deposited following the rupture of the tunnel intake at Eklutna Lake during the earthquake.

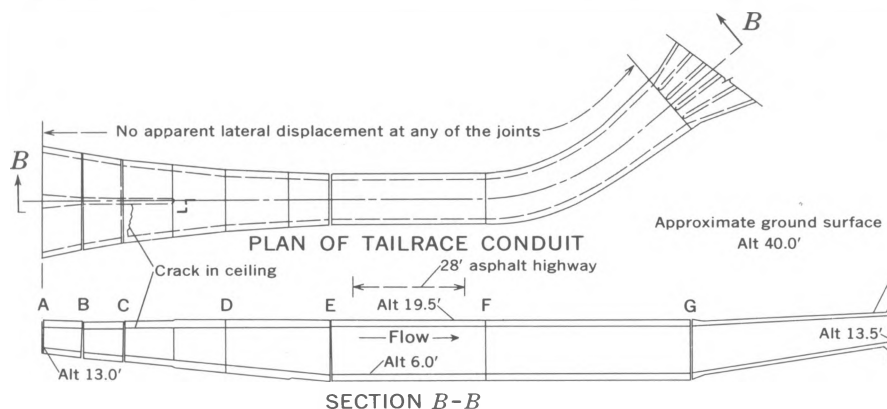
27.—Summary of damage to tailrace conduit.

TAILRACE CONDUIT	
Joint	Remarks
A	Joint open $2\frac{1}{4}$ in. on top, open $\frac{3}{4}$ in. on bottom Waterstop torn for about 1 ft, gravel visible above tear
B	Joint open $\frac{3}{4}$ in. on top, open $1\frac{1}{2}$ in. on bottom with 3 in. vertical offset, downstream side lower. Larger leak on left side of left unit near floor
C	Joint closed on top, open $1\frac{1}{2}$ in. on bottom with $1\frac{1}{4}$ in. vertical offset, upstream side lower
Between C and D	Crack in ceiling, right unit
D	Joint closed
E	Joint open evenly $1\frac{1}{4}$ in. all around with $2\frac{1}{2}$ in. vertical offset, upstream side lower
F	Joint closed
G	Joint open 1 in. all around with $\frac{3}{4}$ in. vertical offset, upstream side lower. Leaking at top

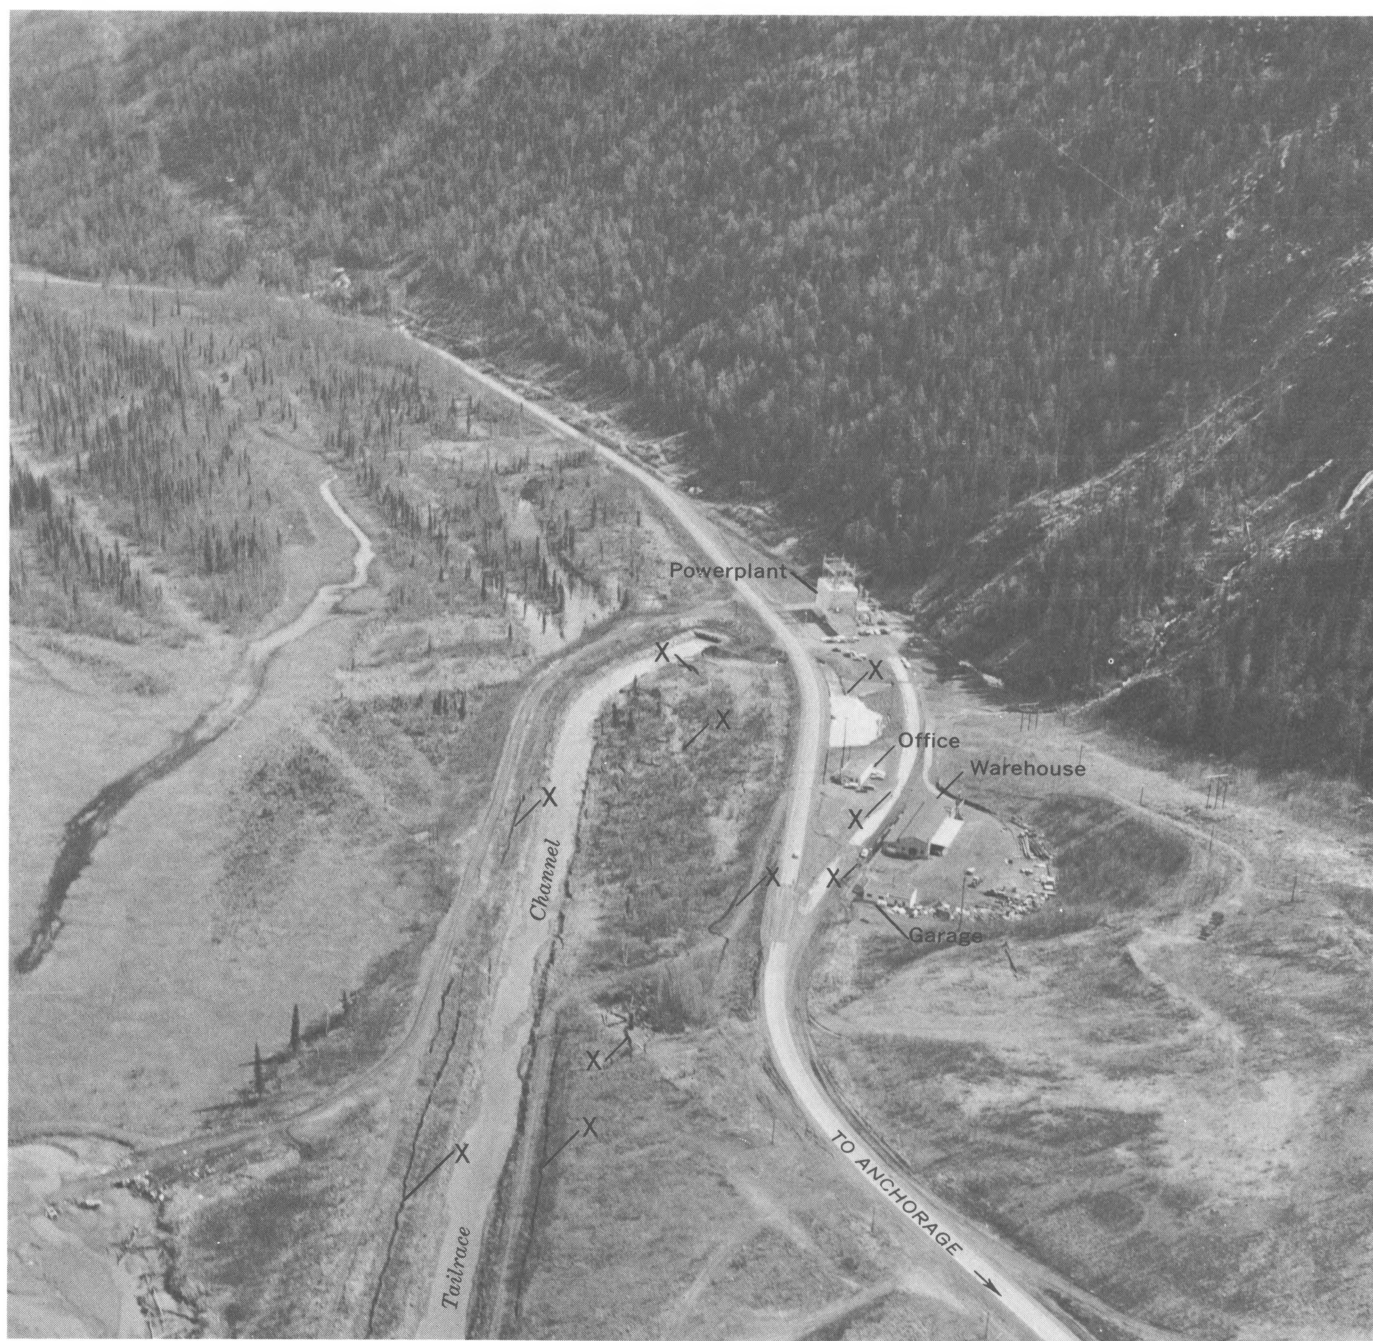
28.—Location of ground cracks in the vicinity of the powerplant.

The ground surface was severely cracked (fig. 28) in the area adjacent to, and parallel with, the 2,000-foot-long open canal section of the tailrace. The cracks ranged in width from a few inches to 5 feet and had the effect of squeezing in the sides of the channel. The invert was irregularly mantled by gravelly debris ranging in depth from a few inches to several feet.

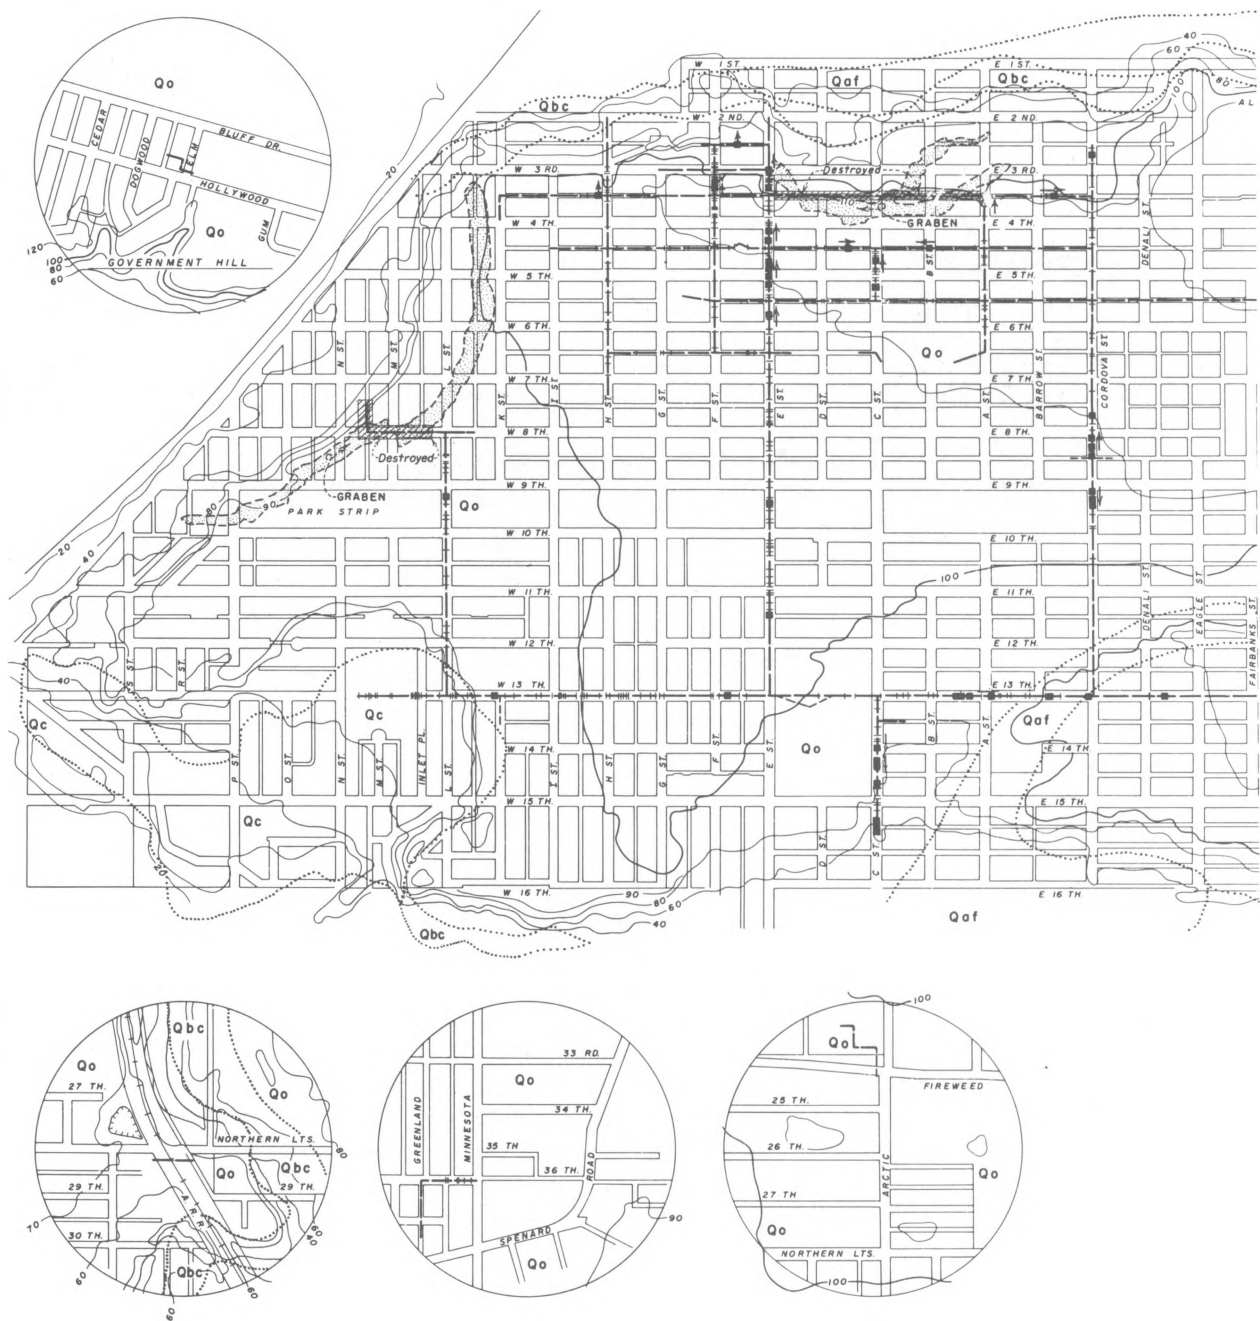
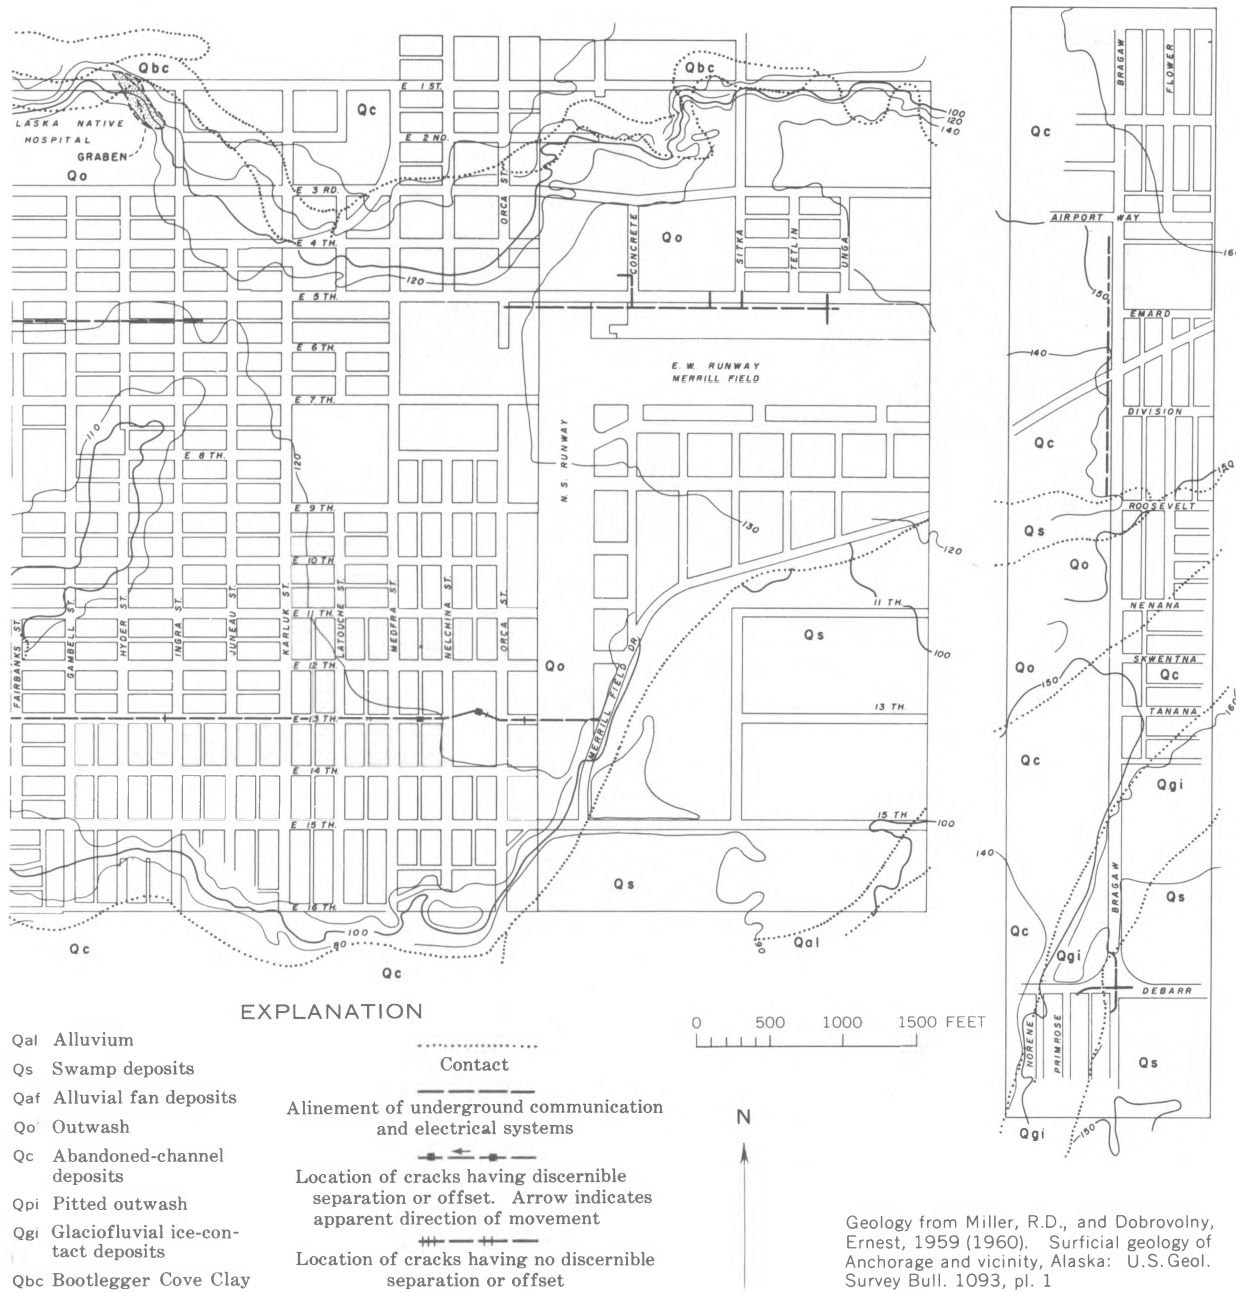
33.—Topography, surface geology, and location of fractures

in underground communication and electrical systems.

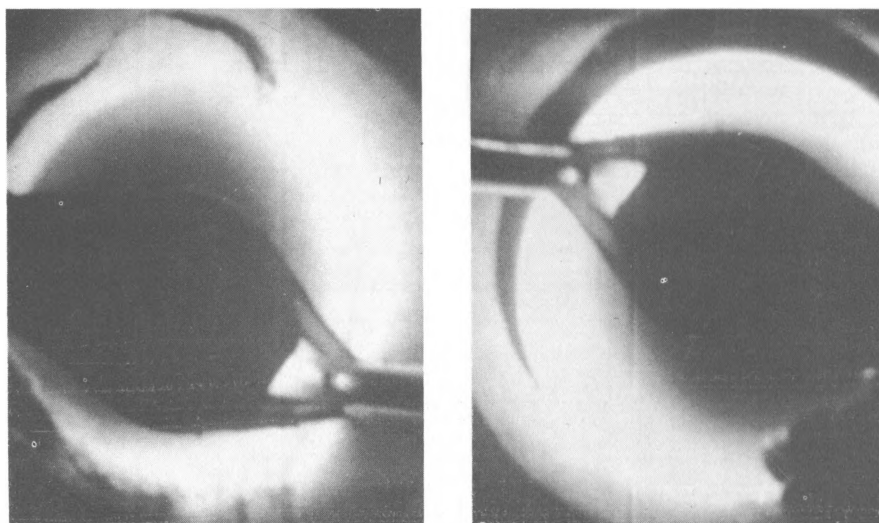
34.—Axial views of breaks in the ducts, as seen on the television monitor screen.

observed at 52 locations. Photographs of two such fractures, as viewed on the monitor screen, are shown in figure 34. The maximum displacement noted was 1 inch, although most were in the $\frac{1}{16}$ - to $\frac{1}{4}$ -inch range. Soil and water had entered the ducts through many such openings, and water was found in some areas where only hairline cracks were present.
