The Alaska Earthquake

March 27, 1964

Effects of the Earthquake of March 27, 1964, on the Alaska Highway System

GEOLOGICAL SURVEY PROFESSIONAL PAPER 545-C

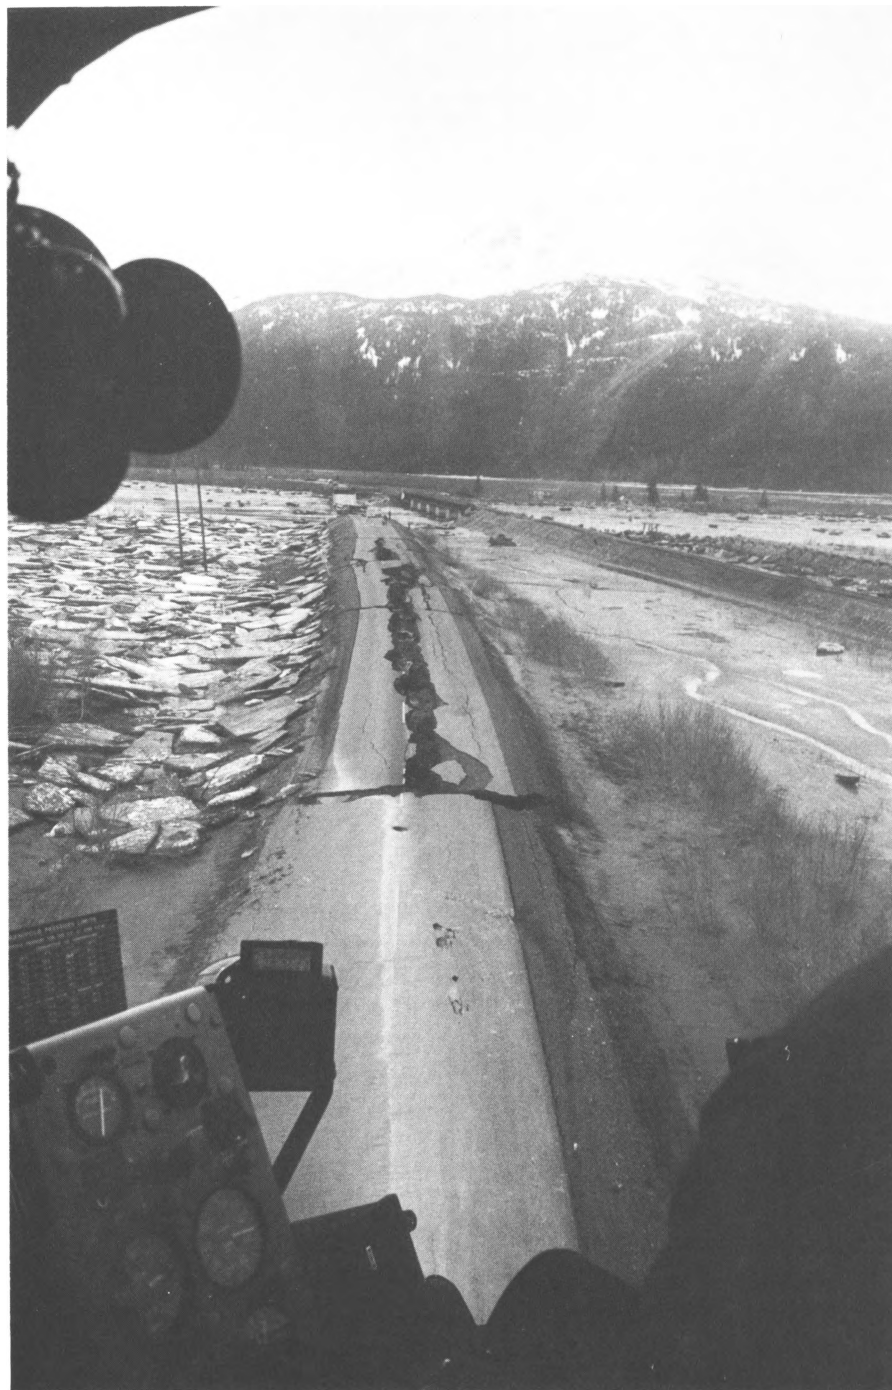
The most conspicuous fractures observed were those normal to the axis of the roadway (figs. 12E, 13); they were extensive along the Seward-Anchorage Highway and on the Richardson, Sterling, and Glenn Highways, particularly in paved sections. These fractures, plus the oblique type shown on figure 12F(2), represent about 90

13.—View northwest showing conspicuous centerline fracture and more typical perpendicular fractures on Seward-Anchorage Highway between Portage and Twentymile River. Photograph by D. S. McCulloch.

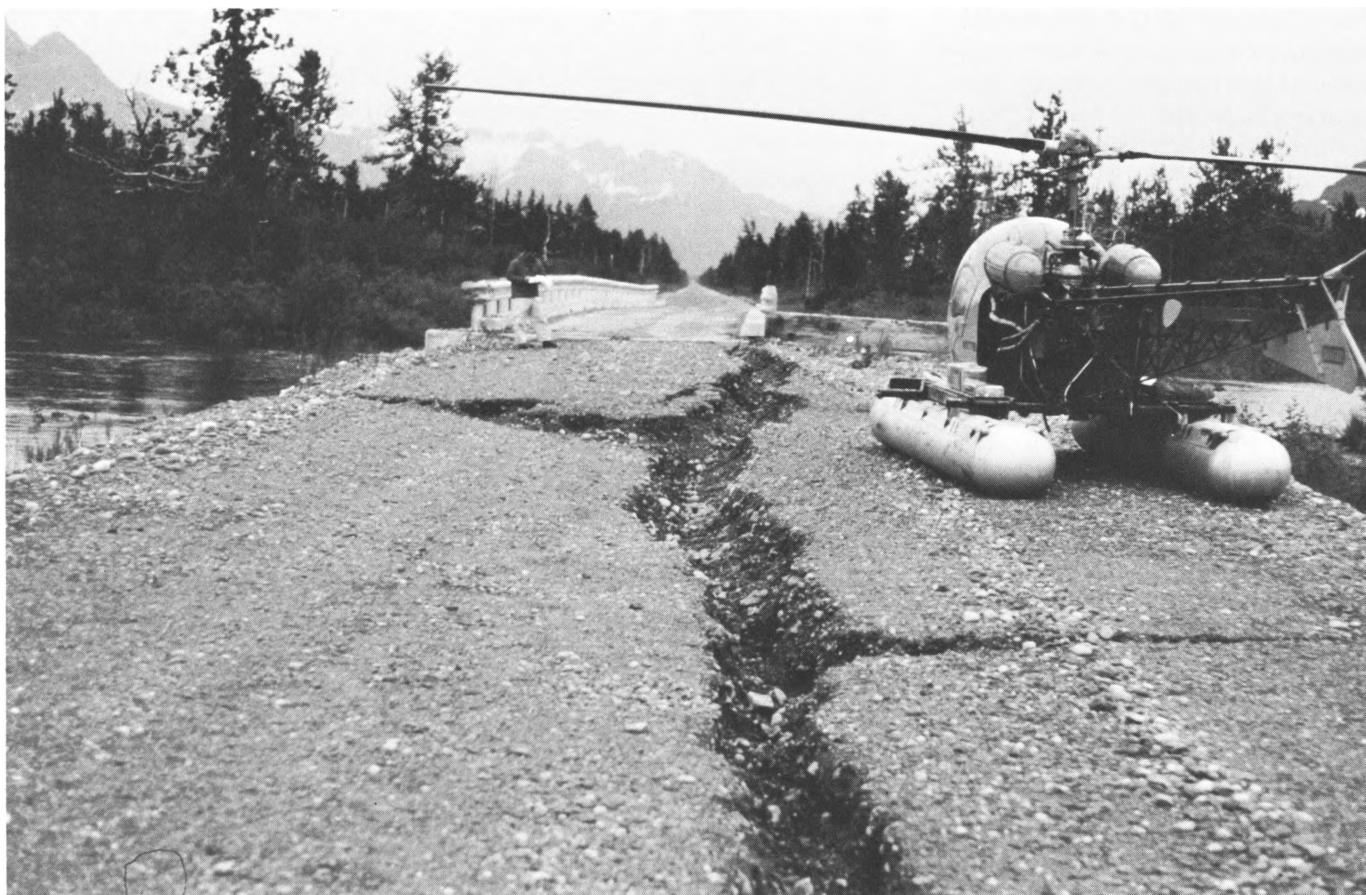
14.—Centerline fracture on unpaved Copper River Highway at south approach of Clear Creek bridge 329 at mile 41.0. Photograph by George Plafker.

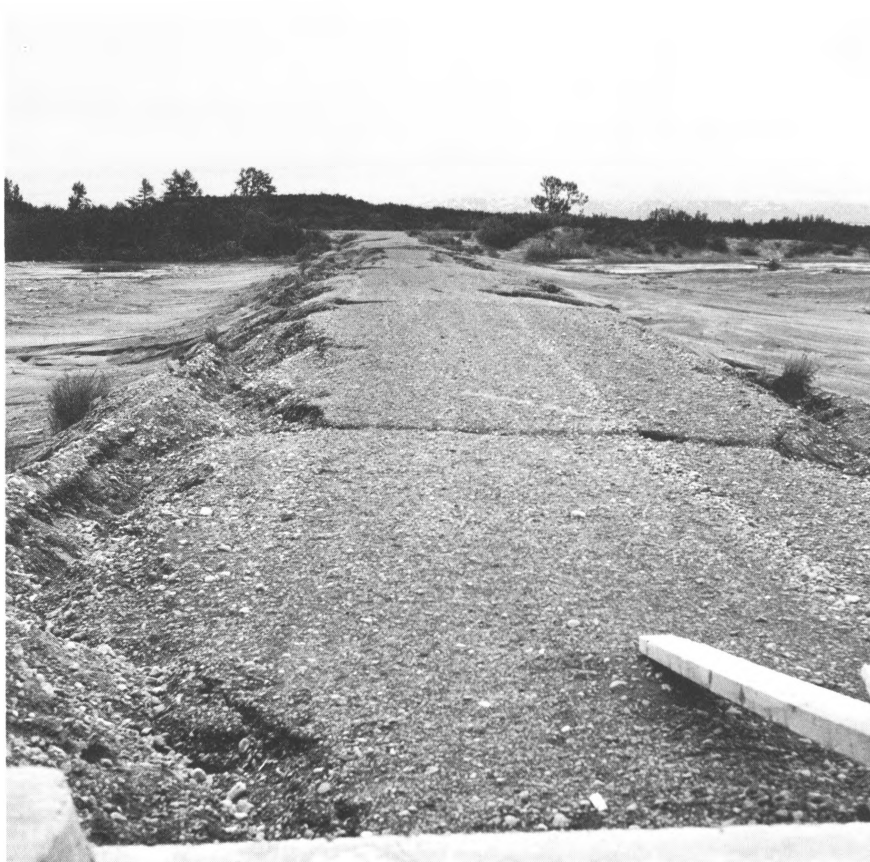
15.—Fractures normal to and along highway edge, Copper River Highway. Looking east from Copper River bridge 2, mile 27.1. Approach subsided 3 feet and fractured.

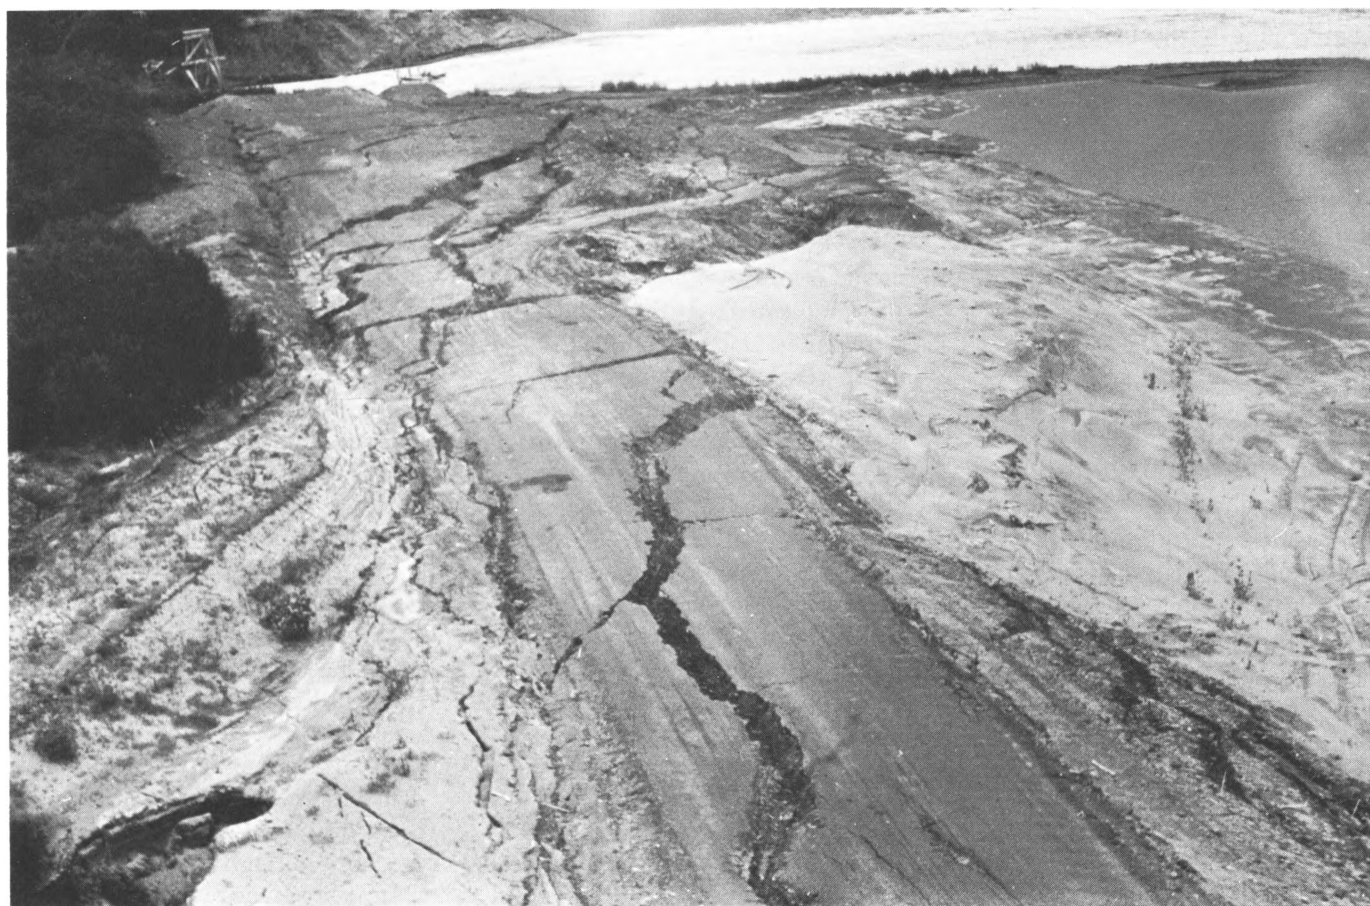
16.—Complex fractures with relatively large lateral and vertical displacements, produced by movement of saturated fine sand and silt toward free faces. View north near mile 58.5, Copper River Highway. The Allen River, which drains Allen Glacier, is in the background.

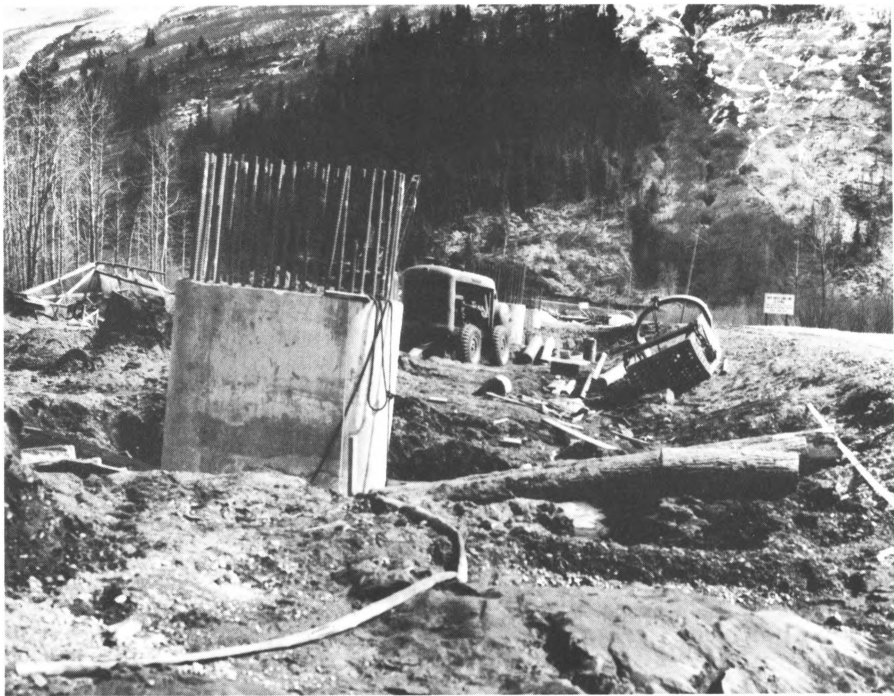
21.—Bridge pier for new crossing at Snow River displaced by compaction of underlying sediments or by liquefaction of fine silts. Photograph by D. S. McCulloch.

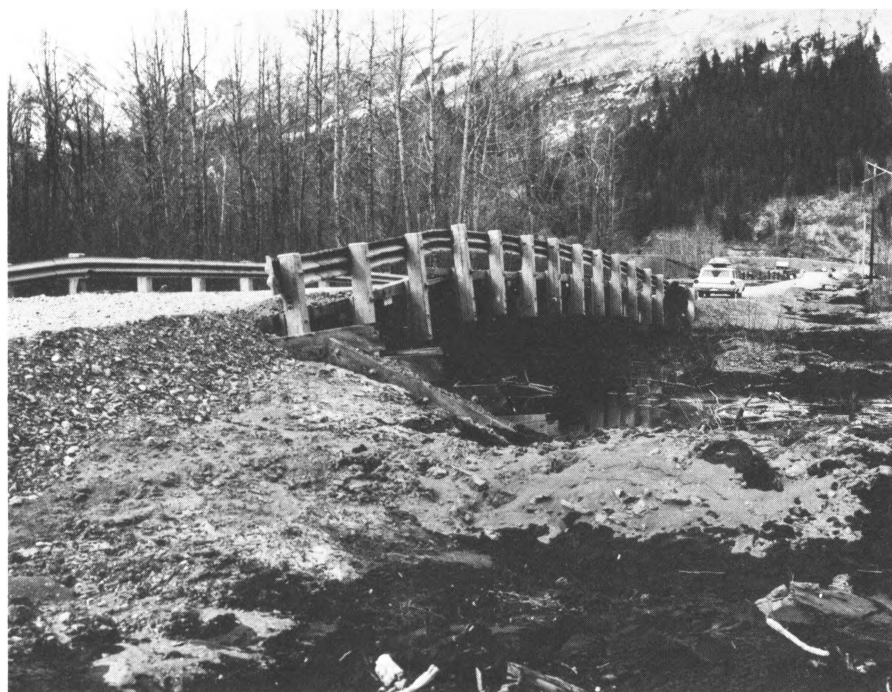
22.—View, looking west, of arched bridge at Snow River Crossing. Note that new fill in foreground was added to compensate for subsidence of approach fills and arching of bridge. Some of the original road fill had to be completely replaced. Photograph by D. S. McCulloch.

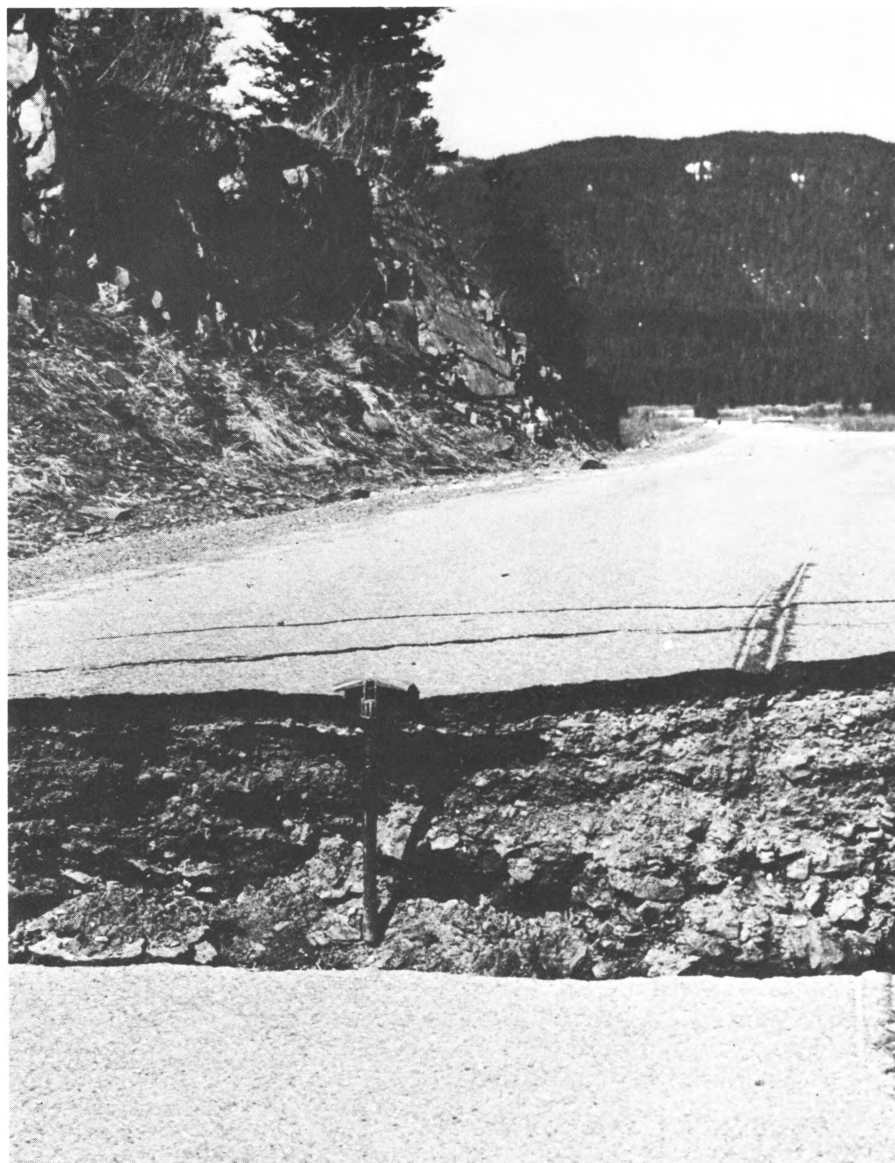
23.—Vertical displacement of roadway southeast of Ingram Creek on the Seward-Anchorage Highway. Pavement in foreground is underlain by sediments; in background, by bedrock. Trench shovel handle is 19 inches long. Photographs by Helen Foster.

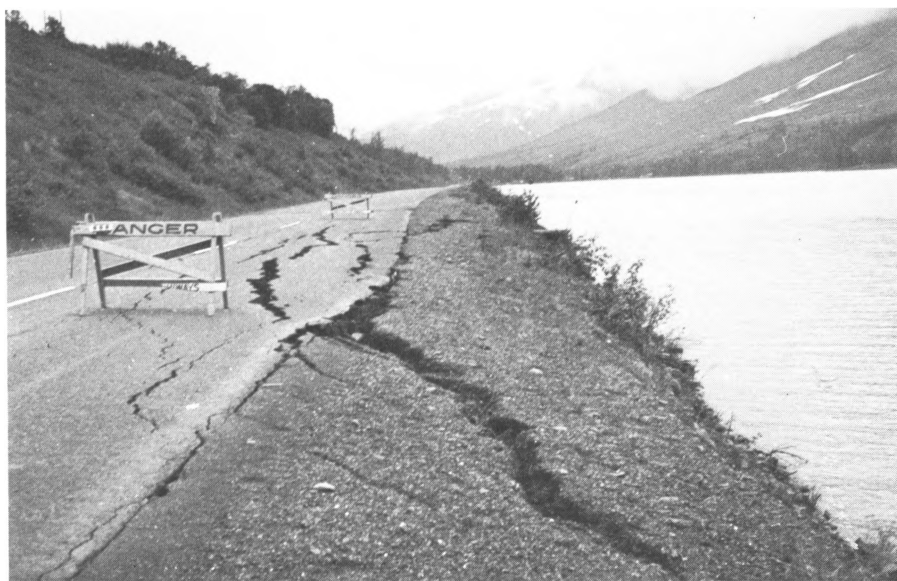
24.—Small landslide on Seward-Anchorage Highway near mile 44.5, along shore of Summit Lake.

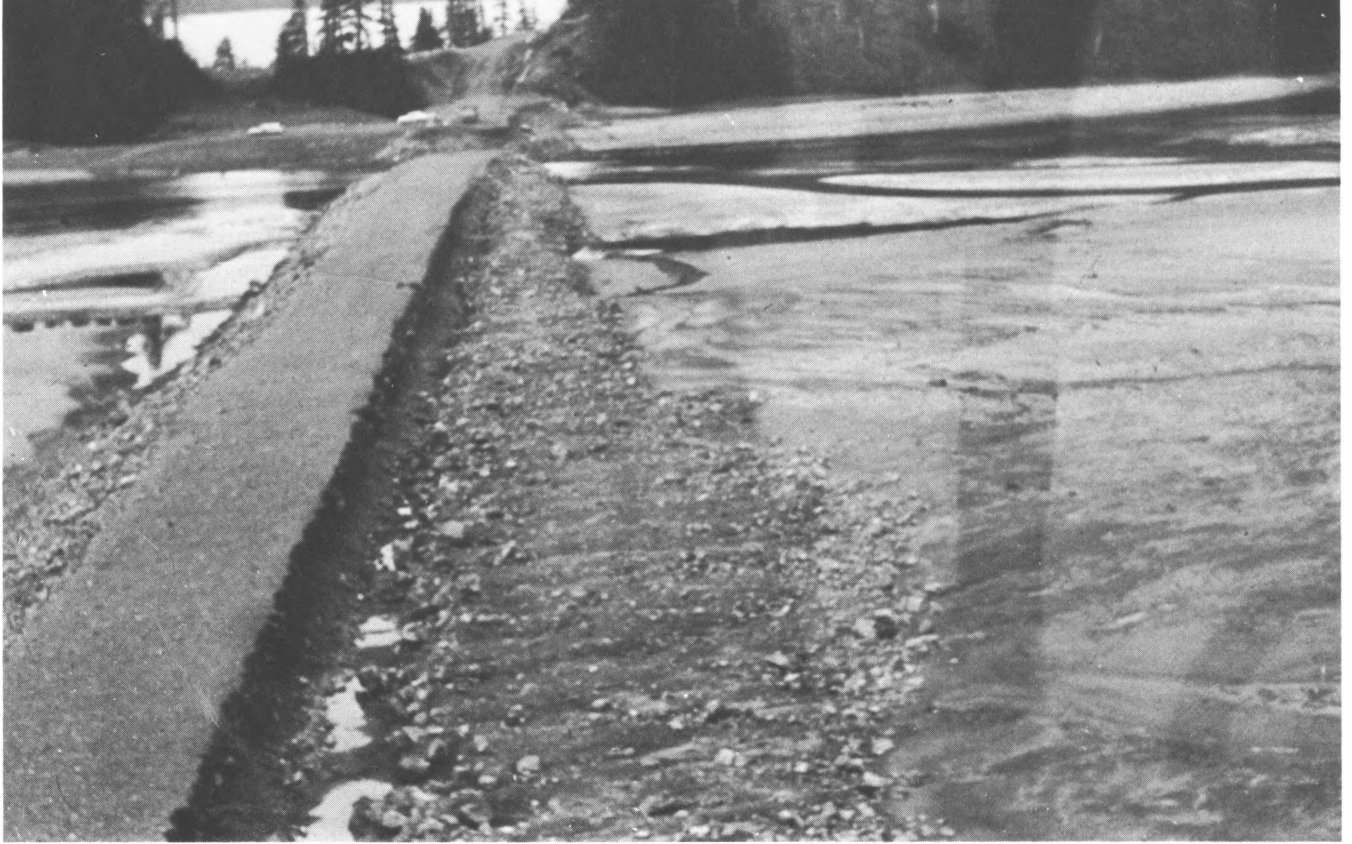
26.—Right side of Point Whitshed Road destroyed by seismic sea waves. Waves advanced over roadway from the left and cut sharp edge on right side of roadway. View northeast; Hartney Bay is to the right.

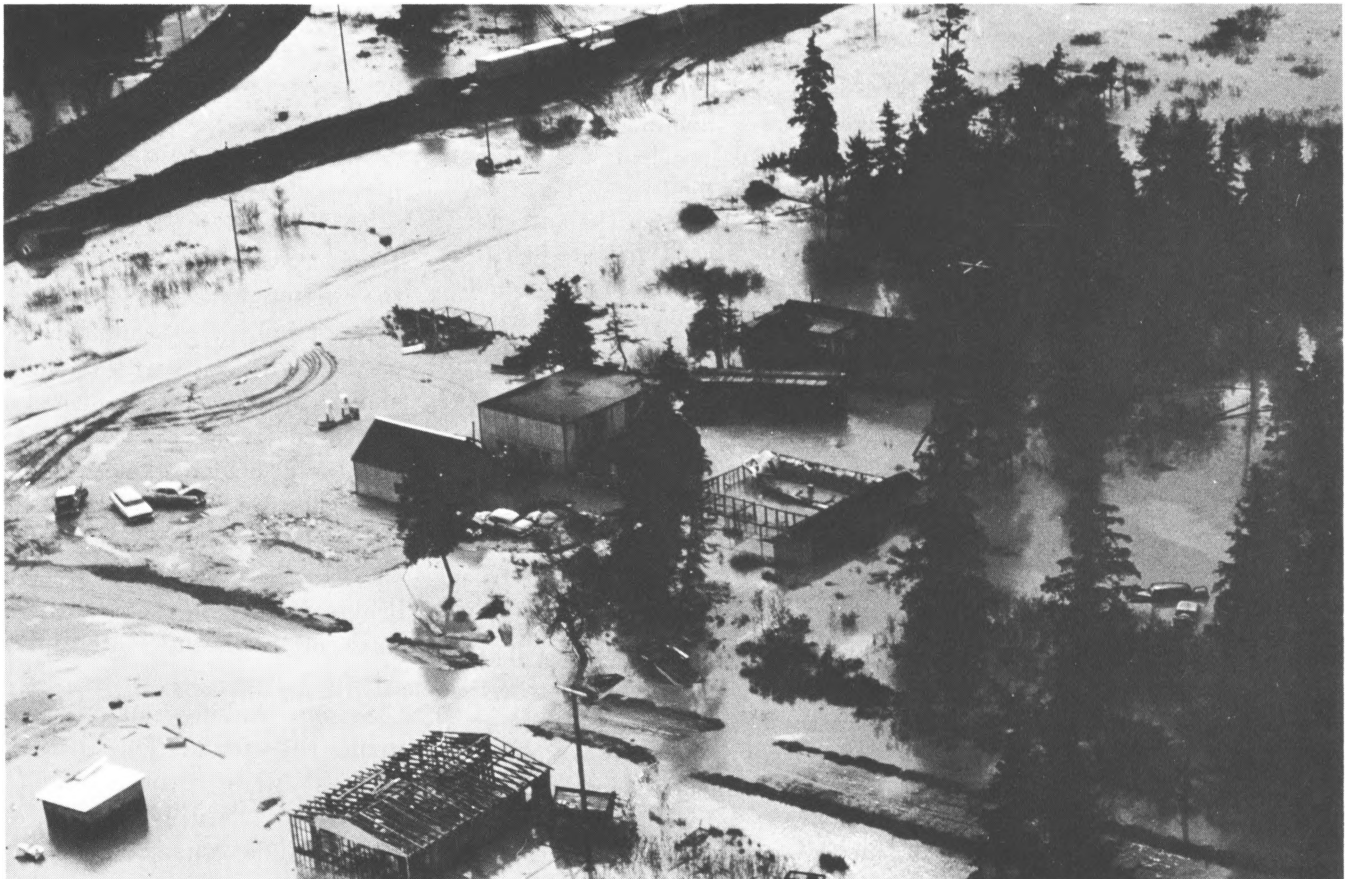
27.—View of Portage on Seward-Anchorage Highway during 28-foot tide, after regional subsidence caused by the earthquake. Highway is under water, just below railroad grade in far background. Photograph taken August 10, 1964.

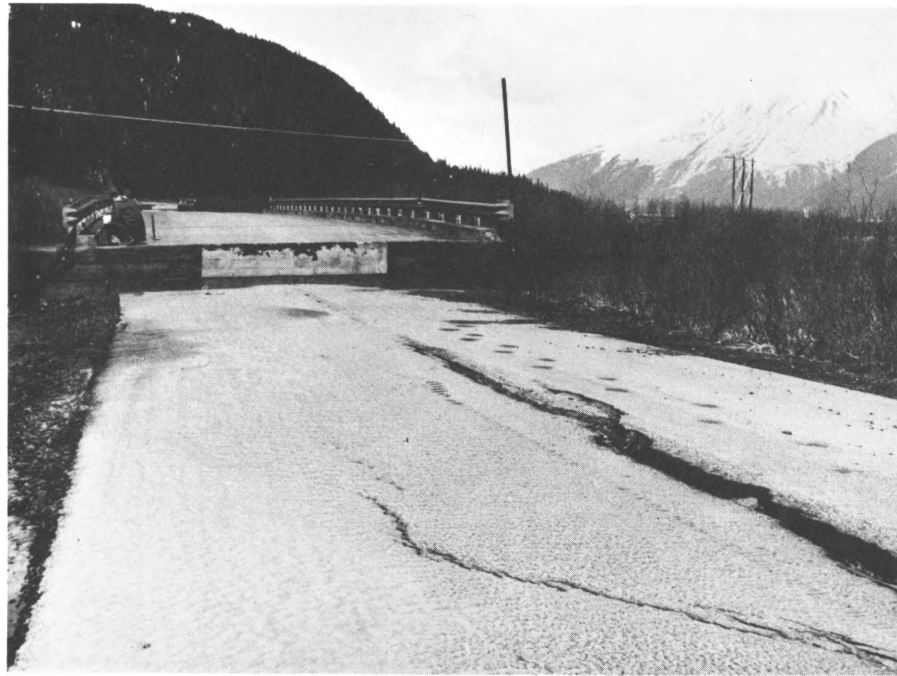
30.—Subsidence of bridge approach fill at Tidewater Slough 2 bridge, mile 76.4, Seward-Anchorage Highway. View is west. Photograph by Helen Foster.

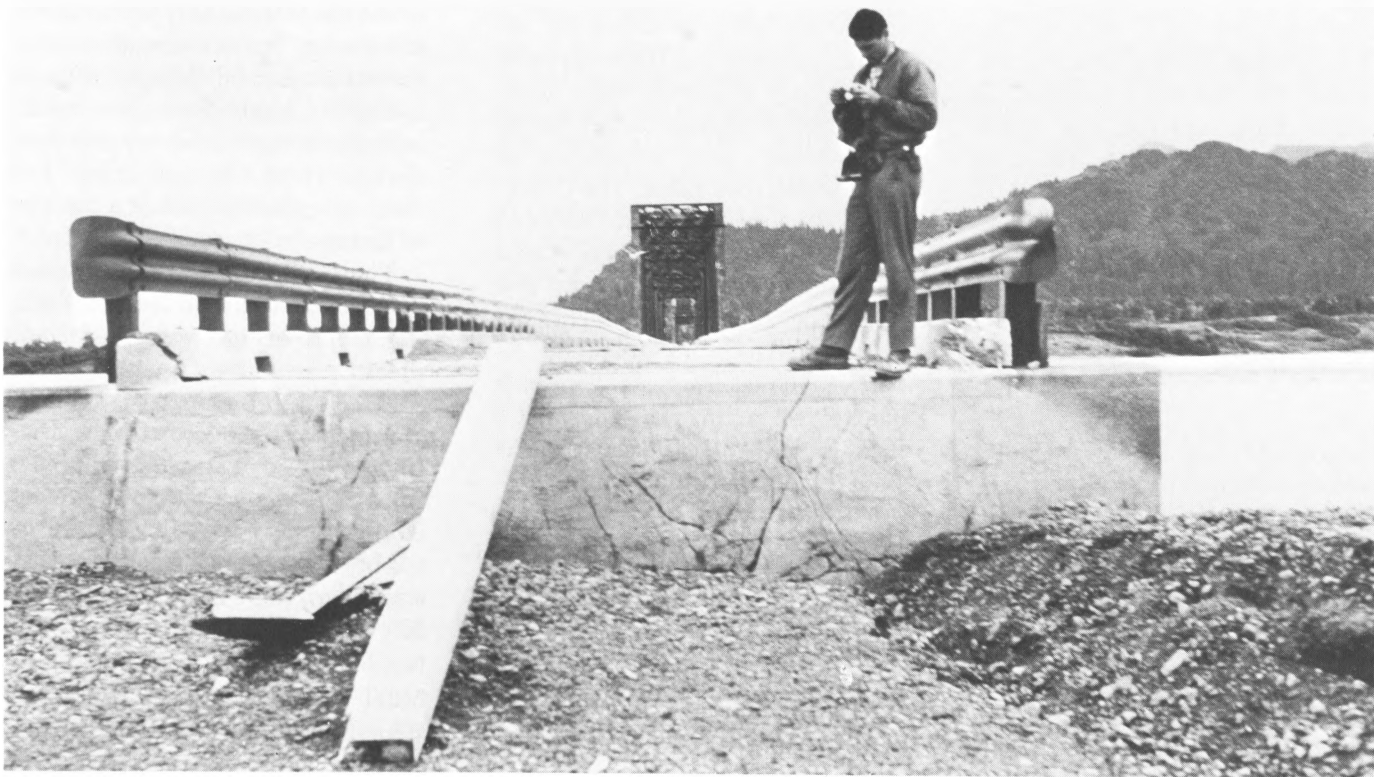
31.—View looking west, Copper River bridge 2, mile 27.1, Copper River Highway. Approach subsided 3 feet as a result of seismic shaking.

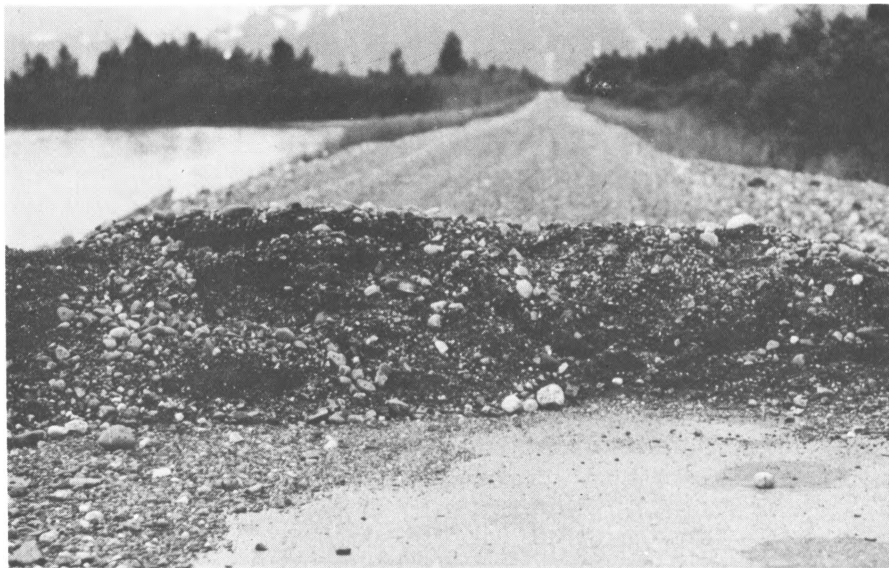
32.—Mound formed by bulldozing of approach fill against bridge deck (foreground), at north end of Copper River 12 bridge, mile 36.9, Copper River Highway.

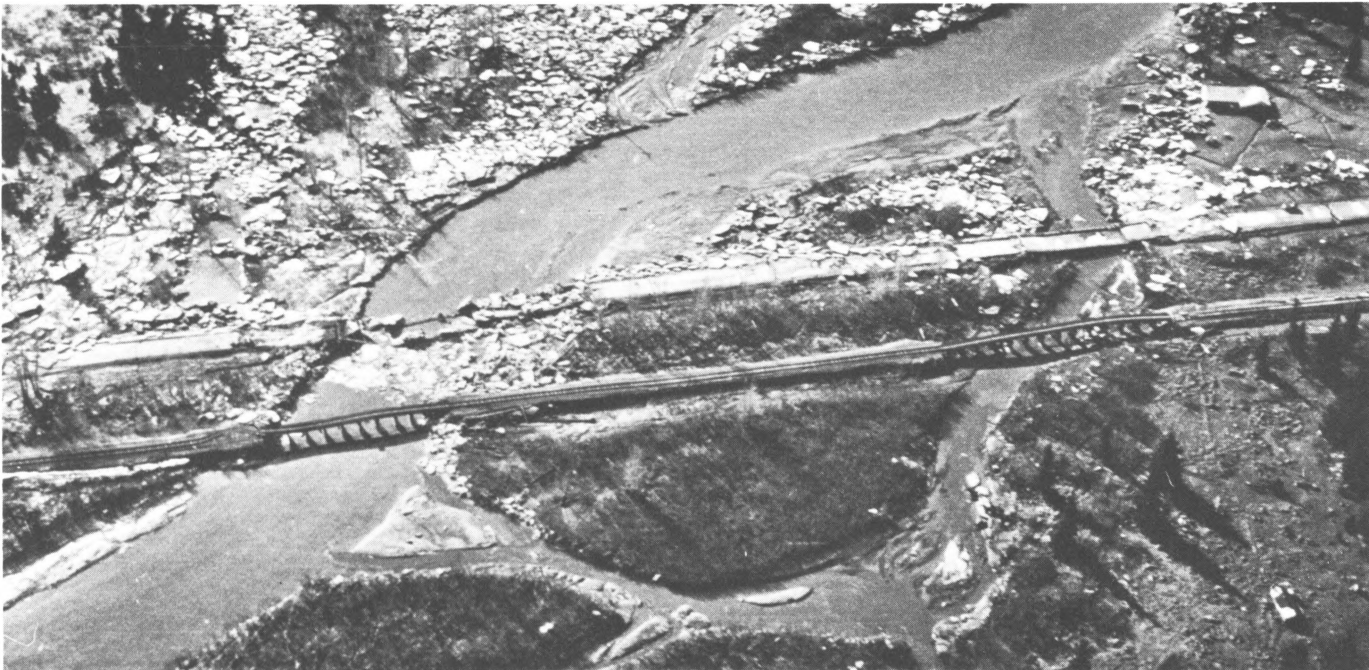
33.—Wreckage of Portage Creek bridges 2 and 3, Seward-Anchorage Highway. The Alaska Railroad grade and bridges are in foreground of highway. Photograph by U.S. Army.

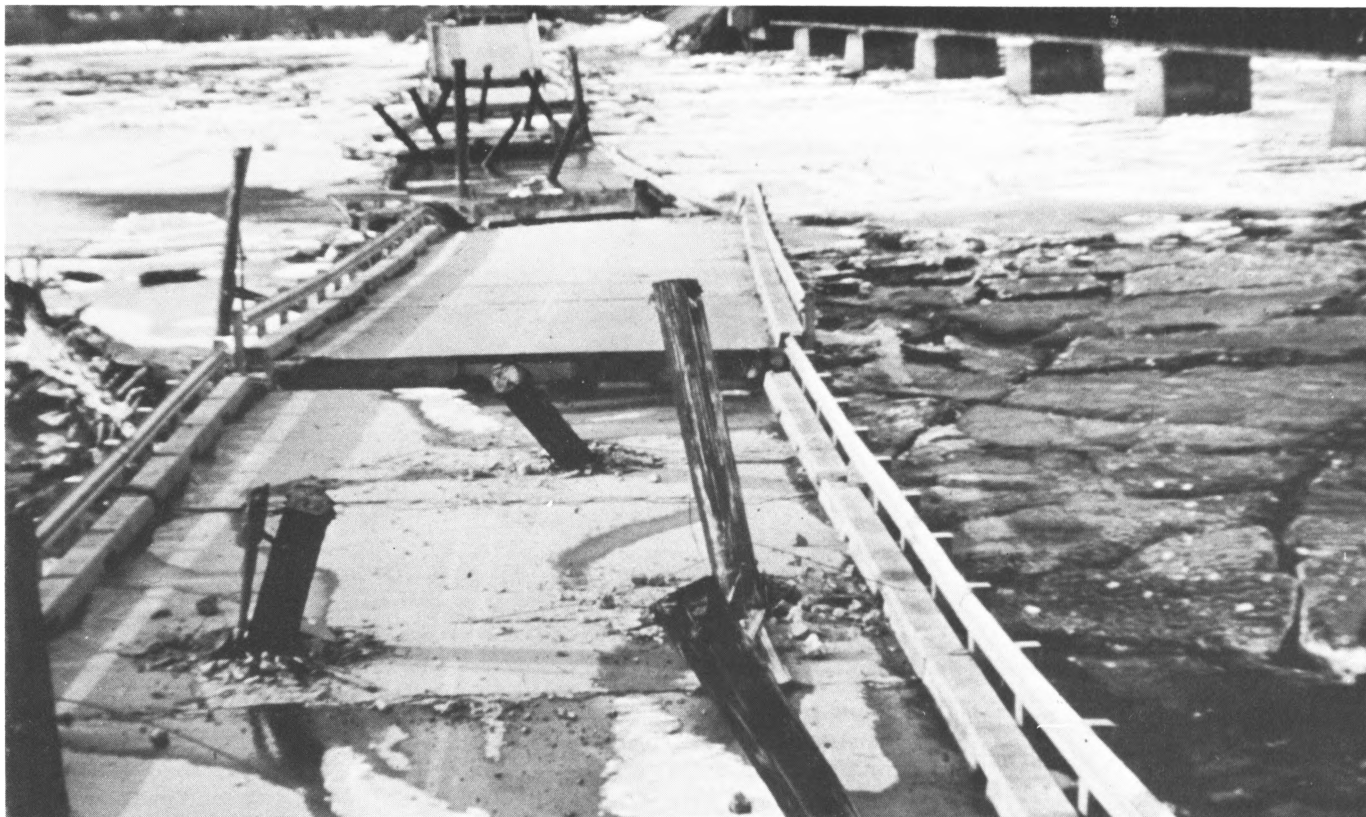
34.—Collapsed bridge across Twentymile River. Railroad bridge in upper right photograph did not collapse.

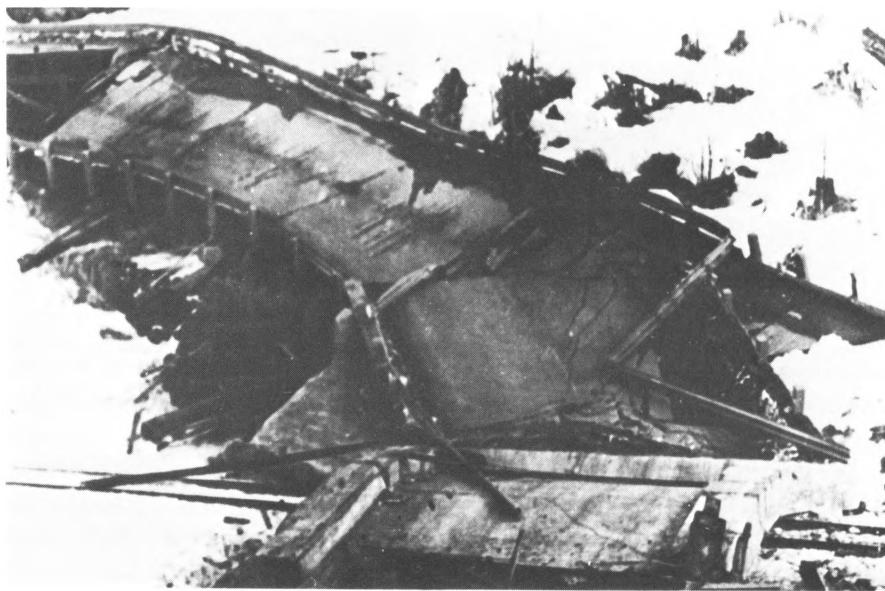
35.—Overhead at east side of Snow River Crossing. Structure collapsed upon tracks of The Alaska Railroad. Photograph by U.S. Army.

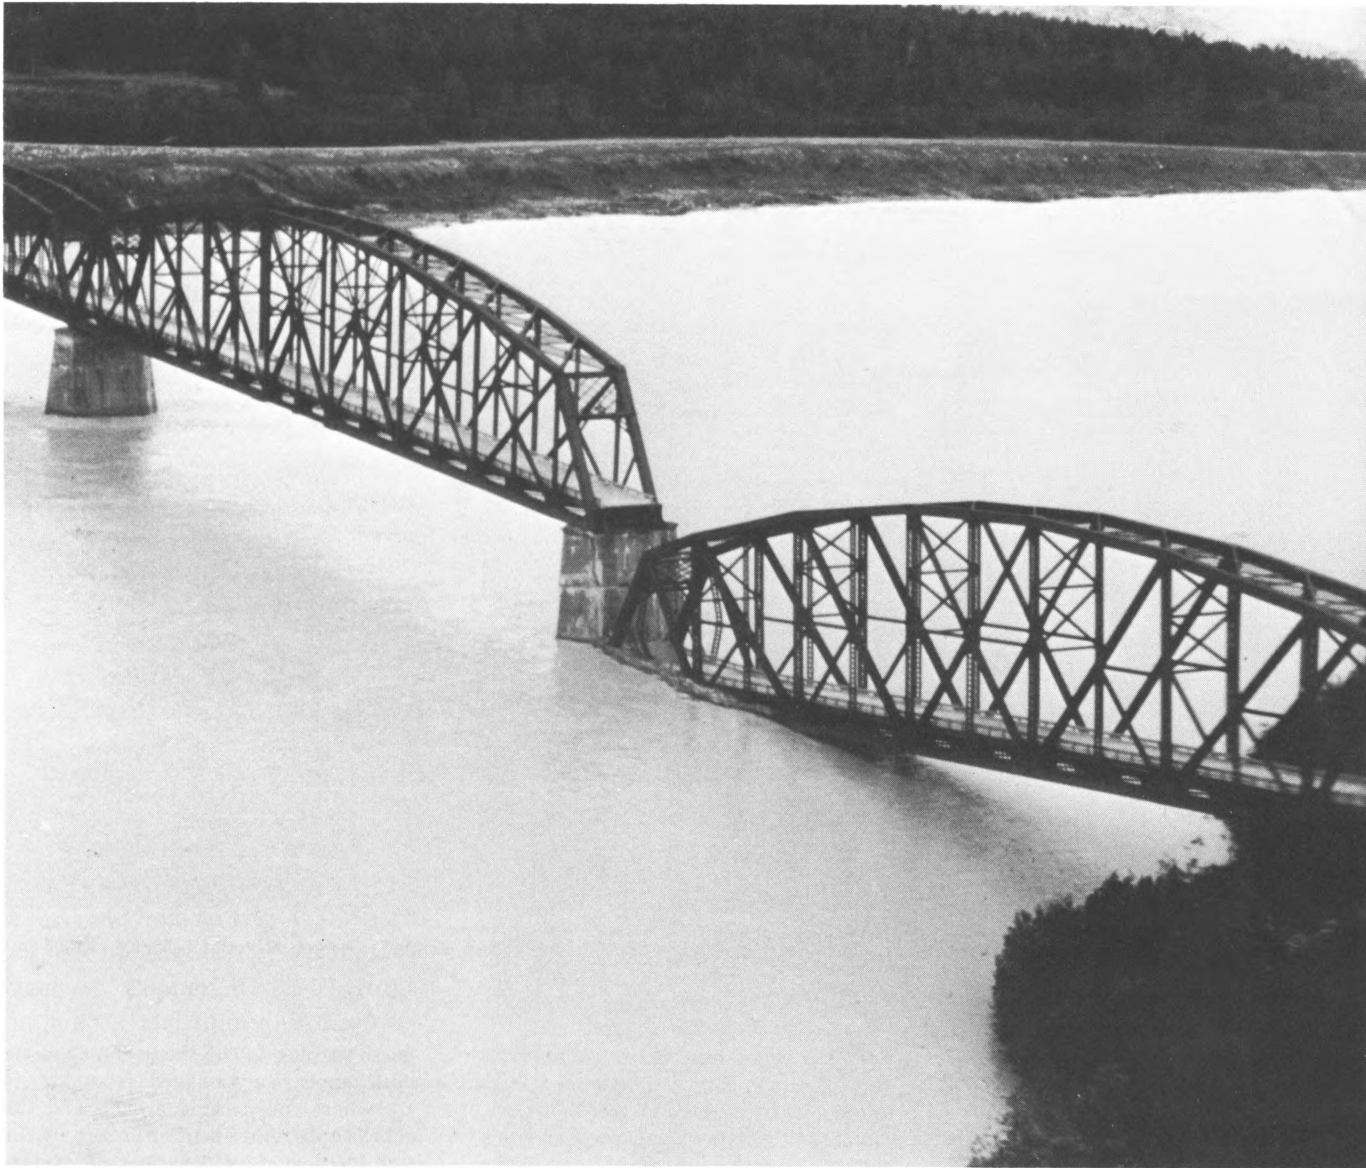
36.—Million Dollar Bridge, Copper River Highway ; No. 4 span off No. 4 pier. View is southwest.

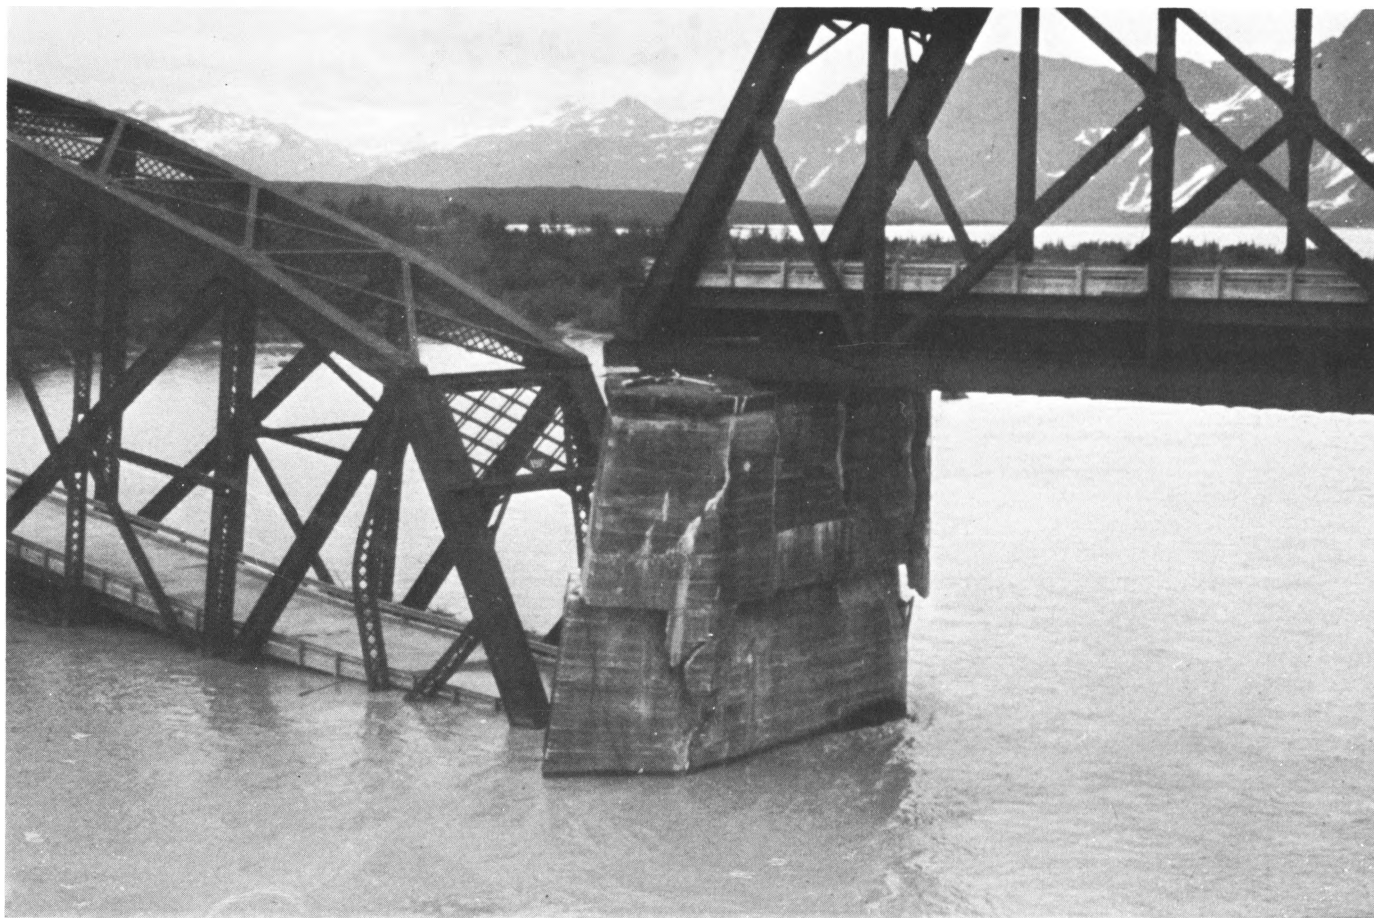
37.—Collapsed No. 4 span and horizontal fracture in No. 4 pier of Million Dollar Bridge, Copper River Highway. View is northeast.

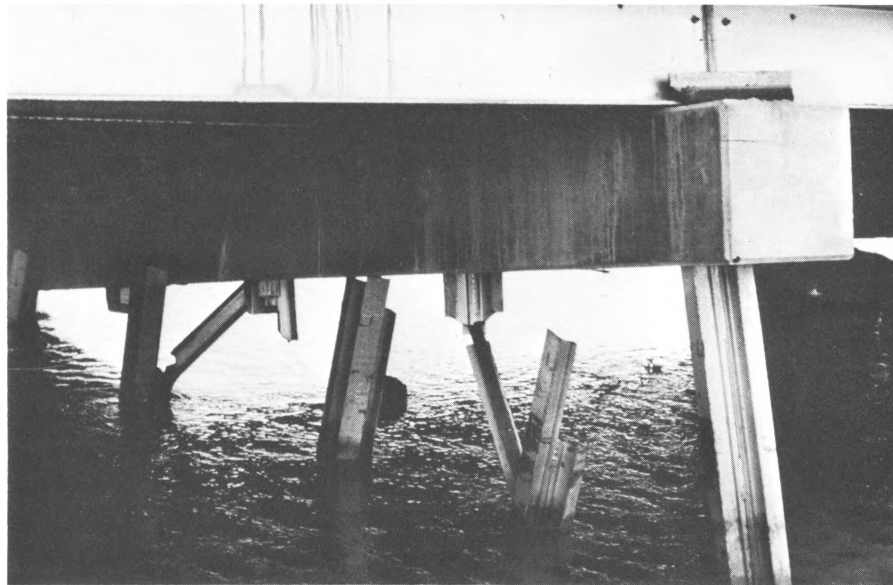
38.—Broken rail piles on Scott Glacier 6 bridge, mile 5.9, Copper River Highway.

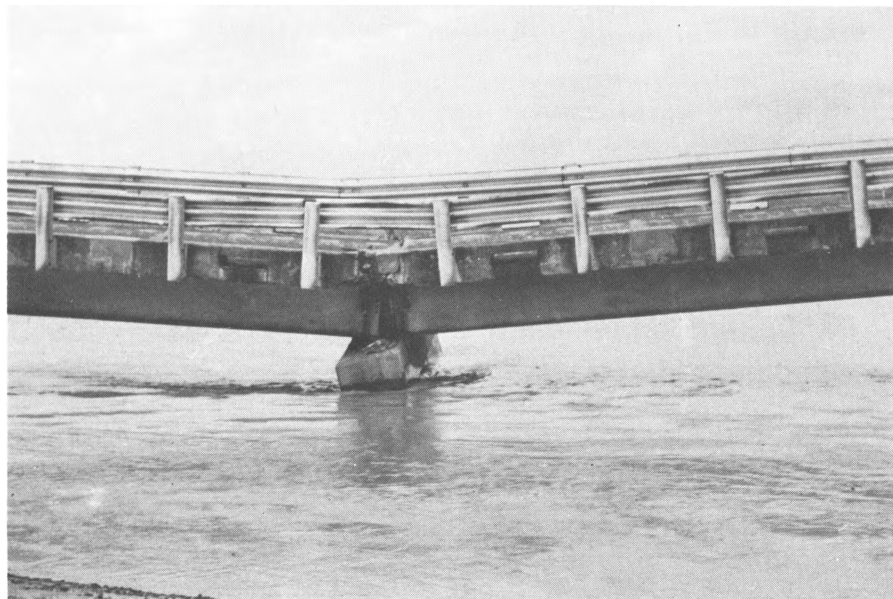
39.—Collapsed bent and deck of Copper River 5 bridge, mile 35.0, Copper River Highway.

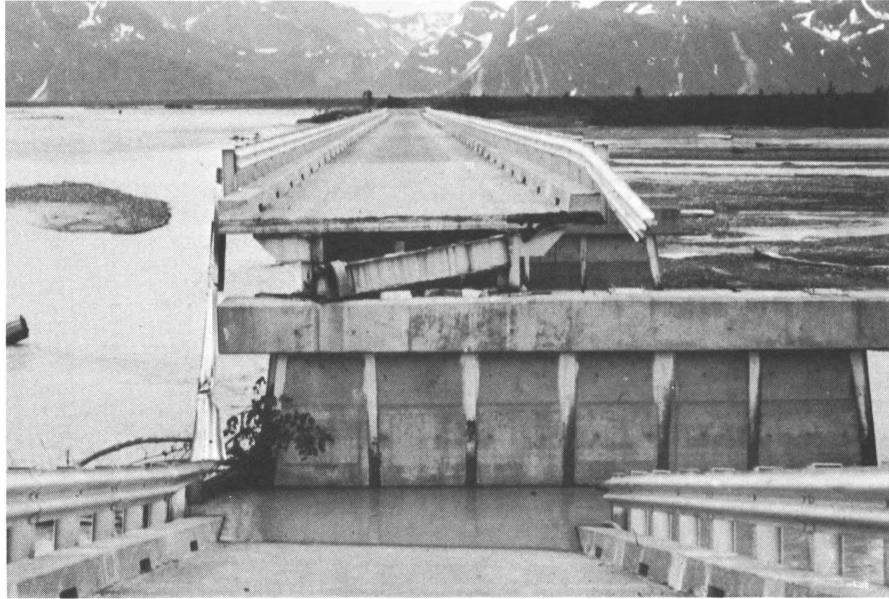
40.—Collapsed deck on Copper River 5 bridge, mile 35.0, Copper River Highway.
Concrete between rail piles is to protect rails against ice.

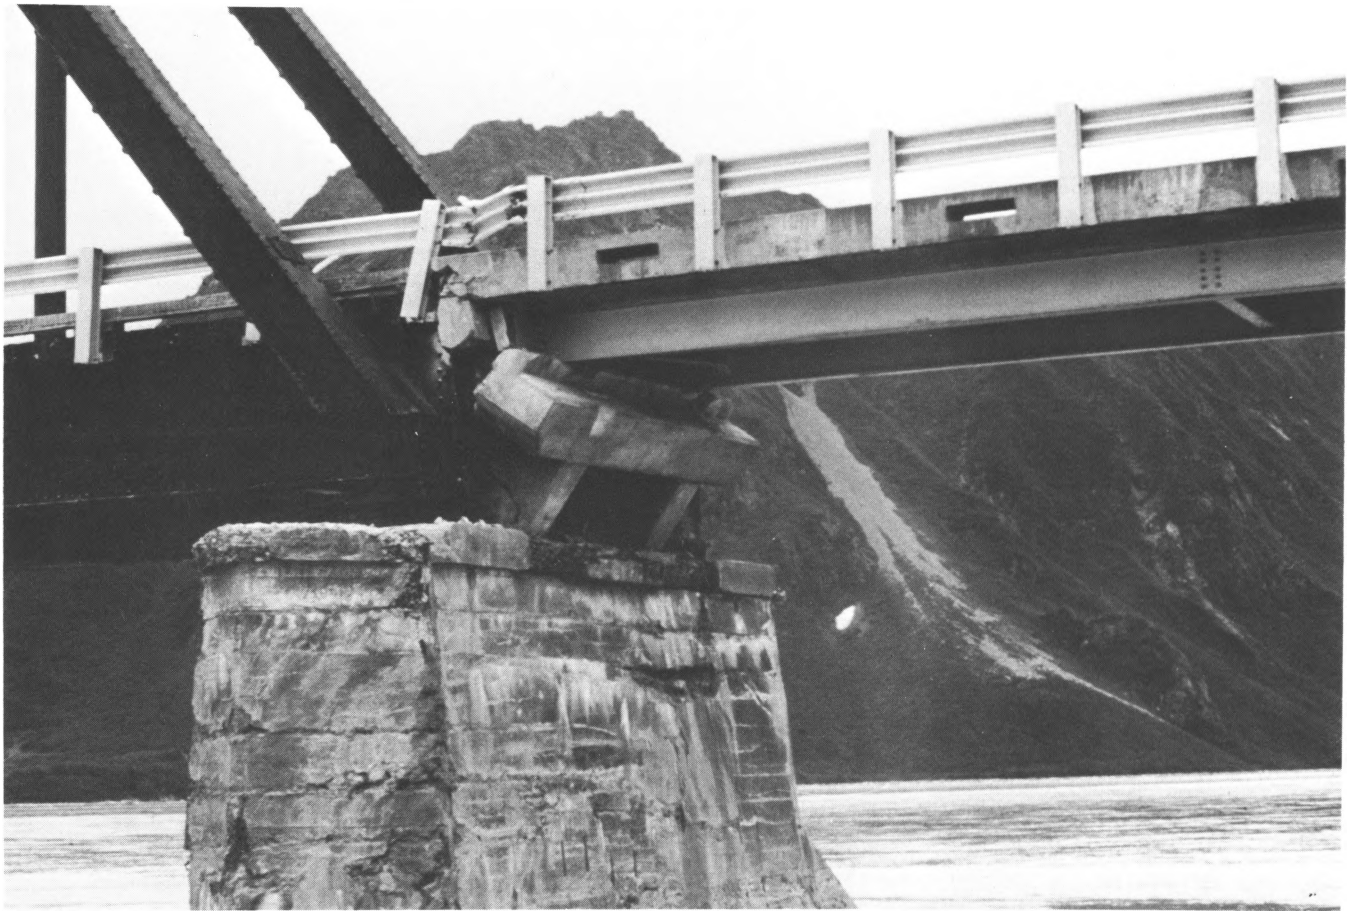
41.—Contact between steel truss and concrete deck on pier 26, Copper River 2 bridge, mile 27.1, Copper River Highway.

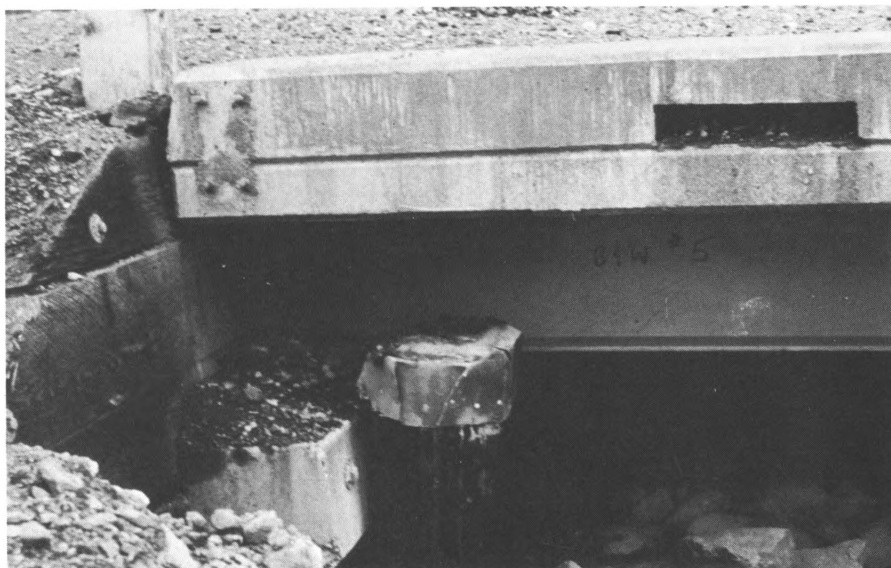
42.—West abutment of Scott Glacier 5 bridge, mile 9.2, Copper River Highway. Concrete cap displaced 2 inches to the left off the pile bent. Compare with figure 43.

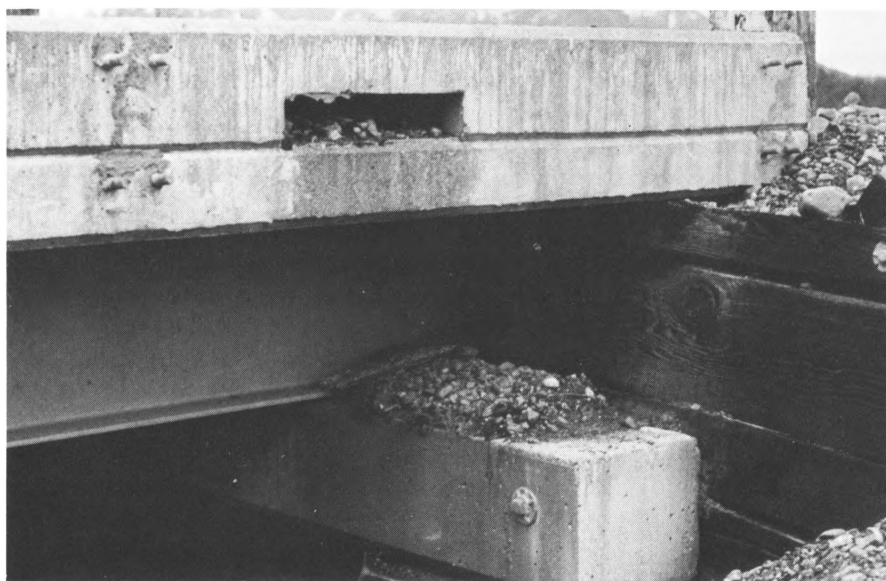
43.—East abutment of Scott Glacier Creek 5 bridge at mile 9.2, Copper River Highway. Superstructure is displaced about 2 feet to the right, relative to the abutment. Compare with figure 42.
