The Alaska Earthquake

March 27, 1964

Effects of the Earthquake of March 27, 1964, on the Alaska Highway System

GEOLOGICAL SURVEY PROFESSIONAL PAPER 545-C

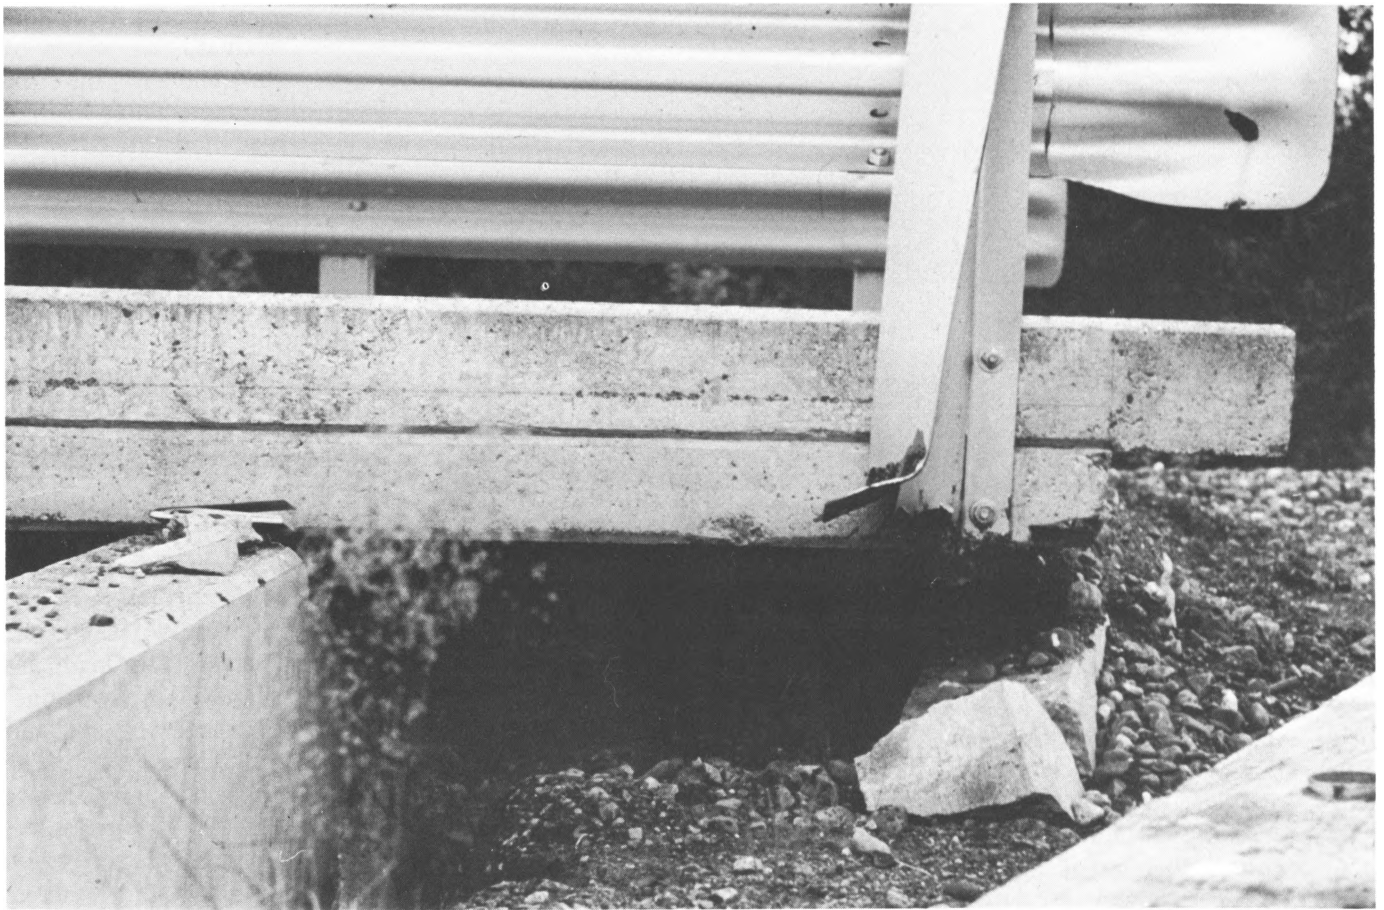
44.—North abutment of Clear Creek bridge 329, mile 41.0, Copper River Highway. Superstructure is displaced to the right relative to the abutment.

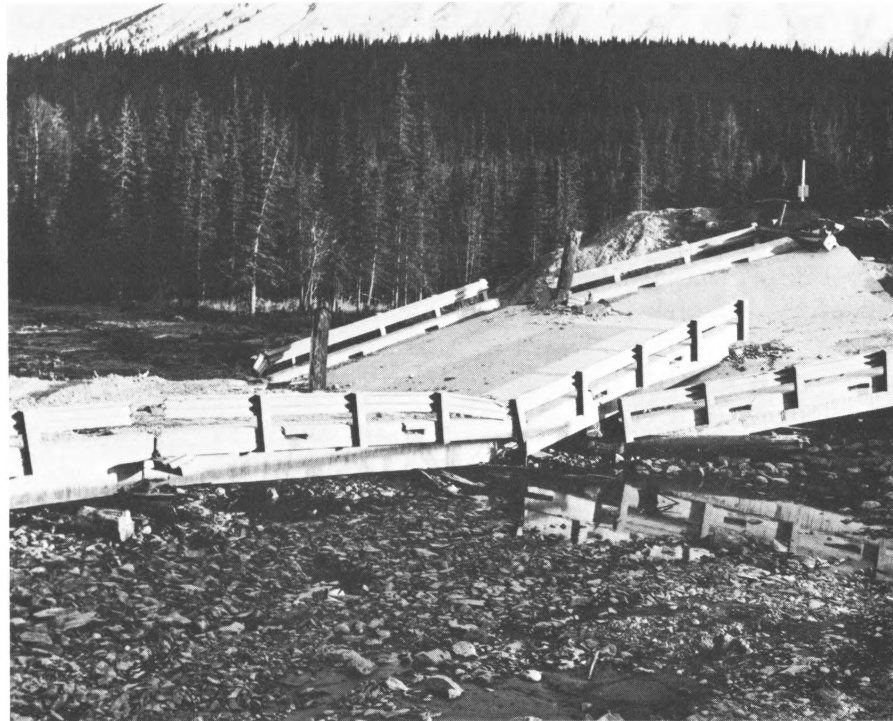
45.—Collapsed bridge across Kenai River at Kenai Lake, mile 48.9, Sterling Highway. Wood piles are driven through the collapsed reinforced concrete deck. Photograph by Helen Foster.

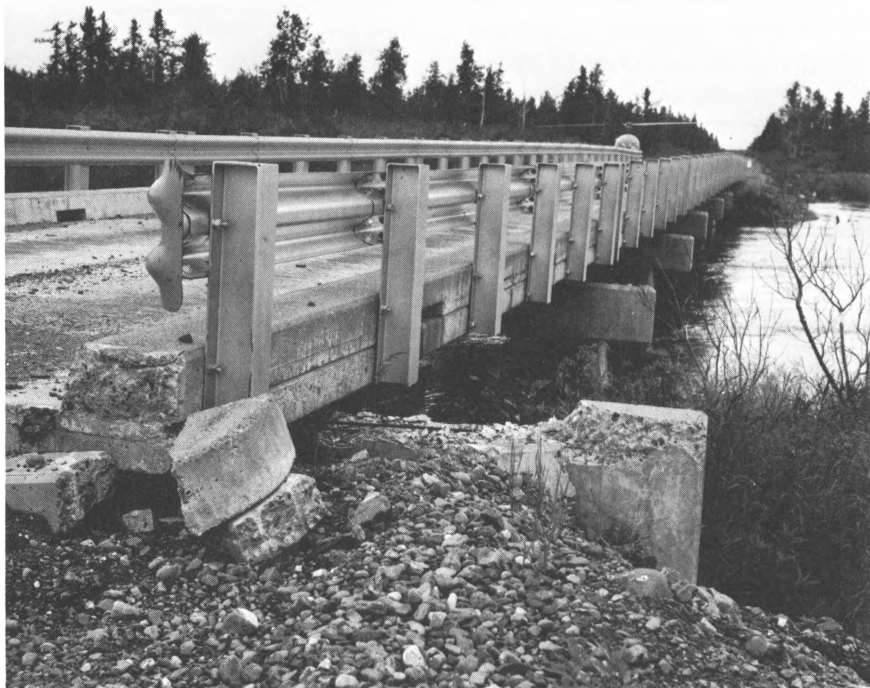
48.—North abutment of Copper River 9 bridge, 338, mile 36.1, Copper River Highway, showing displacement of deck laterally to the left relative to substructure. Photograph by George Plafker.
