The Alaska Earthquake

March 27, 1964

Effects of the Earthquake Of March 27, 1964 On the Communities of Kodiak and Nearby Islands

GEOLOGICAL SURVEY PROFESSIONAL PAPER 542-F

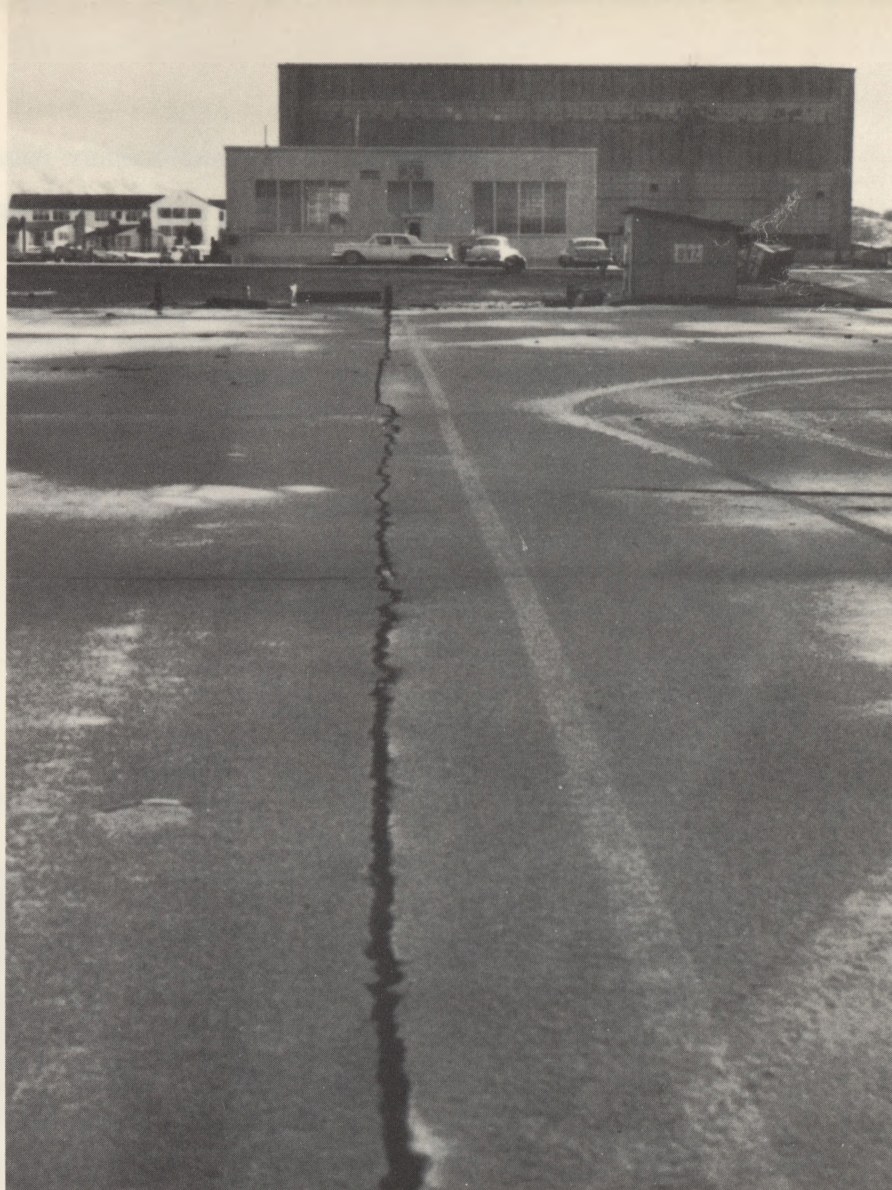
3.—East-west-trending fissure in aircraft parking ramp at Kodiak Naval Station. View is west. Photograph by U.S. Navy, March 29, 1964.

One of the effects of the earthquake was the development of fissures in the low-lying areas underlain by unconsolidated sediments and artificial fill. Fissuring occurred in the asphalt of the aircraft parking ramps at the head of Womens Bay (fig. 3) and along the highways throughout the station. Figure 3 shows a long east-west-trending fissure. The surface ex-

pression of the fissure may in part be controlled by the type of construction that was employed when the asphalt was placed and may actually represent a construction joint. The fissures developed only in areas where more than 5 feet of unconsolidated deposits or fill overlay the bedrock. In at least one locality, at the aircraft parking ramps, fissures developed primarily as a result of seismic shaking that caused some lateral extension or displacement of the unconsolidated deposits and artificial fill toward a free face. The sediments underlying the parking

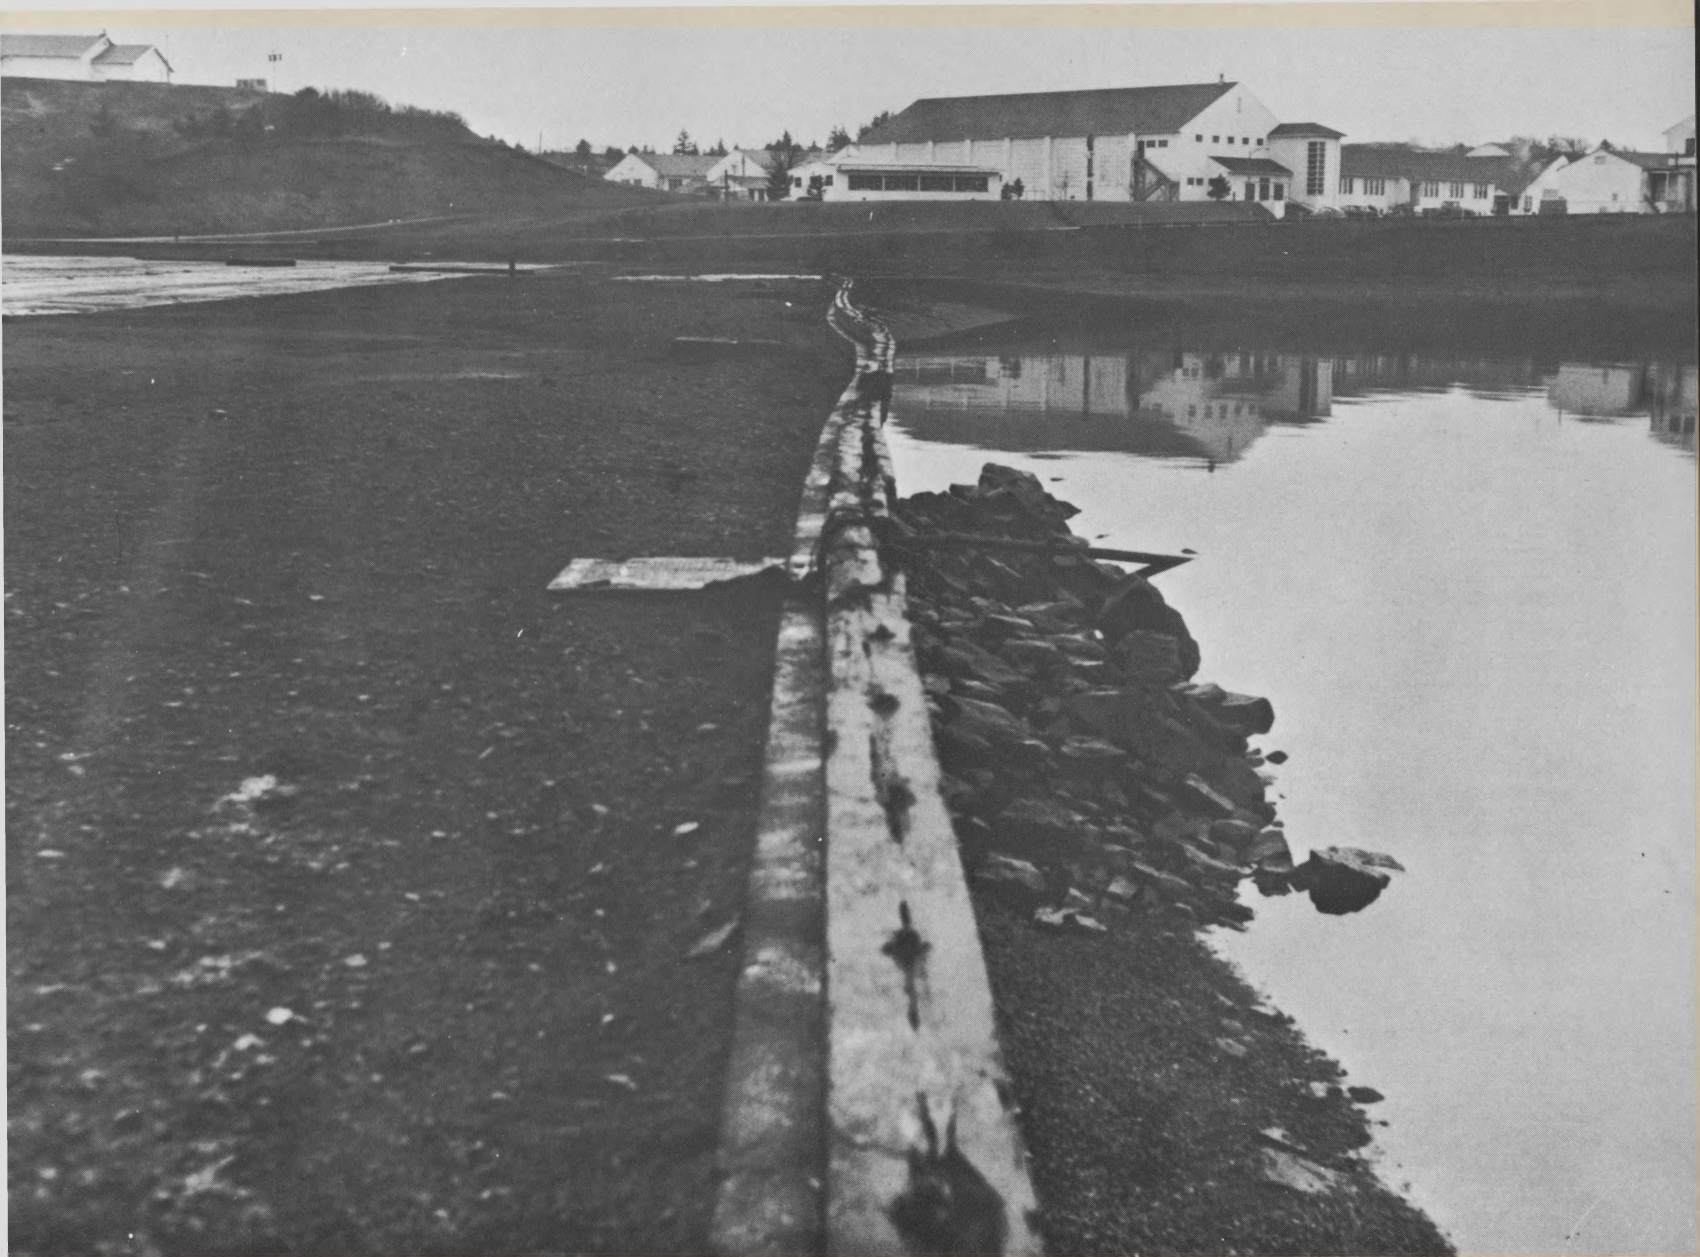
4.—Displacement of seawall toward Womens Bay, Kodiak Naval Station. View is east. Photograph by U.S. Navy, April 1, 1964.

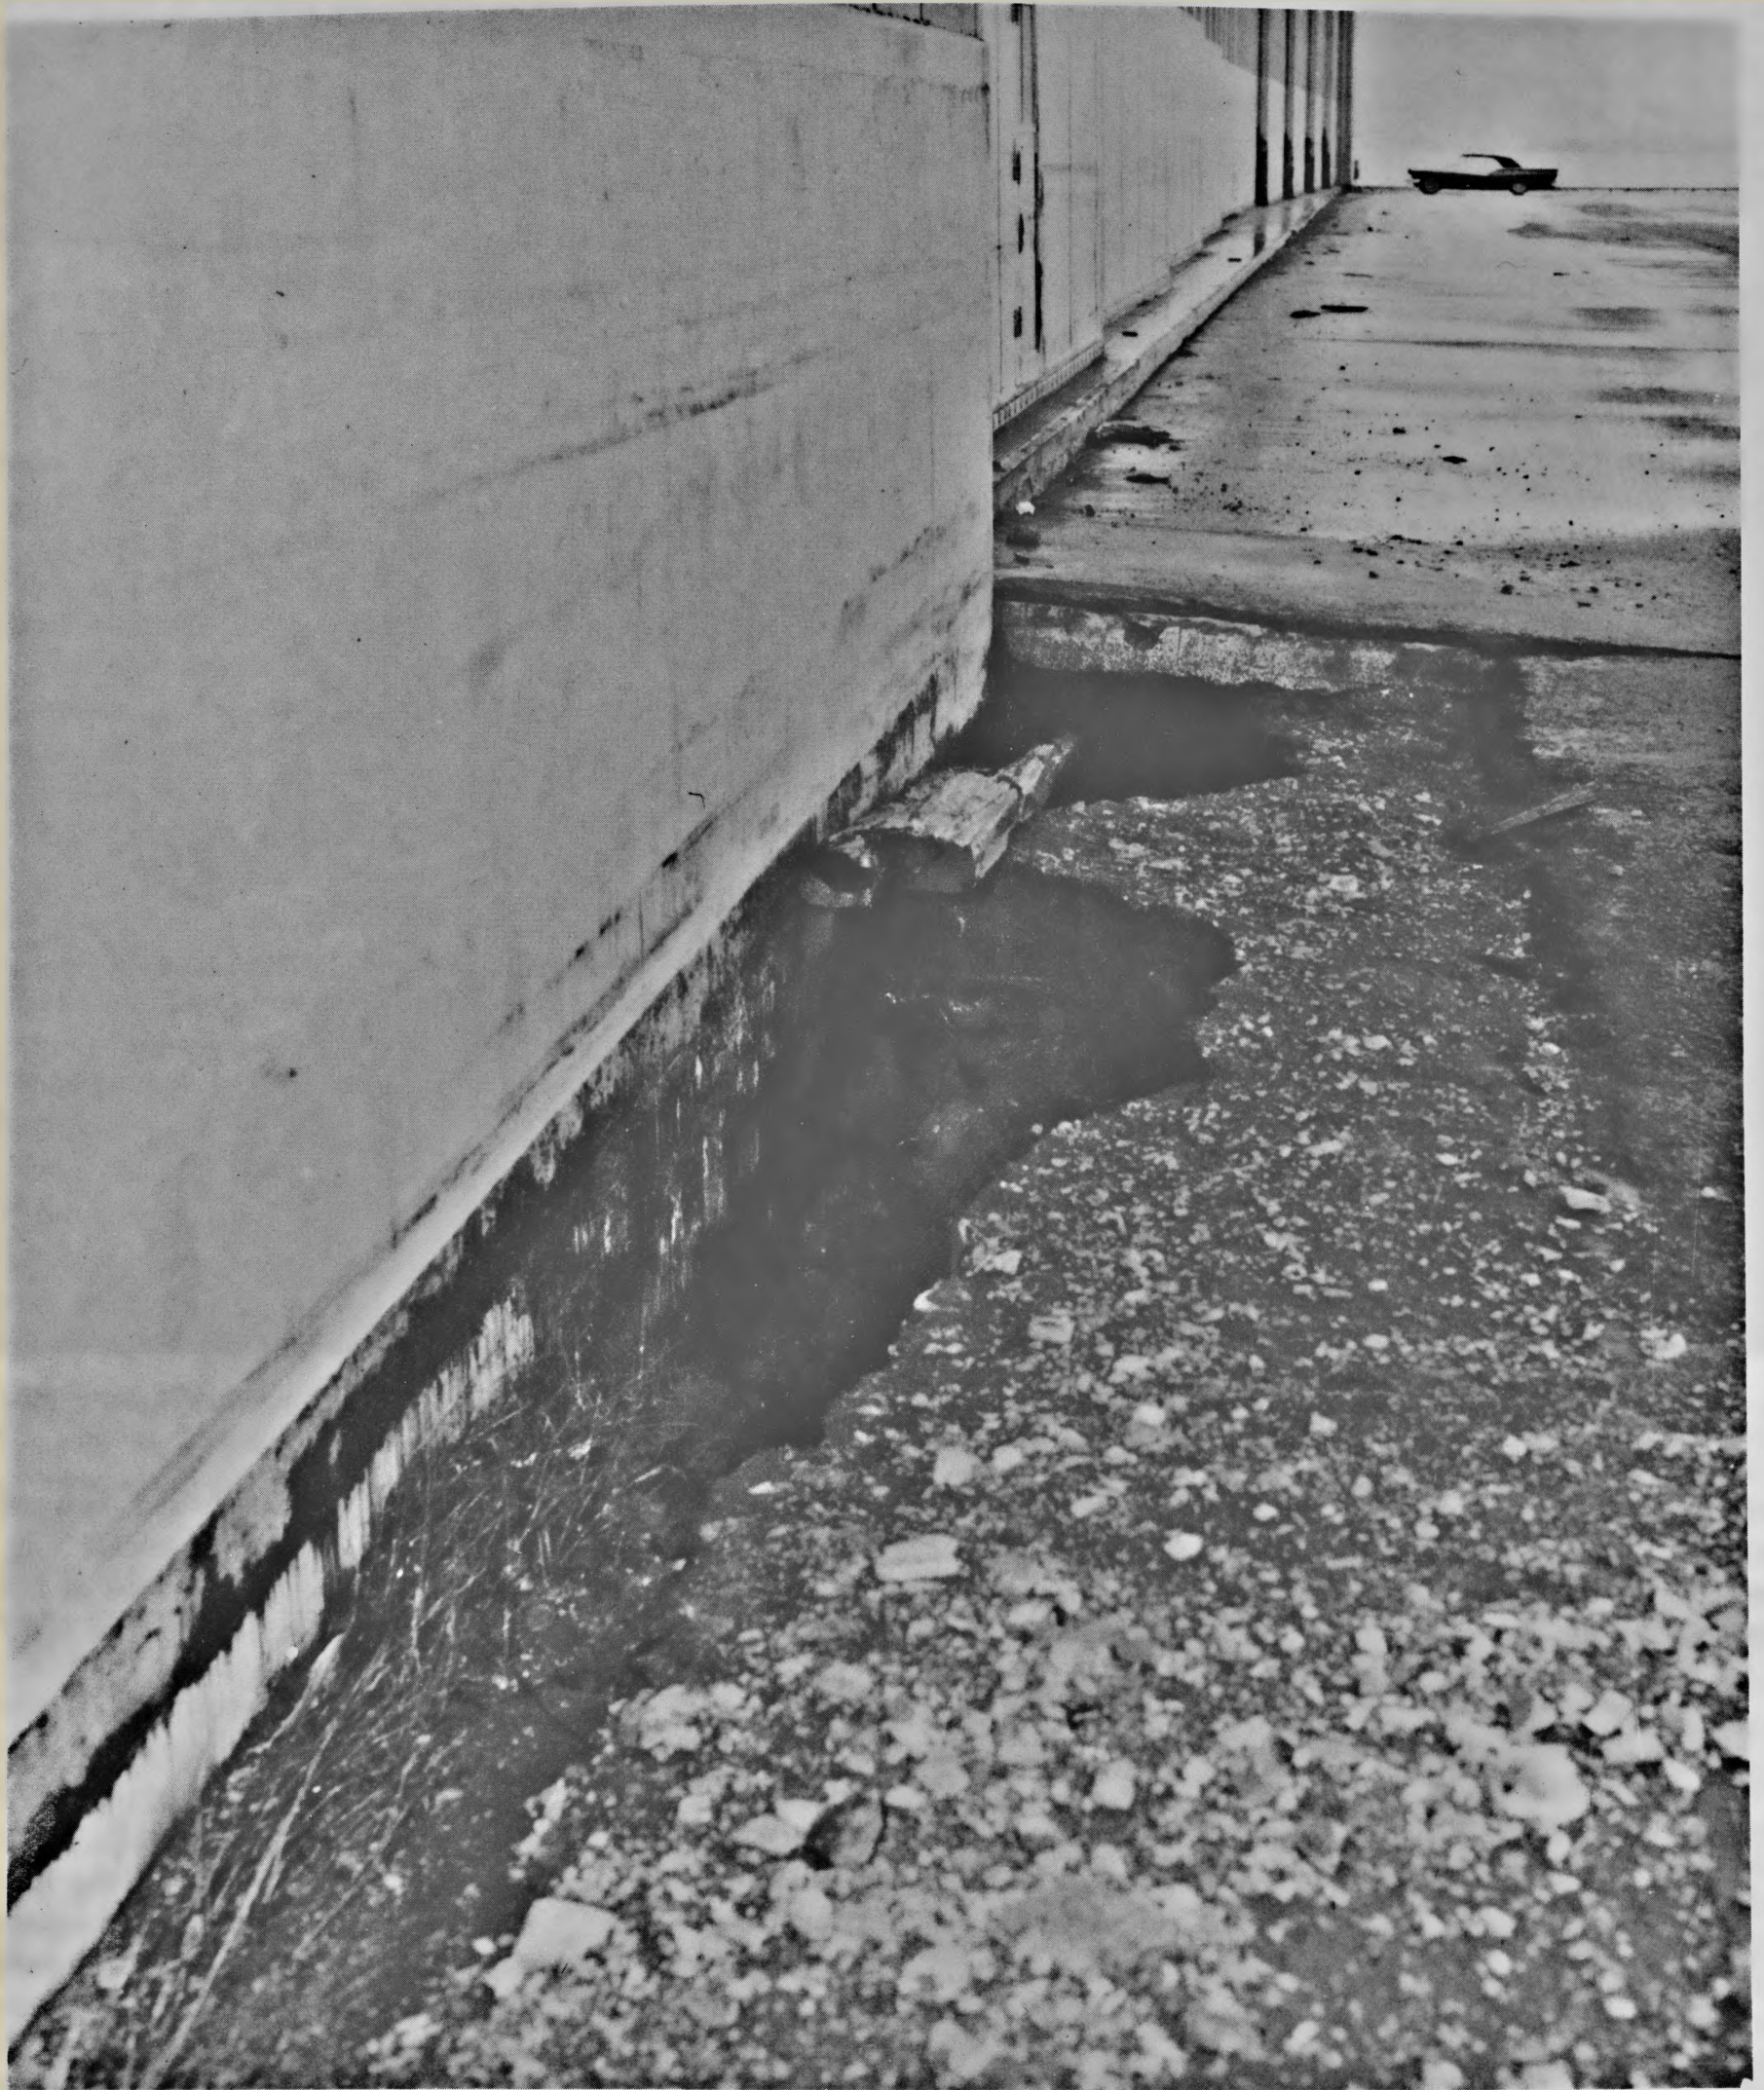
Differential settlement, or compaction, took place in the unconsolidated sediments underlying some of the structures at the Kodiak Naval Station. The compaction was due to seismic action and amounted to as much as 1 foot beneath hanger 1. Compaction of fill also occurred under the asphalt aircraft ramp outside a hangar (fig. 5, next page). The compac-

5.—Result of compaction of fill debris underlying asphalt aircraft ramp outside hangar at Kodiak Naval Station. Note the settlement of back-fill material adjacent to foundation of structure in the foreground. Photograph by U.S. Navy, March 29, 1964.

tion here was so great that a step several inches high developed between the footing of the hangar and the ramp. The hangar footing itself had some slight differential settling. Locally, the backfill material against the foundation of the hangar has compacted substantially. One might expect that scouring would have occurred during the retreat of the inundating seismic sea waves, but if it had occurred, it would have been widespread throughout the naval station, and none was observed. Furthermore, we noted the same

phenomenon of differential compaction at the Eklutna Hydroelectric Project near Anchorage, Alaska, where seismic sea waves had not inundated the area. The hangars were constructed on 15–20 feet of engineered fill consisting of glacial debris (Tudor, 1964). The columns of the hangars rested on piles, whereas the deck of the hangars rested on fill. There apparently was not settlement of the columns of the hangars, but differential settlement of the fill beneath the hangar footings caused slight deformation of the bracing

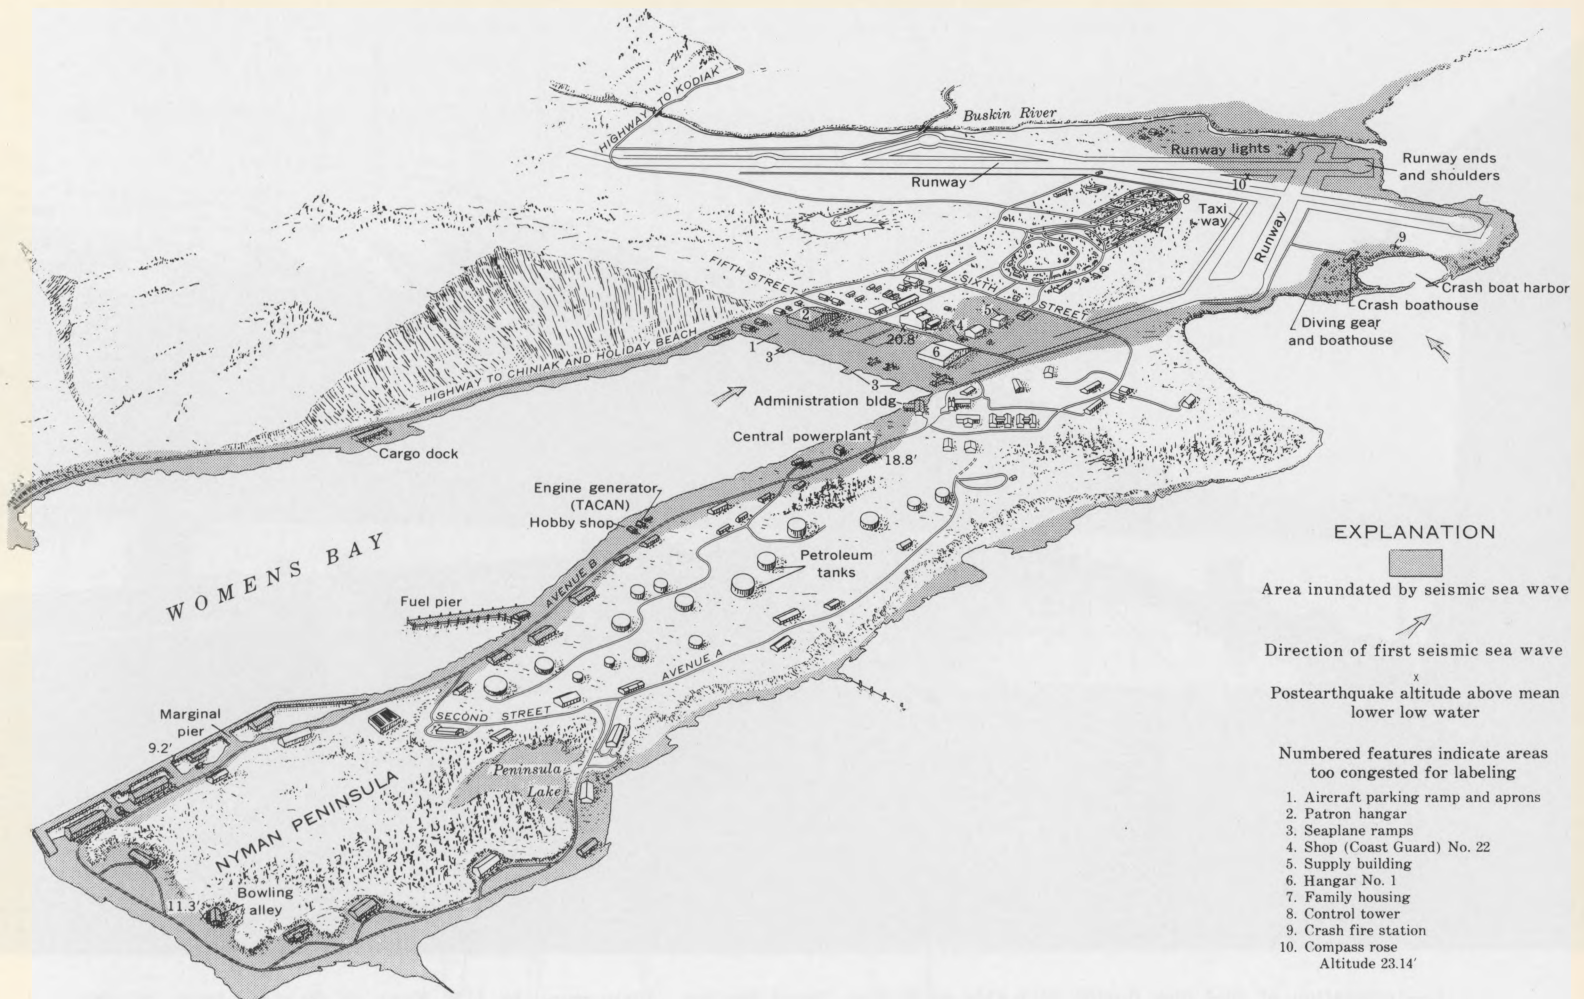
6.—Area of maximum inundation by seismic sea waves and structures damaged at Kodiak Naval Station.

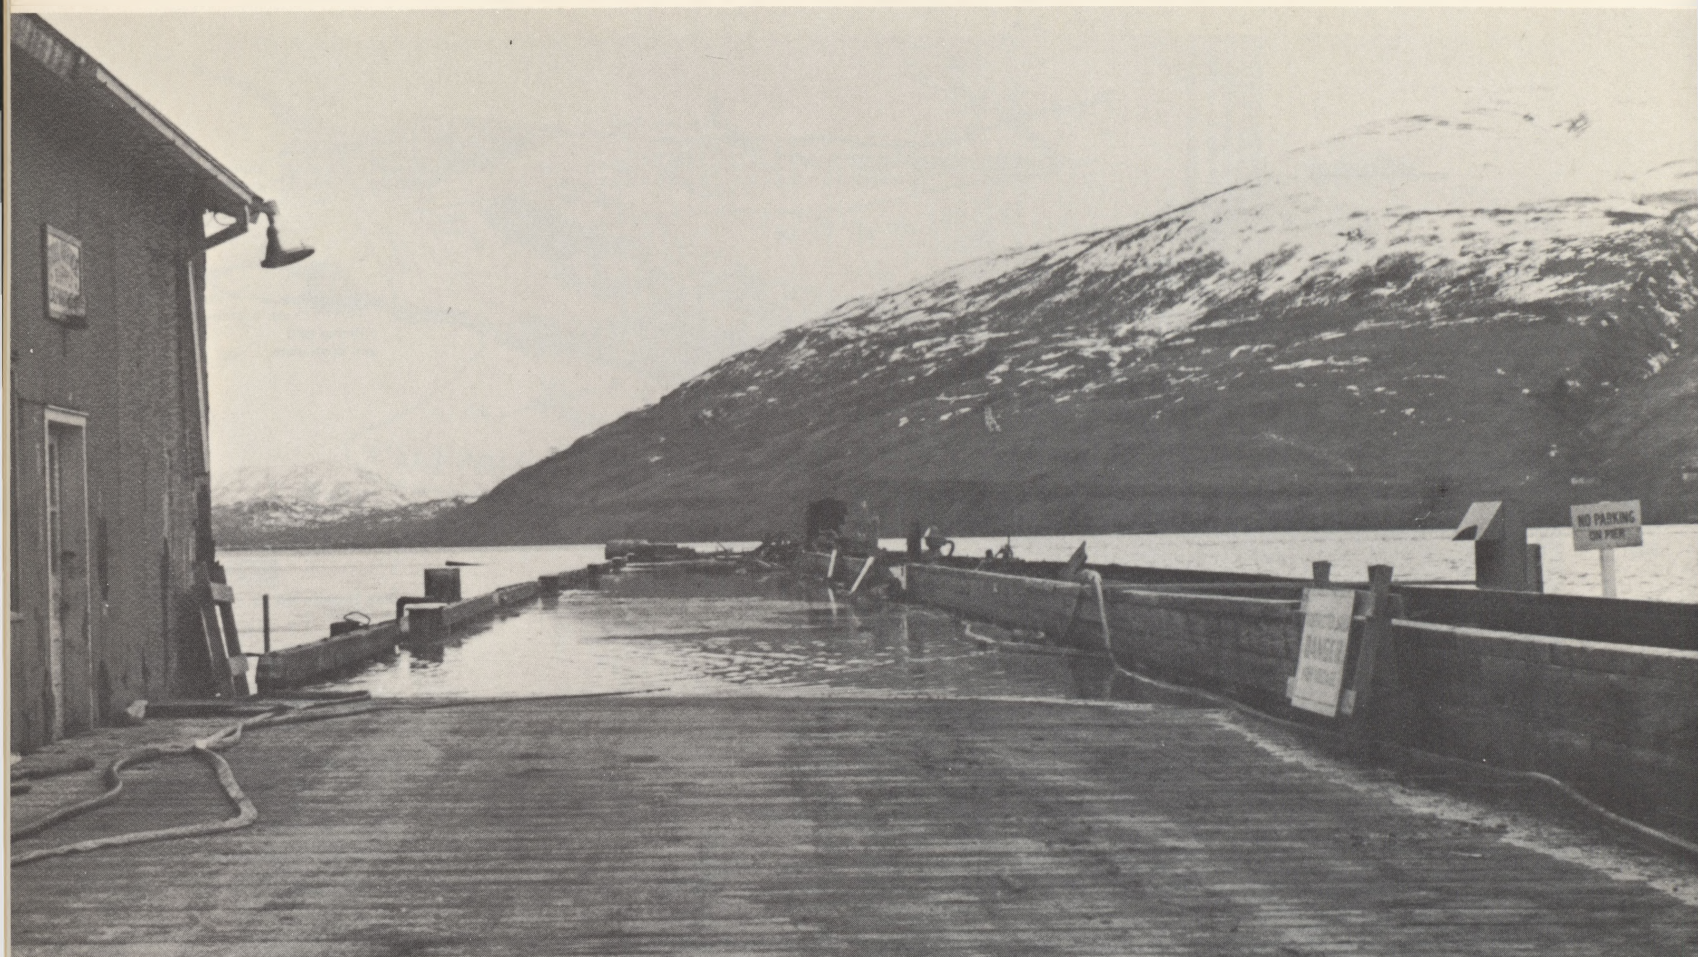
7.—Inundation of fuel pier during high tide at Kodiak Naval Station. Photograph by U.S. Navy, 12:59 p.m., April 12, 1964.

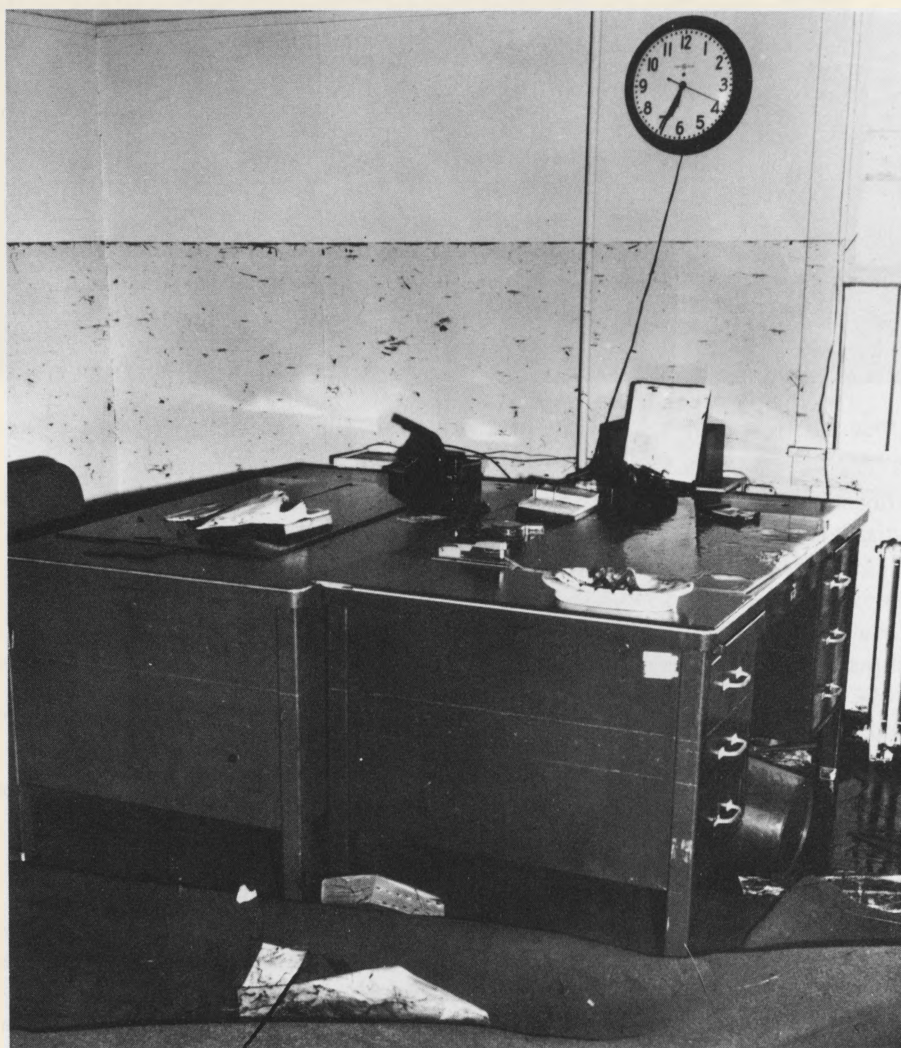
9.—Clock in the intelligence office, Kodiak Naval Station, showing time power failed at the station. Black watermark on the wall indicates maximum height of inundation. Photograph by U.S. Navy, March 29, 1964.

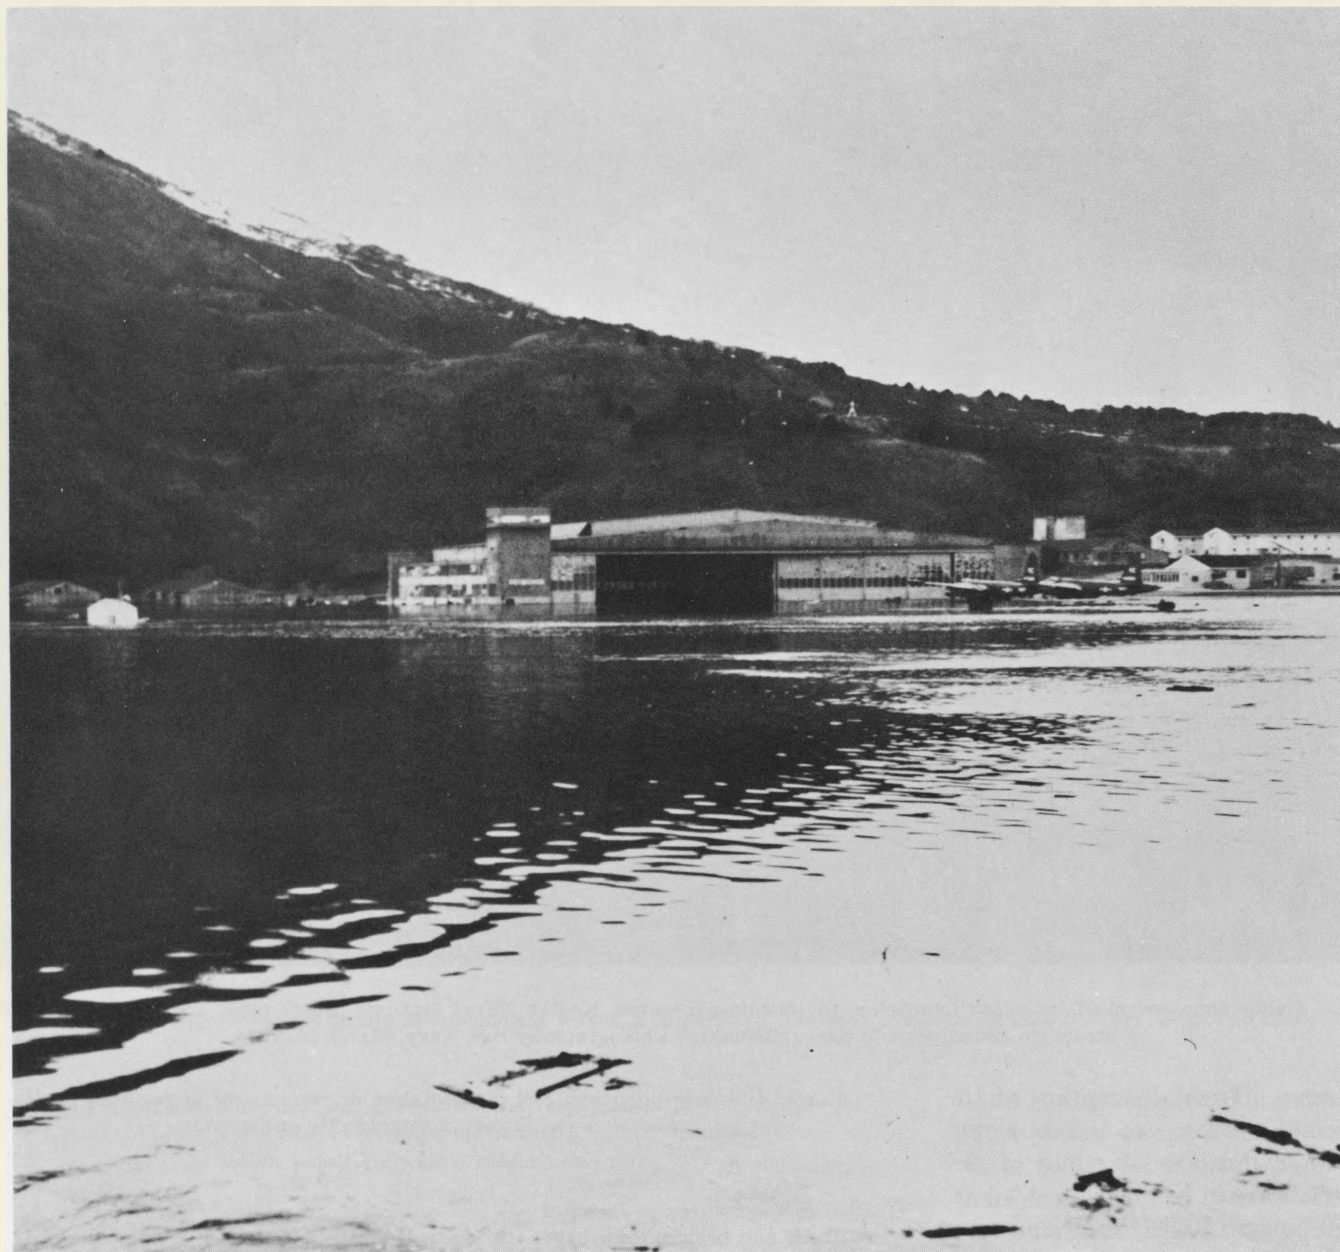
10.—First seismic sea wave flooding parts of the Kodiak Naval Station. View is west. Photograph by U.S. Navy, March 27, 1964.

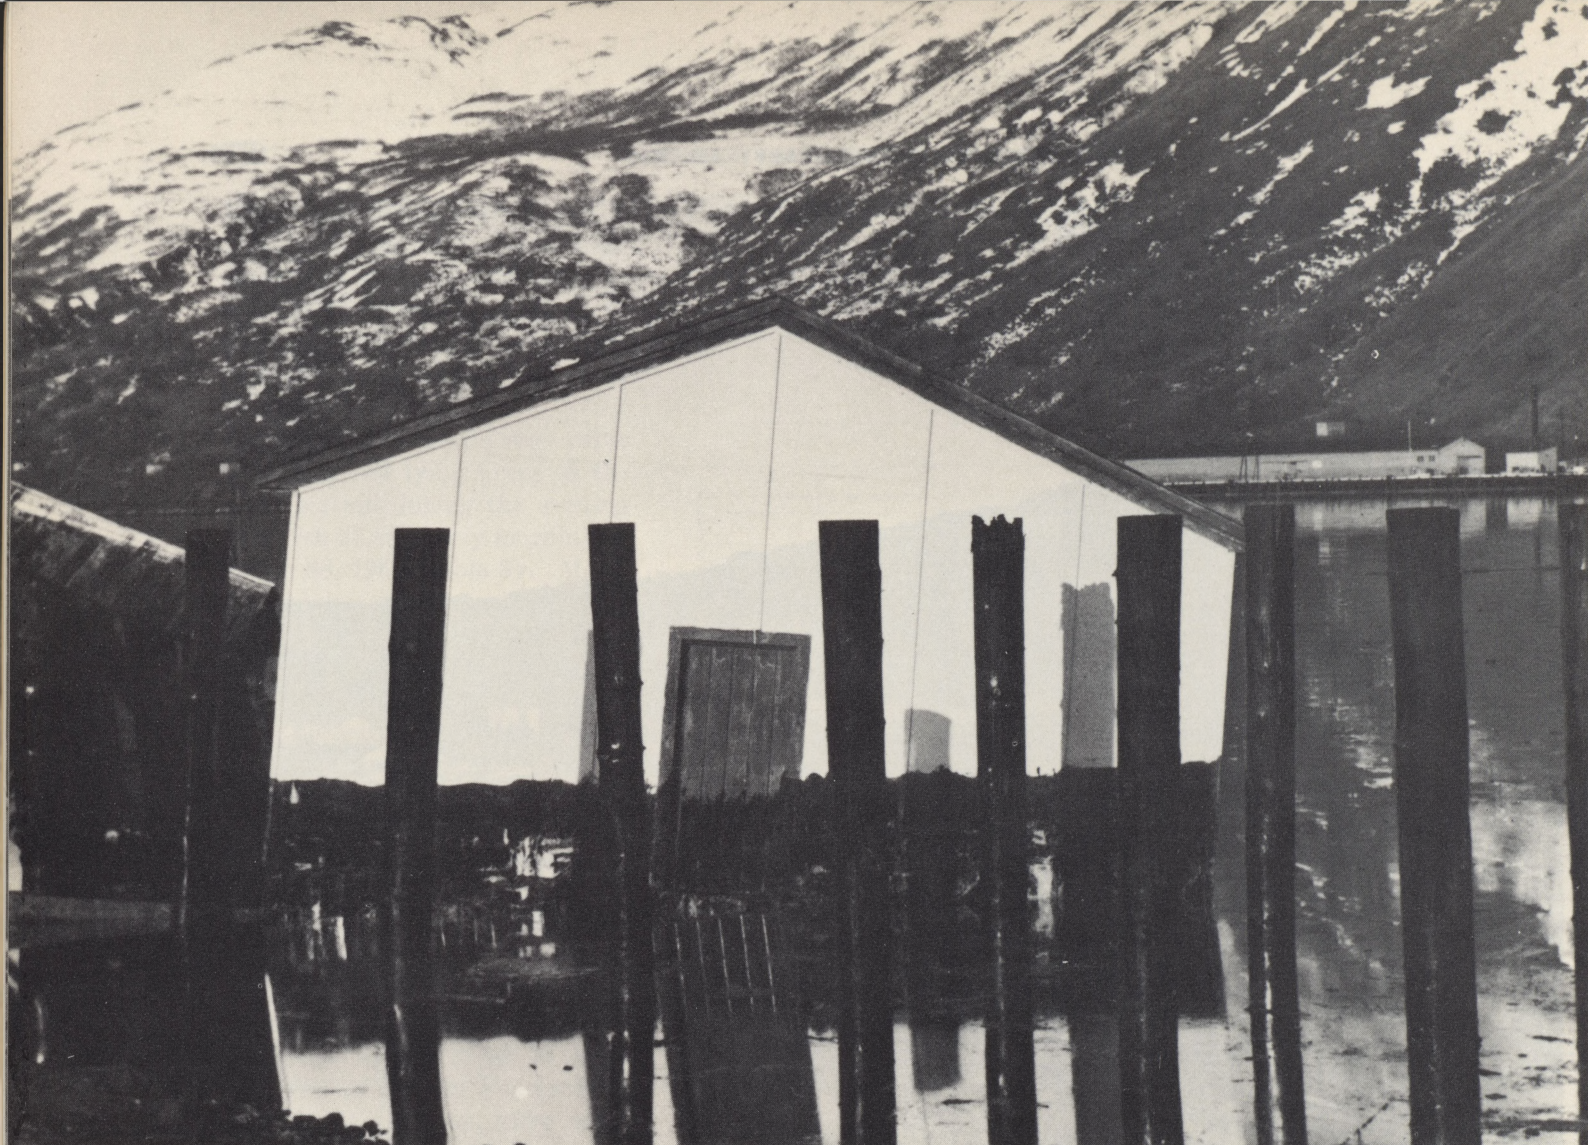
11.—Hobby shop swept off its piling foundation by seismic sea waves, Kodiak Naval Station. Black poles are piles upon which structure rested prior to the earthquake. Photograph by U.S. Navy, March 28, 1964.

The hobby shop and the engine generator buildings were swept off their pile foundations by the seismic sea waves (fig. 11). The structures were not adequately tied

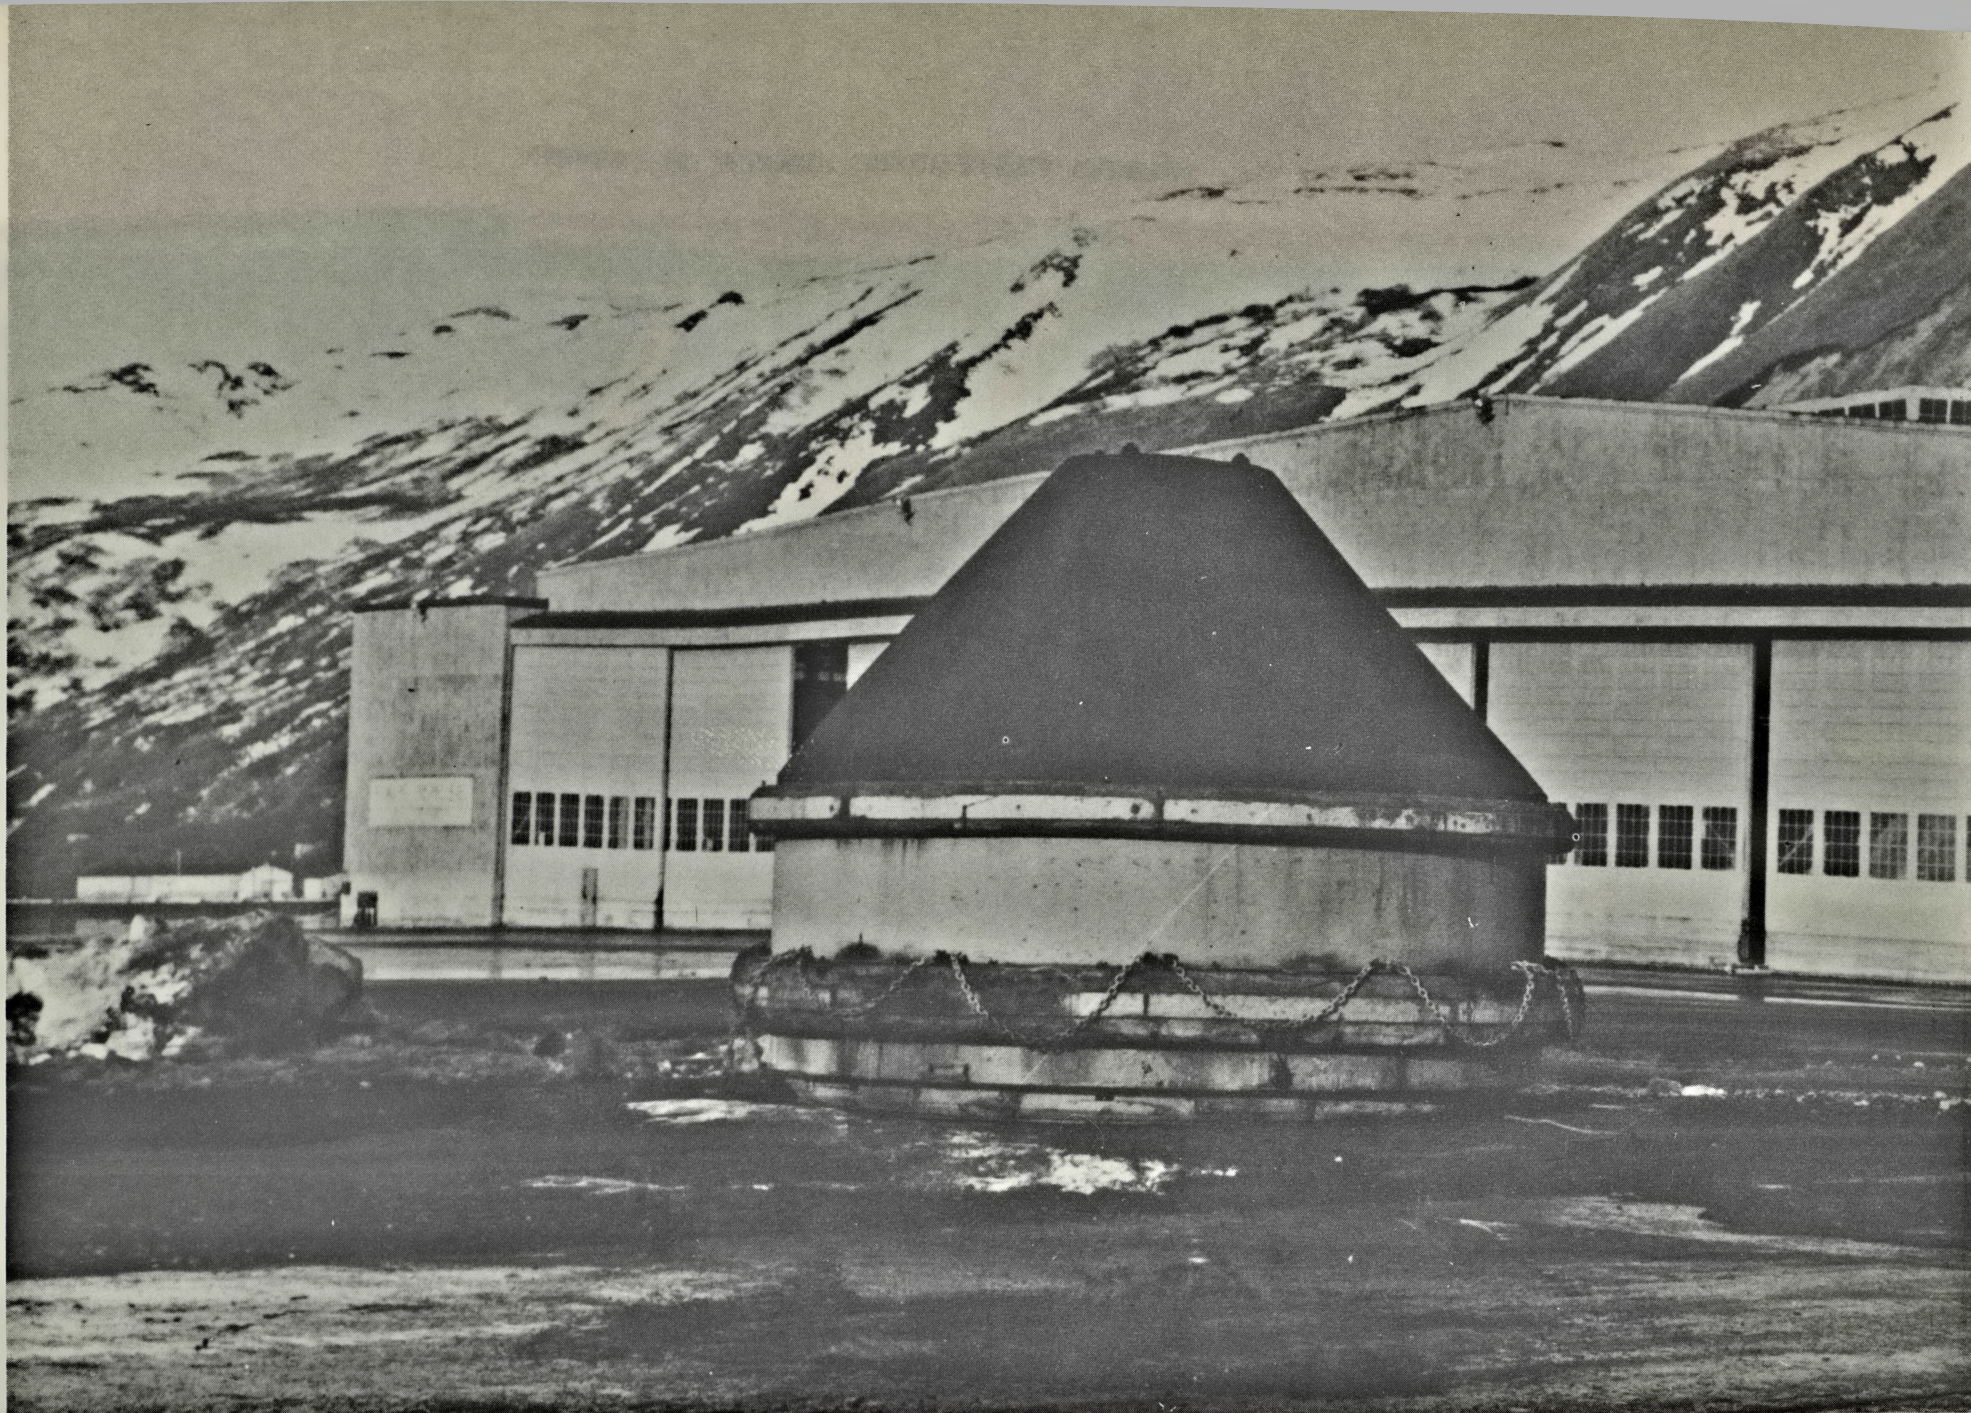
12.—Mooring buoy washed ashore by seismic sea waves, Kodiak Naval Station. Photograph by U.S. Navy, March 28, 1964.

The water also tore loose a 10-ton mooring buoy from its anchorage and deposited it on the taxiway near the supply building (fig. 12). The buoy was carried about a quarter of a mile inland by the water and came to rest at a post-earthquake altitude of about 16 feet. It was carried to this position by the fifth seismic sea wave, which crested, between 11:16 and 11:34 p.m. on March 27, 18.8 feet above postearthquake MLLW.

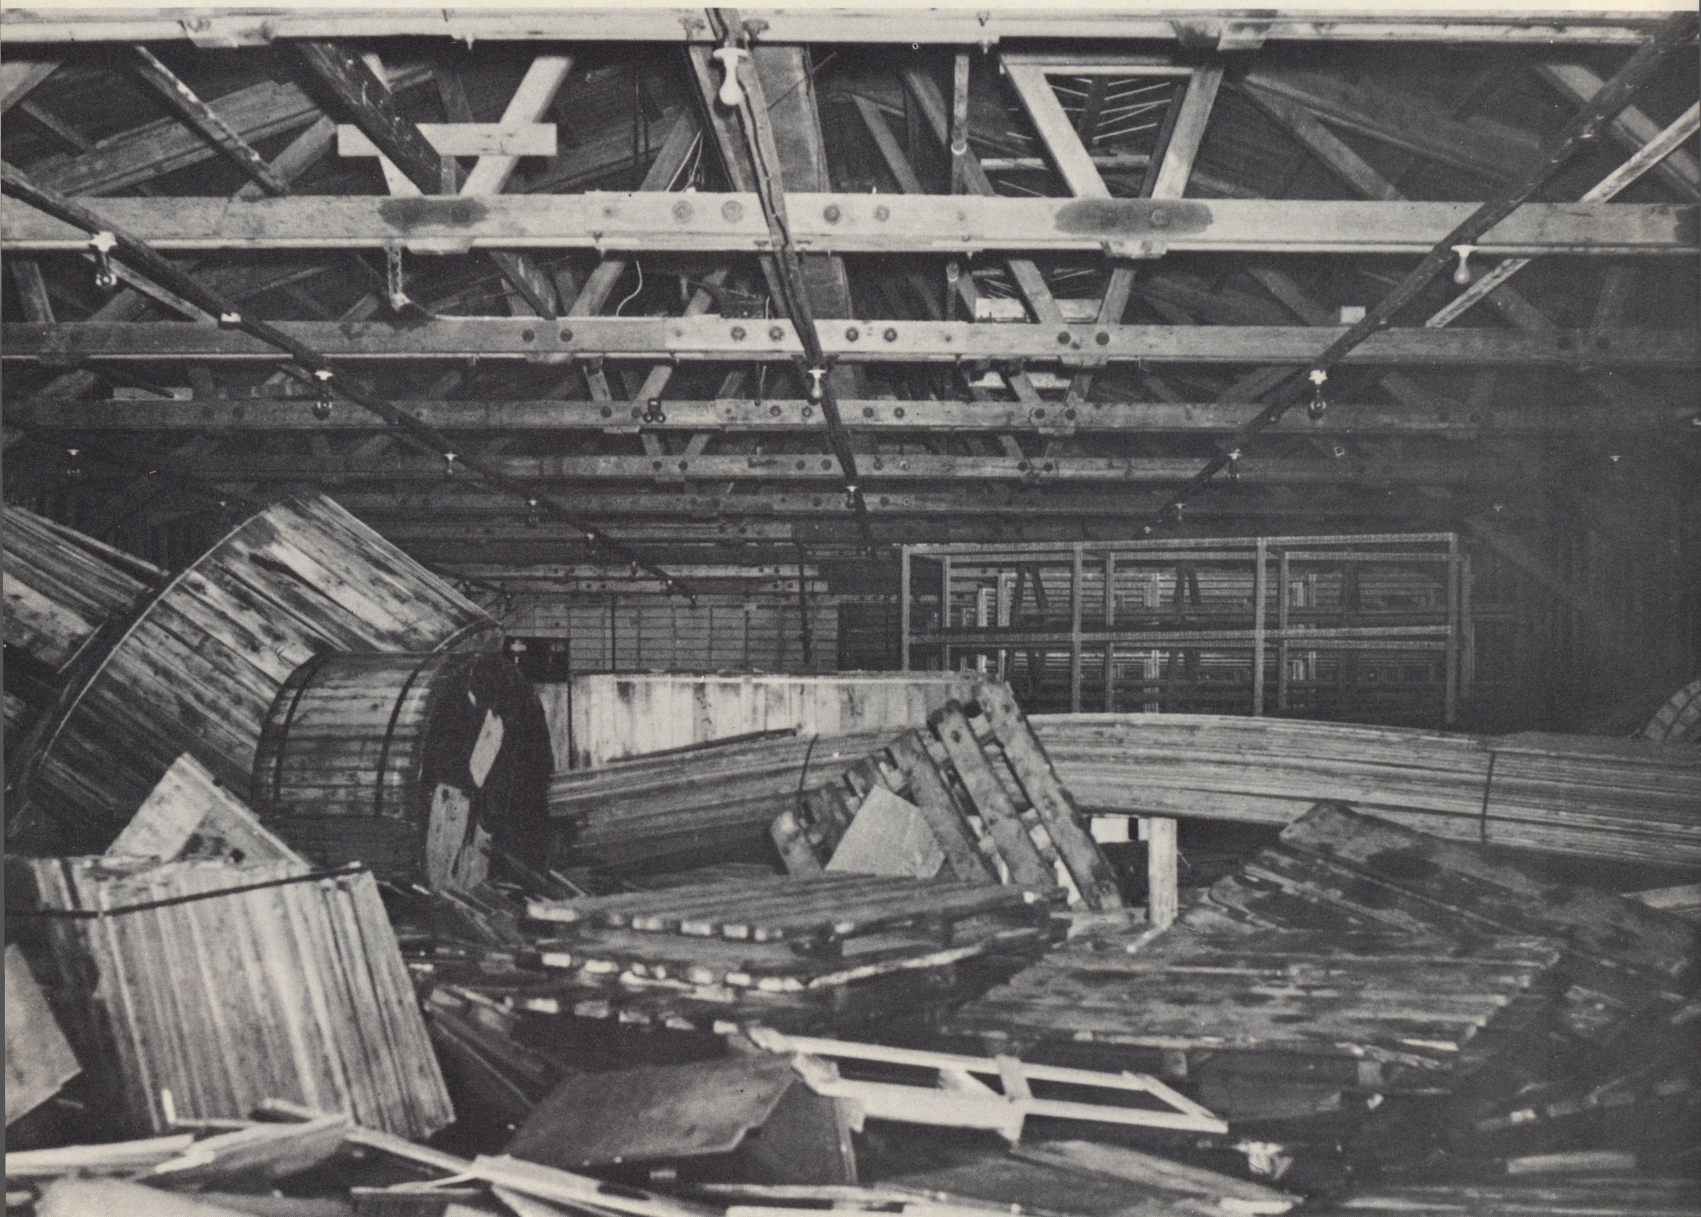
13.—Photograph of interior of supply building, Kodiak Naval Station, showing condition of supplies stored in building after the retreat of the seismic sea waves. Photograph by U.S. Navy, March 29, 1964.

Except for the marginal pier, structures damaged only slightly to moderately were put back into use in a short time. Damage in the buildings was primarily to equipment, supplies, and goods, and to such items as heating units, generators, motors, and blowers, which can be considered as part of the building. Figure 13, a photograph of the interior of the supply building, after the earthquake, shows the chaotic condition of the supplies stored there.

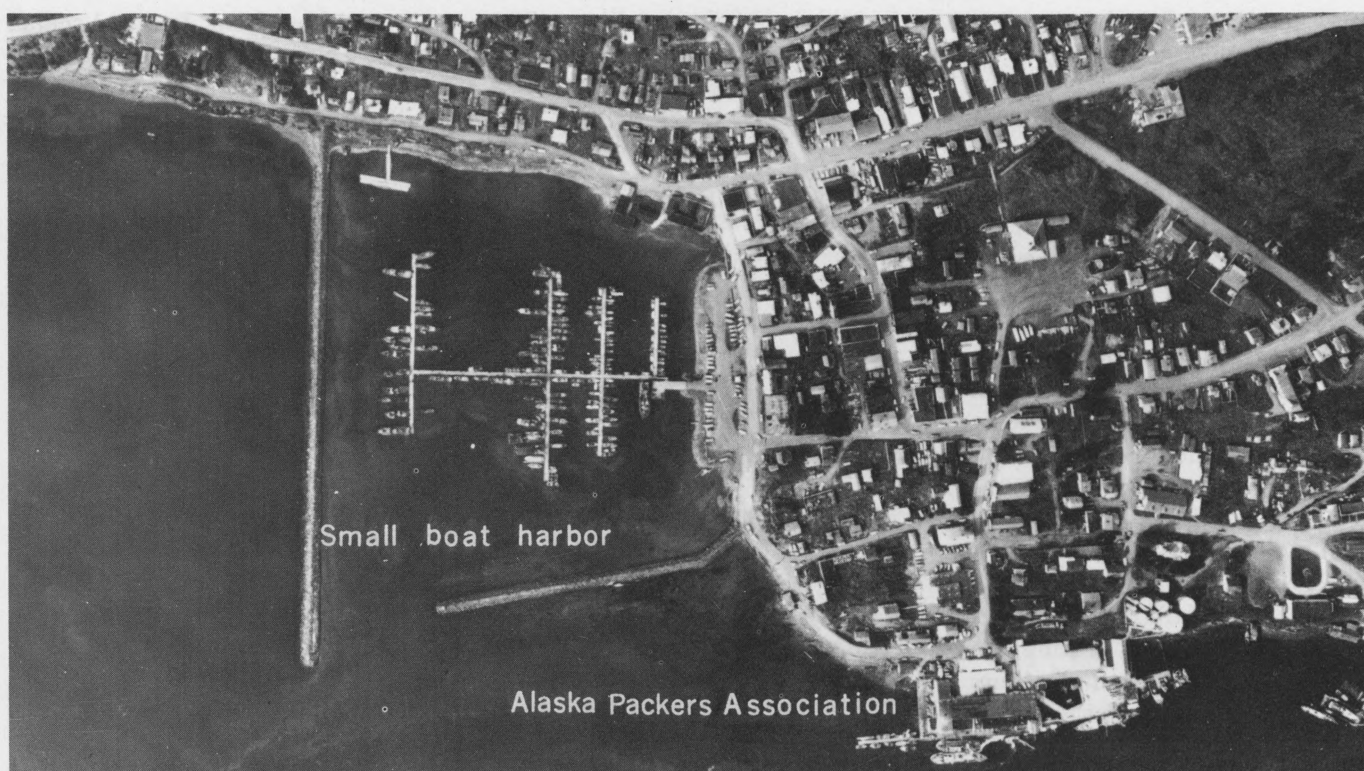
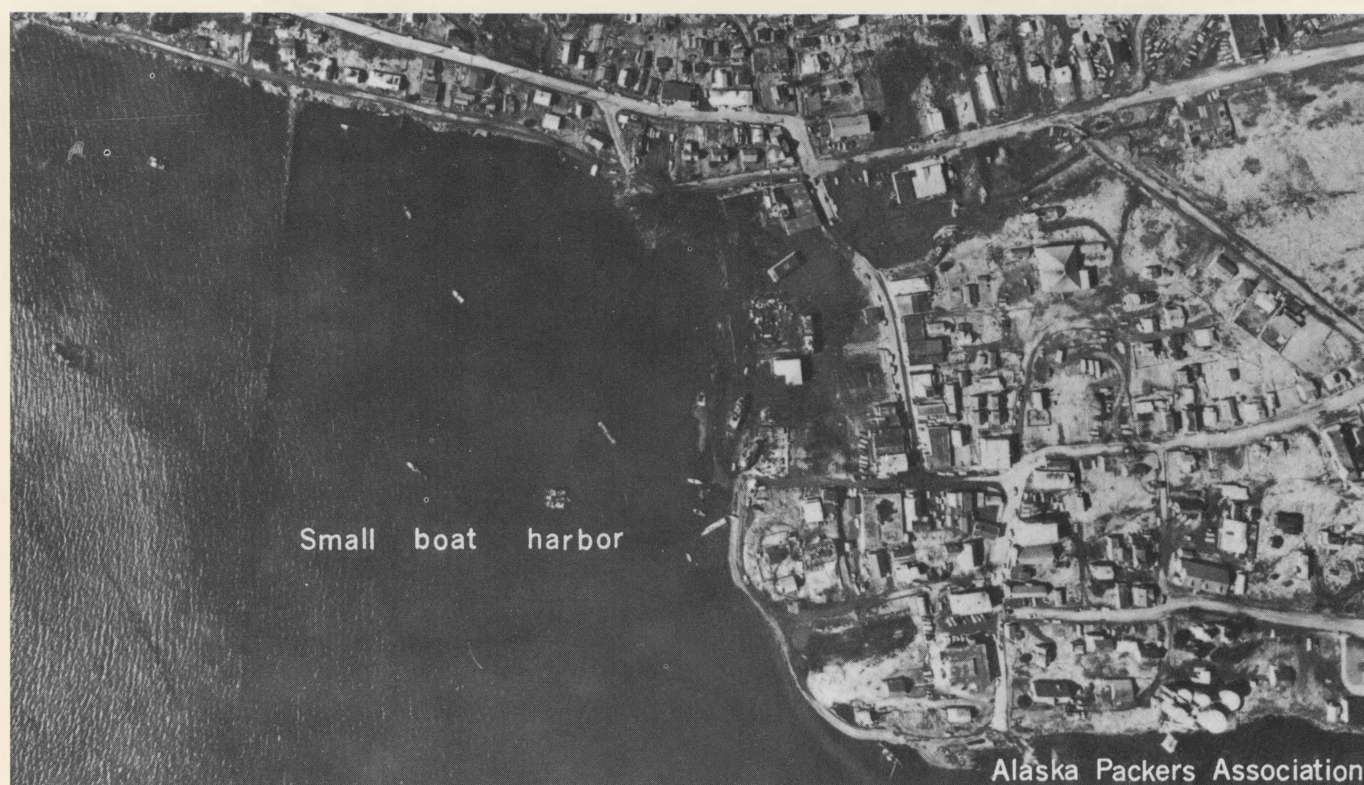
15.—Vertical aerial views of downtown Kodiak, scale 1:6,000. Top, preearthquake photograph by Bureau of Land Management, September 10, 1962. Bottom, postearthquake photograph by Air Photo Tech, Anchorage, April 14, 1964.
