The Alaska Earthquake

March 27, 1964

Effects of the Earthquake Of March 27, 1964 On the Communities of Kodiak and Nearby Islands

GEOLOGICAL SURVEY PROFESSIONAL PAPER 542-F

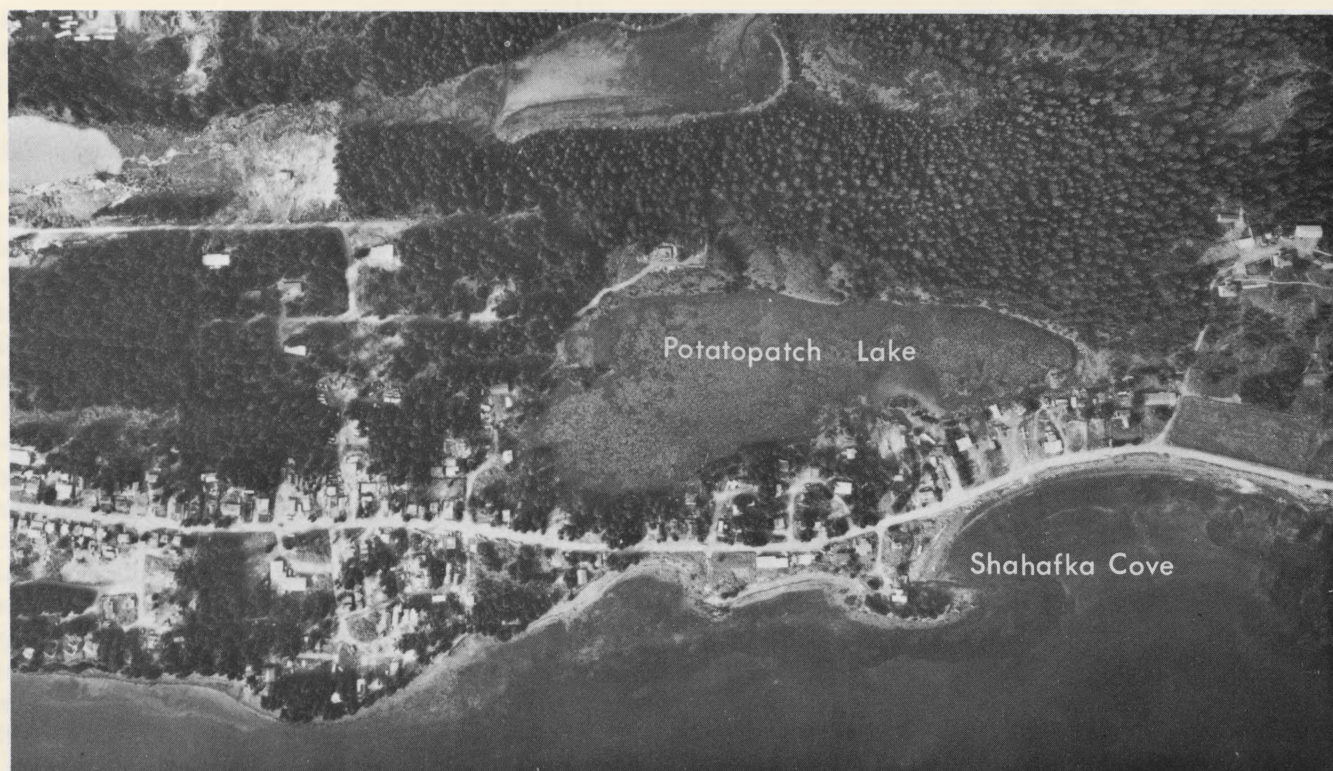
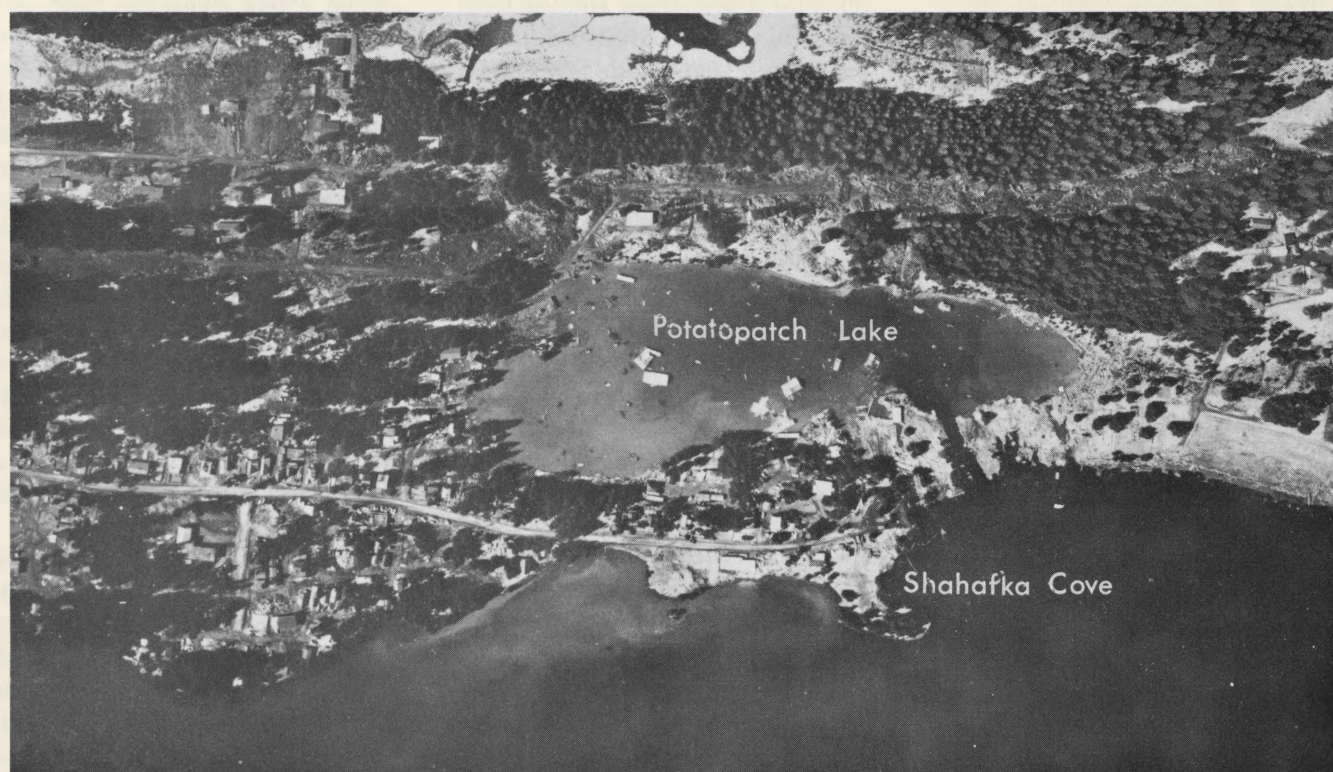
16.—Vertical aerial views of Potatopatch Lake area, northeast of downtown Kodiak, scale 1:6,000. Top, preearthquake photograph by Bureau of Land Management, September 10, 1962. Bottom, postearthquake photograph by Air Photo Tech, Anchorage, April 14, 1964.

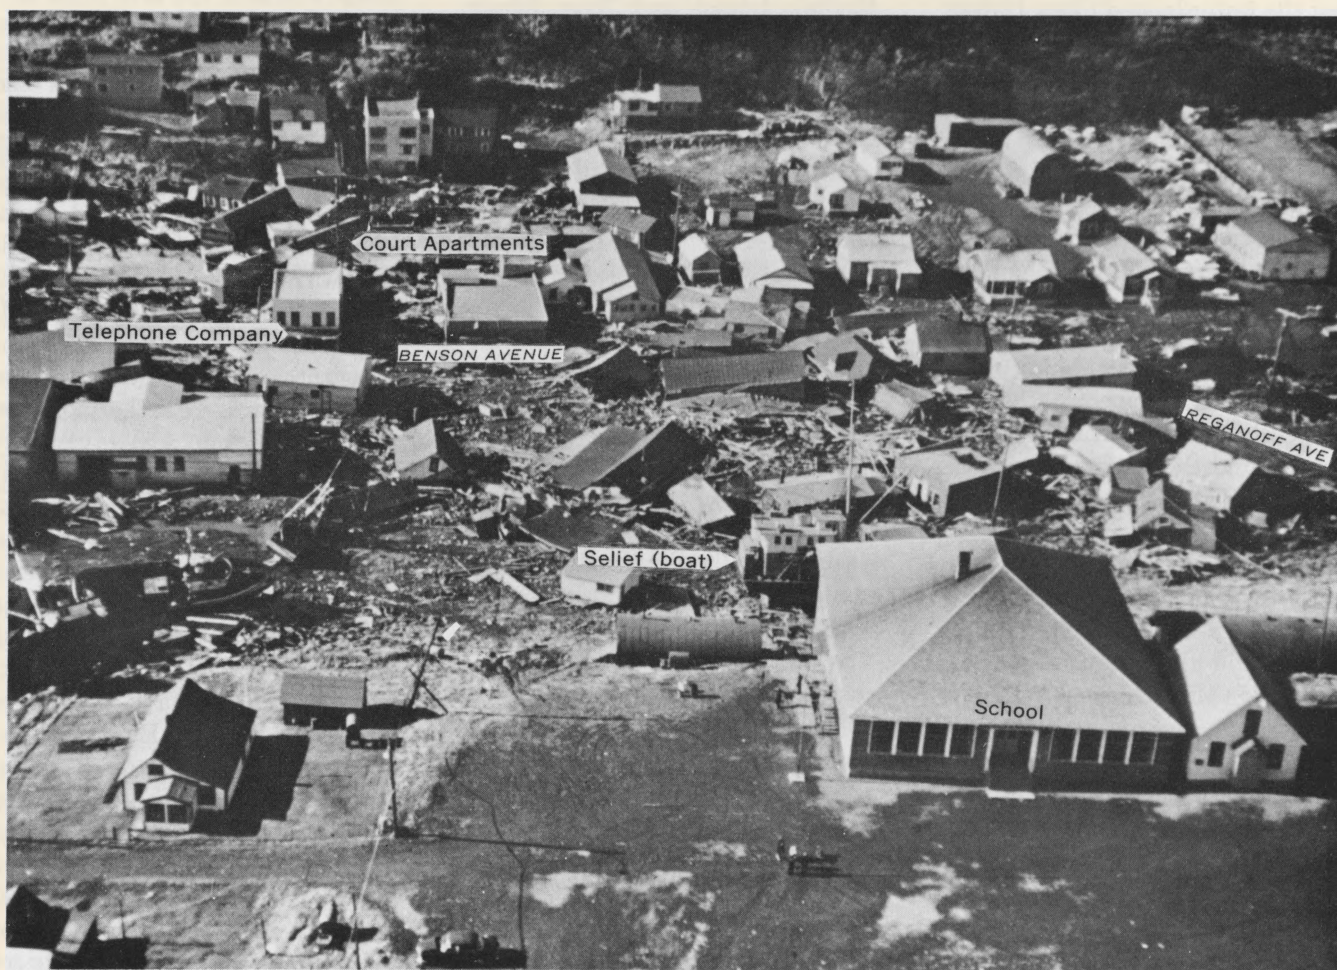
17.—Structures displaced by seismic sea waves, downtown Kodiak. View is west toward intersection of Benson and Reganoff Avenues. Photograph by Mr. Alf Madsen, Kodiak, March 1964.

Many of the displaced structures were moved by the seismic sea waves to the low-lying area on Benson Street; figure 17 shows some of these structures. Along Alaska Way in downtown Kodiak, only structures in the low-lying area east of Benson Street were totally destroyed. Many structures along Marine Way also were

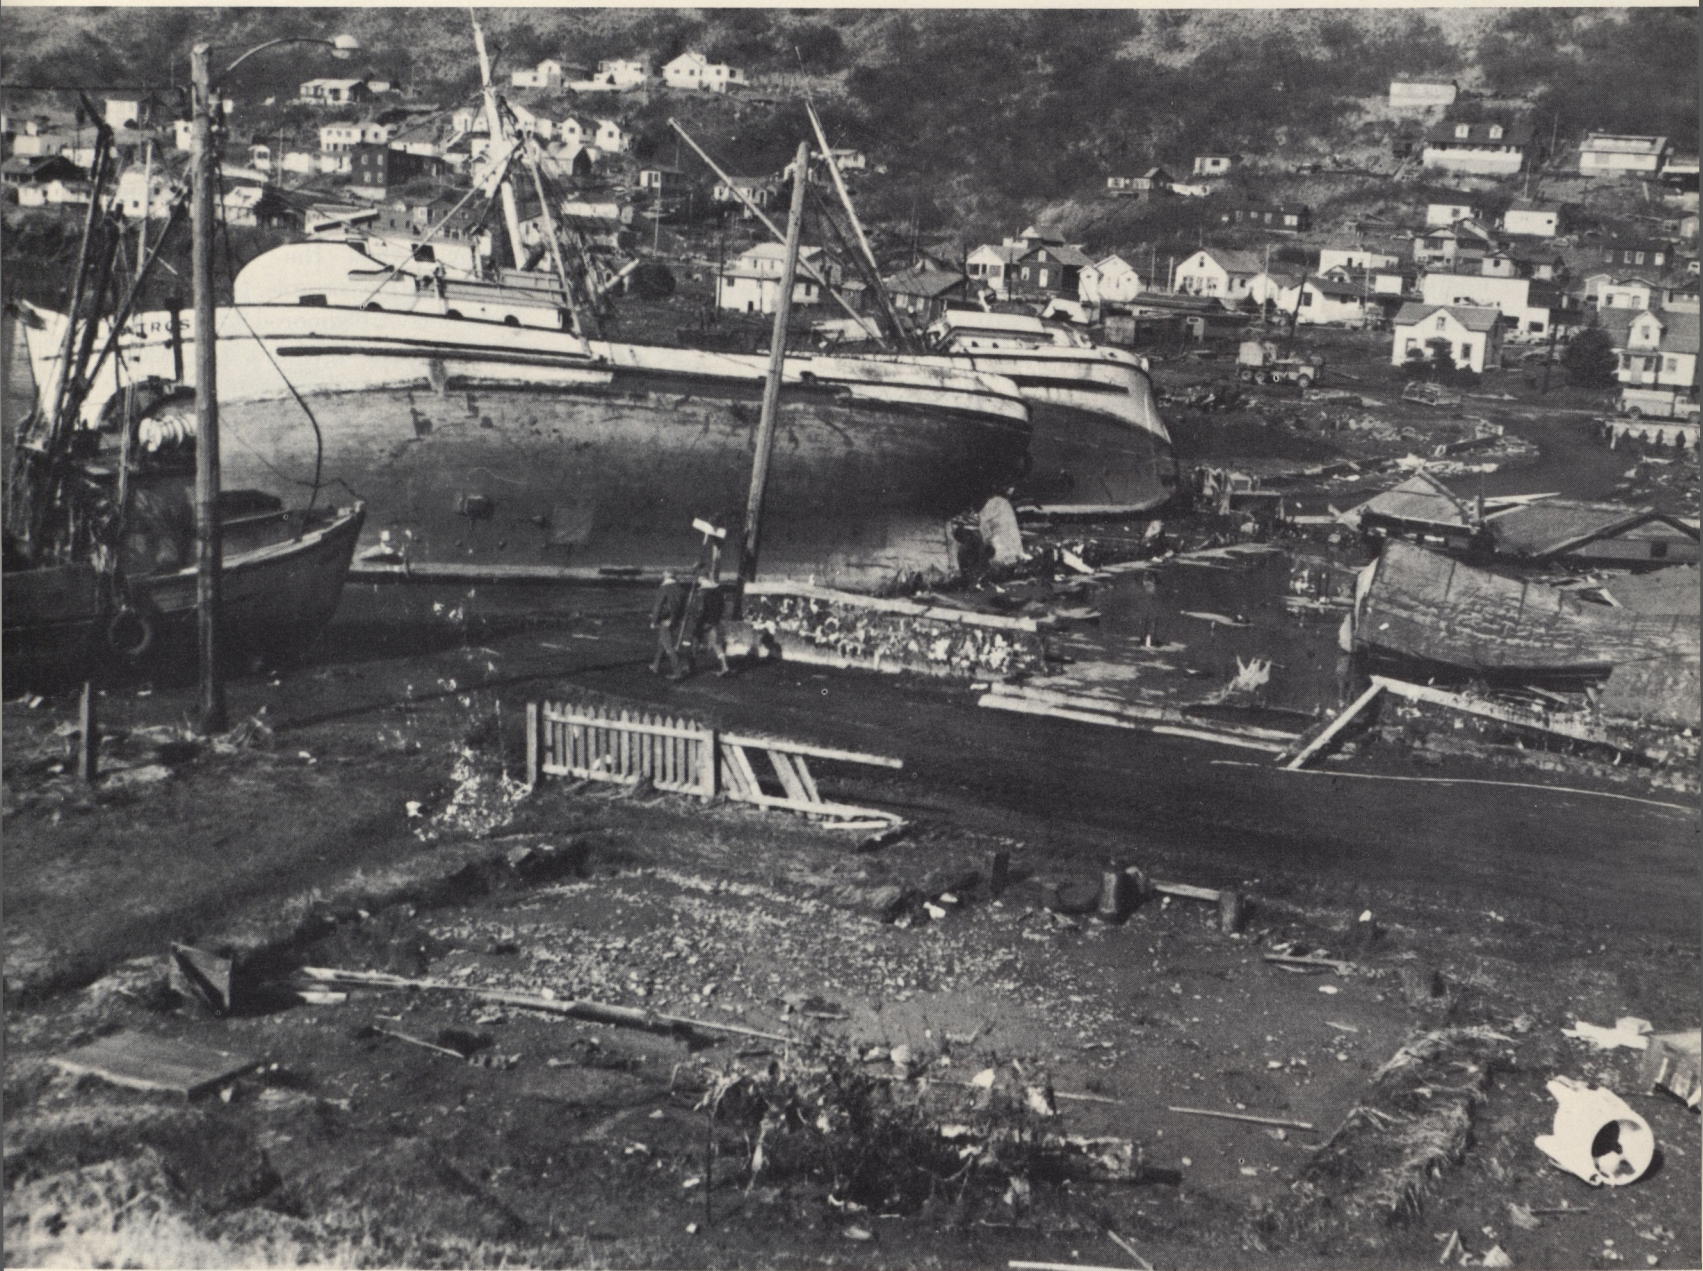
18.—Foundations of structures swept away by seismic sea waves, downtown Kodiak. View is west from intersection of Marine Way and Mill Bay Road. Foundation across Mill Bay Road was the Elks Bowling Alley; the boats are the *Cindy*, *Albatross*, and *Hekla*. Photograph by U.S. Navy, March 28, 1964.

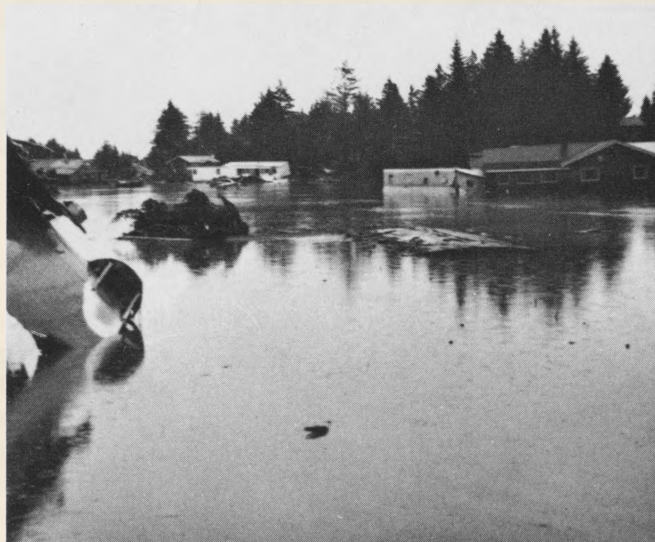
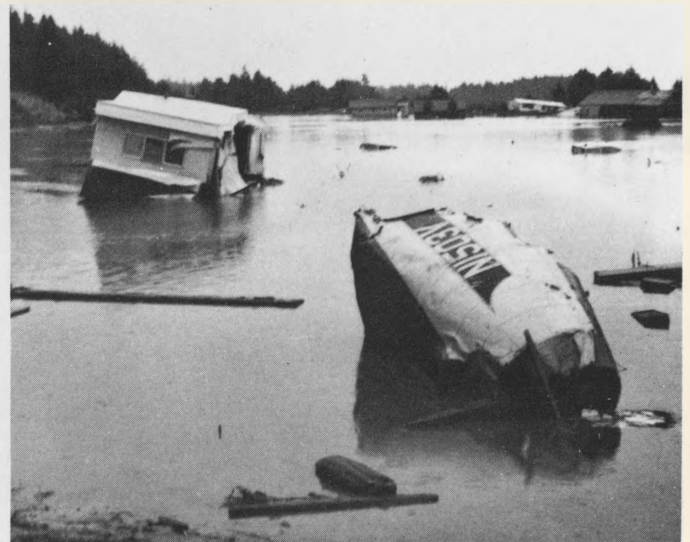
19.—Debris and houses washed into Potatopatch Lake by seismic sea waves. Photographs by Alaska Department of Highway, Kodiak.

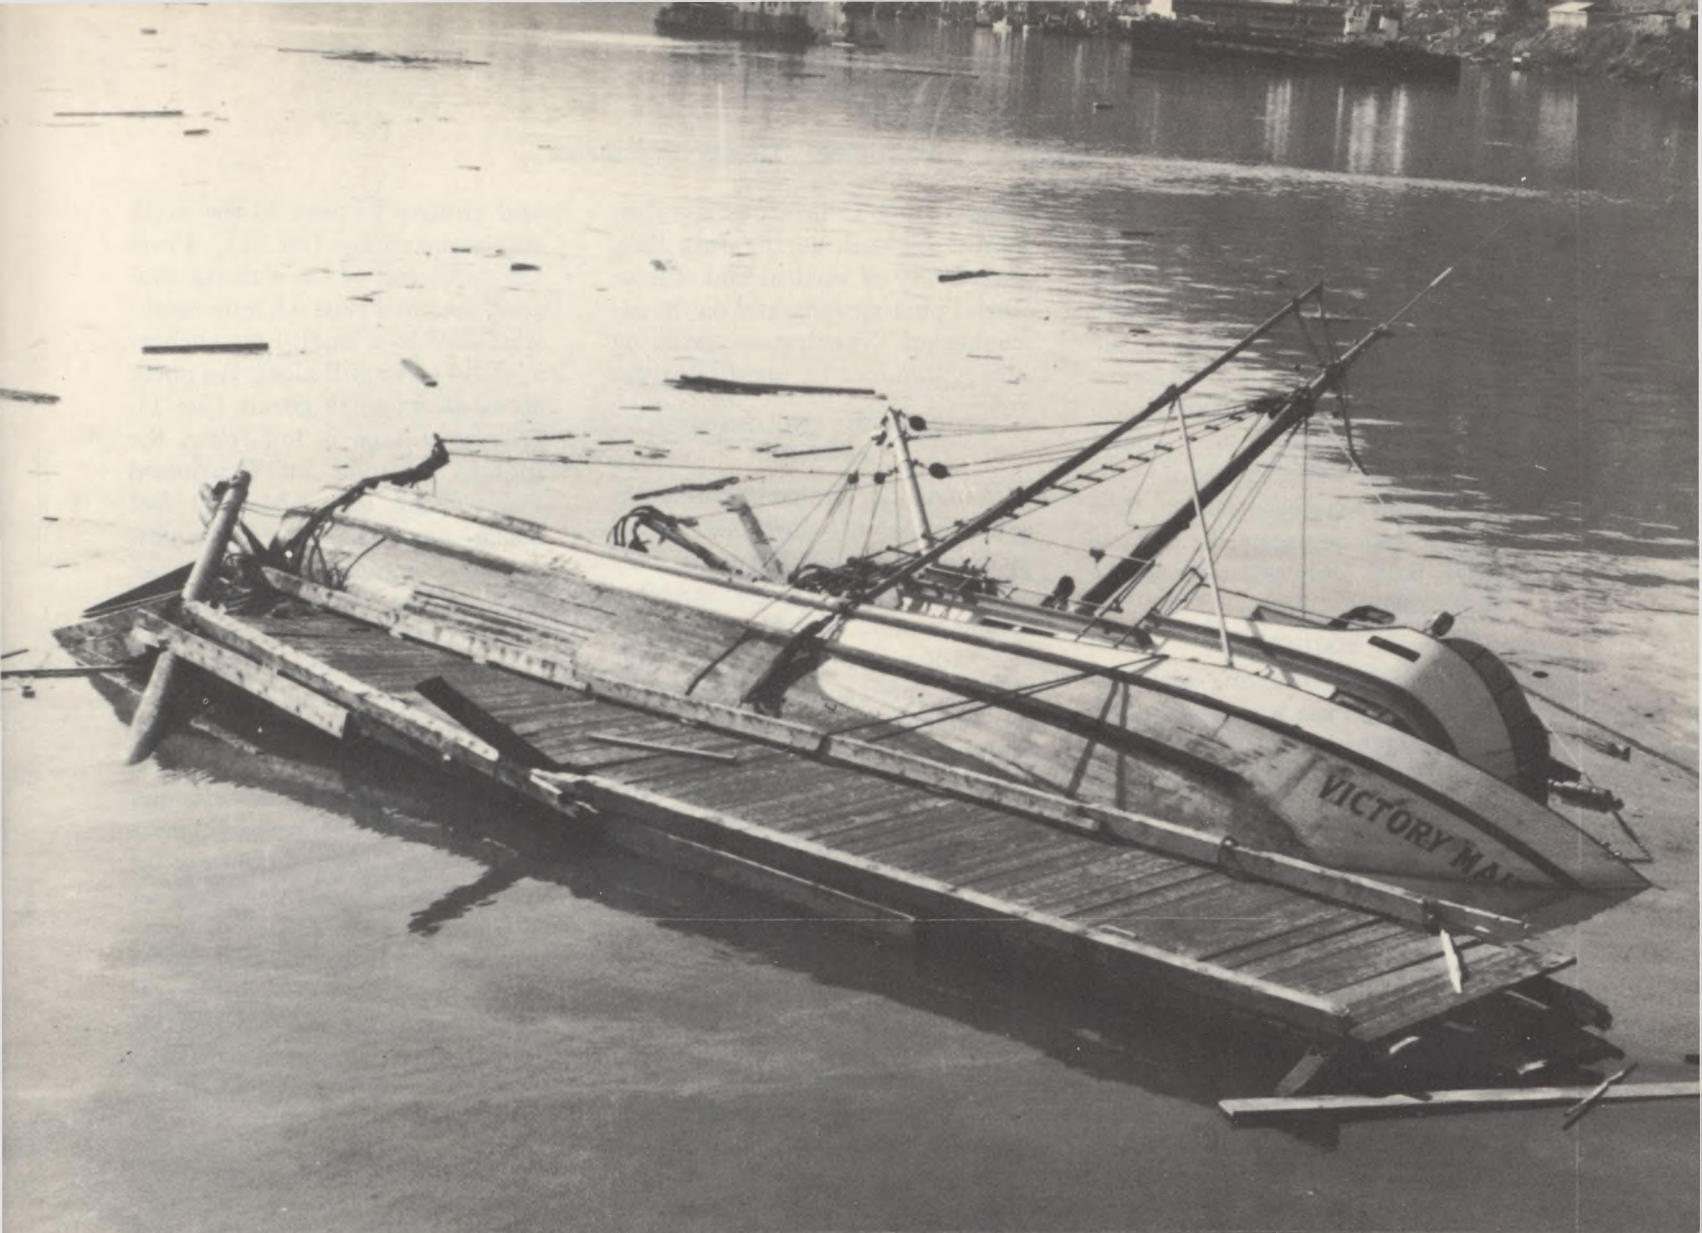
20.—The *Victory Maid* still tied to its dock but aground in Inner Anchorage. City dock is background. Photograph by U.S. Navy, March 28, 1964.

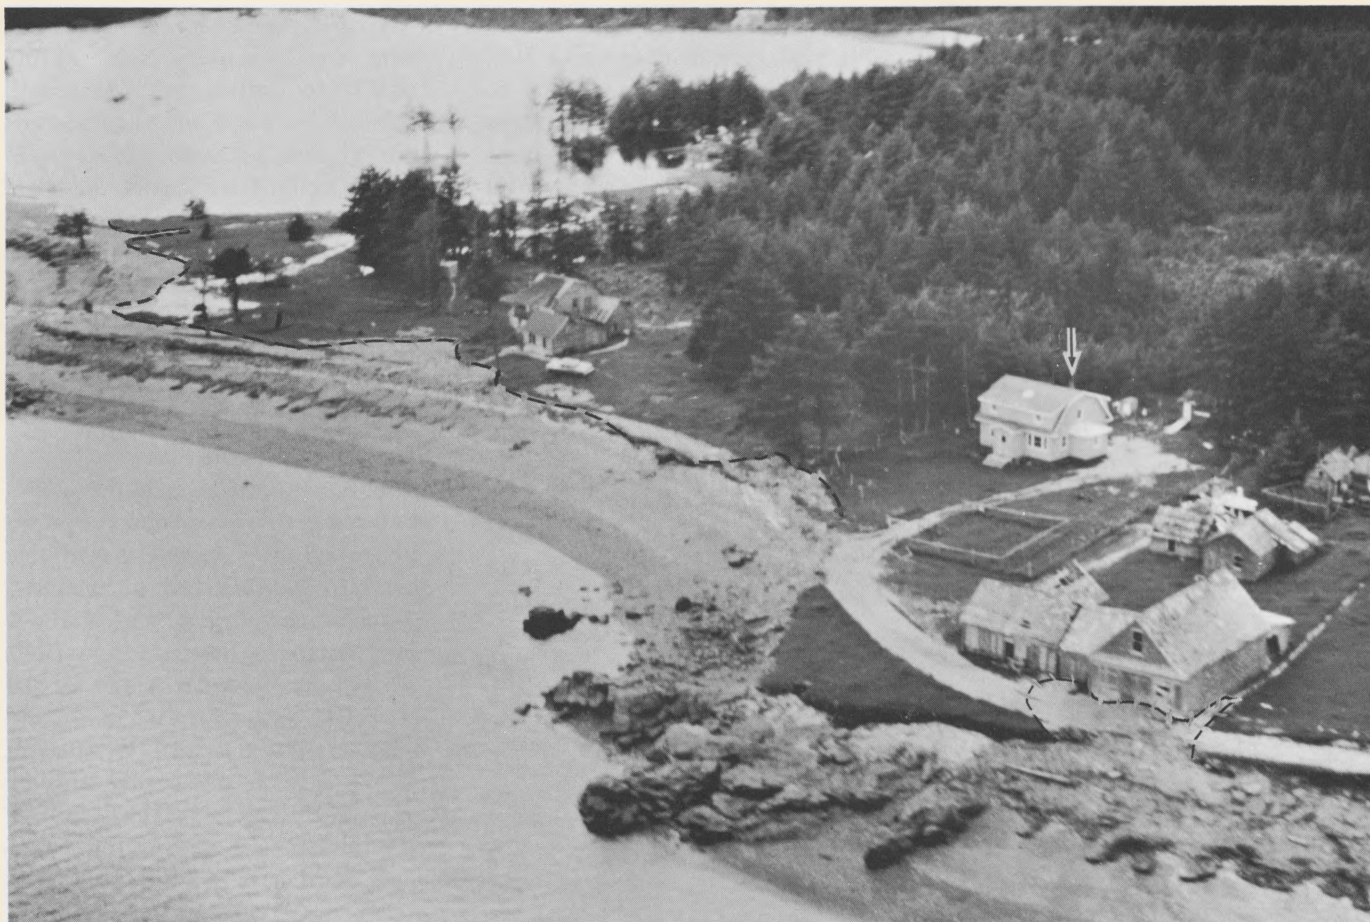
22.—Part of Afognak; note eroded road along coast, new beach berms (outlined by dashed line), and part of large lagoon ponded behind beach berm. The arrow points to undamaged brick chimney. Location of this view is shown on figure 21.

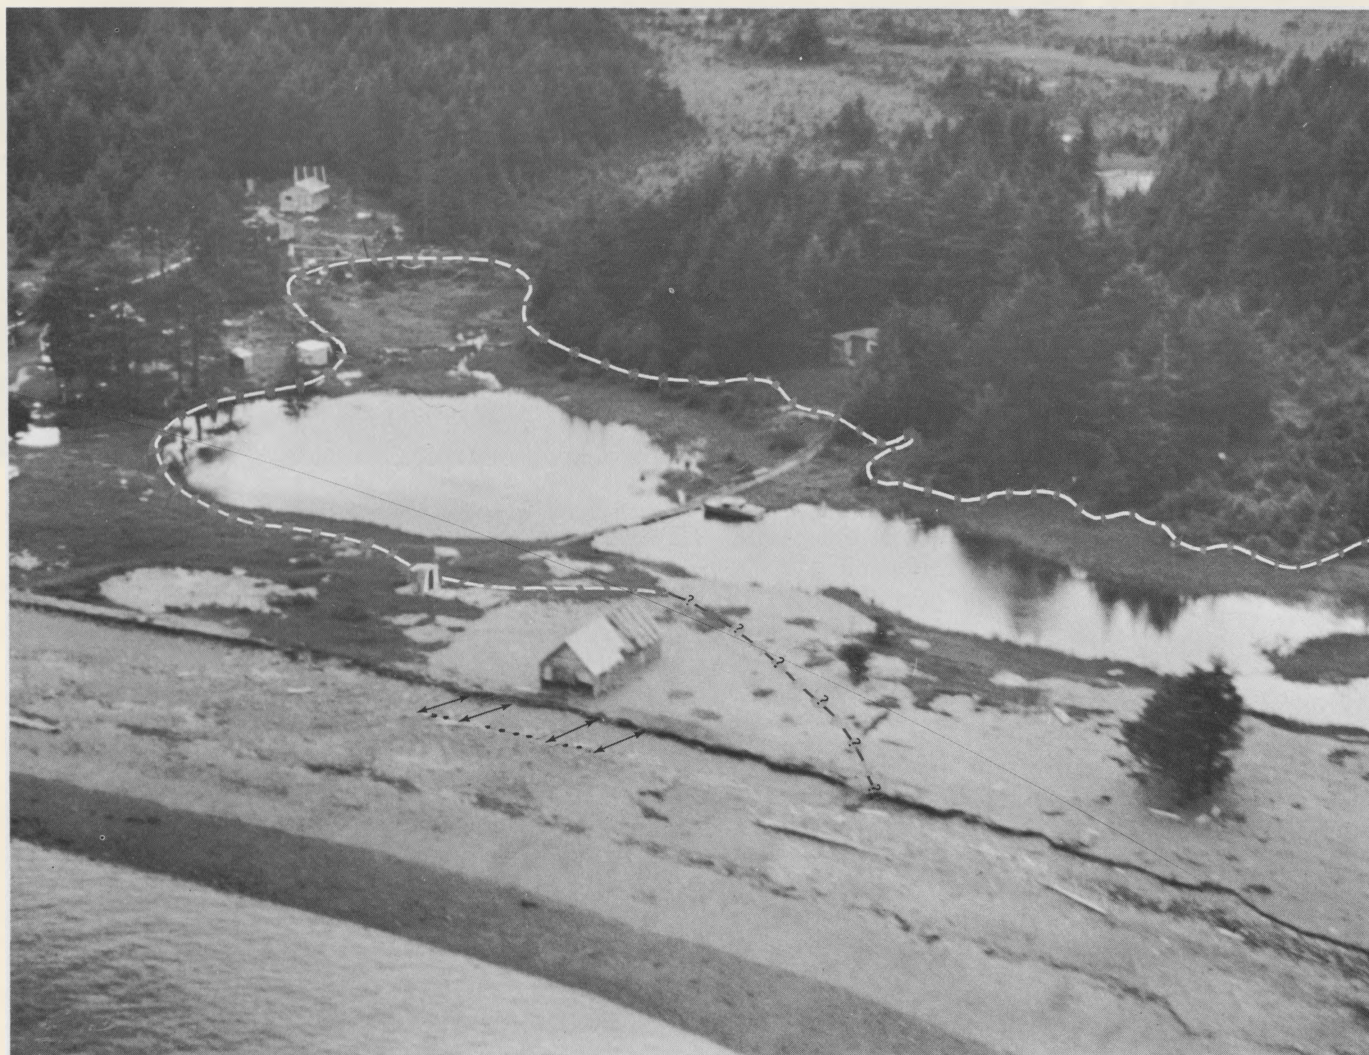
23.—Part of coast at Afognak. Arrows show approximate amount of landward retreat; newly formed beach berm is gray, and approximate extent of seismic sea wave inundation is indicated by dotted line. Note partly submerged automobile in pond.

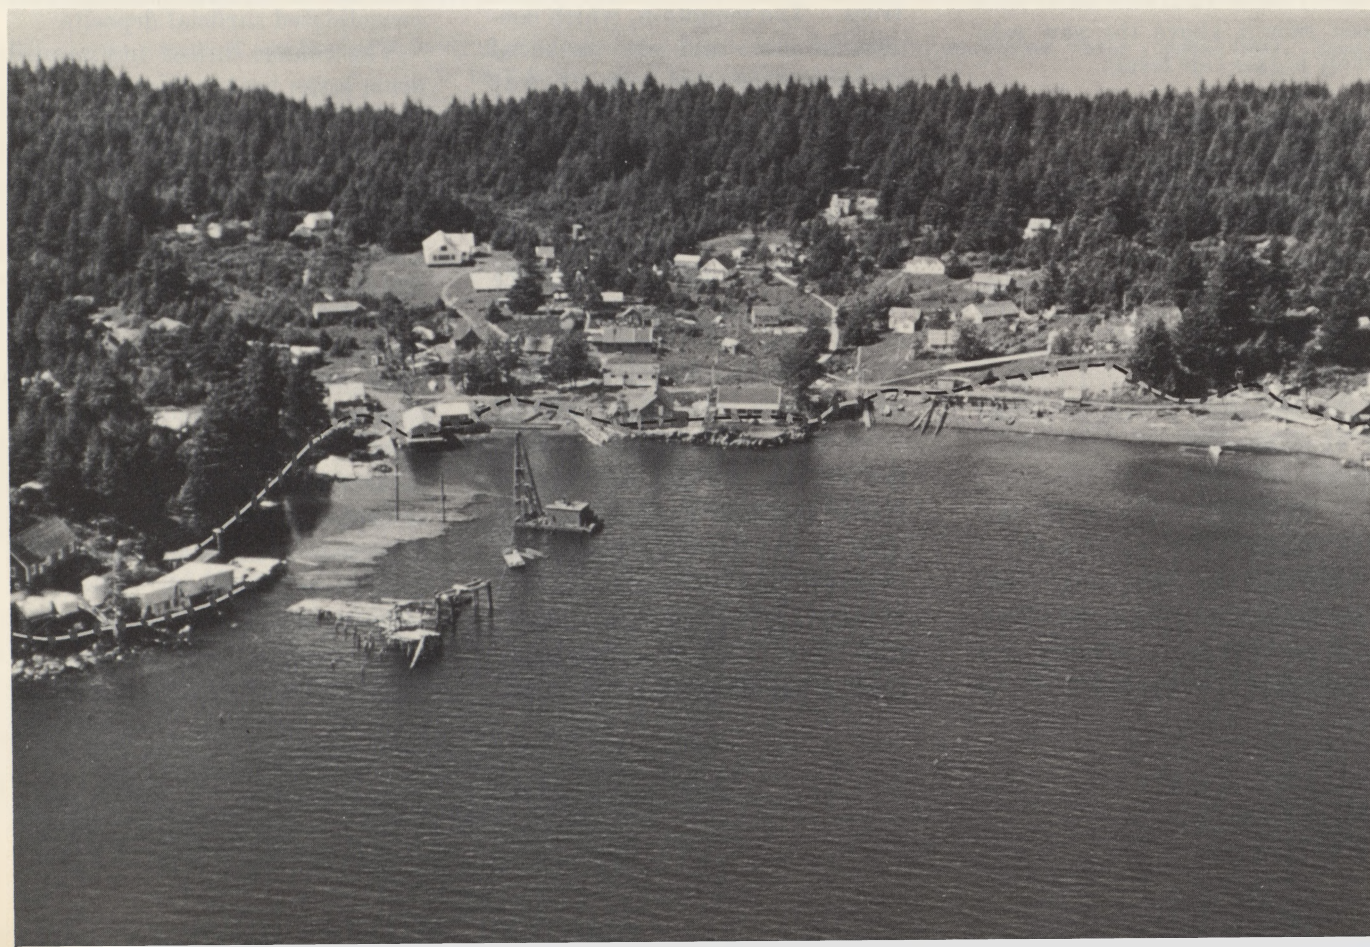
25.—Oblique aerial view of Uzinki in July 1965 showing approximate inland limit of seismic sea wave inundation (dashed line) and remains of the Ouzinkie Packing Co.'s salmon cannery (left center).

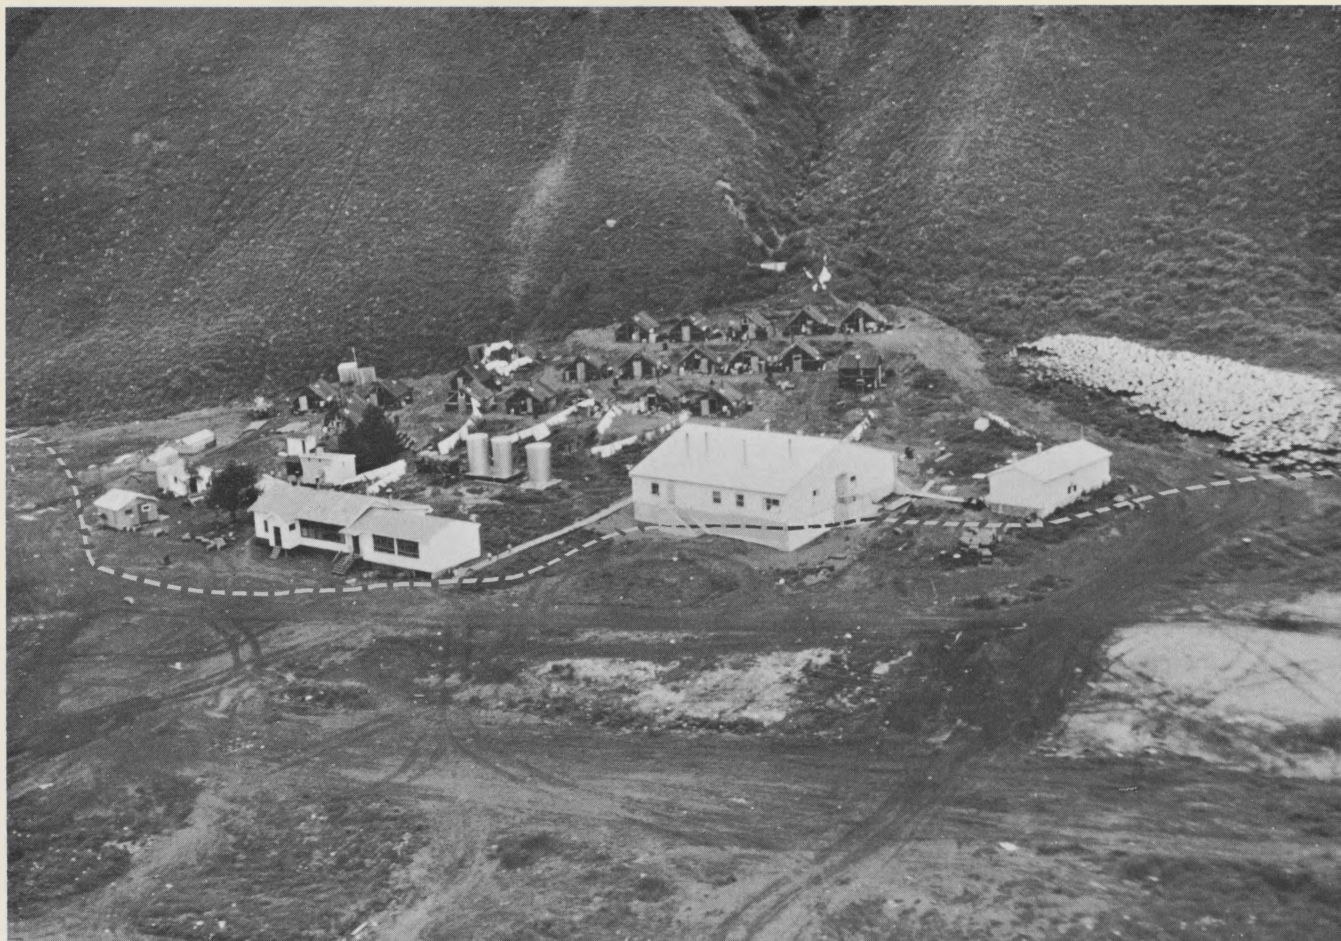
27.—Oblique aerial view of school area, Old Harbor, showing approximate inland limit of seismic sea wave inundation (dashed line). The area below the high-water line had been cleared of debris by the time this photo was taken (July 15, 1964). The structures near the apex of the alluvial fan are temporary shelters.

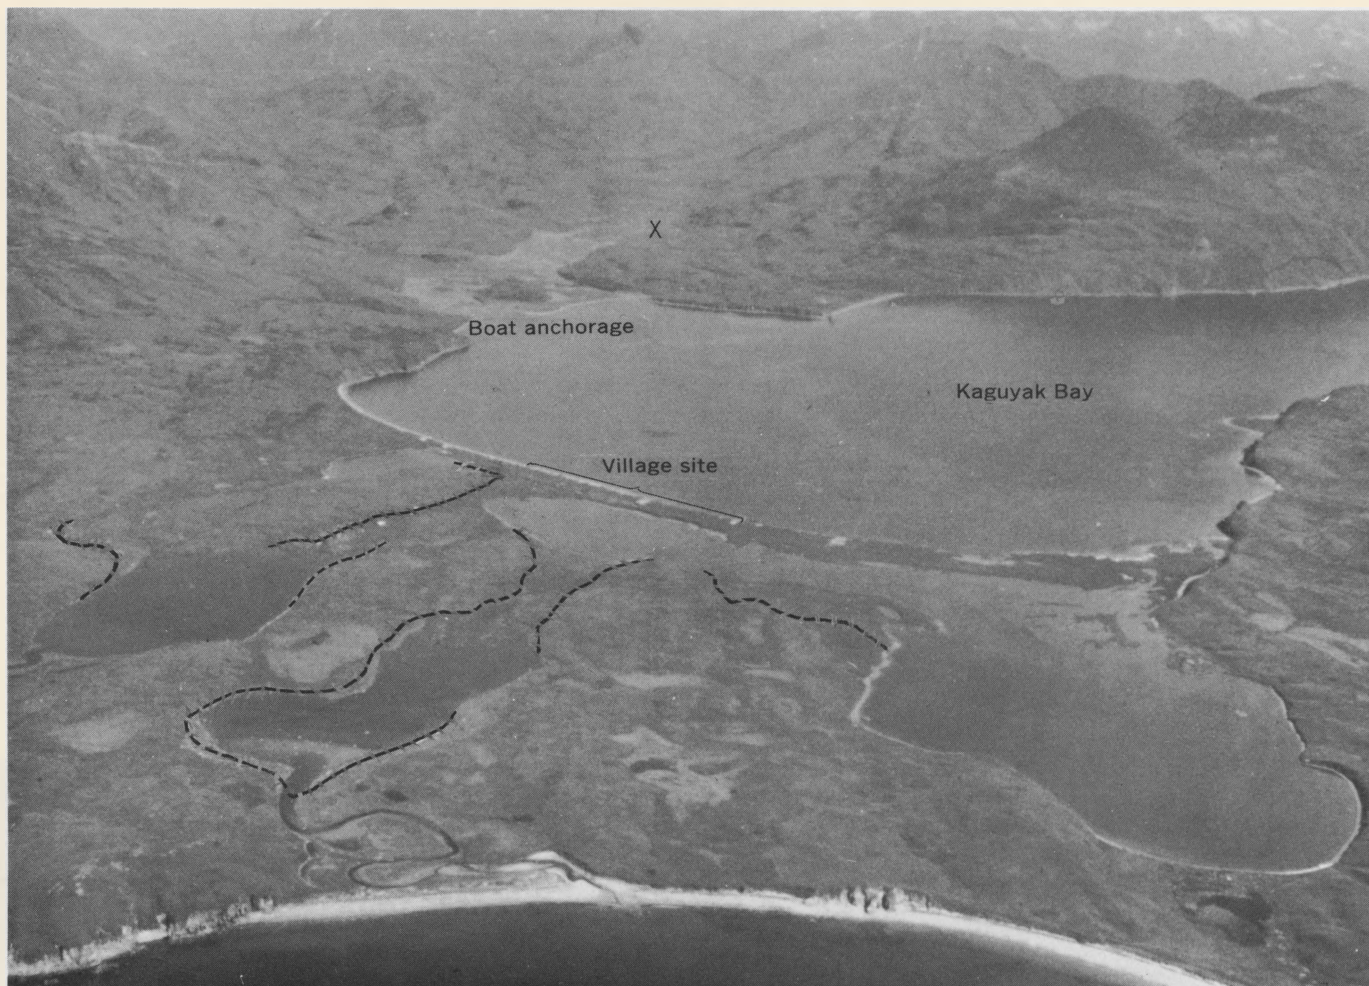
29.—Oblique aerial view of the head of Kaguyak Bay showing site of Kaguyak (fig. 28), approximate inland limits of debris deposited by seismic sea waves (dashed line), and location of small-boat anchorage. X marks position at which one 30-foot salmon trawler was stranded by the waves.

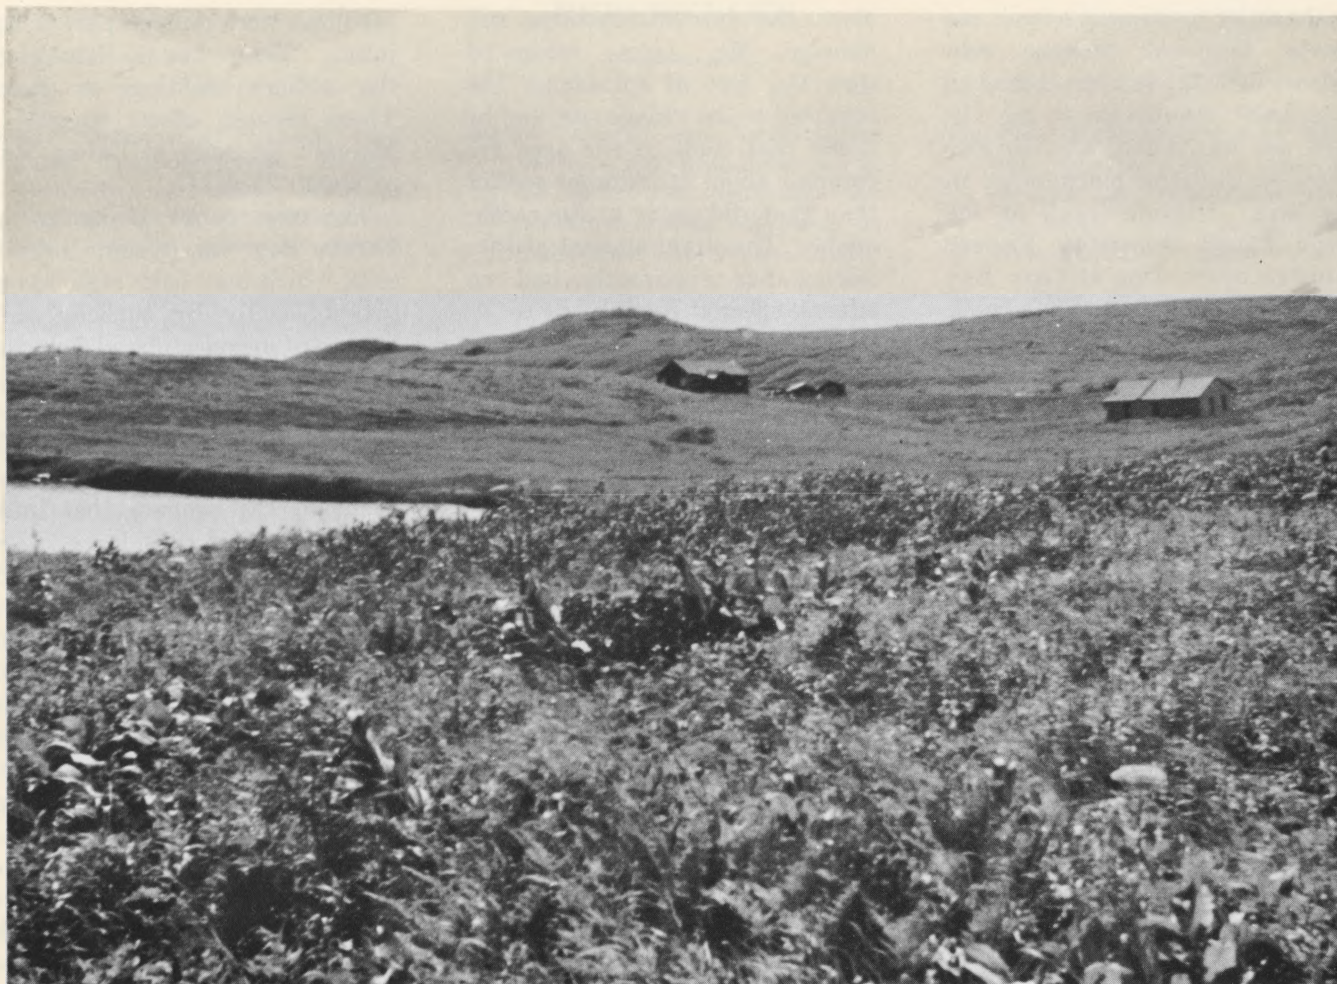
30.—Wood-frame houses that were floated inland from Kaguyak by seismic sea waves and deposited almost undamaged.
