# Effects of the Earthquake Of March 27, 1964 In the Copper River Basin Area, Alaska

By OSCAR J. FERRIANS, JR.

*A description and analysis of the earthquake-  
induced ground breakage, landsliding, regional  
uplift and subsidence, and damage to manmade  
structures in the Copper River Basin*

GEOLOGICAL SURVEY PROFESSIONAL PAPER 543-E

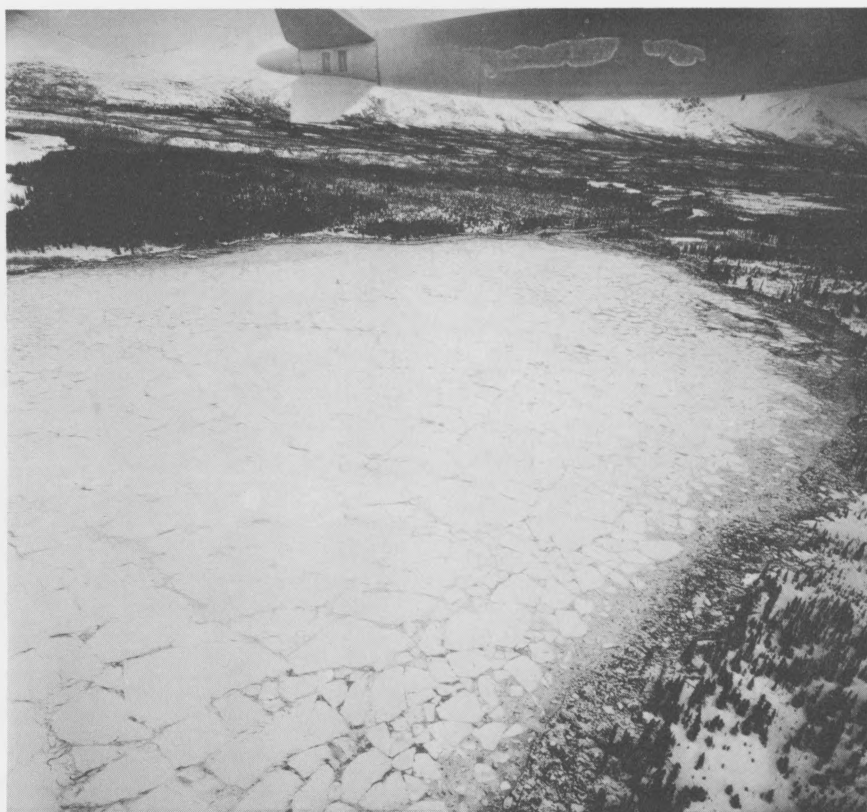
5.—View, to the northeast, of the northern end of Tonsina Lake showing intensely fractured ice and large blocks of ice stranded above water level along the shore. The lake is about half a mile wide at this point. Photograph by U.S. Army, April 8, 1964.

this general pattern. Ice on Klutina Lake and Tonsina Lake was highly fractured throughout (fig. 5). On Tazlina Lake the ice on the northern half of the lake was highly fractured (fig. 6), but ice on the southern half was fractured only around the margin, and a few linear cracks were formed across the lake. The greater intensity of the cracking of ice on these lakes was caused by water waves generated by sublacustrine landsliding off the fronts of large deltas built out into the lakes.

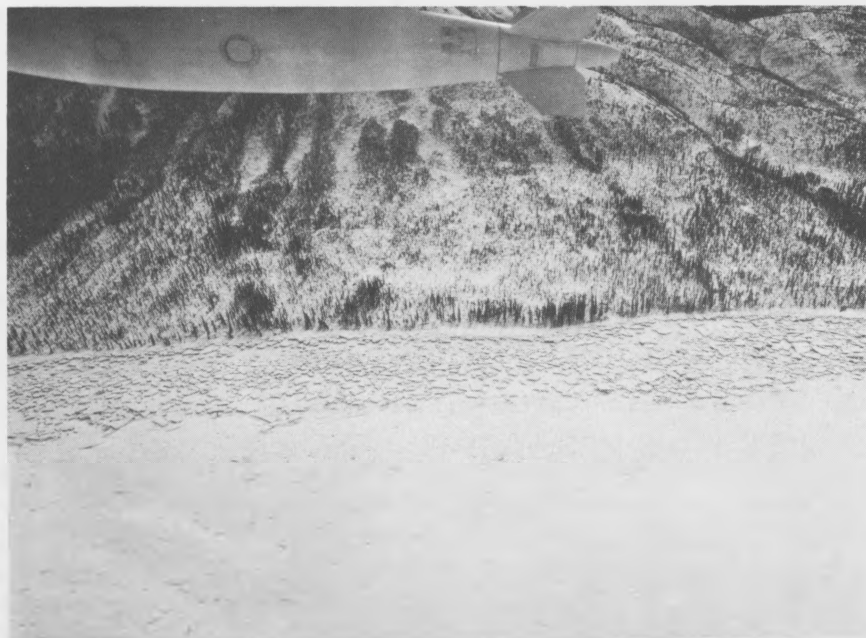
6.—View, to the east, showing intensely fractured ice along the eastern shore of Tazlina Lake, across from the large Nelchina River delta. Large blocks of ice stranded above water level along the shore are easily discernible, but the intense fracturing of ice away from the shore is obscured by the refreezing of the lake water and by a postearthquake snowfall. The segment of shoreline shown in this photograph is about half a mile long. Photograph by U.S. Army, April 8, 1964.

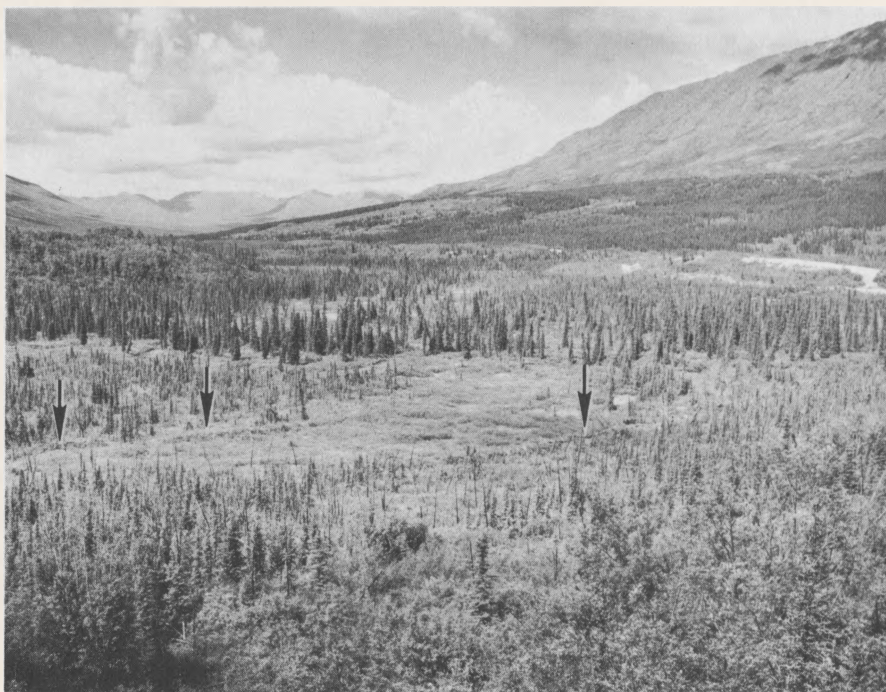
The Little Tonsina River landslide site (fig. 8, next page) is in the southern part of the area, on the southwestern side of the Richardson Highway at mile 65. Landsliding occurred along the northwestern side of a small hill underlain by unconsolidated silt, sand, and gravel deposits. Lateral movement of segments of the hill toward the northwest caused several large ground cracks to form on and parallel to the face of the hill and pressure ridges to develop on the floor of the Little Tonsina River valley (fig. 9). One of the large ground cracks formed by the lateral extension of materials toward an unconfined face (hillside) is shown in figure 10, and a pressure ridge developed in front of the slide area is shown in figure 11. The horizontal forces that formed the ridge were transmitted through a layer of seasonally frozen peat and silty sand, approximately 2 feet thick, overlying water-saturated silty sand. Locally, water-saturated silty sand was ejected to the surface through cracks in the seasonally frozen layer.

9.—View, to the northwest, showing pressure ridges on floor of Little Tonsina River valley near mile 65, Richardson Highway; pressure ridges (indicated by arrows) caused by landsliding on face of hill.

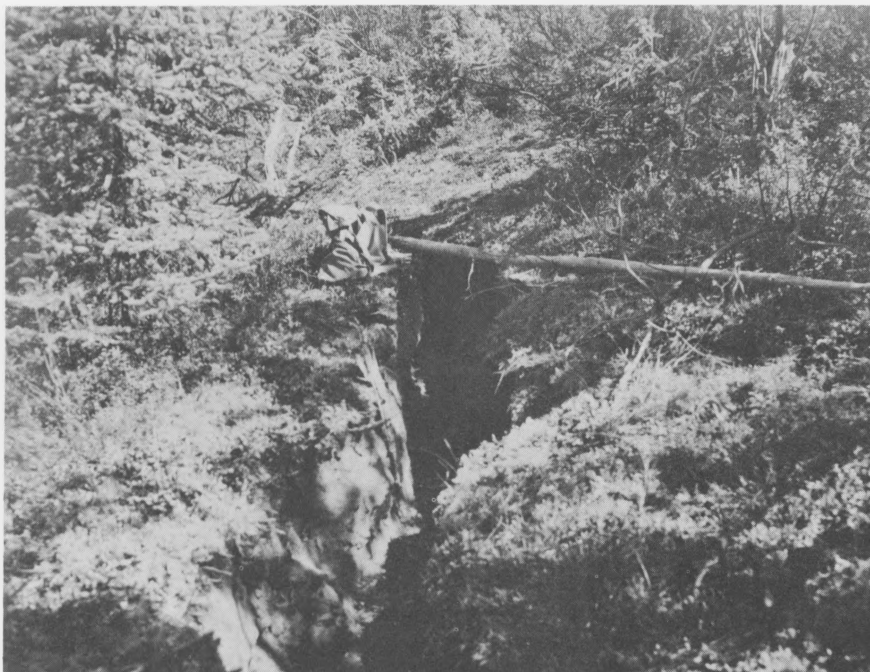
10.—One of several large ground cracks paralleling northwest side of small hill near mile 65, Richardson Highway. Crack, formed in fine- to medium-grained sand, has maximum width of 3 feet and depth of about 5 feet. The lateral extension of materials down the side of the hill caused the ground cracks and also caused pressure ridges to form on level ground several hundred feet in front of the base of hill.

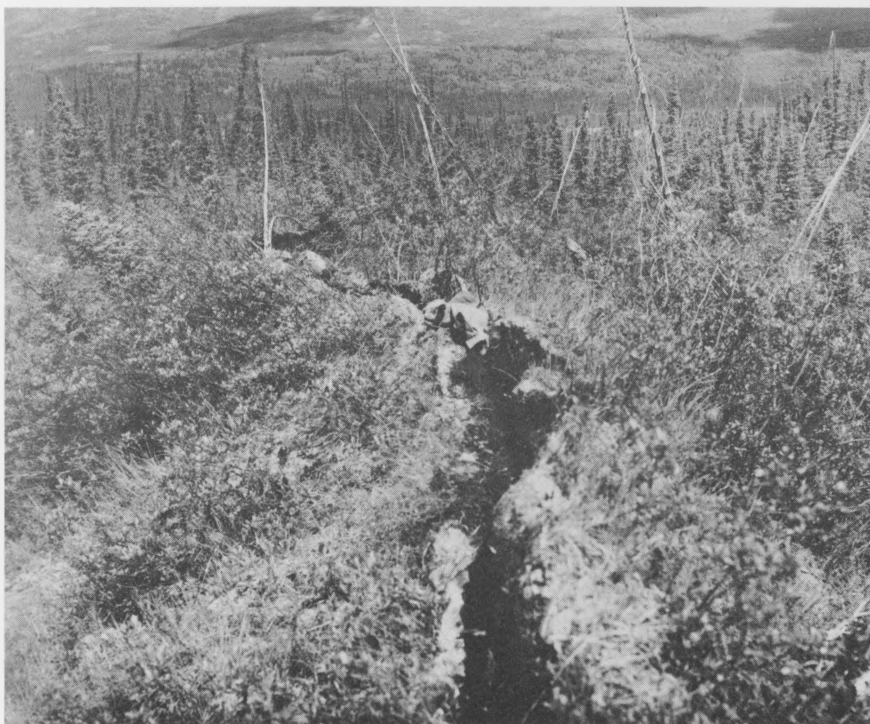
11.—Pressure ridge, 6 feet high, on flat surface bordering Little Tonsina River near mile 65, Richardson Highway. Crest of ridge broken irregularly by upward flexing of frozen peat caused by landsliding on a nearby hillside.

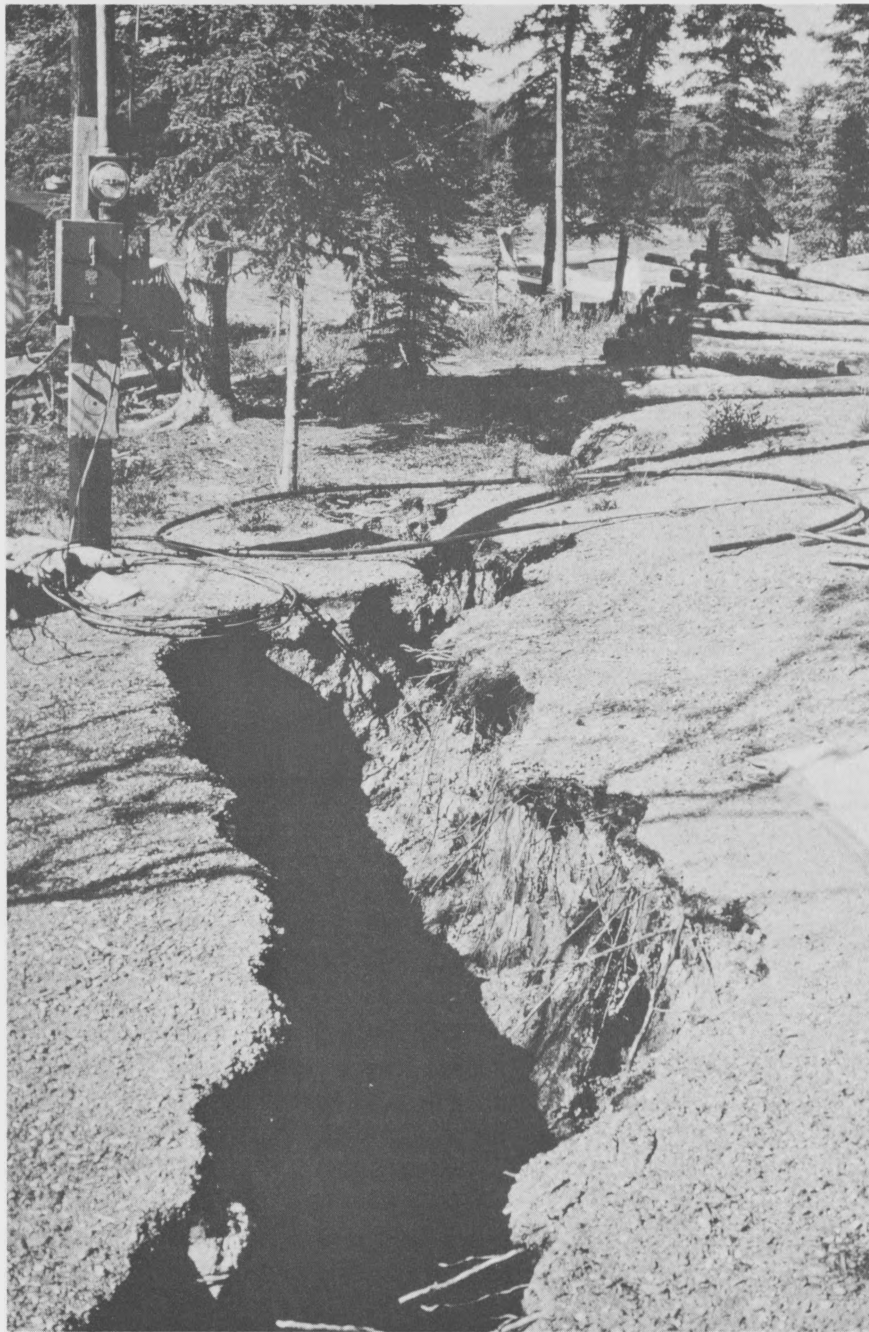
Other landslides include a large one at the mouth of Klutina Lake which caused the Klutina River to be diverted, several small ones along bluffs of the major rivers of the area, and numerous small slides marginal to lakes (see fig. 7). Ground cracks formed along margins of lakes by lateral movement of materials. An example is shown in figure 12 (p. 16).

12.—Large ground crack formed in clearing along south shore of lake about two-tenths of a mile north of mile 158, Glenn Highway. Maximum width of crack is 4 feet and depth is 6 feet. This ground crack is one of several that generally parallel the lakeshore.

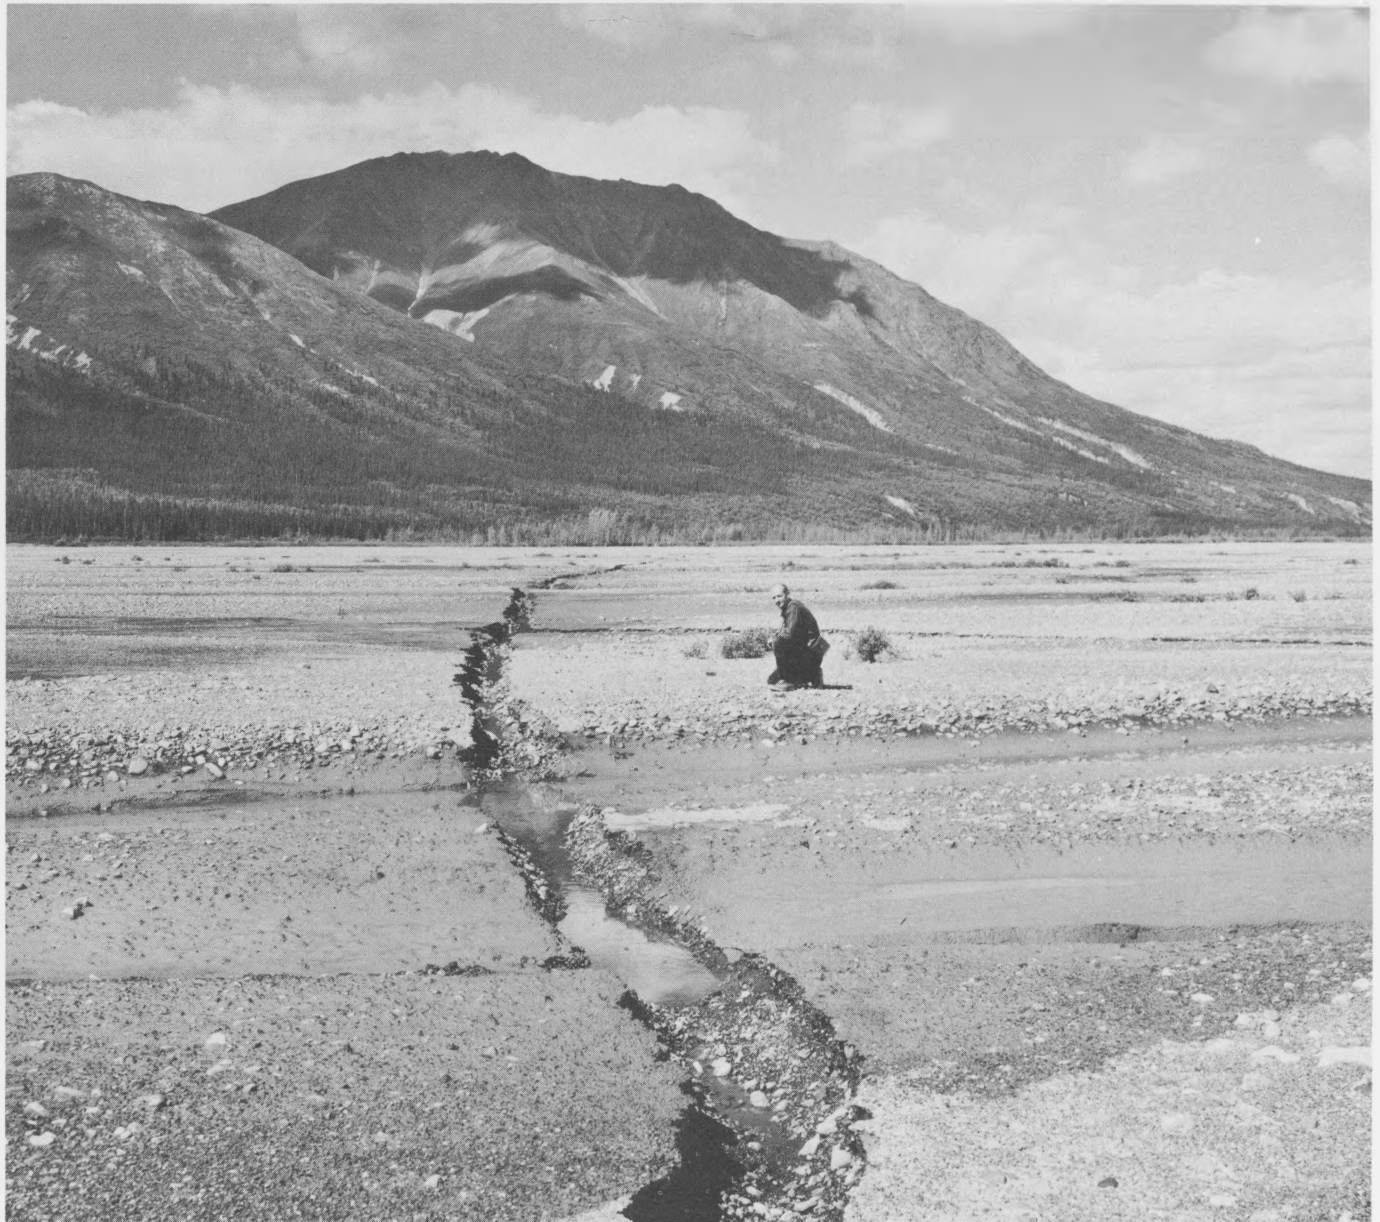
14.—Typical ground crack in outwash apron of Nelchina River 2 miles north of terminus of Nelchina Glacier; crack about 2 feet wide at widest point. Note how crack was deflected slightly in crossing swale in foreground. Standing water in swale marks the shallow ground-water table. Dark line behind man is trace of intersecting crack.

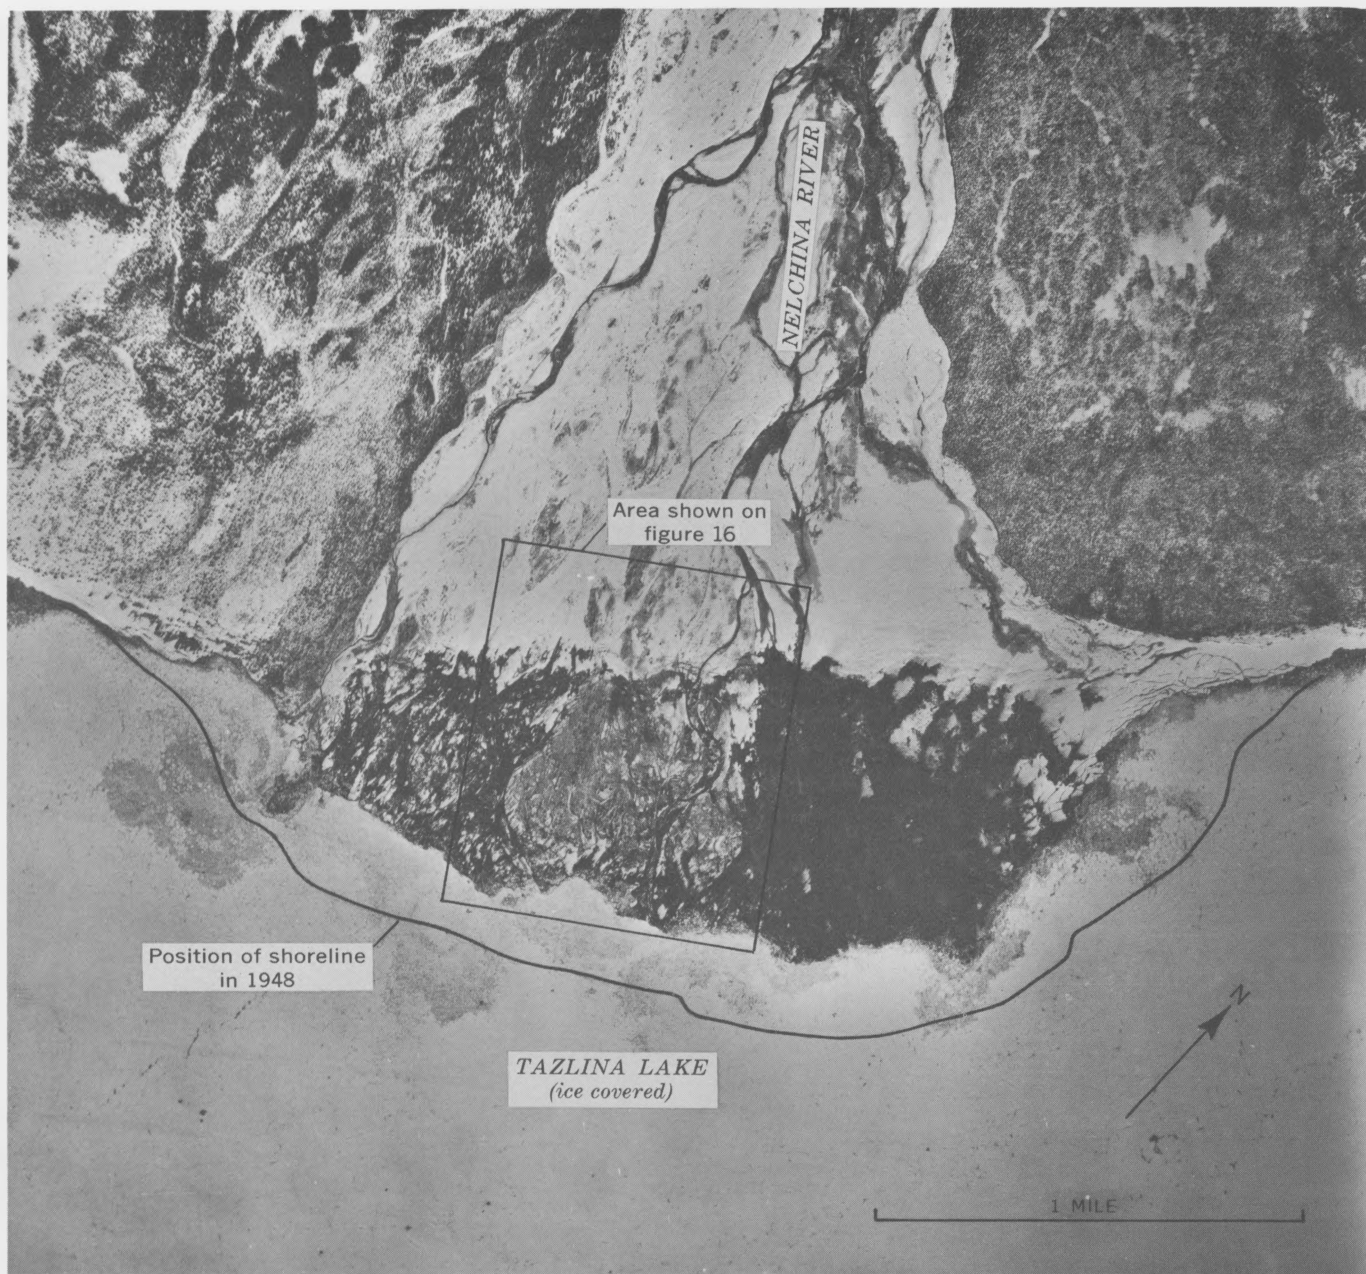
15.—The Nelchina River delta. Hingeline across the delta is conspicuous because most of the snow has been removed from the downslope side by water and sediment ejected from ground cracks. The position and character of the water-delta interface or shoreline in 1948 compared with the postearthquake shoreline indicate that large segments of the delta front slid into the lake. Photograph by U.S. Coast and Geodetic Survey, April 10, 1964.

The position and character of the water-delta interface in 1948 as compared with the position and scalloped character of the post-earthquake interface (see fig. 15) indicate that not only was there subsidence but that large segments of the delta front slid into the lake. This sublacustrine landsliding generated large waves that severely fractured the ice on the northern part of the lake and stranded large blocks of ice above water level along the shore. Large quantities of sediment and ice were discharged through the outlet of the lake into the channel of Tazlina River. Similar sublacustrine landsliding occurred off the fronts of deltas in Klutina Lake and in Tonsina Lake.

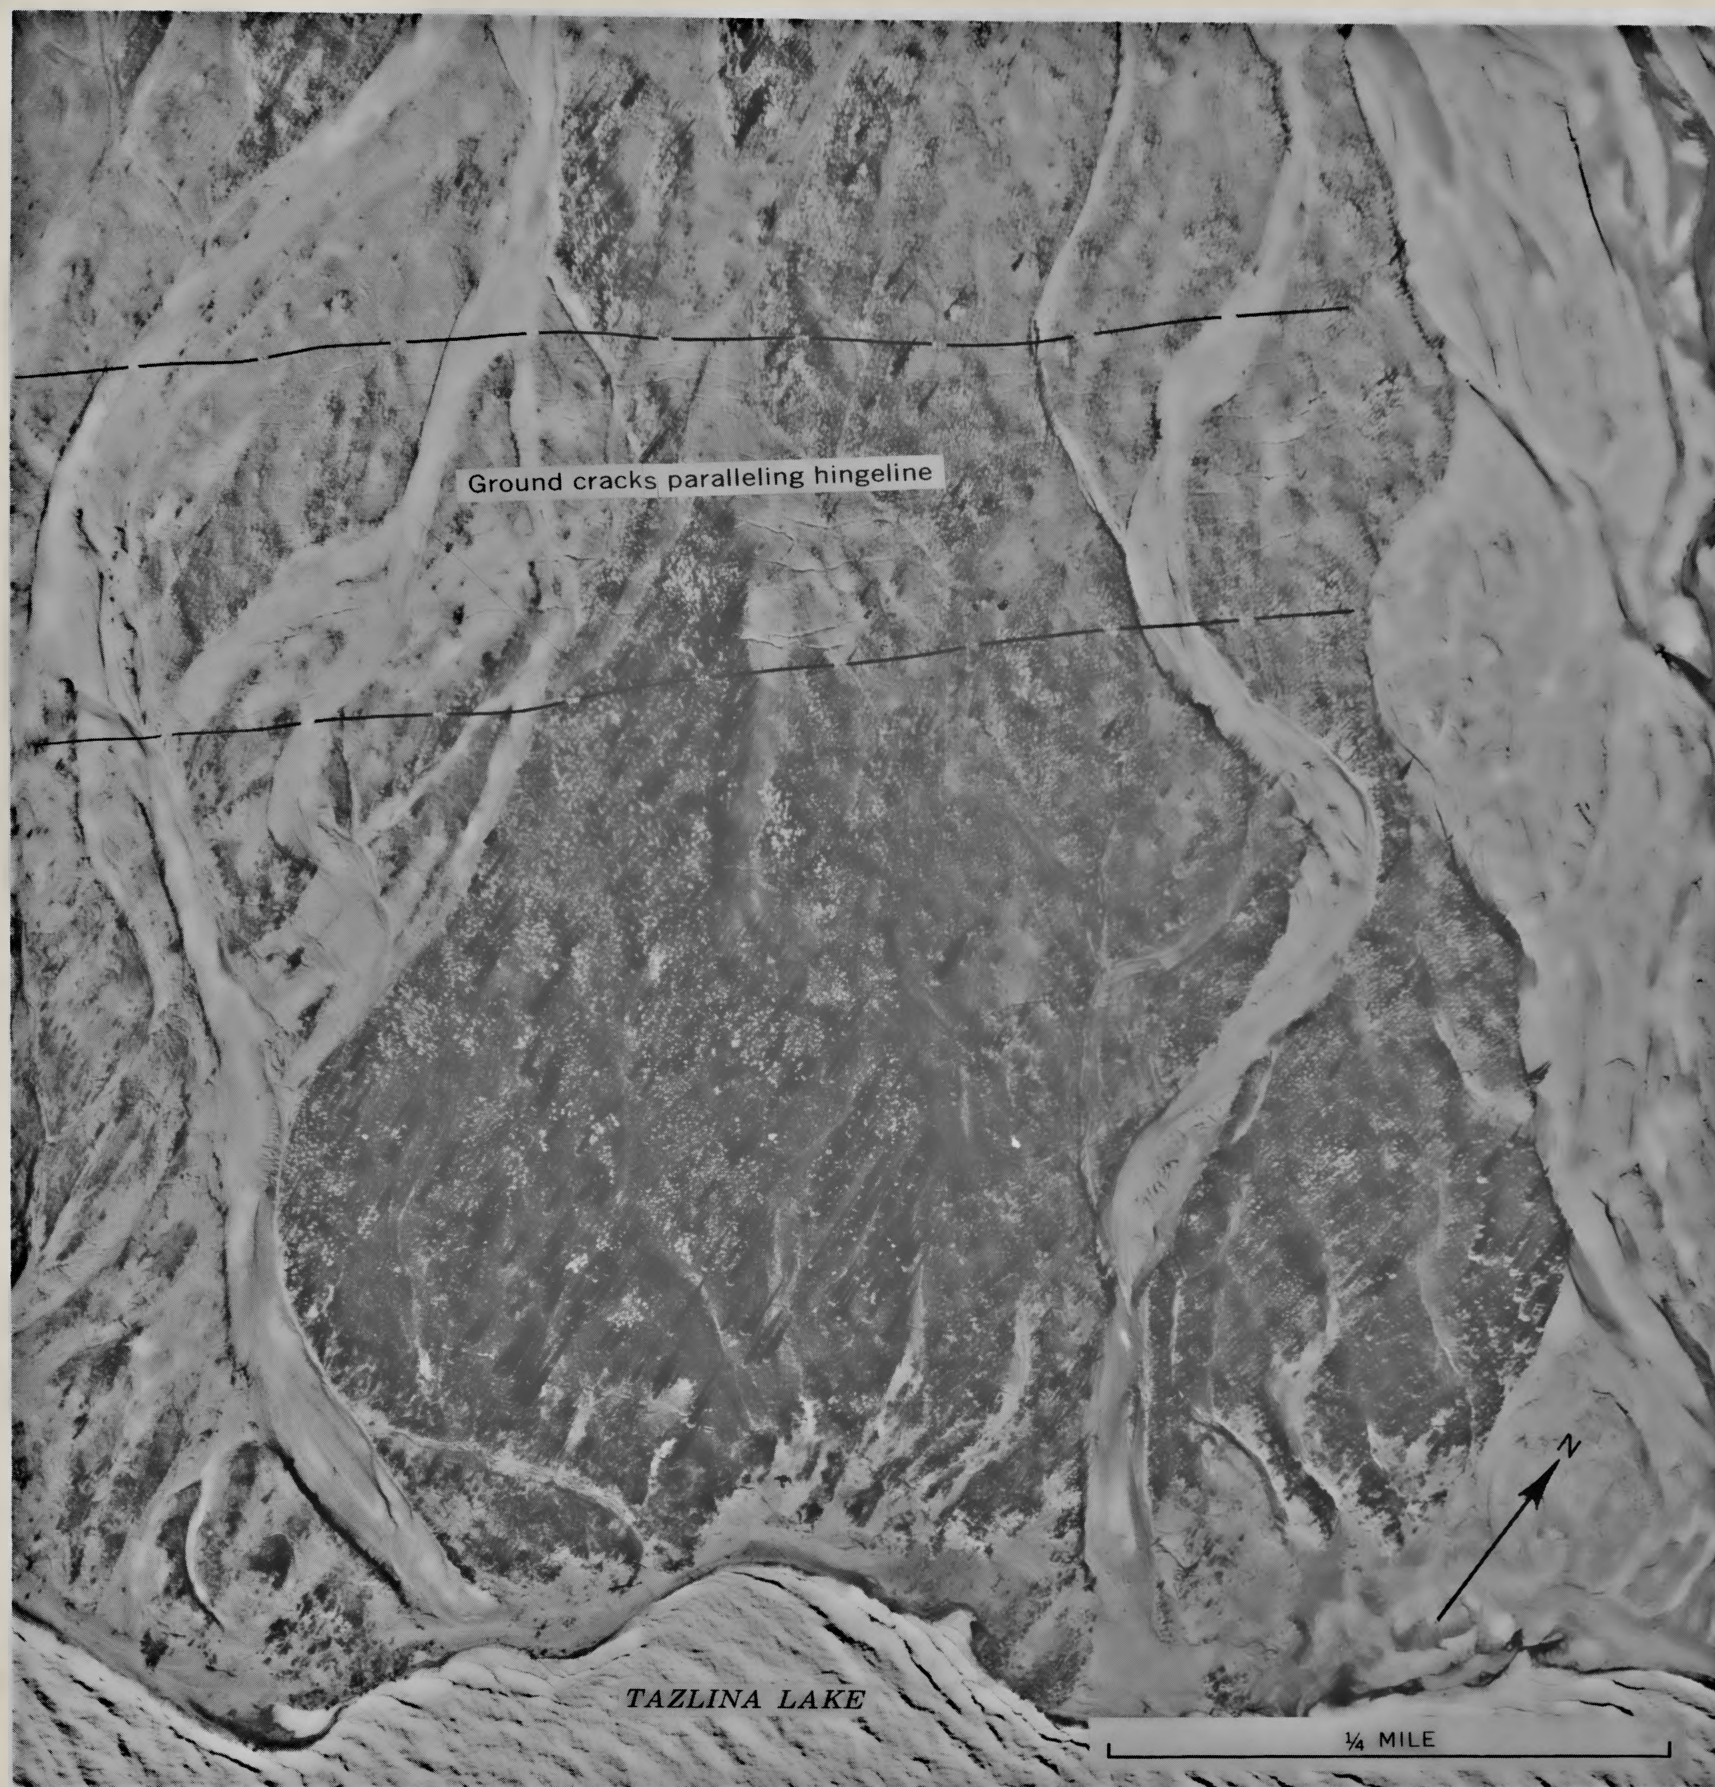
16.—Ground cracks along and paralleling hingeline on Nelchina River delta. Photograph by U.S. Geological Survey, October 1964.

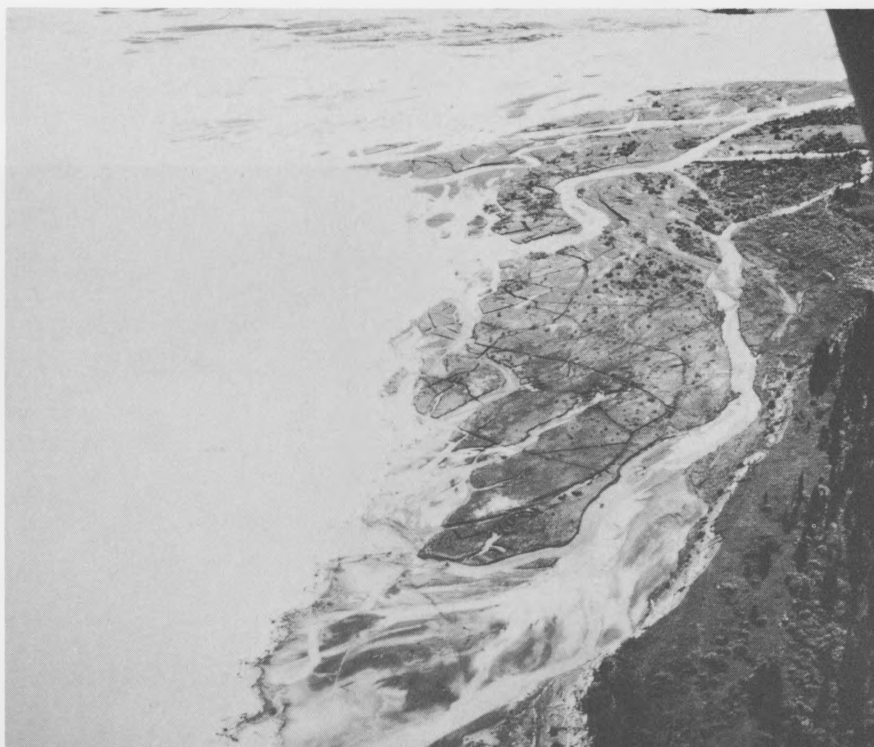
17.—North end of the large Nelchina River delta along the western shore of Tazlina Lake. Note the reticulate pattern of ground cracks which are as much as 6 feet wide.

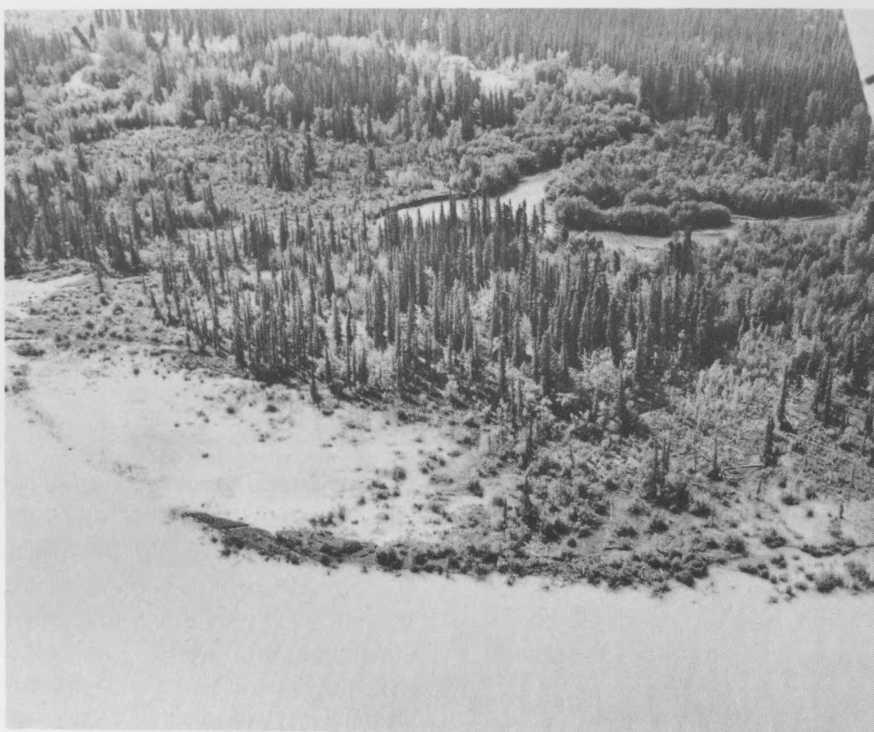
18.—View showing flooding of Kiana Creek delta along eastern shore of Tazlina Lake.

The flooded delta of Kiana Creek along the eastern shore of Tazlina Lake is shown in figure 18. Subsidence, probably caused by compaction of unconsolidated sediments, and lateral movement of materials toward the lakeshore caused flooding of the delta and the formation of numerous ground cracks. A large area along the eastern shore of Tazlina Lake just south of the Kiana Creek delta was inundated (fig. 19). This area, which is part of an old alluvial-fan delta of Kiana Creek formed when the creek was a much larger stream, was subjected to changes similar to those that occurred at the Kiana Creek delta.

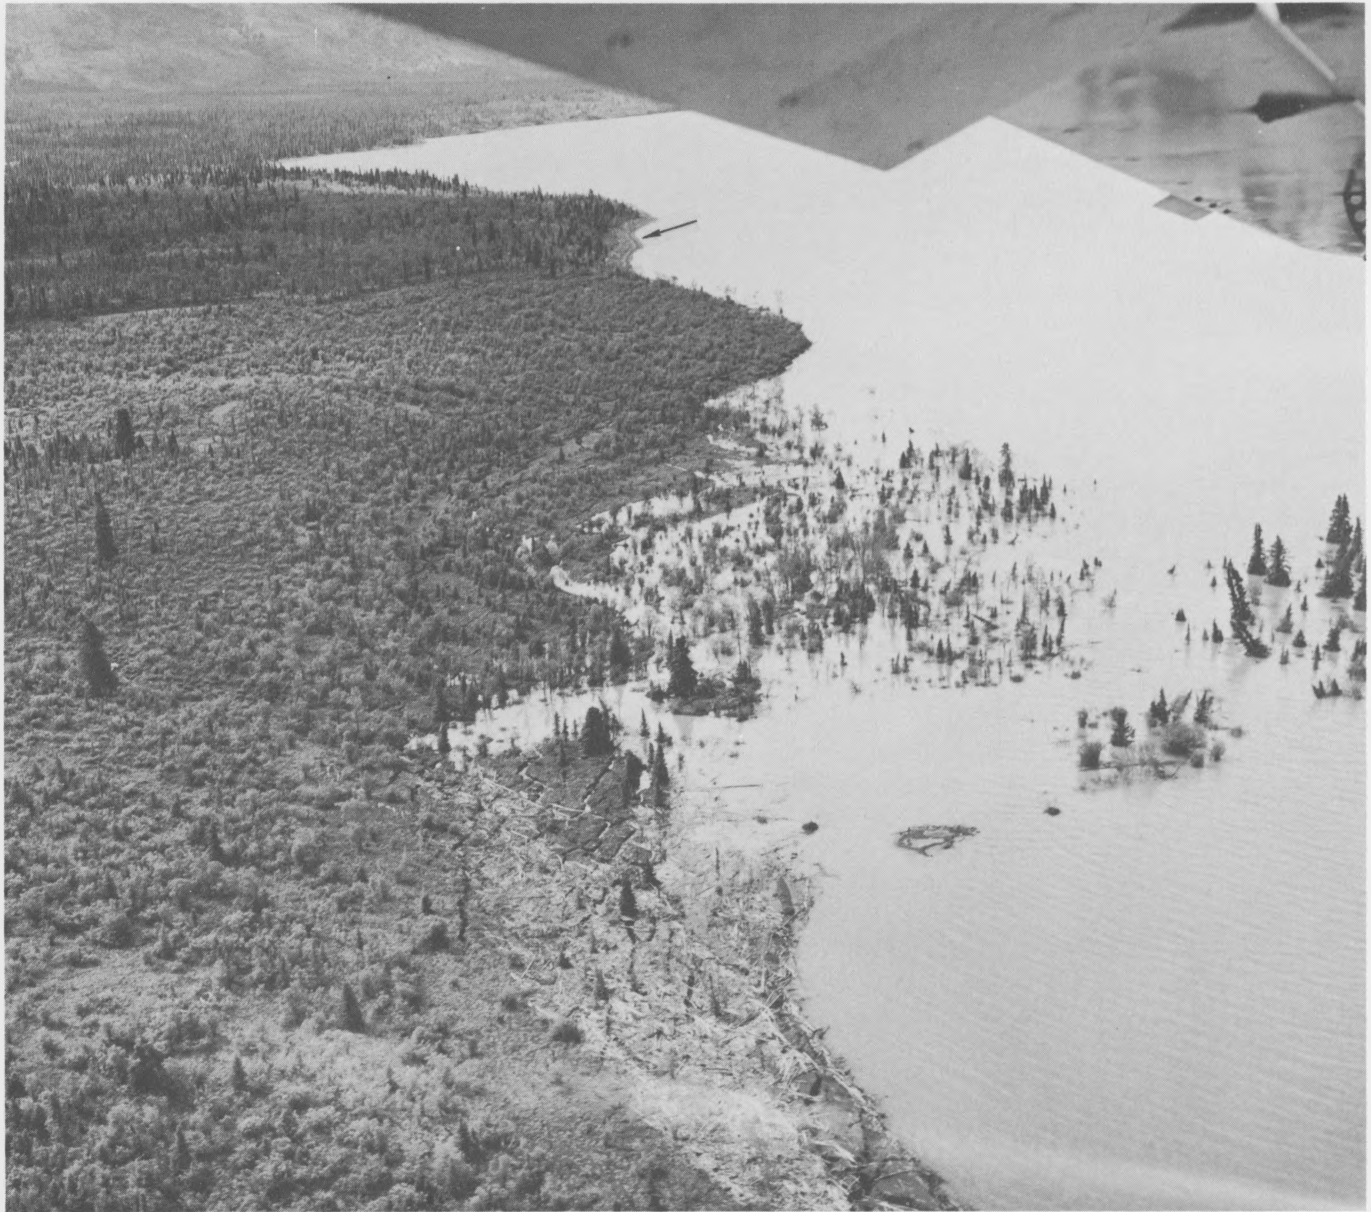
19.—Large inundated area along eastern shore of Tazlina Lake just south of the Kiana Creek delta. Lateral movement and vertical compaction of materials along lakeshore caused numerous ground cracks to form and the area to subside. Note normal beach (indicated by arrow) in the distance.

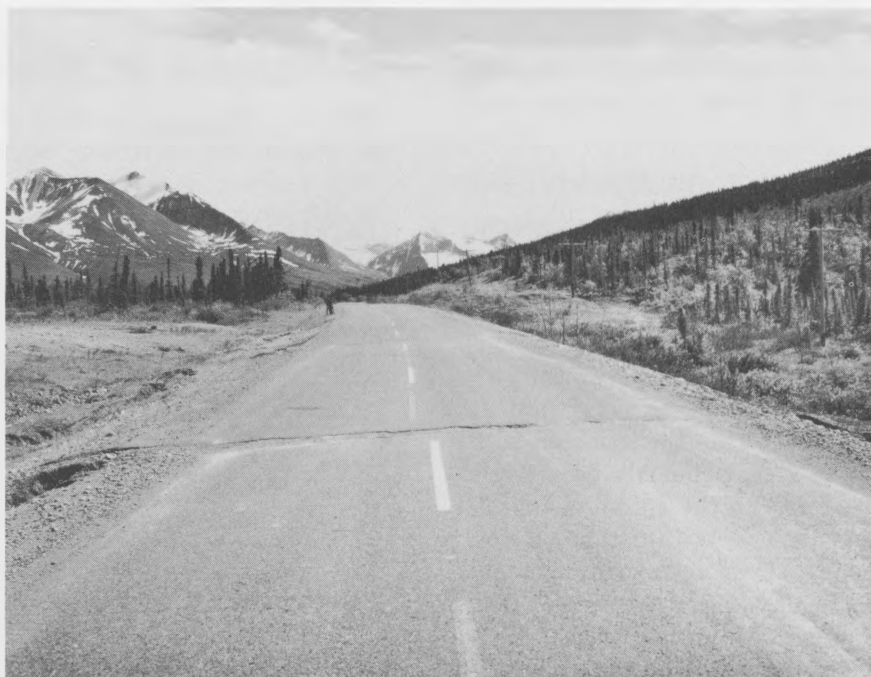
21.—View, to the southeast, showing the pavement surface of the Richardson Highway just south of the Little Tonsina River bridge at mile 65. Note the 8-inch horizontal offset of the centerline; vertical displacement is as much as 3 inches.

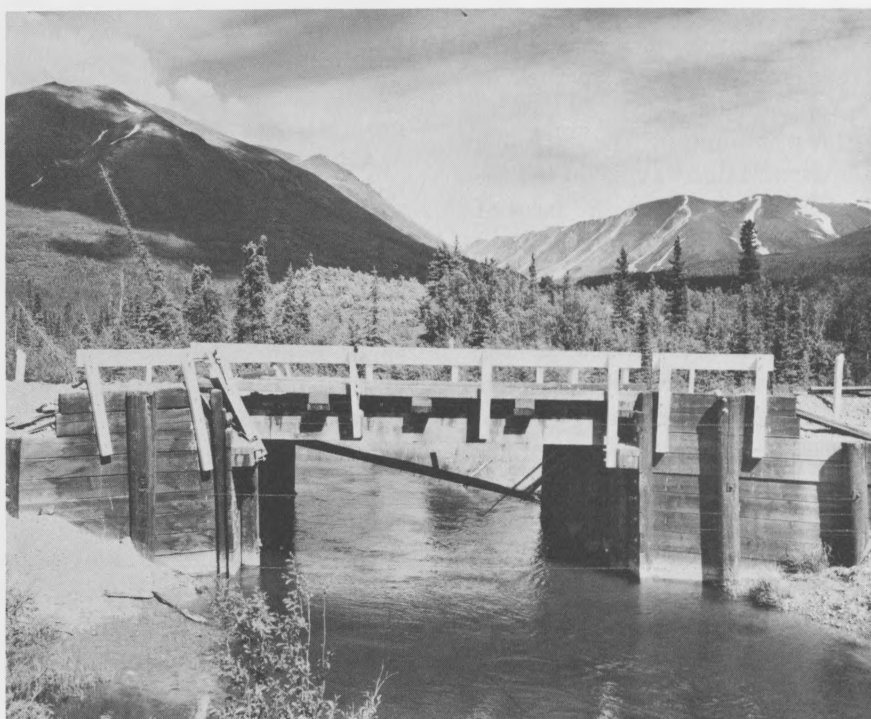
22.—Landslide movement on a hillside approximately two-tenths of a mile away caused the Little Tonsina River bridge to be shoved from the right to the left. Minor slumping occurred in road fill to the left of the bridge. Immediately after the earthquake the pavement was buckled more than 3 feet high at the left end of the bridge.

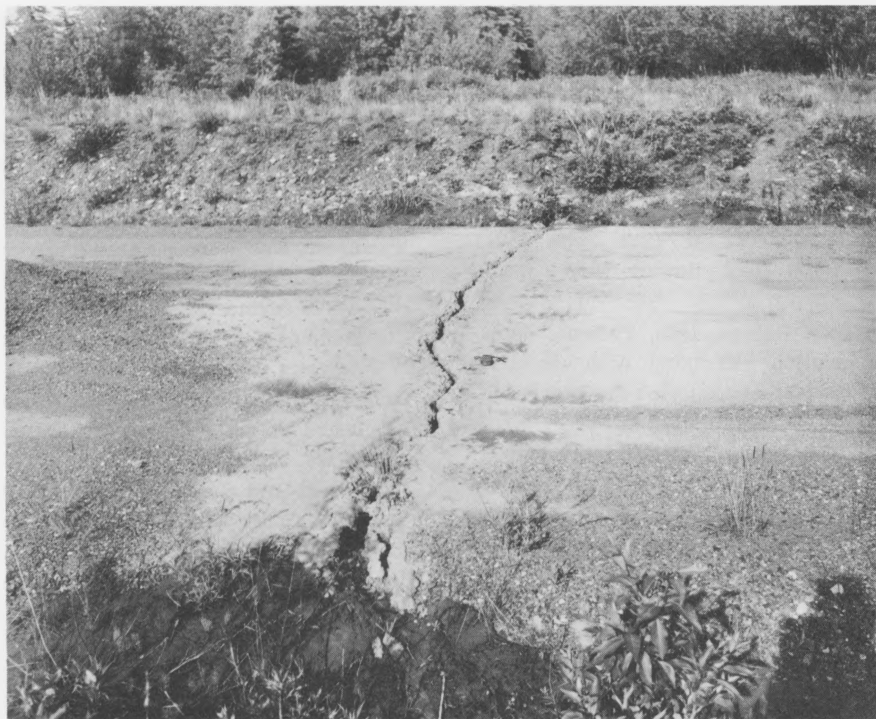
23.—Small crack across abandoned section of road on a low gravel terrace adjacent to Rock Creek at mile 86.1, Richardson Highway. Note the fine sand and silt along both sides of the crack.
