The Alaska Earthquake

Ground Breakage in the Cook Inlet Area

Ground Breakage and Associated Effects in the Cook Inlet Area, Alaska, Resulting from the March 27, 1964, Earthquake

GEOLOGICAL SURVEY PROFESSIONAL PAPER 543-F

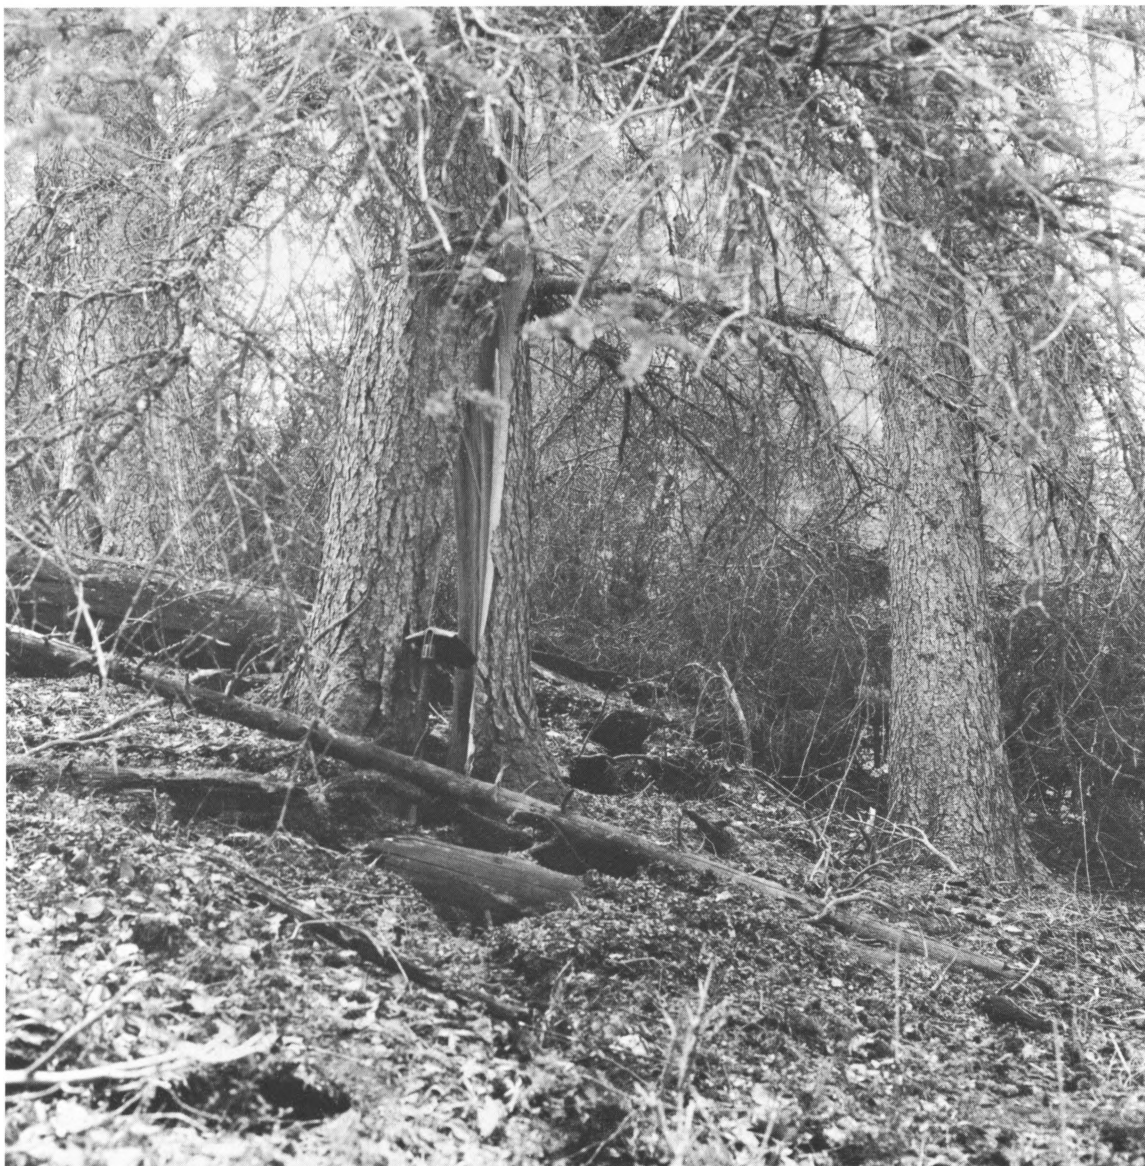
5.—Tree split by ground cracking (loc. 2, pl. 1), Kenai Lowland. The ground crack which trends into the split in the tree (loc. A, fig. 4) cuts across the top of a small knoll in moraine.

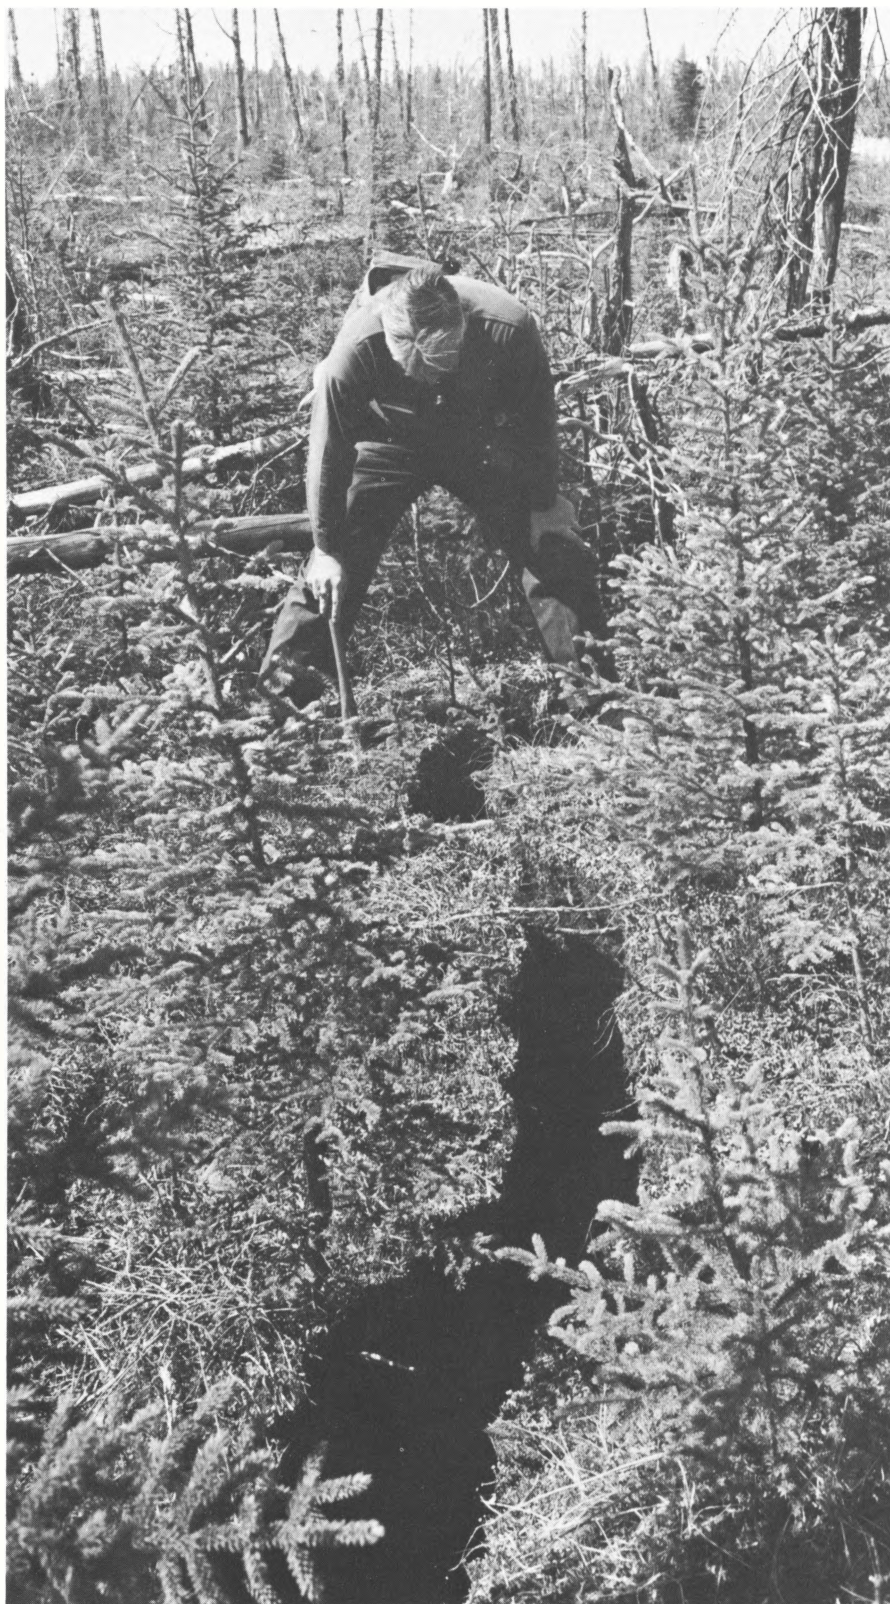
Most of the cracks within the zone ranged in width from knife edge to a foot (fig. 6). They were generally very sharp, vertical, and straight with abrupt angular changes in direction and sharp angular intersections with other cracks (fig. 7). Major cracks had many smaller branch cracks that intersected the main cracks at sharp acute angles or sometimes at right angles. In places, major cracks abruptly changed direction at crack intersections. Vertical and horizontal displacements occurred along some cracks; most were less than a foot but a few were as much as 2 feet (fig. 7). Most displacements appeared to be primarily the result of adjustments in the surficial materials by slumping and differential compaction, or of removal of underlying materials by ground-water eruption.

6.—Typical large ground crack (loc. 1, pl. 1), Kenai Lowland. Crack was 4 inches to 1½ feet wide; it cut a sand plain. Sand was not extruded along this crack (loc. A, fig. 3).

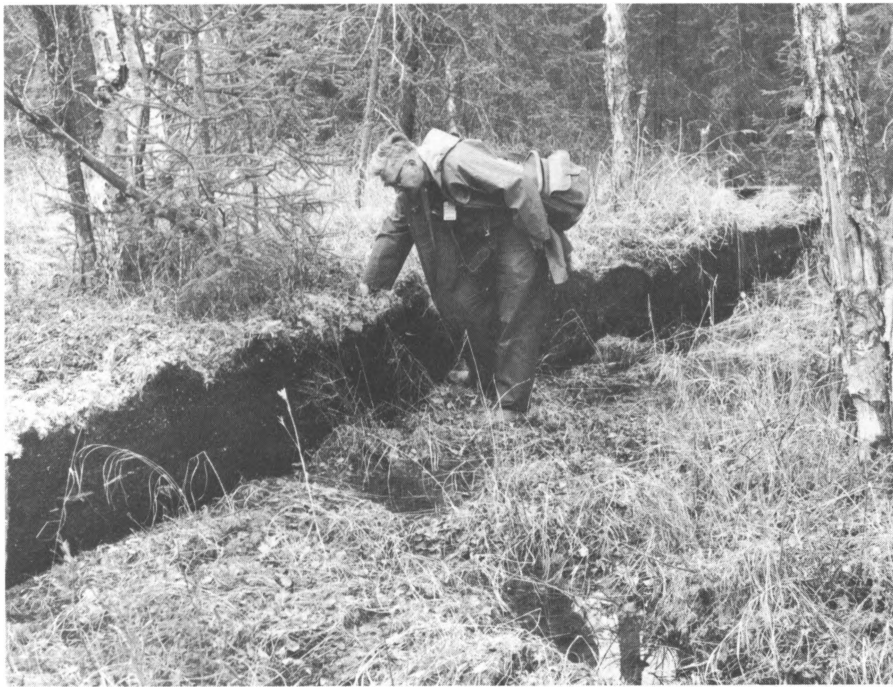
7.—Vertical displacement (loc. 2, pl. 1). A scarp more than 200 feet long and 2 to 3 feet high was produced in a thick section of frozen peat and organic silt (loc. B, fig. 4). Crack at the base of the scarp was 6 inches to 1 foot wide. Another crack intersects scarp at right angles; this displacement probably resulted from differential compaction and downslope extension of silty deposits in a muskeg bordering a small lake.

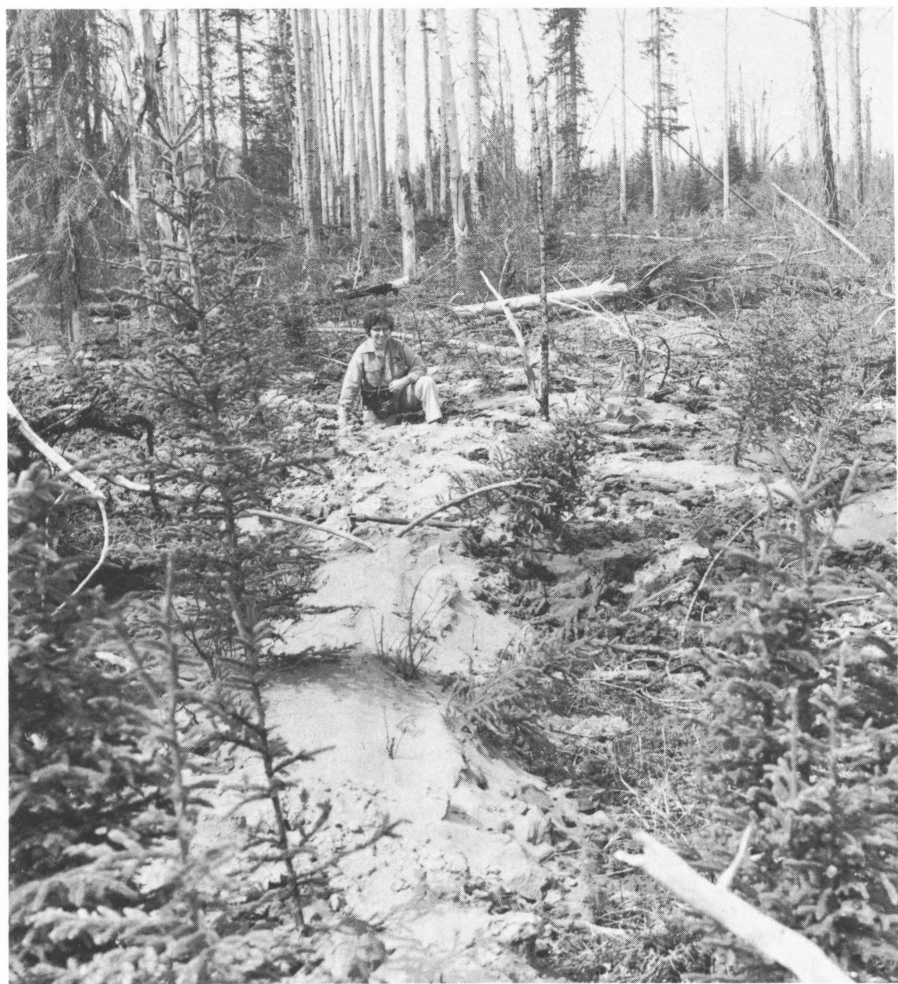
Features associated with ground-water eruptions were common throughout the zone. These features included ridges and mounds of sand aligned along cracks (fig. 8); sand sheets as much as 2 feet thick, locally covering acres of ground associated with the cracks (fig. 9); vents from which erupted sand either spread in all directions or was extruded primarily in one direction—and made a sand apron extending from the vent; collapse pits, as much as 30 feet in diameter; and fissures as much as 20 feet wide and 25 feet or more deep (figs. 9, 10), resulting from the removal of material by copious outpouring of ground water. In a few places great outpourings of sand were followed by small extrusions of watery silt which formed low (2 to 3 inches high) silt ridges and mounds and irregular microrelief features on the surface of the sand (figs. 11, 12). These silt extrusions must have occurred in the very last stages of the ground-water eruptions and after the main shaking

8.—Sand ridges deposited along a ground crack (loc. 2, pl. 1) by eruption of ground water during the earthquake. A sand ridge on the right side of the picture intersects the main ridge at nearly right angles. Person has right leg in deep crack (loc. C, fig. 4).

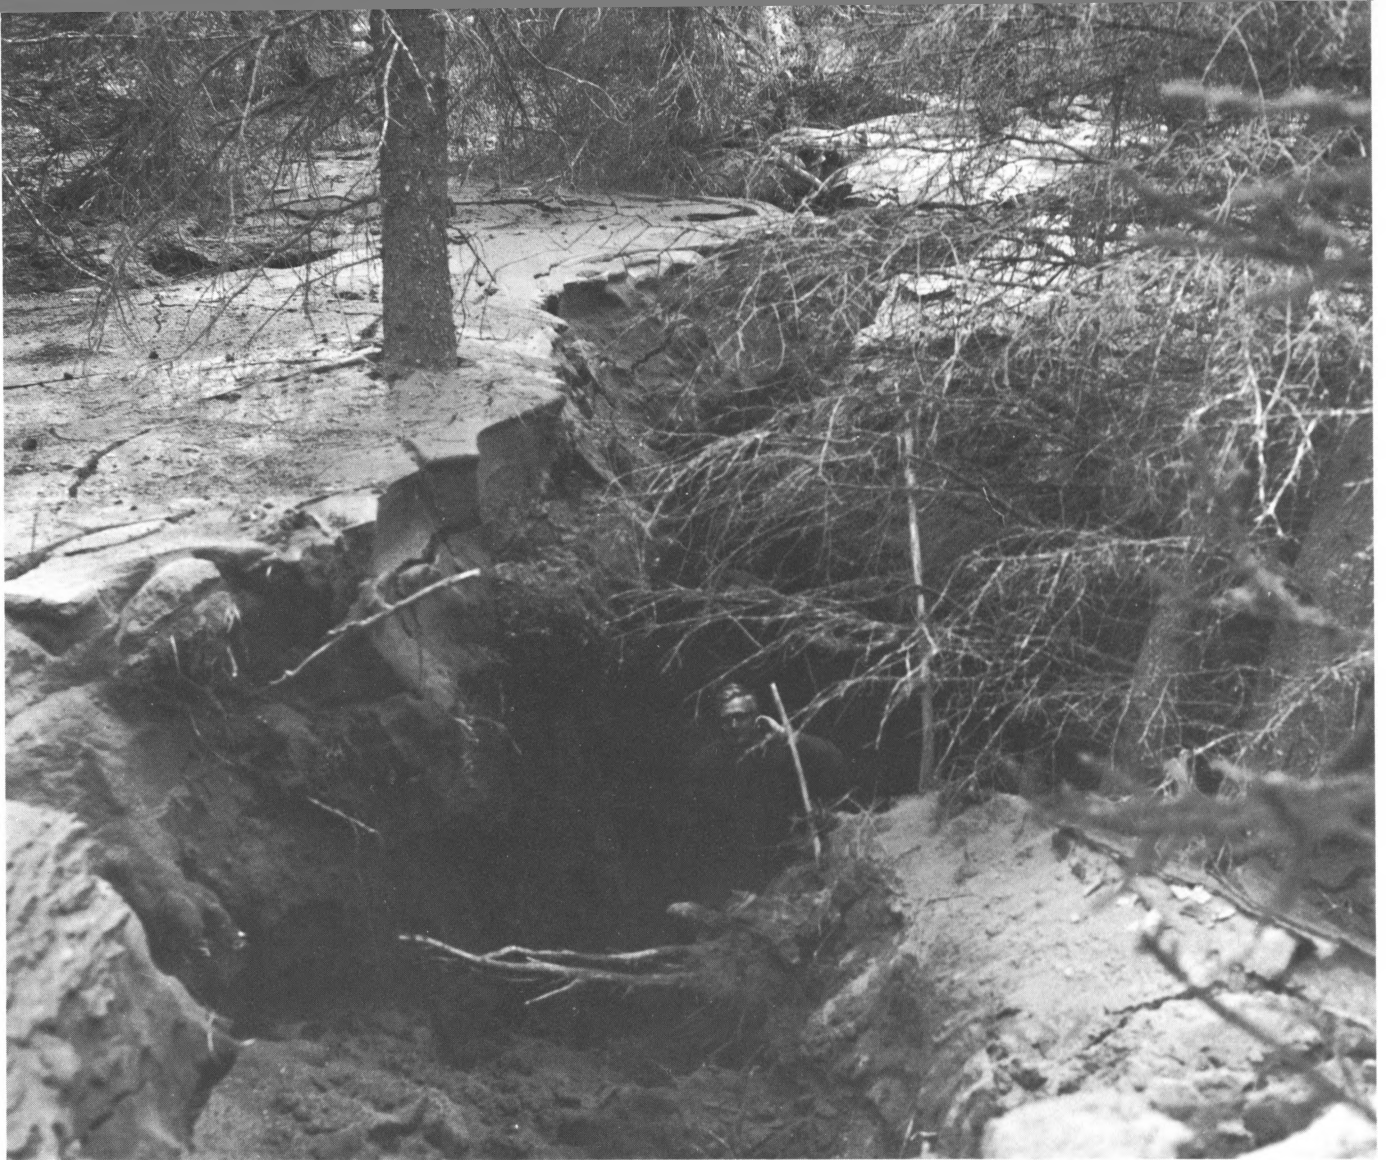
9.—Large fissure at locality 2 (pl. 1). This fissure was 25 or more feet deep and as wide as 20 feet in places. A thickness of 2 or more feet of sand which was extruded from the fissure can be seen around the tree. Photograph was taken at locality D (fig. 4).

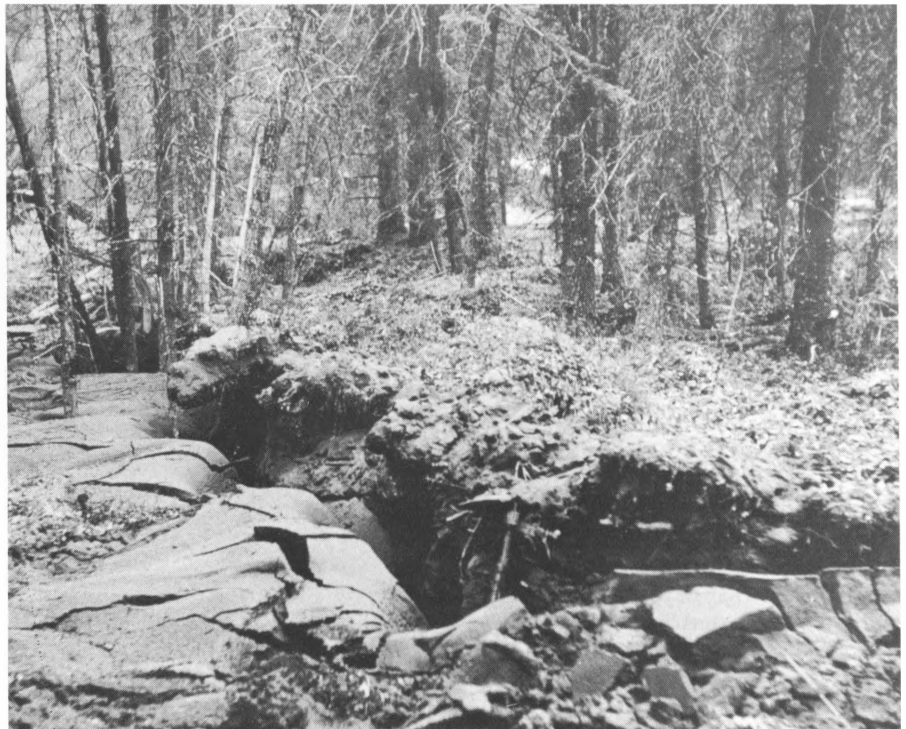
10.—Large ground crack with vertical displacement (loc. 2, pl. 1). Thick deposits of sand border the left side of the crack. Photograph was taken near E (fig. 4).

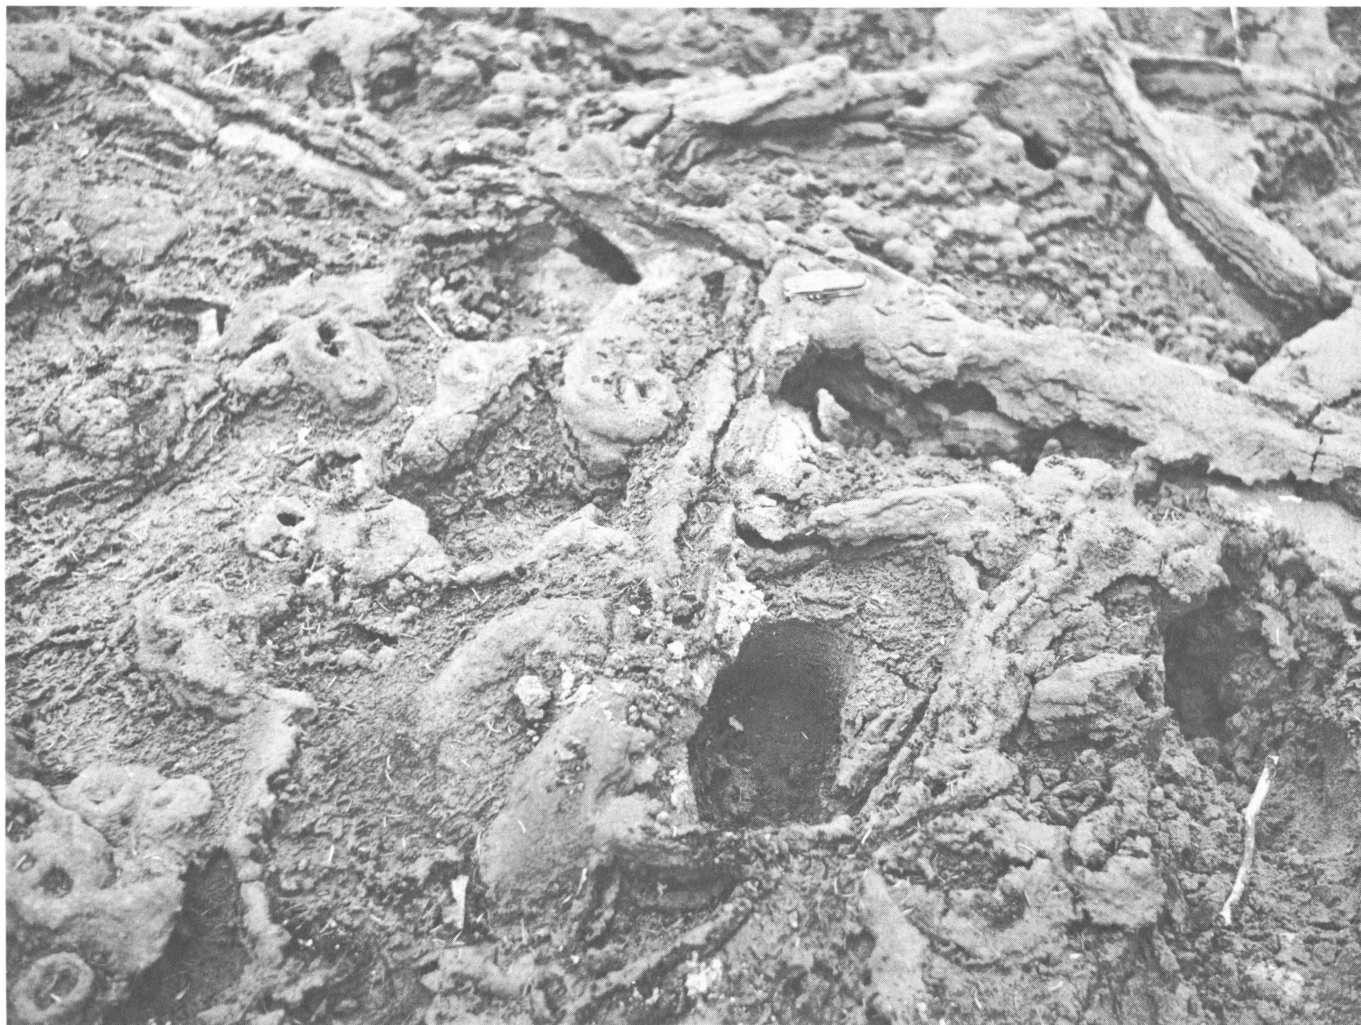
11.—Microrelief features formed in extruded silt (loc. 2, pl. 1). Area pictured is about 48 inches wide) 3-inch-long jackknife is slightly above center of picture). The delicate silt mounds and ridges were formed in the last stages of ground-water eruption on the surface of previous sand extrusions.

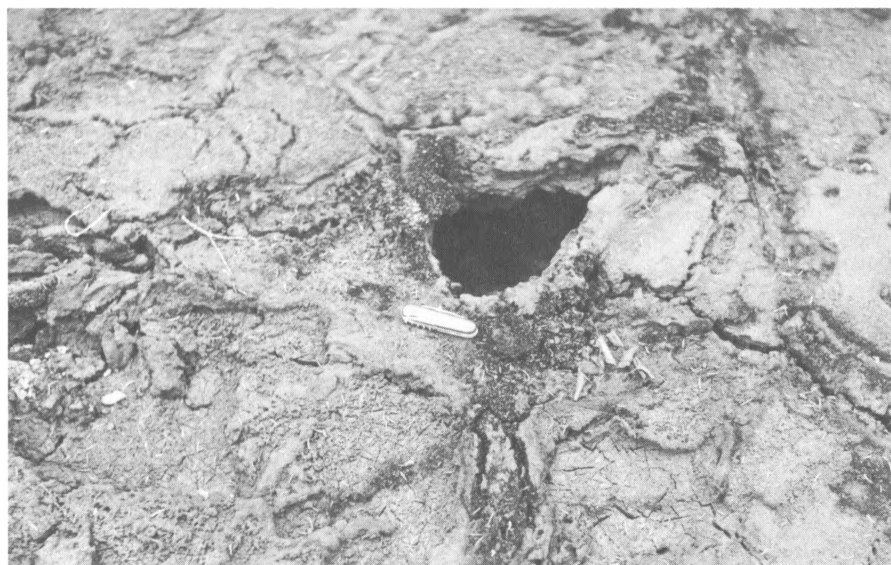
12.—Small vent which extruded watery silt (loc. 2, pl. 1). Jackknife is 3 inches long. Near locality D (fig. 4), watery silt from small vents such as this was extruded in the last stages of eruption and spread out over the top of previously erupted sand.

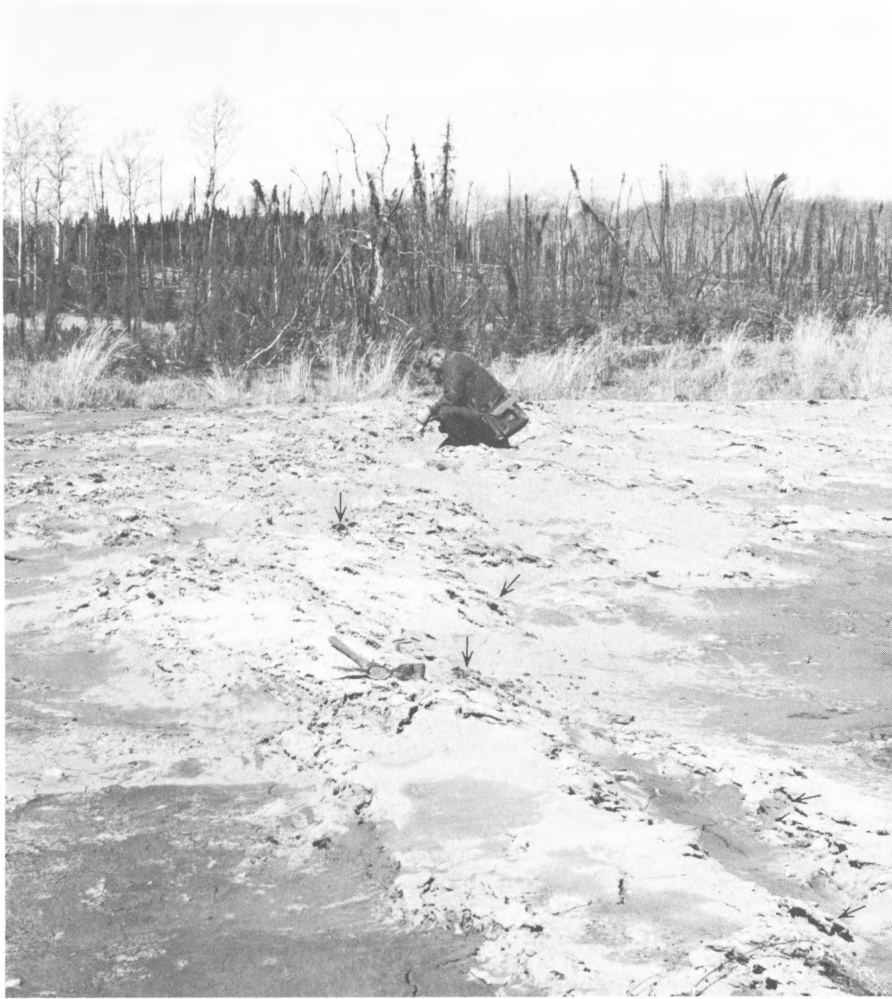
The deposits laid down by ground-water eruption within the zone are predominantly fine- to medium-grained sand. In most localities the sand contains scattered pebbles and cobbles of detrital coal and lignite as much as 6 inches long (fig. 13). The largest amounts of sand and much of the coal were commonly concentrated at the intersection of two or more major cracks or at the intersection of a wide and a narrow one. Many, if not all, of the coal fragments carried to the surface during the earthquake by ground water could have been derived from near-surface deposits that contain detrital coal originally derived from underlying Tertiary coal beds. However, derivation of some of the coal from the Tertiary coal beds at depths of several hundred feet, though unlikely, is not excluded as a possibility by present evidence.

13.—Detrital coal extruded with sand (loc. 1, pl. 1). Copious amounts of sand were extruded from a fissure cutting a gravel road (loc. B. fig. 3). Pieces of coal and lignite as long as 6 inches (some indicated by arrows) were extruded with the sand.

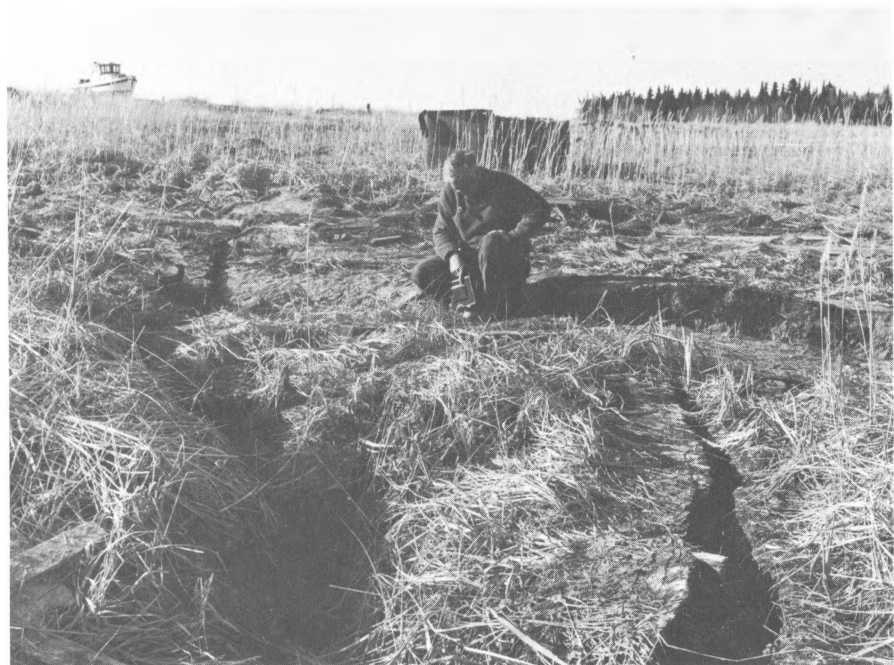
At Kasilof, which is approximately in line with the northeast-trending zone of ground breakage previously described (p. F3), cracks as much as 1 foot wide were formed. The cracks were traceable for several hundred feet and cut sand dunes and beach deposits at the coast (fig. 14). Crack walls were generally sharp—in fact, exceptionally sharp for occurrence in loose sand. Some had small vertical displacements as much as 10 inches high. They had the usual pattern of many branches and cracks intersecting from several directions. Collapse occurred along some cracks where large amounts of sand had been extruded (fig. 15). Pressure ridges a few inches high and 2 to 3 inches across were noted in silt on tidal flats; some radiated from a central point in several directions for distances of 25 feet or more.

14.—Ground cracks at Kasilof in elevated beach deposits. Cracks were as much as 1 foot wide. Vertical displacement is evident along crack near man. Considerable clastic coal was brought up from beneath the surface and deposited with the sand.

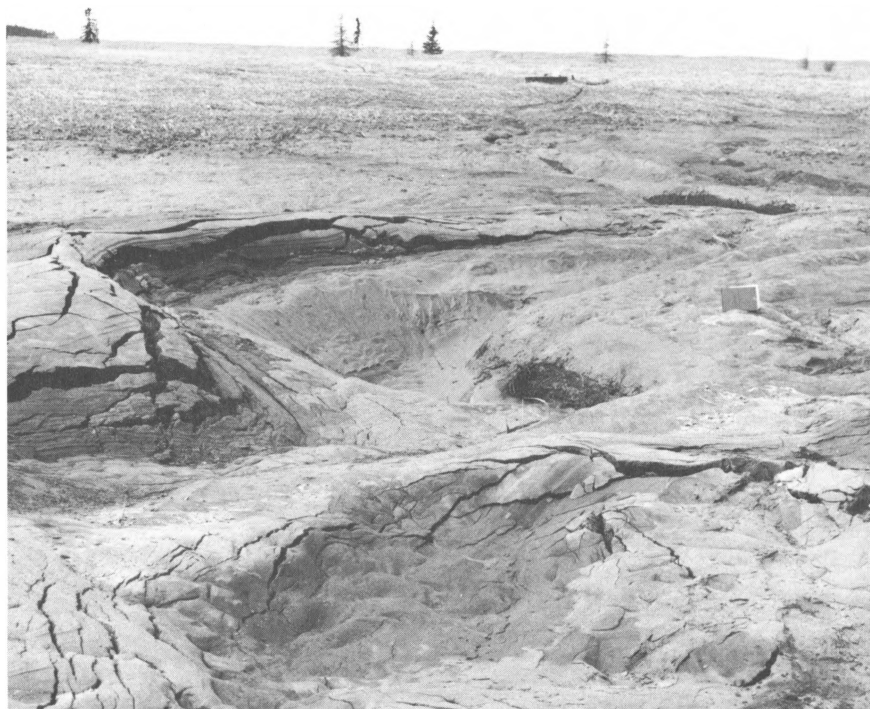
15.—Collapse pits at Kasilof formed after eruptions of ground water and sand. Pit in foreground is about 3 feet in diameter. Erupted sand covers the ground. A large crack extends from the pits in the middle background.

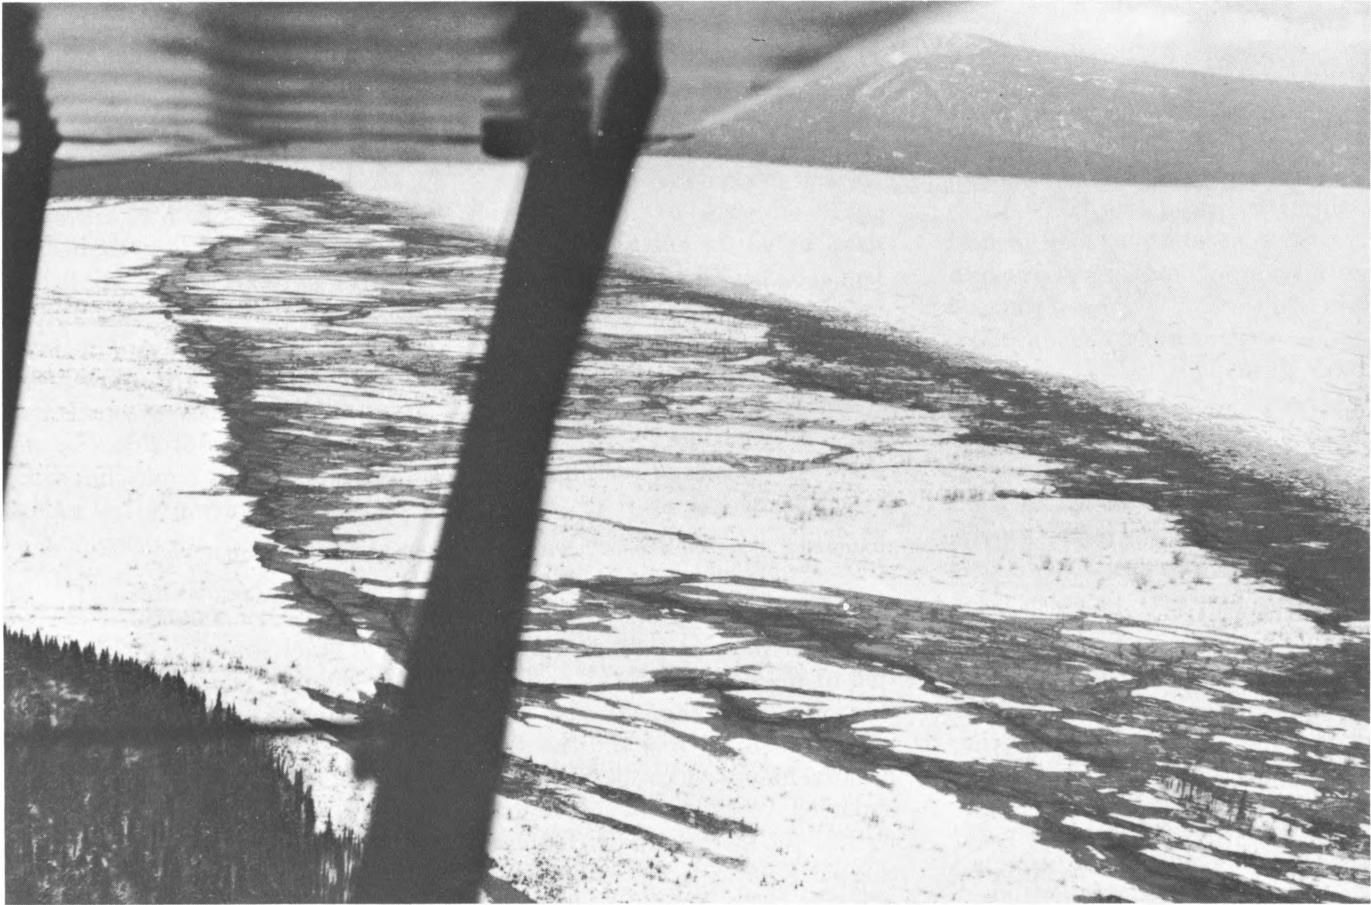
Photographs obtained after the earthquake (fig. 16) indicate that a major zone of fissures oriented $N. 5^{\circ}-10^{\circ} W.$ formed subparallel to the southern delta front about half a mile from the lake shore. This break defined the inland margin of the part of the delta most disrupted by the earthquake. Much sand was extruded along this fracture zone and flowed out upon the snow-covered surface (fig. 16).

16.—Outwash delta at head of Tustumena Lake a few days after the earthquake. View is south (pl. 3). The ground was snow covered, and water and sand erupted along major cracks (dark-gray areas) partly removing the snow and covering the ground surface with sand. The cracked ice-covered lake surface is to the right. A major fissure system paralleling the delta front is seen to the left of center. Photograph by Avery Thayer, Fish and Wildlife Service, Kenai, Alaska.

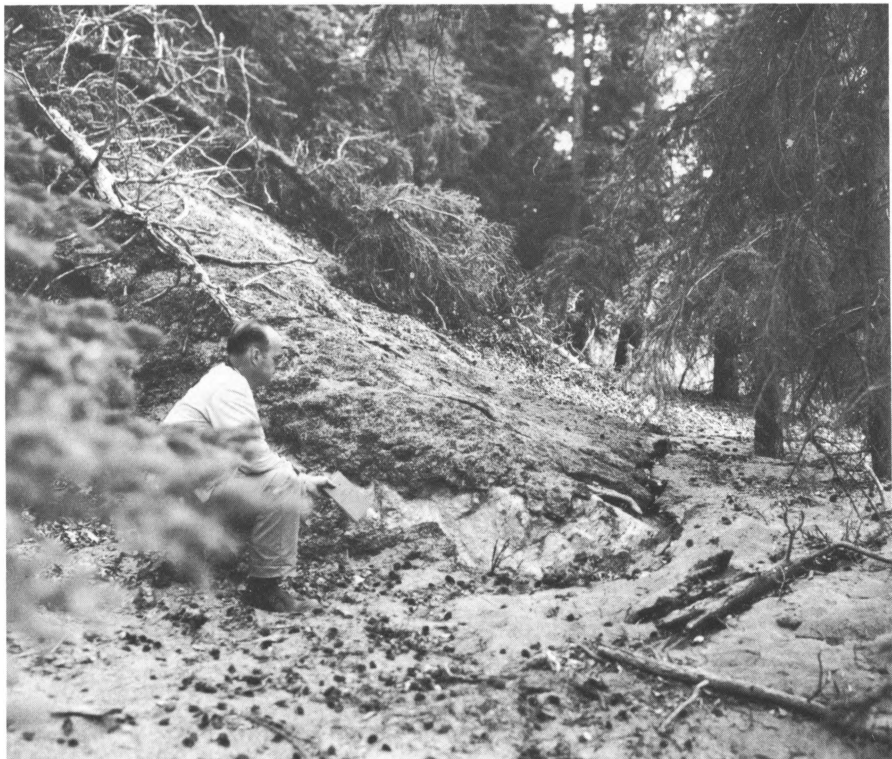
The ground cracks in the outwash delta ranged in width from a fraction of an inch to 4 feet (fig. 17). Most cracks showed no vertical displacement, but a few indicated subsidence of several inches to $1\frac{1}{2}$ feet on the lake side. Little overall evidence of subsidence of the delta front was observed, and it is estimated to have been less than 10 feet.

17.—Crack between delta front and bedrock at Tustumena Lake (loc. A. pl. 3). A wedge of outwash deposits pulled away from the stable bedrock face during the earthquake shaking.

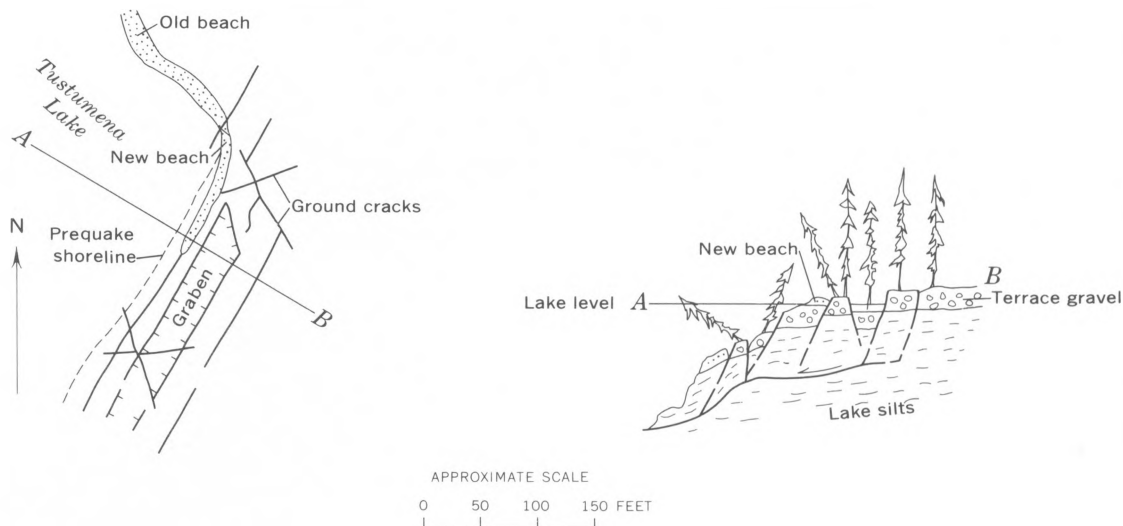
18.—Diagram showing type of ground disruption on the north shore of Tustumena Lake (loc. 3, pl. 1).

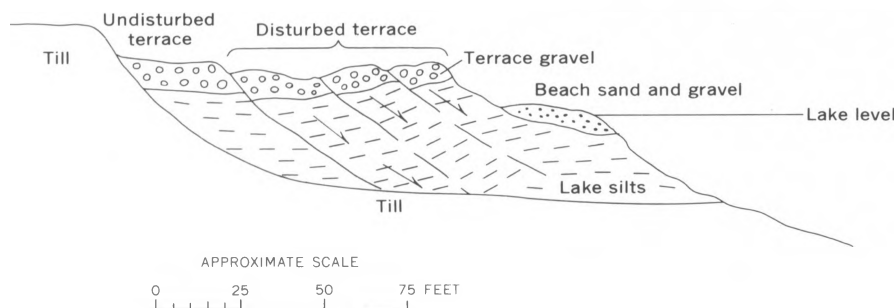
19.—Diagram showing a type of slumping on the south shore of Tustumena Lake (loc. 4, pl. 1).

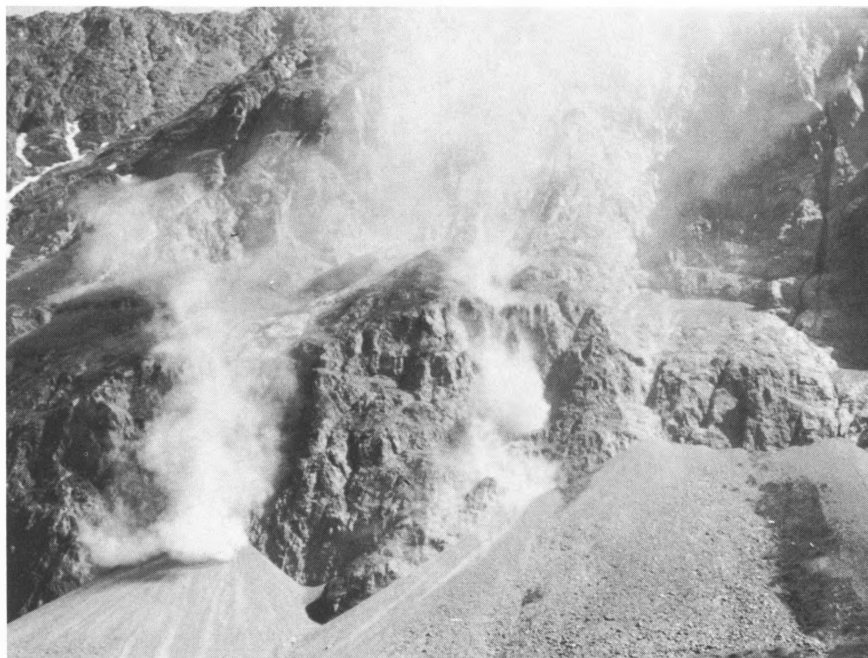
In the early part of the summer of 1964, rock debris cascaded nearly continually from three principal places on the steep high cliffs above Eklutna valley (fig. 20). Talus cones at the base of the cliffs were much enlarged (fig. 21). Dense dust clouds emanated from the avalanches and resulted in erroneous reports of volcanic eruptions when spotted by airplane pilots (figs. 21, 22). Later in the summer, several of the avalanches became inactive, and by August 1965 activity was largely

21.—Sites of avalanche activity in Eklutna valley. These talus cones were present before the earthquake but have been enlarged by avalanche activity since the earthquake. The dust clouds are created by the avalanching.

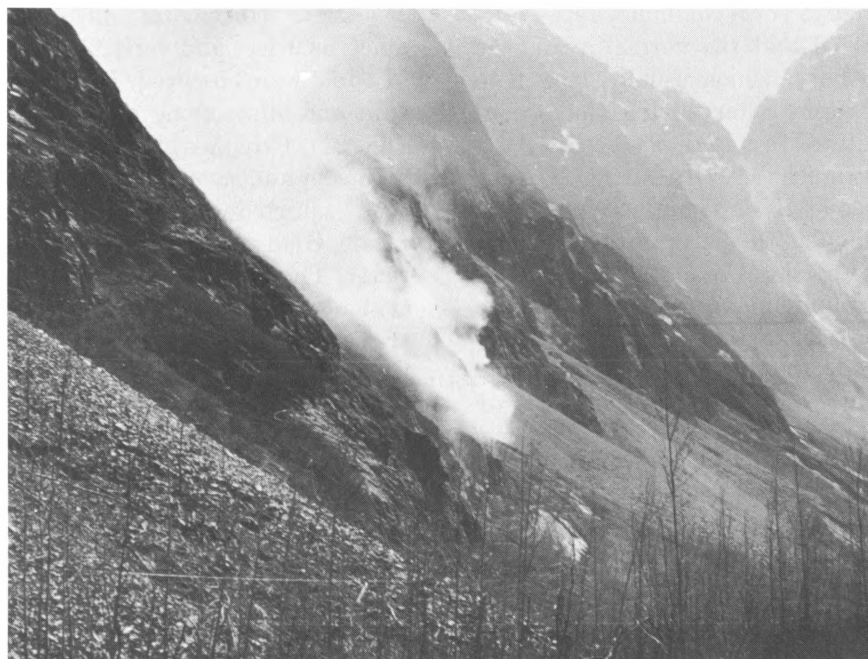
22.—Dust cloud in Eklutna valley caused by avalanche activity. The avalanching has been persistent during the summers since the earthquake.

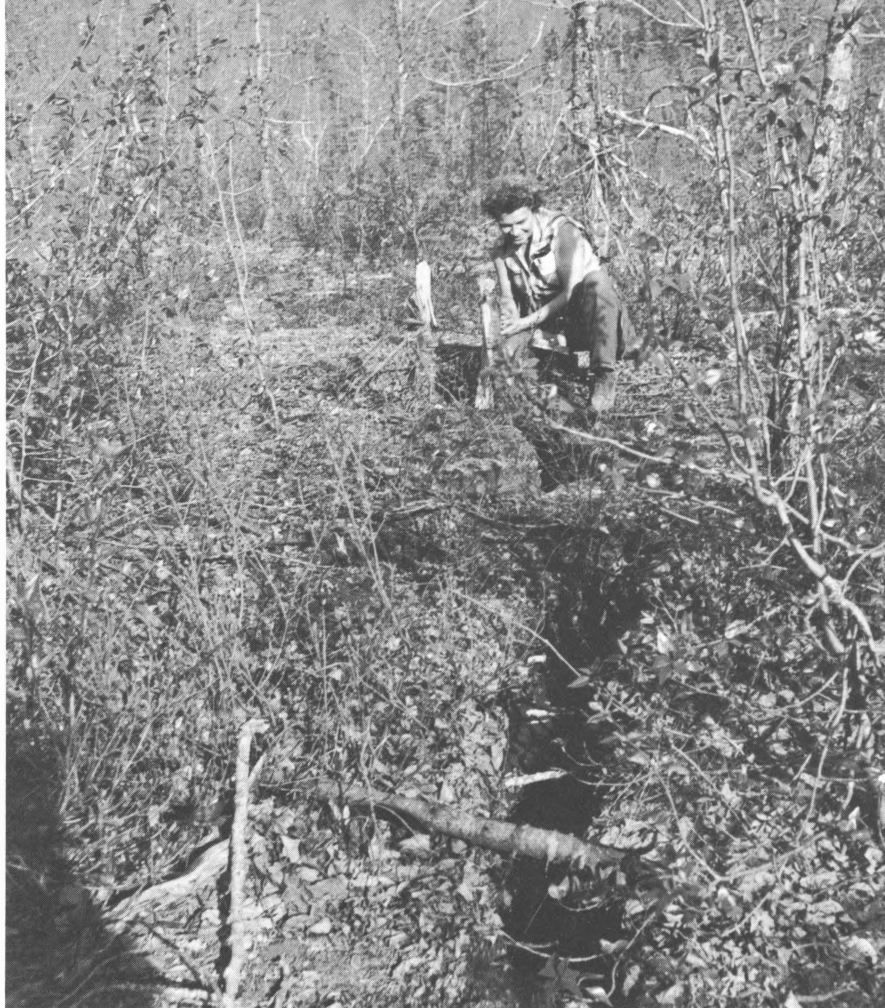
23.—Crack in gravel outwash in Eklutna valley. Crack was about 10 inches wide and split a tree stump. The two halves of the stump were offset about 14 inches.

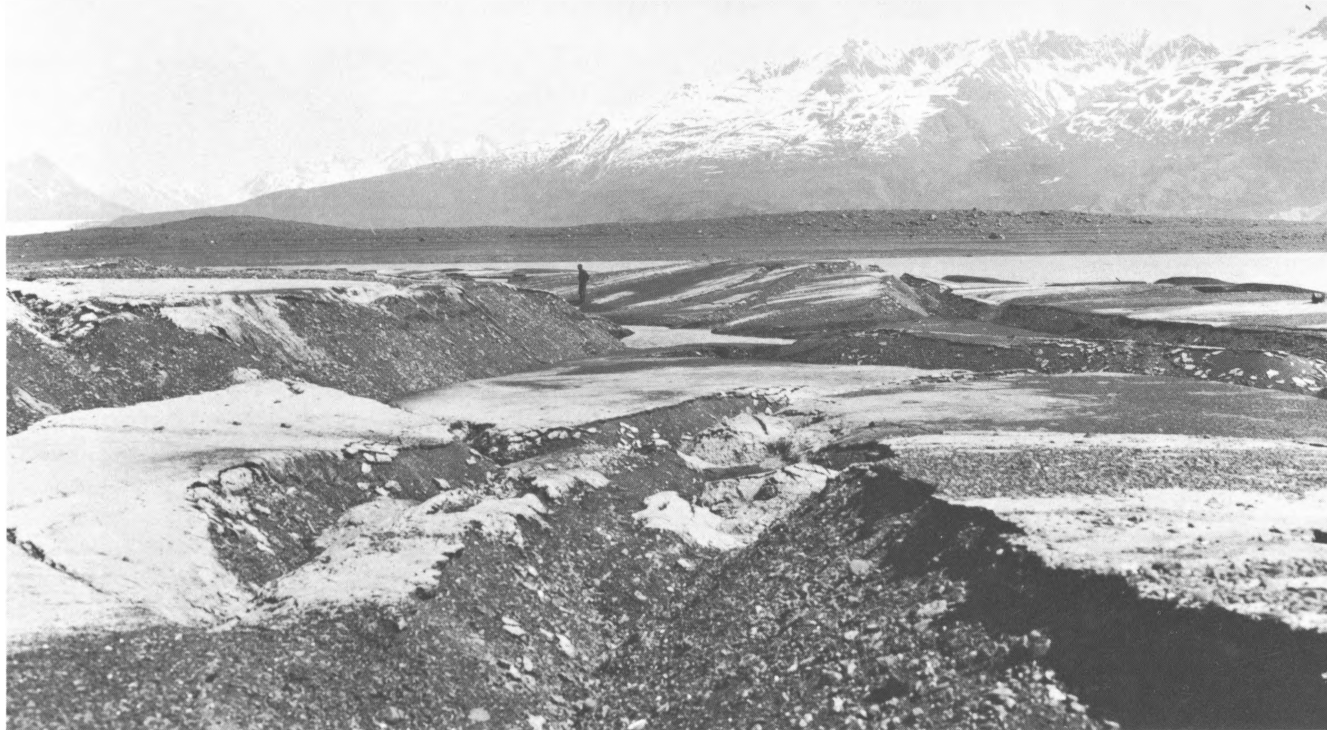
cracking associated with eruptive deposits of emerged bottom sediments at the head of the lake. The most extensive disruption occurred along the front of the Troublesome Creek delta where slumping caused lakeward rotational displacements of frozen gravel blocks as much as 20 feet wide and 100 feet long. Chaotic topography resulted (figs. 24, 25). The delta at the mouth of a creek entering the south end of upper Lake George failed by cracking along the margin of the delta front. Lateral extension, however, was slight, minor vertical or lateral displacements being evident along the cracks.

24.—Failure of the delta front at Troublesome Creek, Lake George (loc. C, fig. 25). Man is standing on a large slumped and rotated block that is bounded front and back by large fissures.

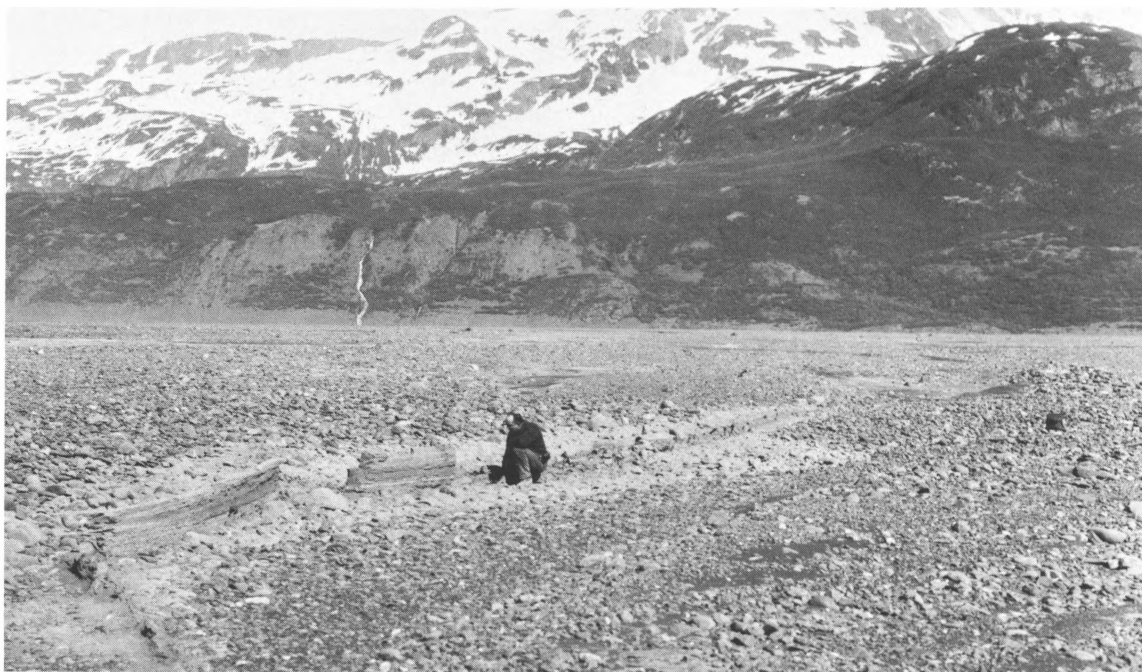
26.—Wall of silt punched up on the emerged bottom of Lake George. The wall was 8 to 24 inches high, 30 feet long, and 6 inches wide (loc. B, fig. 25).

Lake silt was squeezed out of the underlying water-saturated sediments and erupted through cracks in the seasonally frozen surface layer. At one locality a wall of frozen silt, 6 inches wide and about 30 feet long, was punched up 8 to 24 inches by pressures in the underlying unfrozen materials during the earthquake (fig. 26). The undisturbed structure of the fine laminated silts exposed in the wall indicated that the silt must have been rigid and frozen at the time of displacement. Disruption and minor dislocation of the wall along northeast-trending cracks indicate subsequent development of and minor displacements along cracks that cut transversely the northwest set of parallel fractures that defined the wall structure itself. At several locations, mounds of silt 1 to 2 feet high and 2 to 3 feet in diameter and showing internal flow structure formed at the intersection of the cracks. Unfrozen silt was squeezed up as ridges along some of the cracks (fig. 27). On the north side of the moraine along the south side of lower Lake George, some sand eruption occurred at the contact of the moraine with the lake sediments through cracks transecting the moraine.

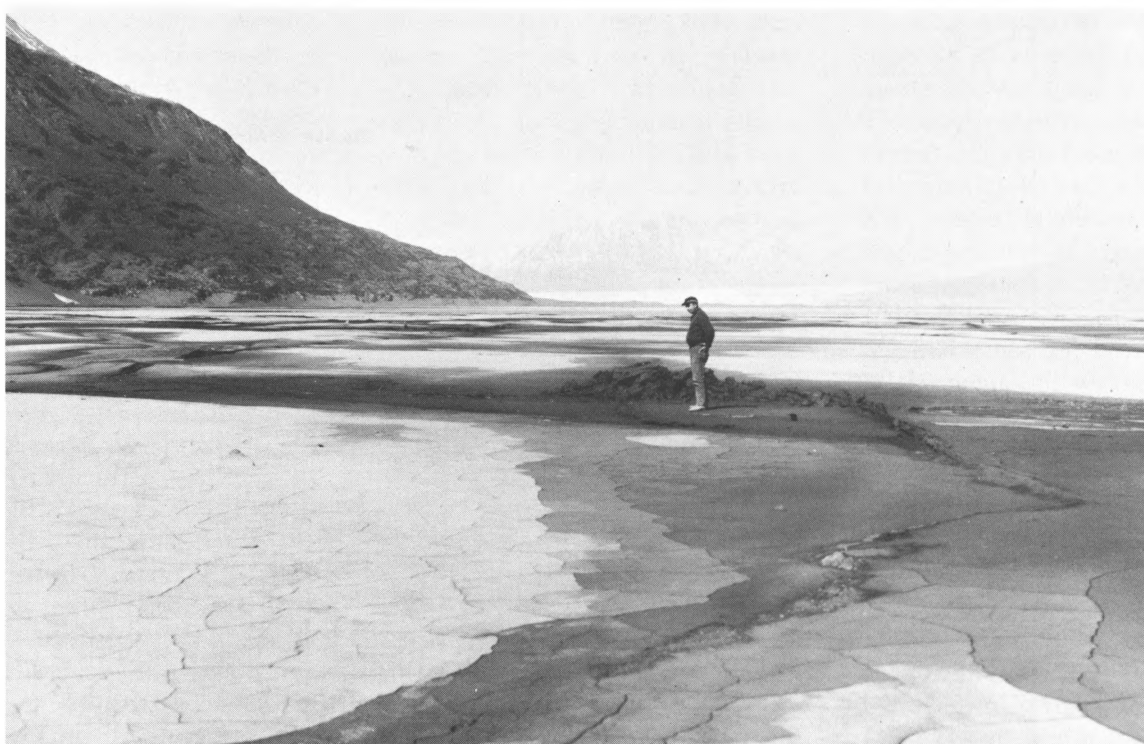
27.—Ridges of silt squeezed up along cracks in the emerged bottom sediments of Lake George (loc. A, fig. 25).

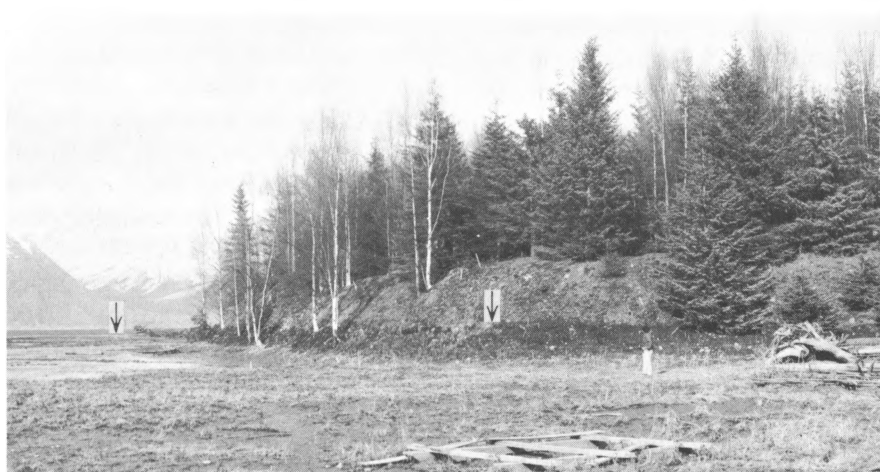
28.—Postearthquake high-tide mark along Turnagain Arm sea bluffs near Hope. Arrows indicate the pre- and postearthquake high-tide positions. The vertical distance of about 5 feet between these two positions approximates the amount of crustal subsidence that accompanied the 1964 earthquake.
