The Alaska Earthquake

Surface Faults
On Montague Island
Associated with the
1964 Alaska Earthquake

By GEORGE PLAFKER

GEOLOGICAL SURVEY PROFESSIONAL PAPER 543-G

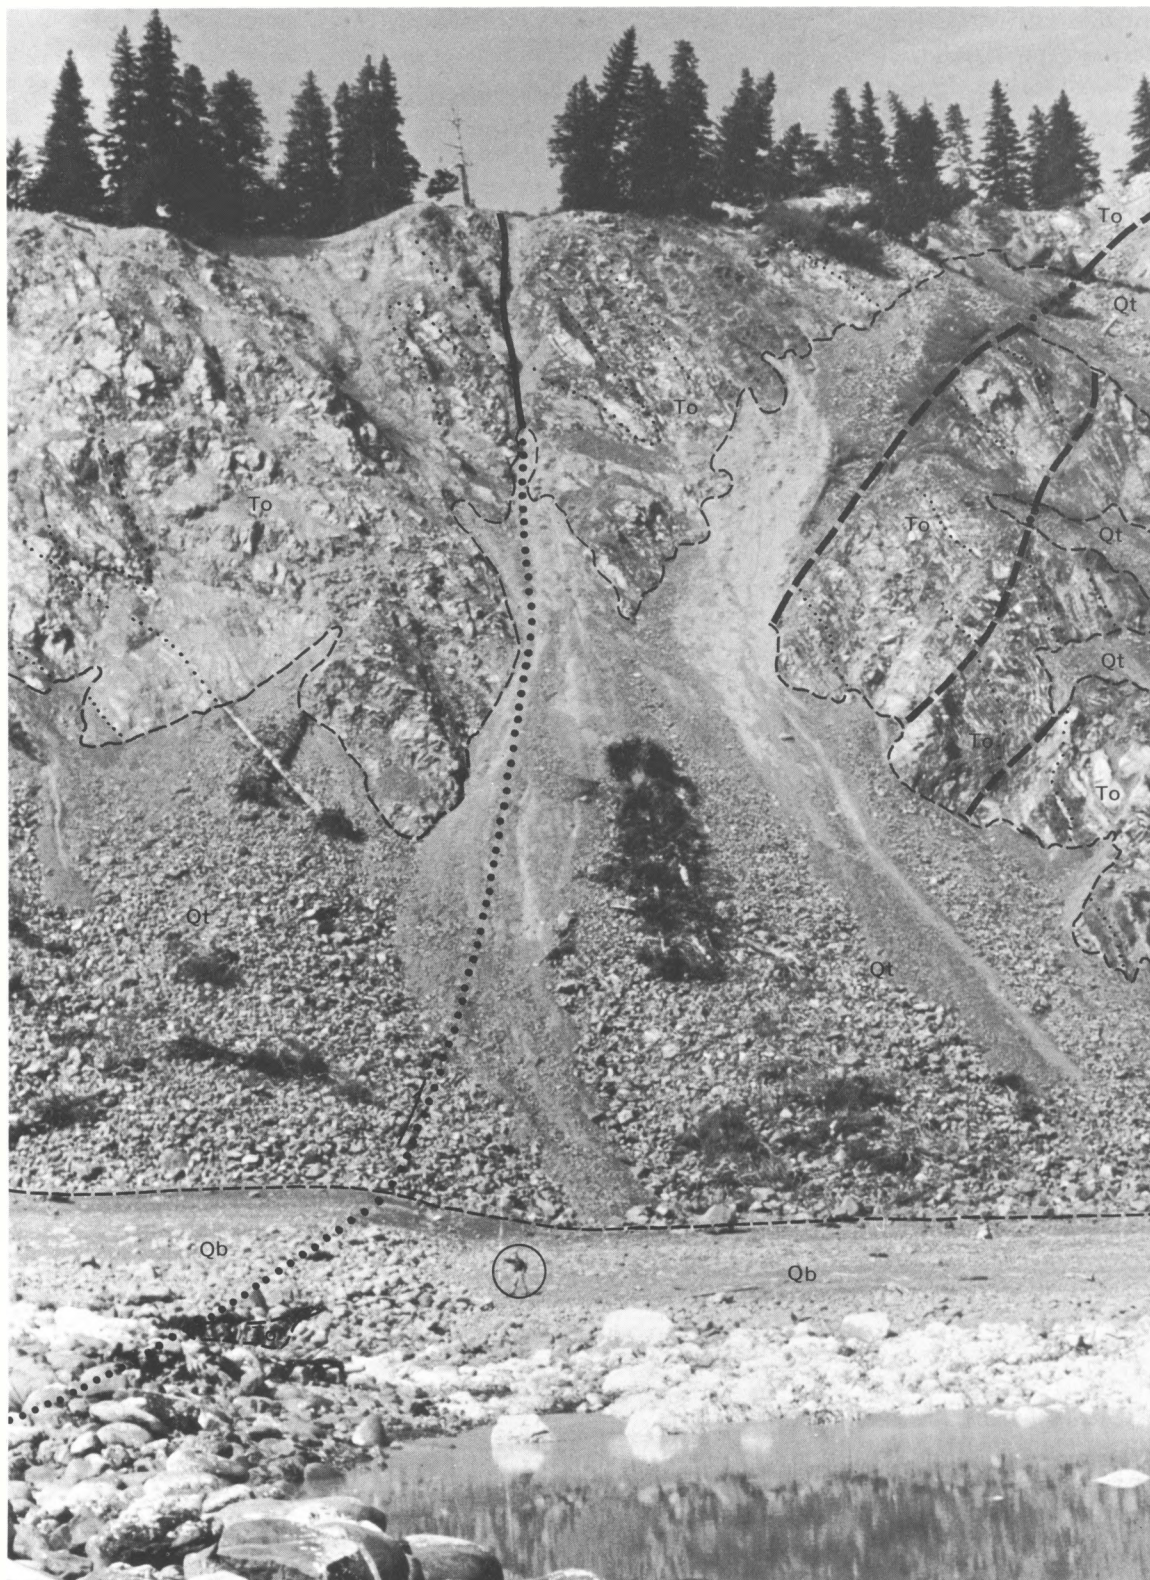
3.—Patton Bay fault (heavy solid and dotted line) at the beach and sea cliff near Jeanie Point. Note the vertical offset of contact between beach deposits (Qb) and talus (Qt). The man (circled) is standing at the base of a scarp 8½ feet high. Light dotted lines are bedding traces in the Orca Group (To); heavy dashed lines are probable fault traces on which there apparently was no movement during the earthquake. Location shown in figure 6.

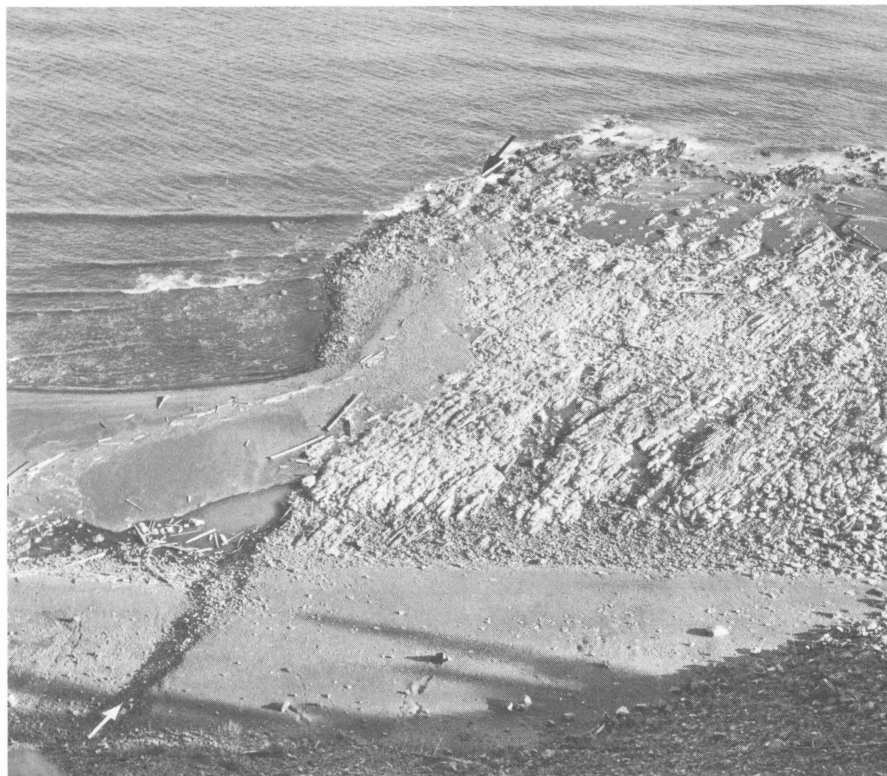
4.—View south from top of the sea cliff in figure 3. Arrows indicate fault trace which displaces the elevated beach prism and cuts obliquely across bedrock structures in the surf-cut platform on the upthrown block. The lower part of the scarp was partially obliterated with newly deposited marine sand and gravel by the time this photograph was taken in August 1965.

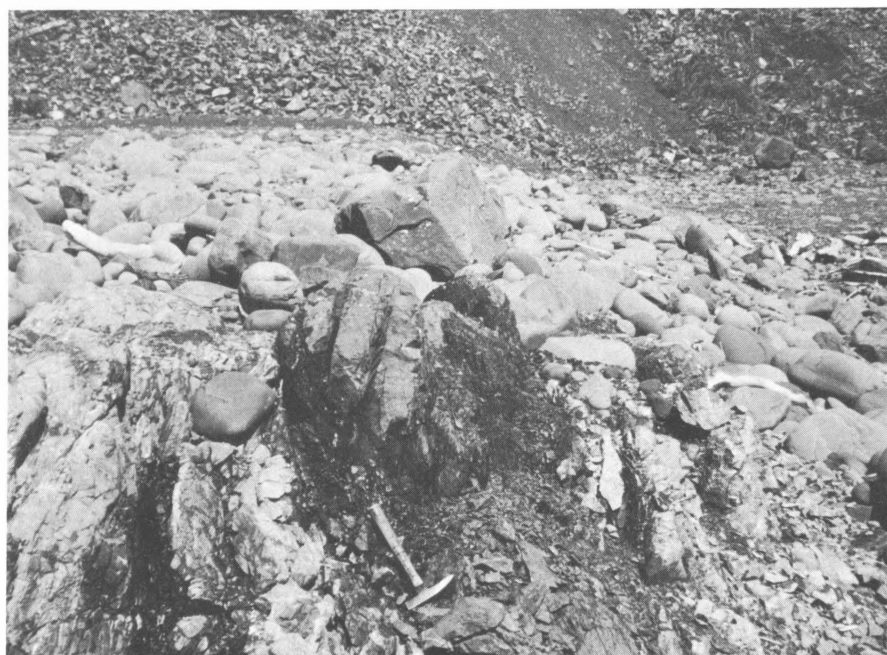
5.—Near-vertical zone of sheared quartz-veined argillite and graywacke along the Patton Bay fault trace at the shore. Location shown in figure 3.

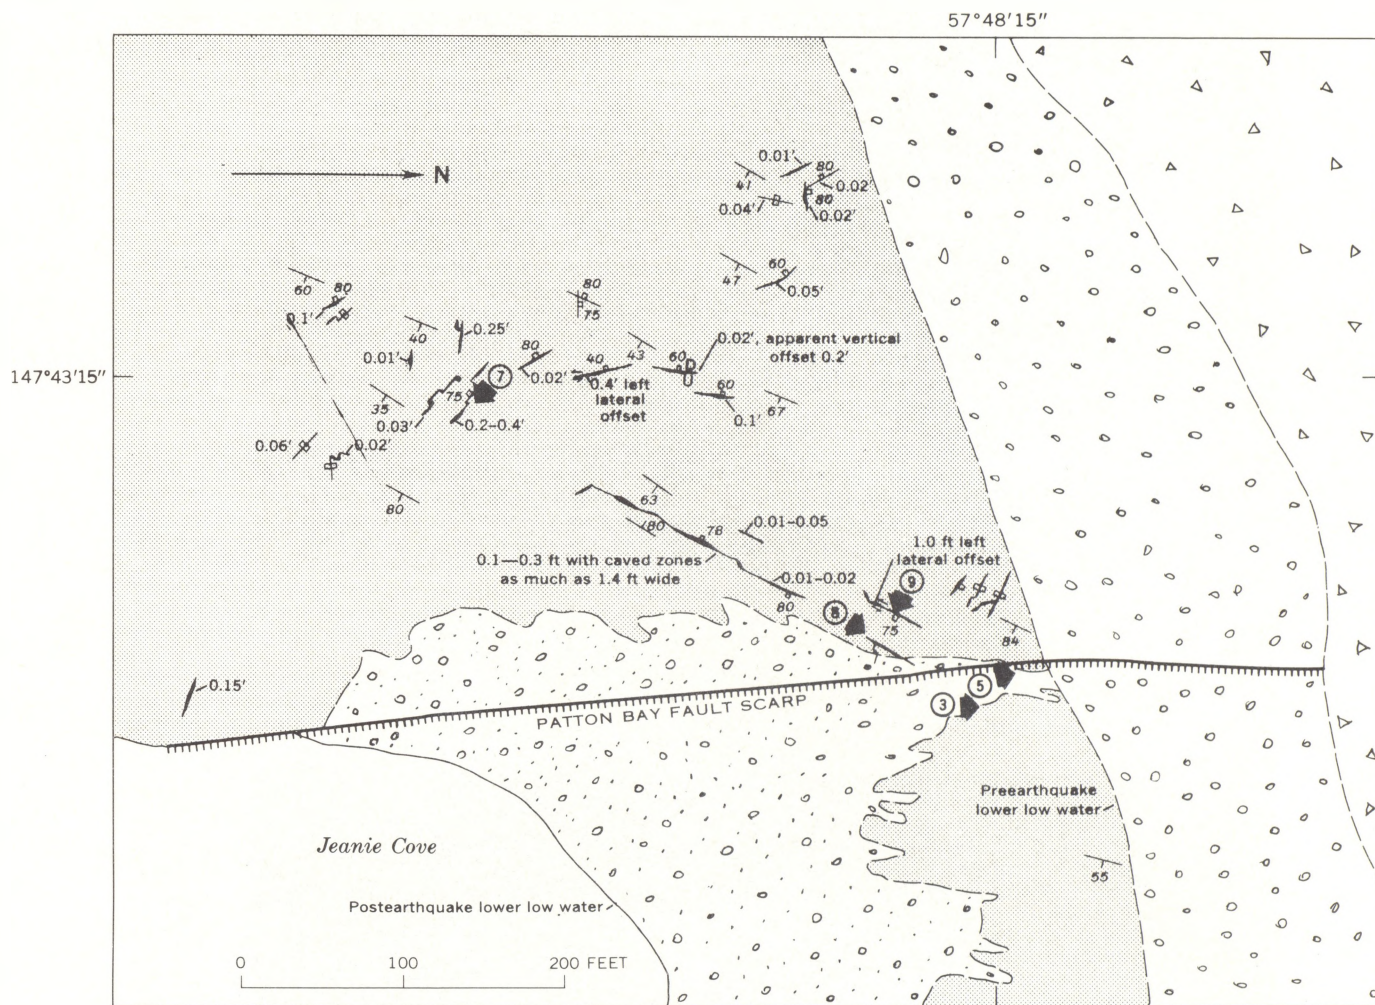
Numerous surface cracks as much as 170 feet long formed in bedrock on the reef part of the upthrown block within 400 feet of the scarp. These newly opened cracks can be readily differentiated from preearthquake cracks because they expose fresh surfaces that do not have a white coating of calcareous algae. Locations, orientations, and displacements of the largest and most conspicuous of these cracks, which were mapped by a pace-and-compass survey, are shown in figure 6. Three typical cracks are illustrated in figures 7-9; the photographs were taken at the locations indicated in figure 6. No newly opened cracks were found near the fault in the downthrown block; close to the fault, however, this block is largely covered by beach deposits.

The cracks all dip steeply or are vertical, and they appear to occur exclusively along bedding planes and preexisting joints. Displacement in the overwhelming majority of cracks is an extension perpendicular to the crack face ranging from less than 0.01 to 0.4 foot. Locally, the cracks are substantially widened where loose narrow wedge-shaped rock slivers as much as 1.4 feet wide have dropped down along them. Left-lateral displacements occurred along two of the cracks. One of the two trends northeast at an oblique angle to the fault scarp and was displaced 1.0 foot (fig. 9). The other crack, which is almost parallel to the scarp, had 0.4 foot of lateral offset.

6.—Sketch map of the scarp and open cracks in the upthrown block of the Patton Bay fault at the shore near Jeanie Point.

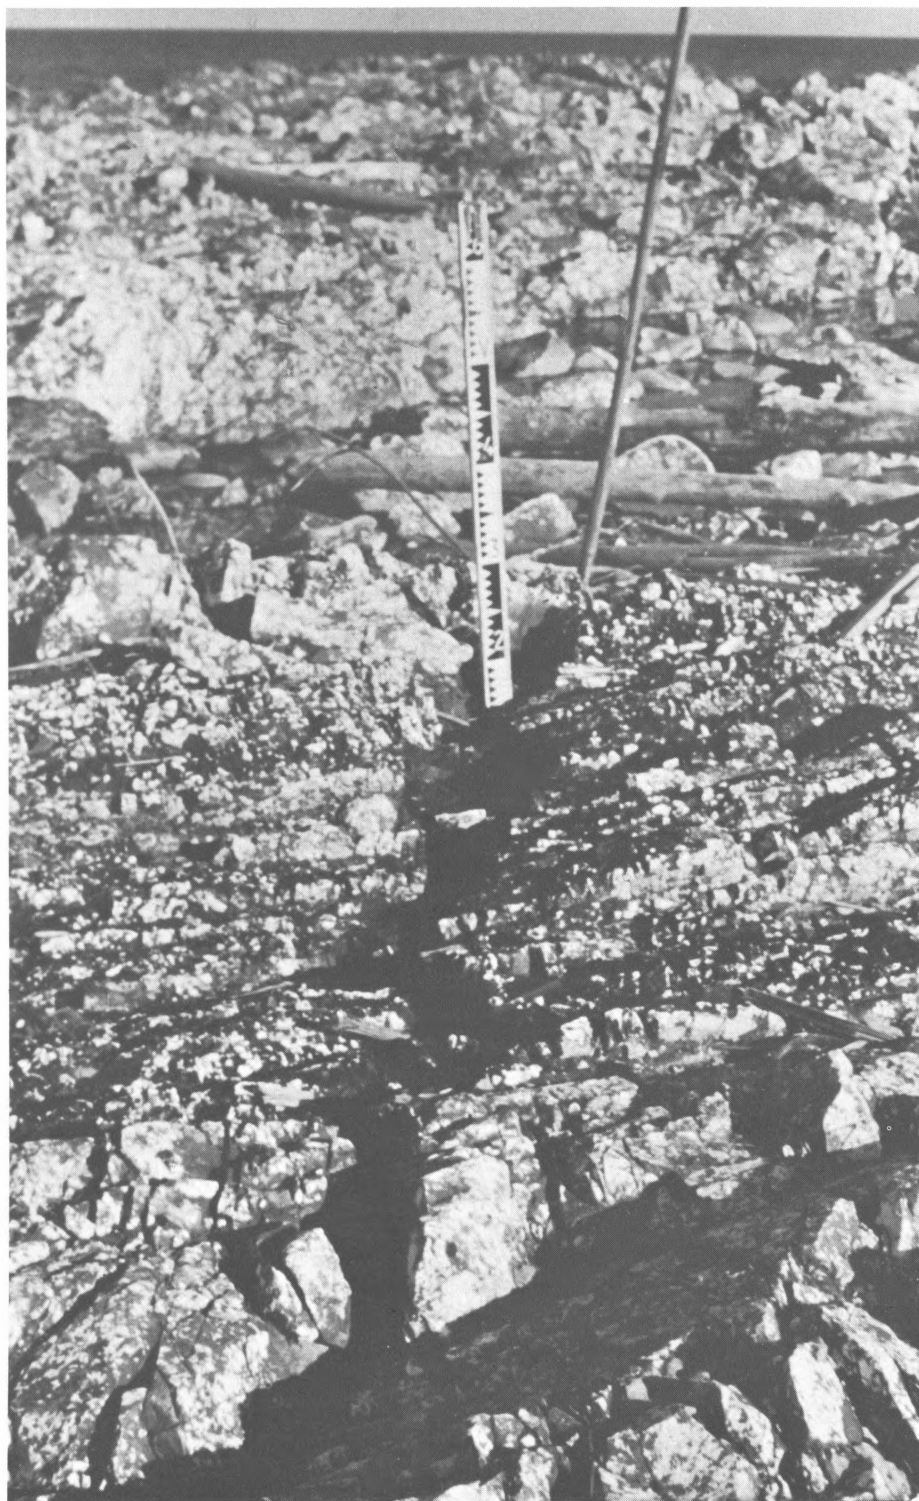
7.—Crack 0.2 to 0.4 foot wide and at least 2 feet deep in the warped relatively up-thrown block of the Patton Bay fault. Crack follows preexisting bedding and joint planes. Location shown in figure 6.

The open cracks that occur in the reef on the upthrown block are probably tension cracks associated with the downwarping near the fault. Left-lateral displacements observed on two of these cracks suggest a possible small strike-slip component of movement of less than 1½ feet on the Patton Bay fault at this locality. No conclusive evidence for horizontal offset of the preearthquake beach strand lines that cross the fault scarp was found on the ground, although an apparent slight tendency for left-lateral bending of these lines was noted on the large-scale vertical aerial photographs.

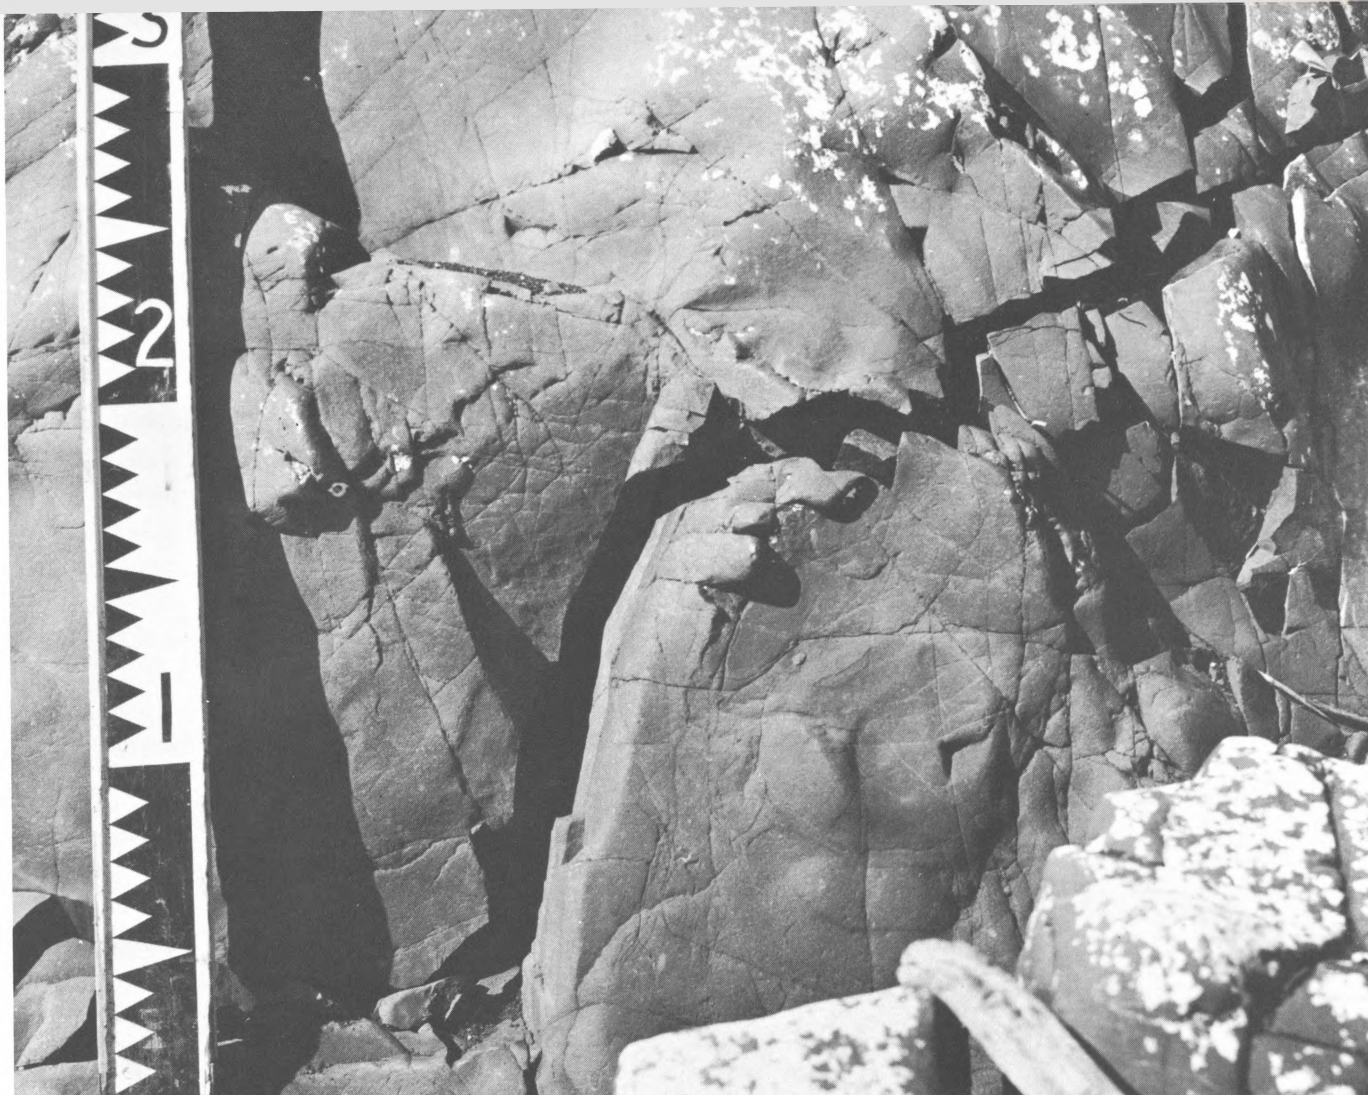
8.—Looking down on vertical crack 0.01 to 0.015 foot wide along preexisting joints in a hard graywacke bed. Location shown in figure 6.

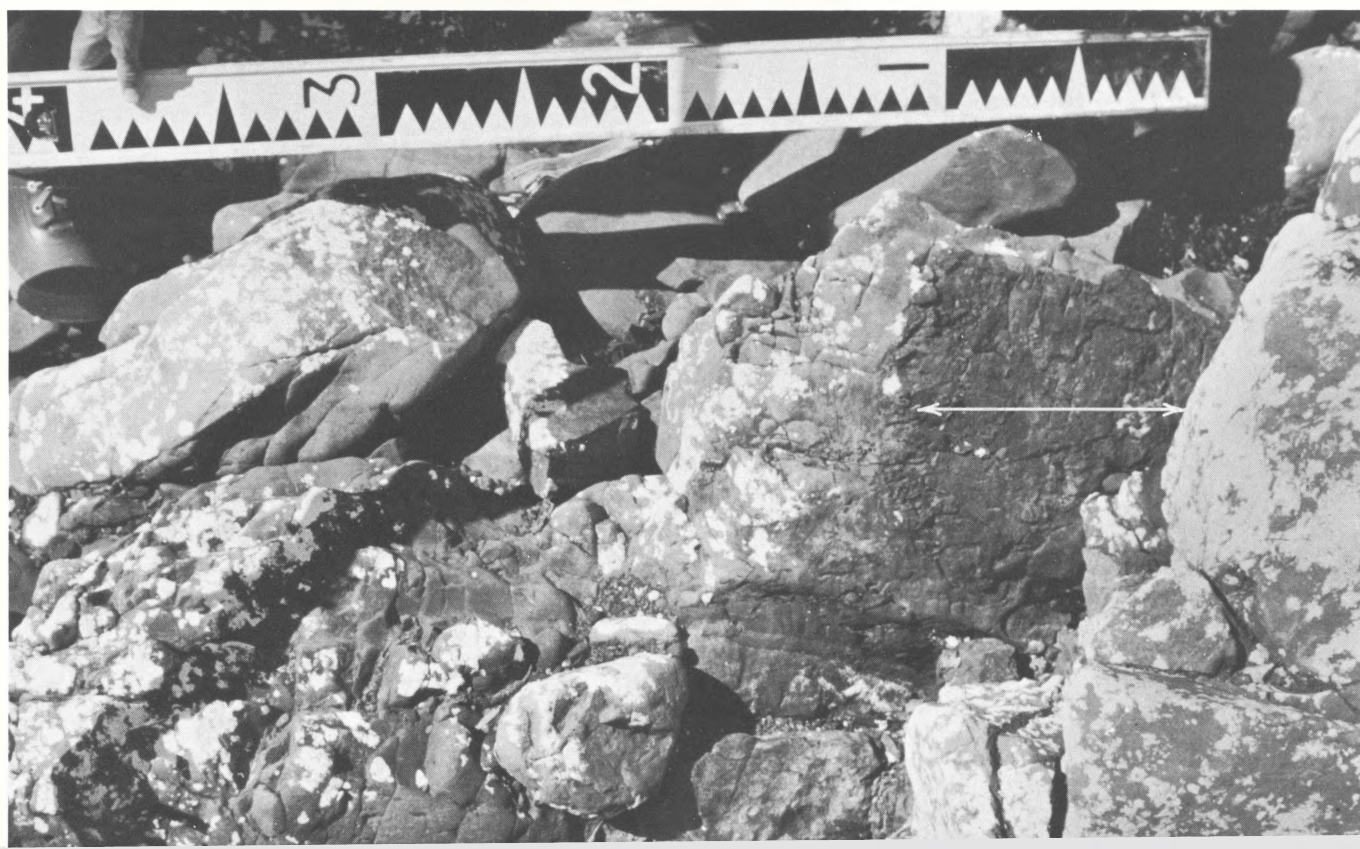
9.—Crack along bedding plane in massive indurated sandstone; 1 foot of left-lateral separation. Location shown in figure 6.

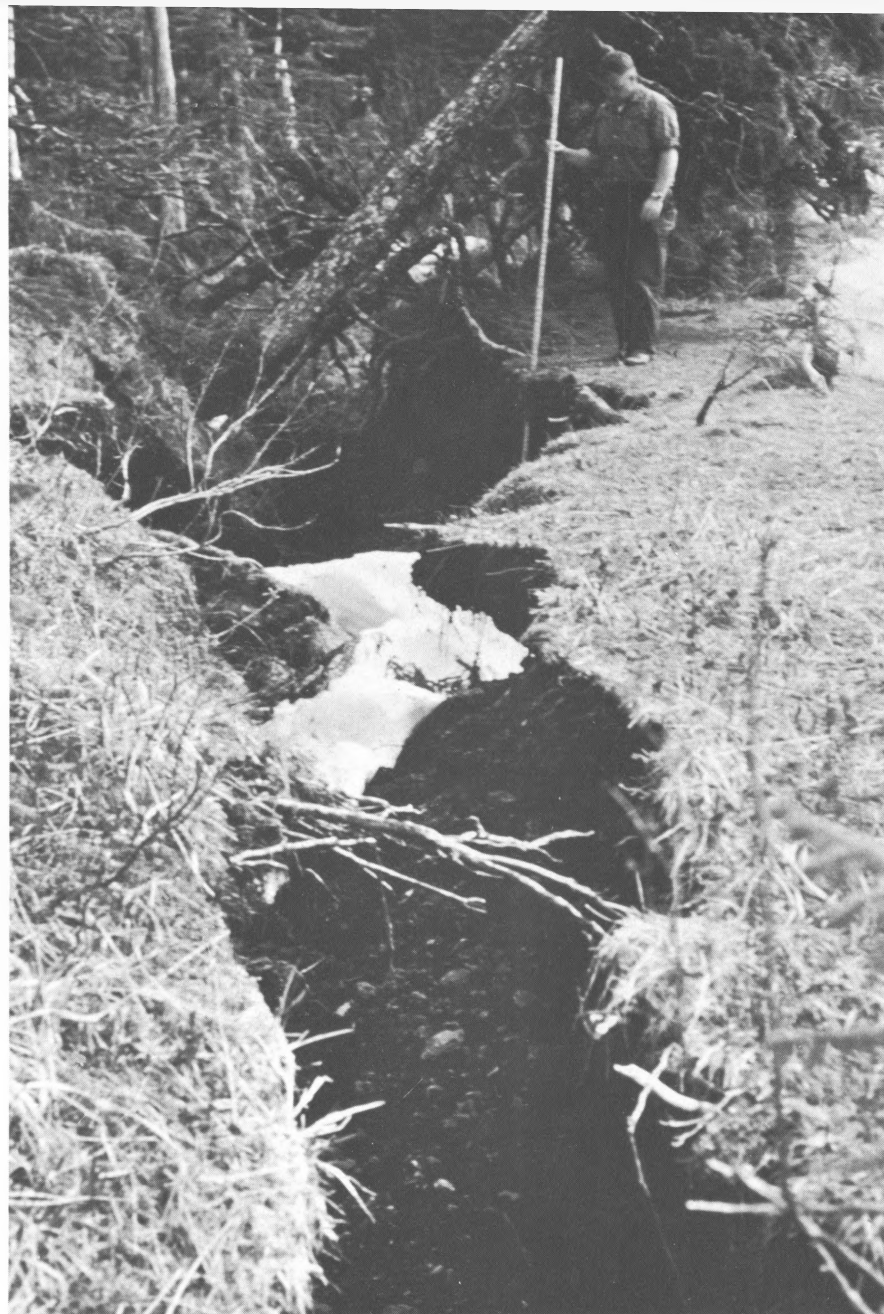
10.—One of the larger fissures along the trace of the Patton Bay fault. The fissure, which is 3 feet wide and 7 feet deep, is in unconsolidated glacial till.

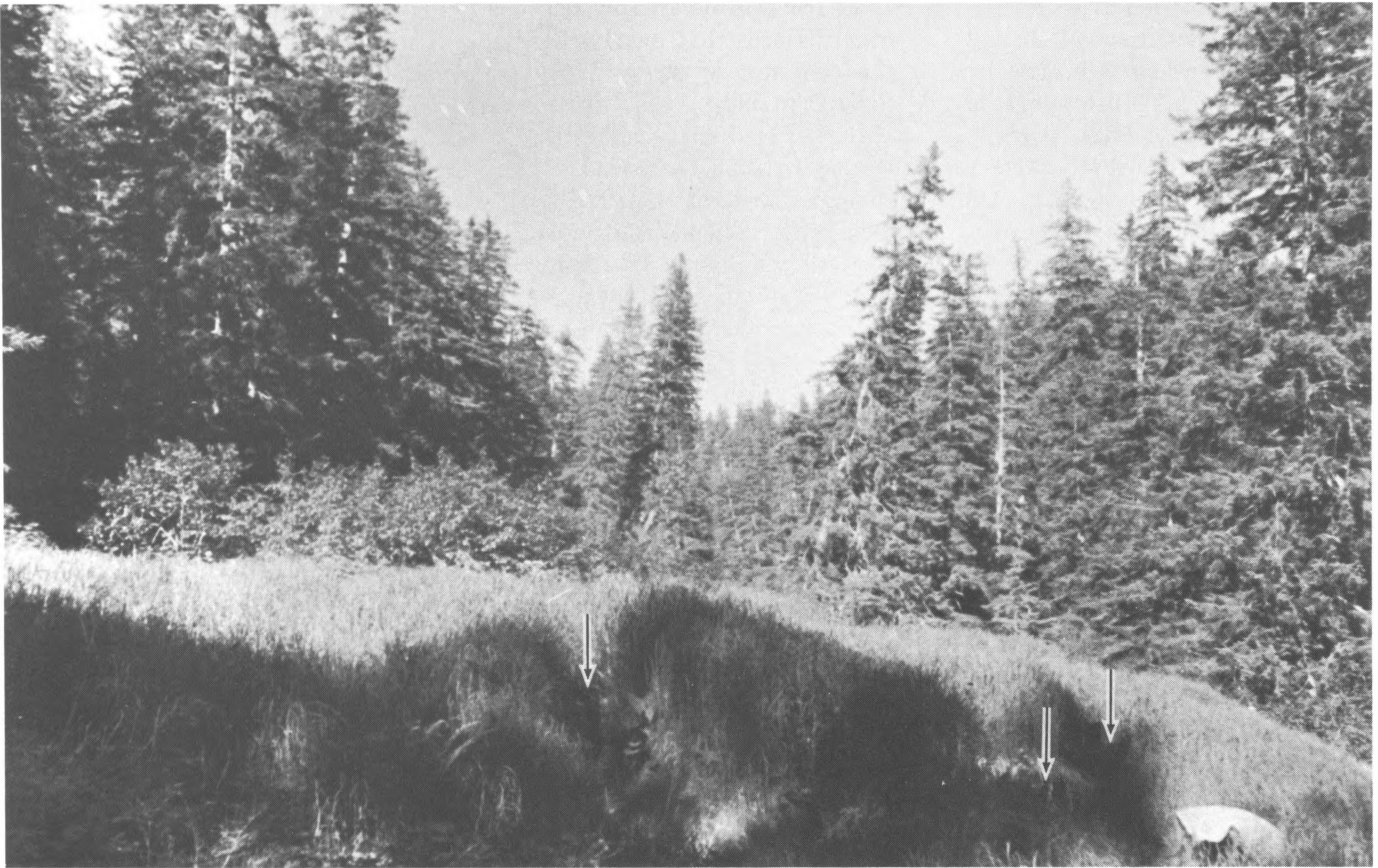
12 (above right).—Warped and fissured muskeg surface along the Patton Bay fault trace. West (left) side of this formerly flat meadow is uplifted 16½ feet relative to the east side. Tilted trees in the background are along the flexure zone that marks the fault trace. Note the characteristic tilt of tree crowns toward the downthrown block. Arrows indicate fissures.

the adjacent wooded area. A continuous sharp flexure about 60 feet wide in the muskeg is broken by a series of open fissures parallel to the trend of the fault that displace the muskeg-covered surface and underlying stream gravel (fig. 12). Relative vertical displacement across the part of the flexure in the bog is roughly $16\frac{1}{2}$ feet. This estimate of the vertical movement is minimal, because it includes only part of the zone of surface warping associated with the fault. The total width of the zone, as indicated by the distribution of spruce trees which are tilted towards the downthrown block owing to warping of the surface, is roughly 125 feet at this locality.

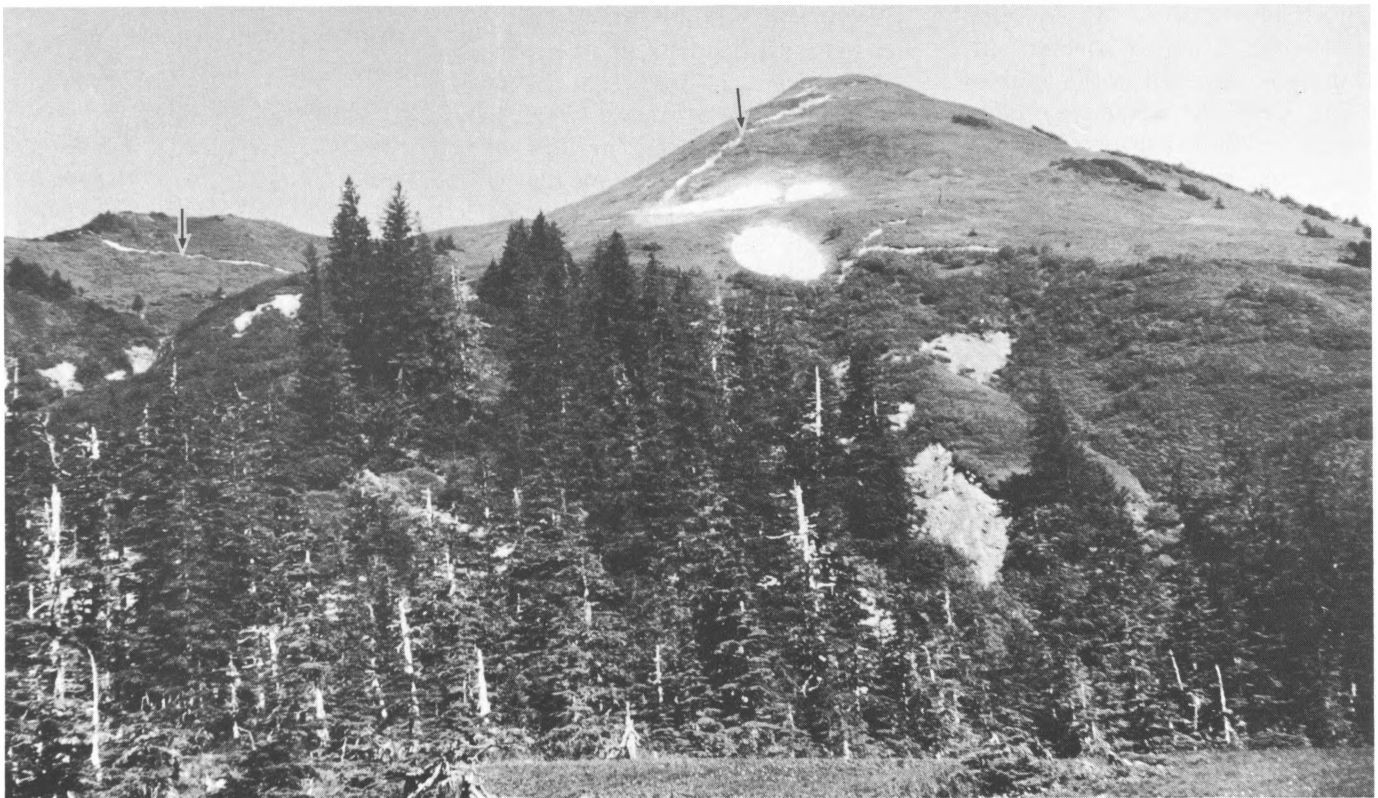
13 (bottom right).—Part of the zone of tectonic fissures north of Tortuous Creek. Two of the larger laterally persistent fissures (arrows) that trend obliquely across the slopes are visible above the brush line. The cracks and scars below the brush line result from earthquake-induced landslides and soil flows. Photograph by M. G. Bonilla.

Immediately to the north of Tortuous Creek, displacement is indicated by a zone of fissuring about half a mile wide that lies between the southern and central segments of the fault (pl. 1; fig. 13). The fissures range from a few hundred to more than 1,000 feet in length, and most have east-facing scarps. The more continuous of these fissures are clearly tectonic features inasmuch as they ignore topography and trend obliquely across mountain slopes and even over ridges as high as

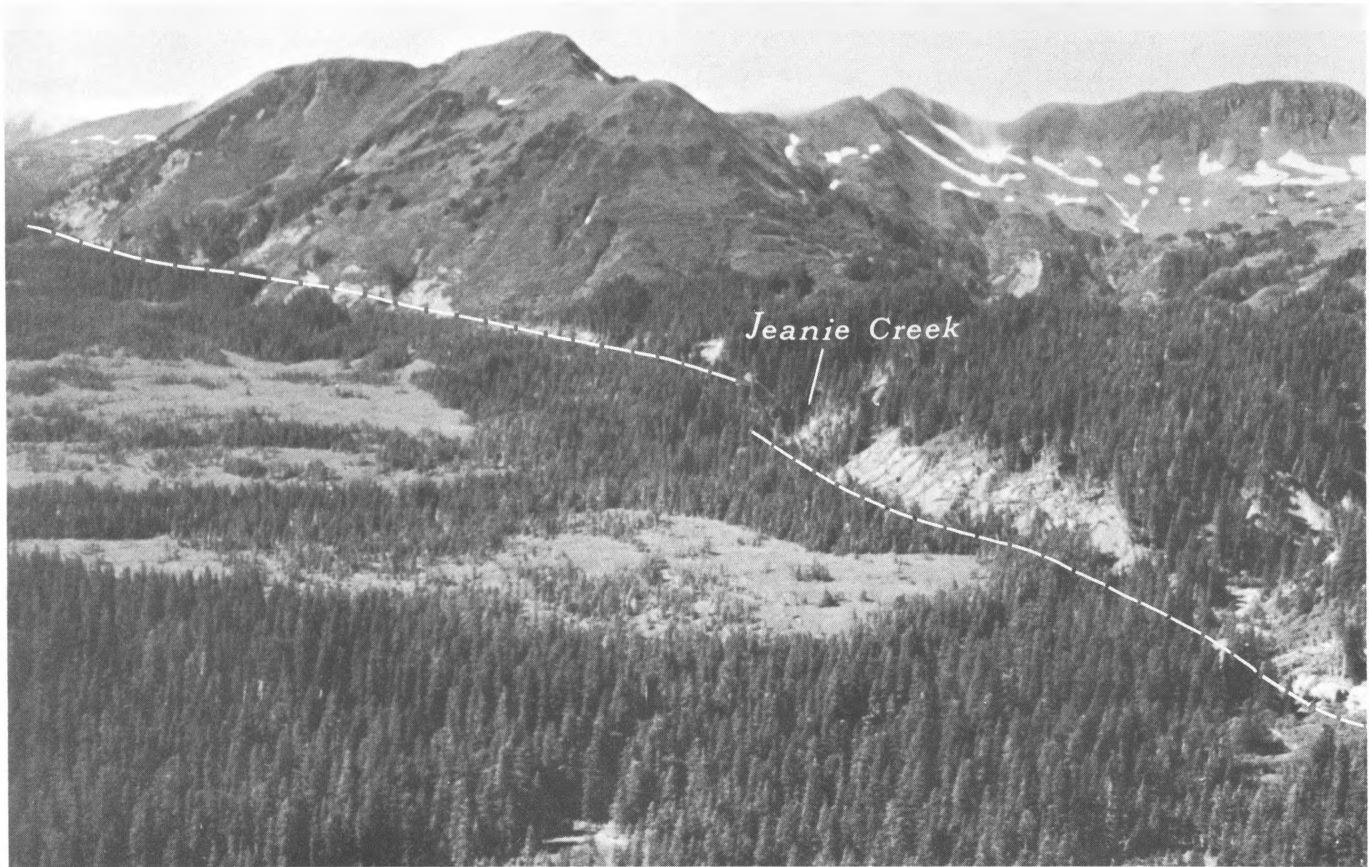
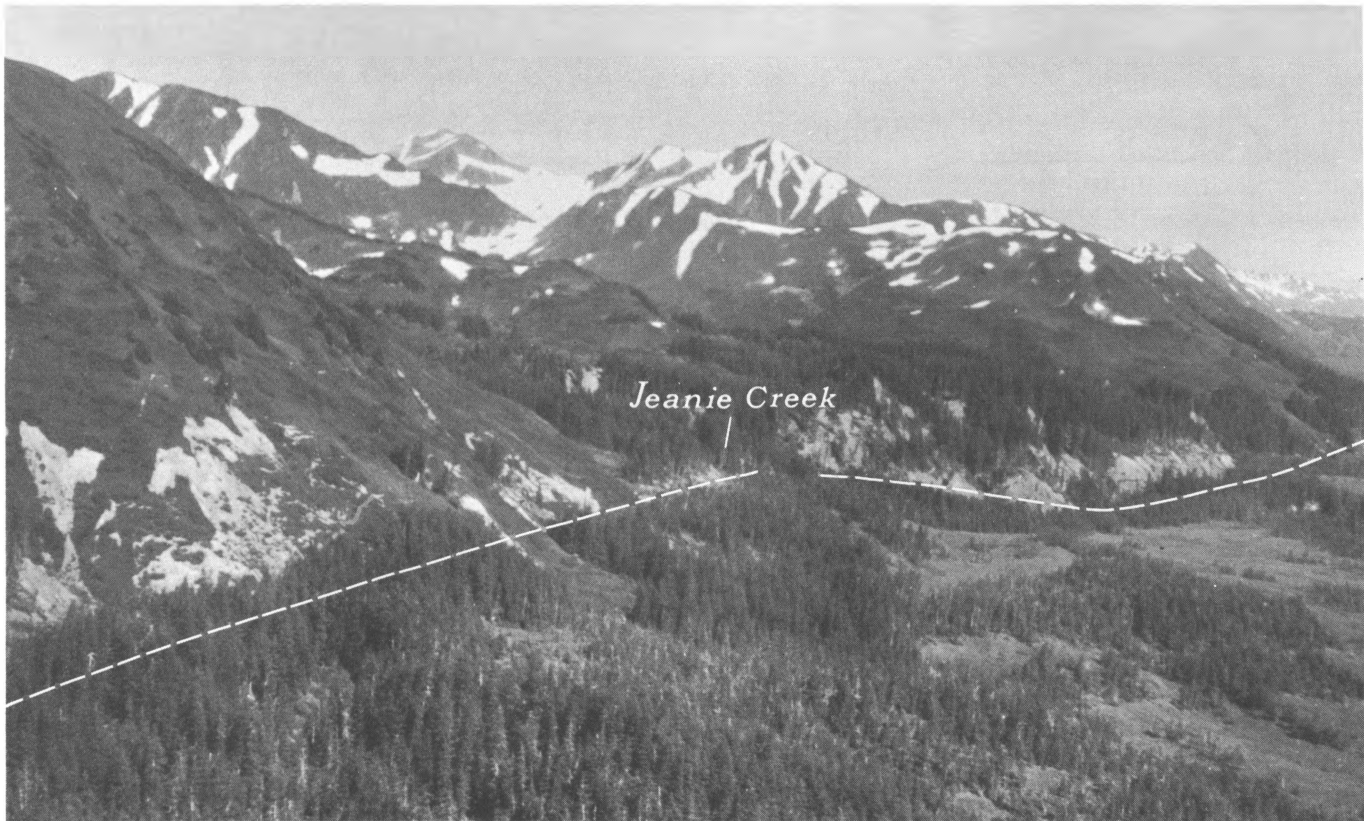
15.—Patton Bay fault (dashed) looking northeast toward Jeanie Creek. The segment of the fault north of Jeanie Creek is offset about 0.4 mile to the east relative to the segment south of the creek. →

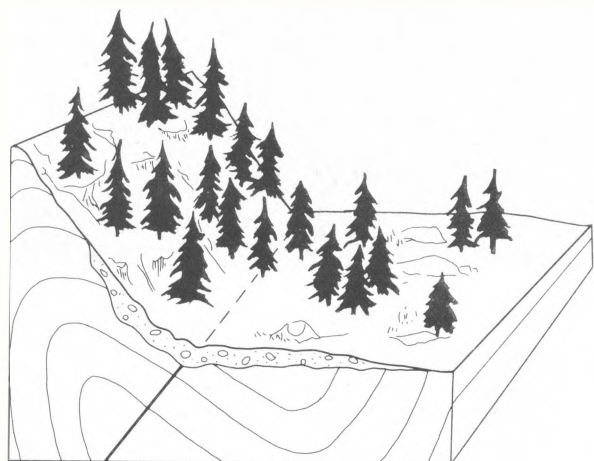
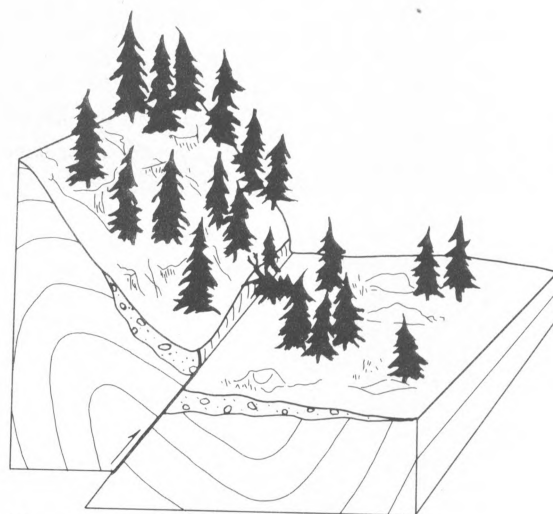
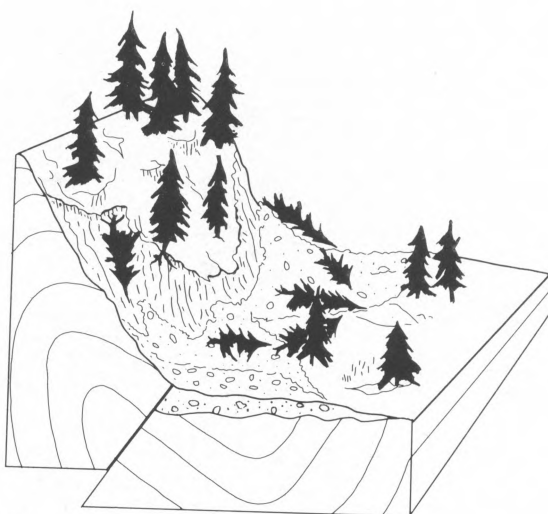
17 (below left).—Sequential diagram illustrating stages in growth of landslides along the base of a fault scarp of the reverse type upon renewed dip-slip displacement. A, preearthquake condition; B, overhanging scarp formed near base of slope by renewed fault movement; C, collapse of unstable slope above the fault scarp.

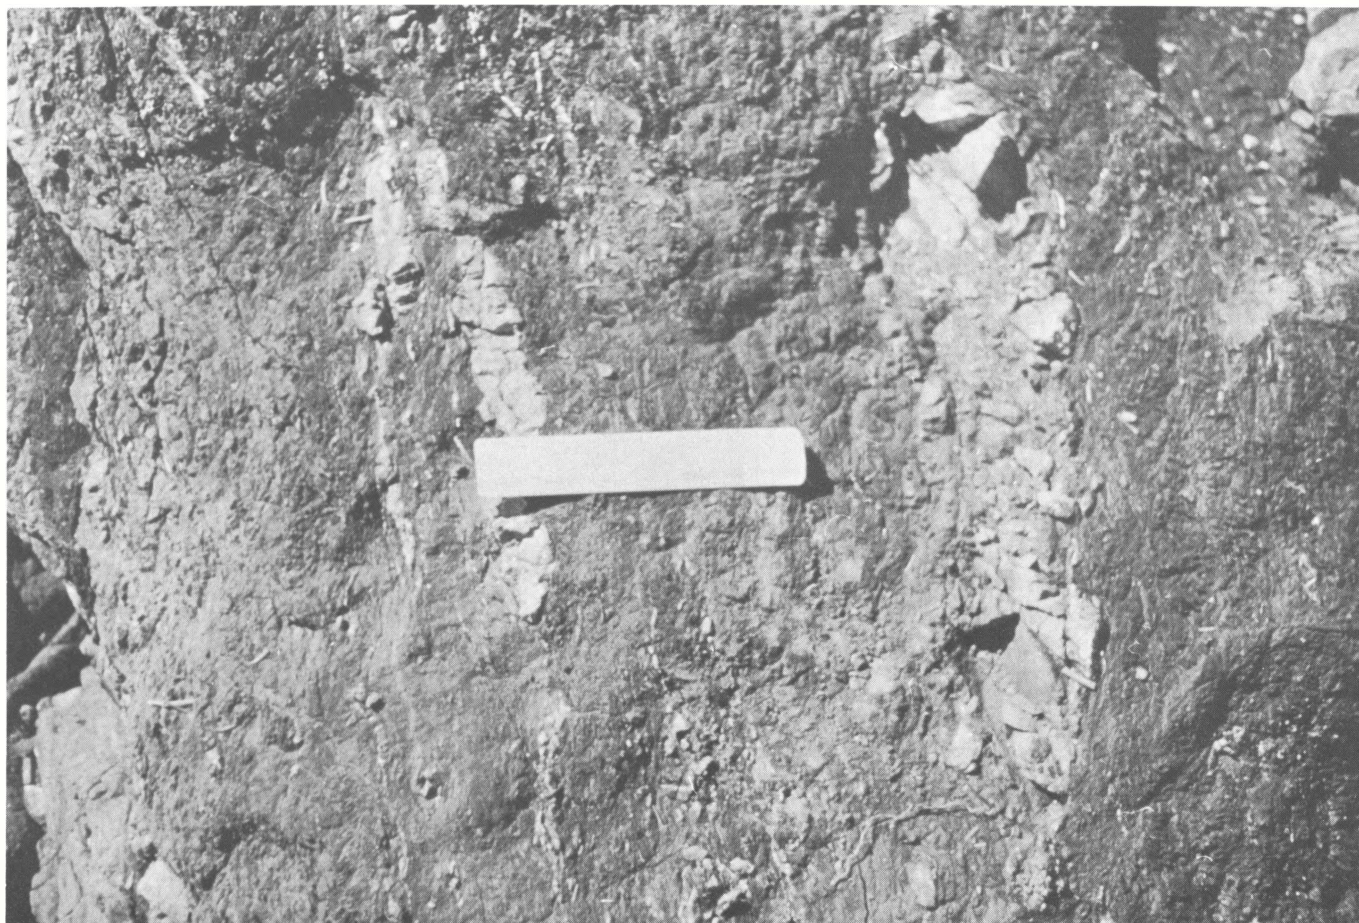
18.—Shattered lenticular boudins of light-gray indurated sandstone in a matrix of sheared black argillite dipping 75° to 85° northwest along the Patton Bay fault at Jeanie Creek.

Part of the fault zone is exposed in a 3-foot-wide outcrop in the bank of Jeanie Creek. The outcrop consists of shattered lenticular boudins of light-gray fine- to medium-grained arkosic sandstone in a matrix of sheared black argillite (fig. 18) that strikes N. 65° E. and dips 75° to 85° northwest. On the north side of the creek the fault passes through a terrace deposit of stream gravel which has been displaced into four gently sloping steps 10 to 20 feet wide separated by three fissured rises of comparable width that are strongly tilted toward the downthrown (east) block. Minimum cumulative vertical displacement of 10 to 12 feet is represented by the rises that displace the terrace.

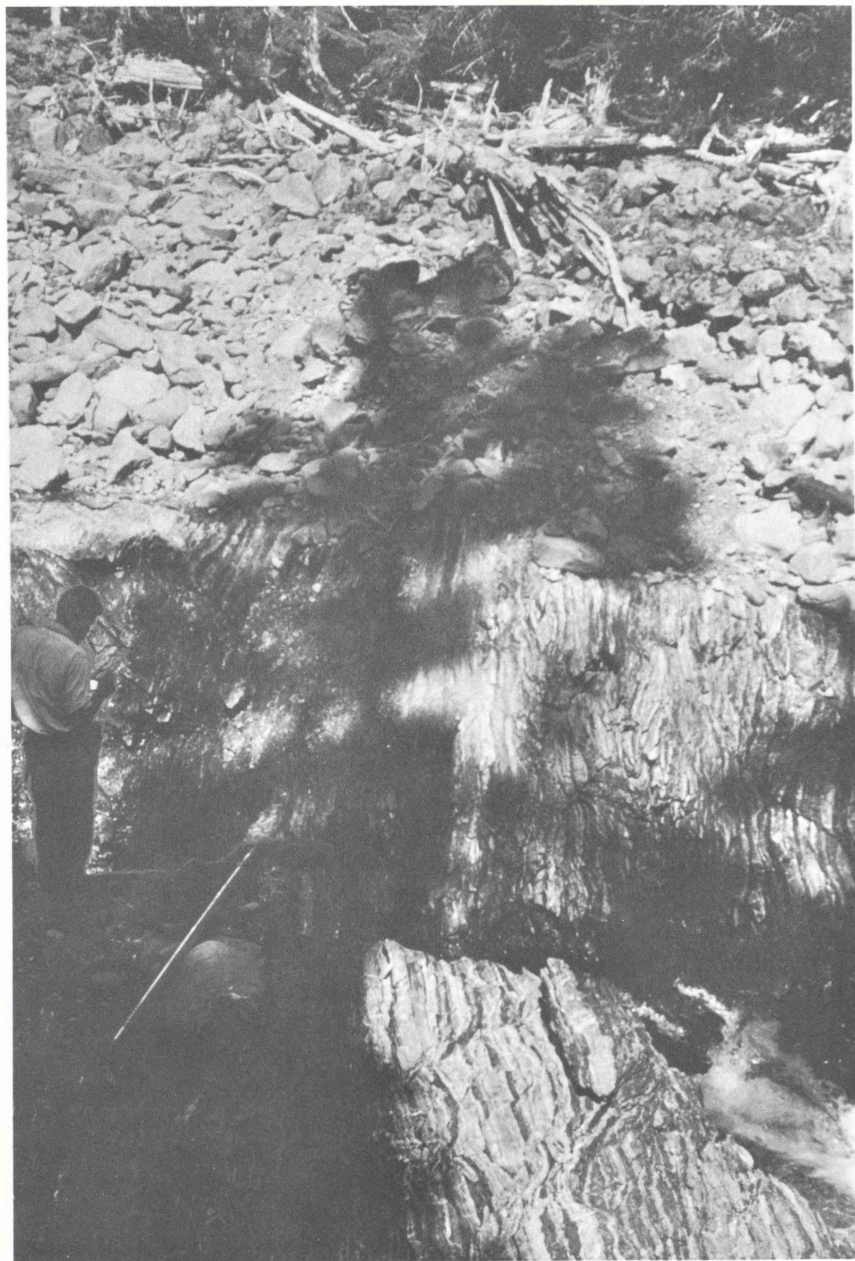
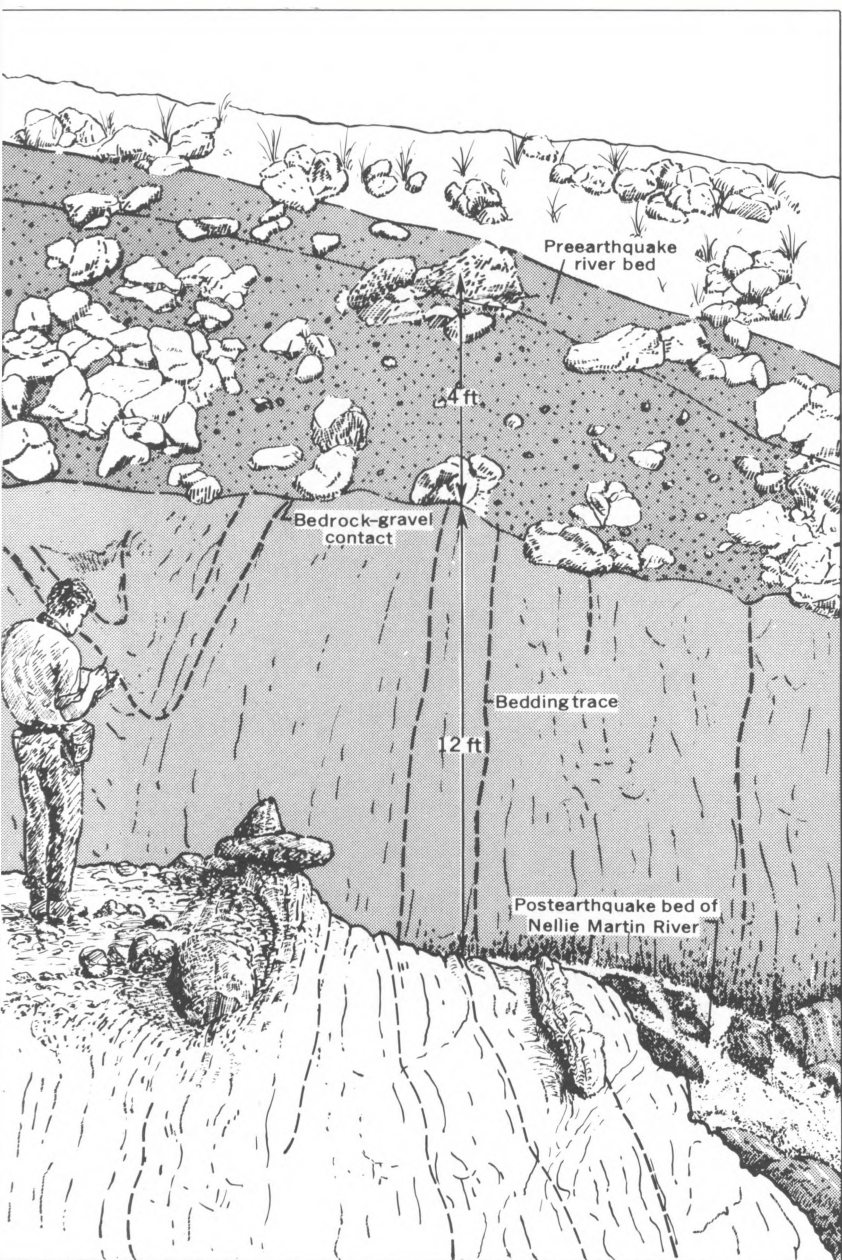
One mile farther north the fault plane is again exposed in the banks of Nellie Martin River; its trace is clearly defined where it crosses the broad alluvial flood plain of the river. The fault zone in the upthrown block along the river consists of 75 feet of intensely sheared siltstone containing veins and lenticular masses of quartz less than half an inch wide; bedrock is concealed by stream deposits in the downthrown block. The siltstone in this zone is so fractured throughout that it can be readily broken into chips by hand. The sheared rock trends N. 35° E. and dips northwest at angles ranging from 50° to near vertical. By August of 1965 the Nellie Martin River, which flows directly across the strike of the bedding and the fault, had incised its channel below the preearthquake level, through 4 feet of stream gravel and 12 feet of bedrock immediately upstream from the fault trace. The amount of incision suggests a minimum of 16 feet of relative vertical displacement across the fault at this locality (fig. 19).

19.—Incised channel of the Nellie Martin River immediately upstream from the gravel and 12 feet of bedrock at this locality between March 27, 1964, and August

Patton Bay fault scarp. The rejuvenated river has eroded about 4 feet of boulder, 1965. Photograph by L. R. Mayo.

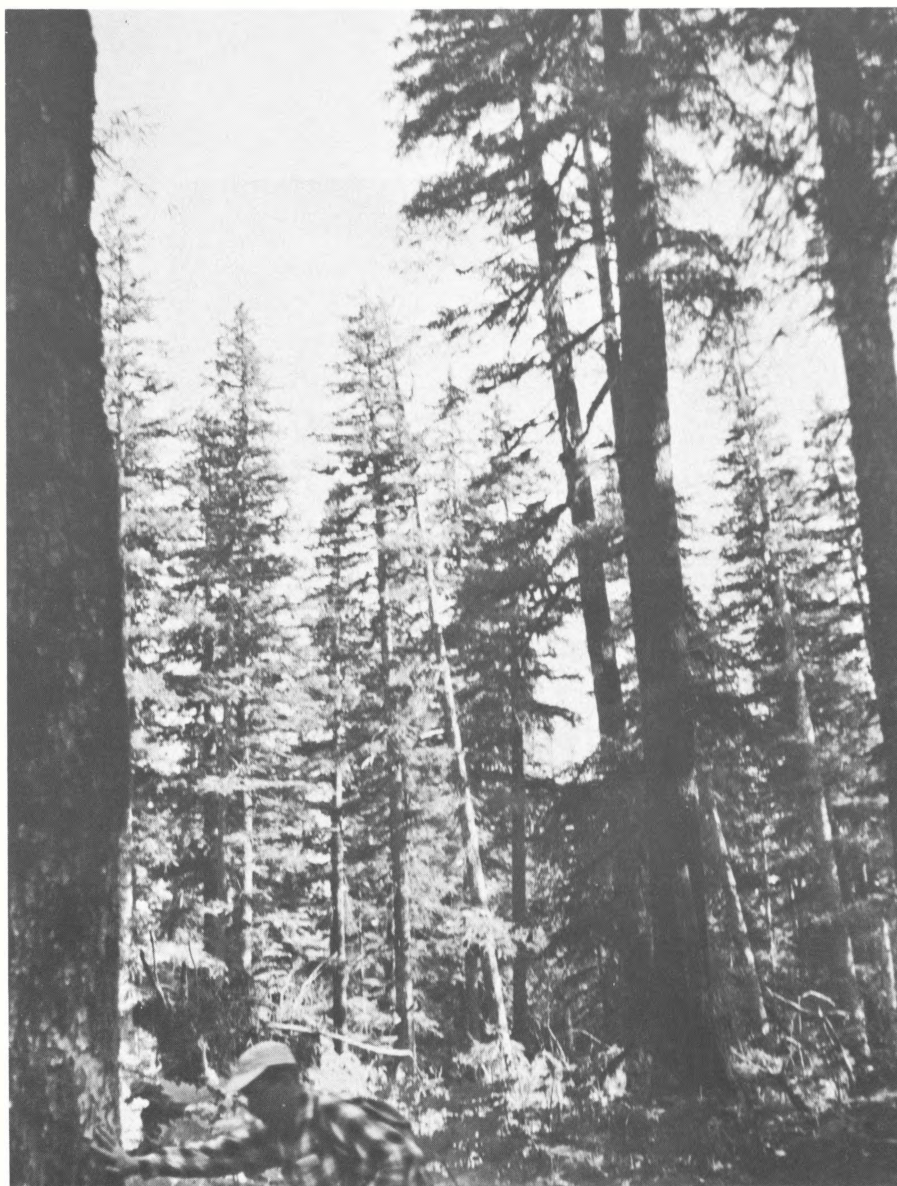
20.—Looking southwest along the Patton Bay fault in the alluviated valley of Patton River. The fault trace is indicated by the tilted giant Sitka spruce trees and by ground fissures that roughly parallel the zone of tilted trees.
