The Alaska Earthquake

Surface Faults
On Montague Island
Associated with the
1964 Alaska Earthquake

By GEORGE PLAFKER

GEOLOGICAL SURVEY PROFESSIONAL PAPER 543-G

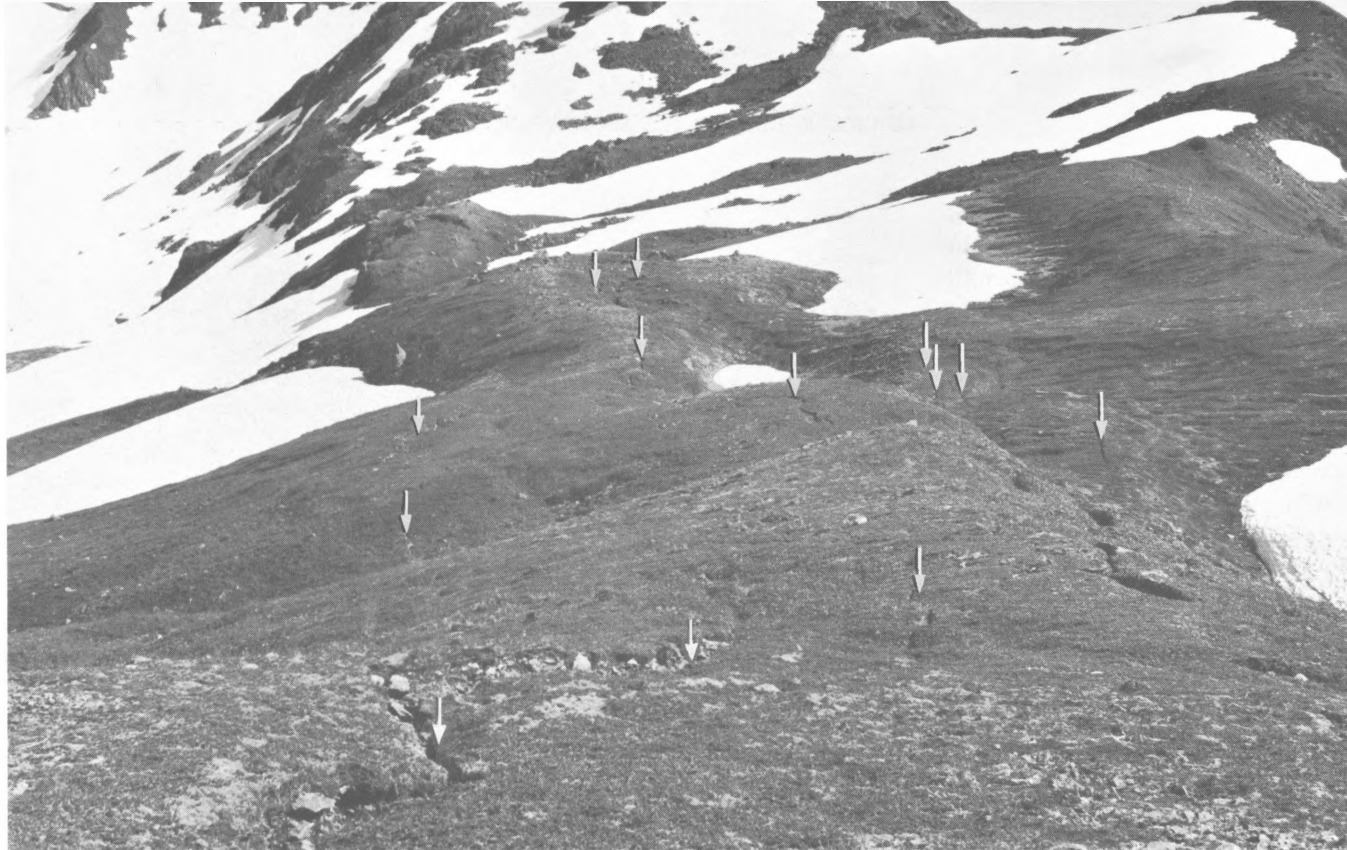
21.—Part of the zone of tectonic fissures at 3,000 feet altitude on the ridge summit north of Patton River. The fissures, some of which are indicated by arrows, could be traced almost continuously to the northeast through the peak (center of photograph) and the notch on the skyline to the left of the peak.

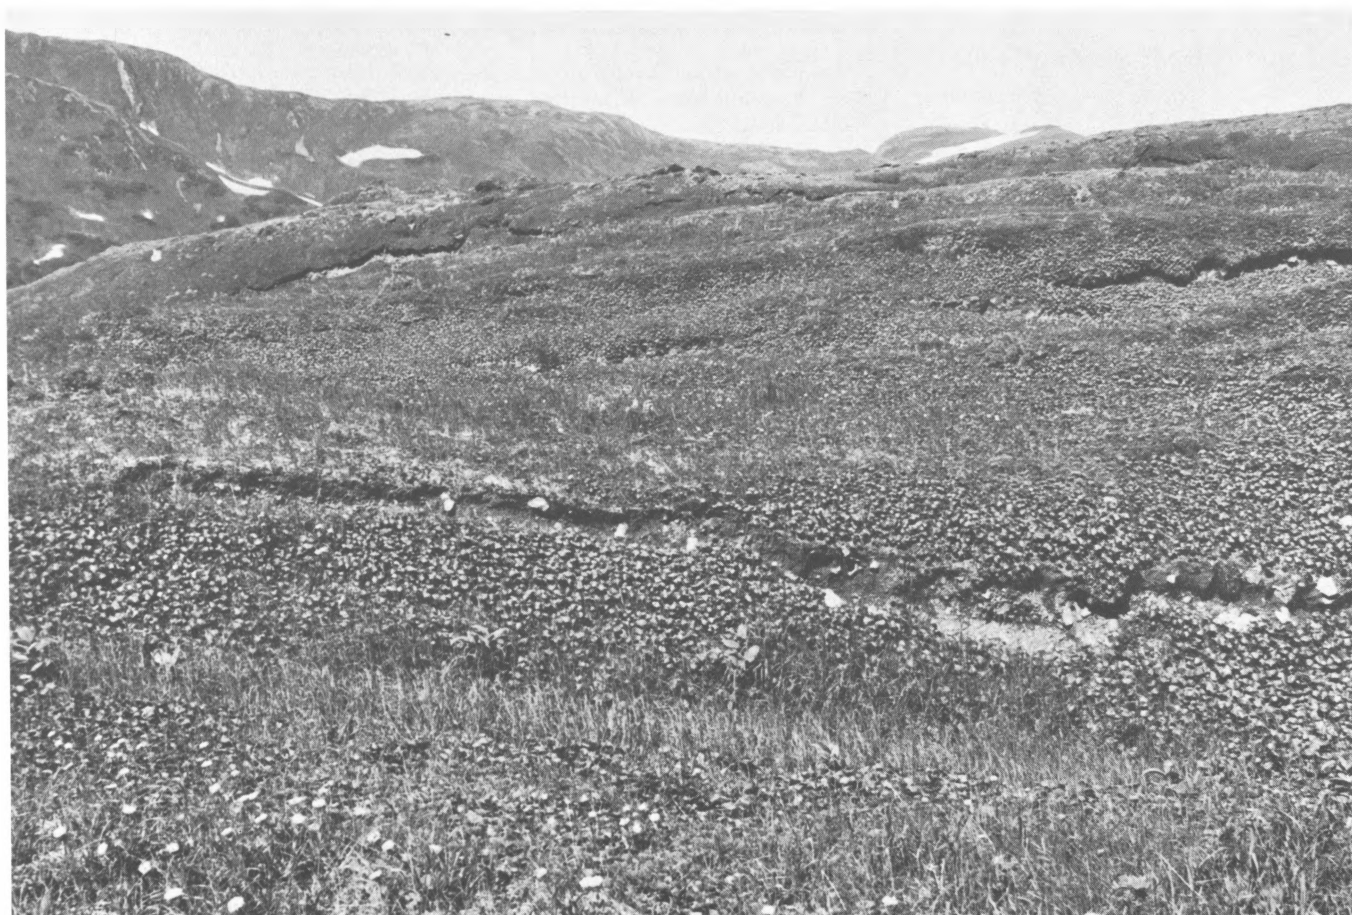
22.—Subparallel minor normal faults within the area shown in figure 21. Note that some of these fissures coincide with pre-existing linear scarps.

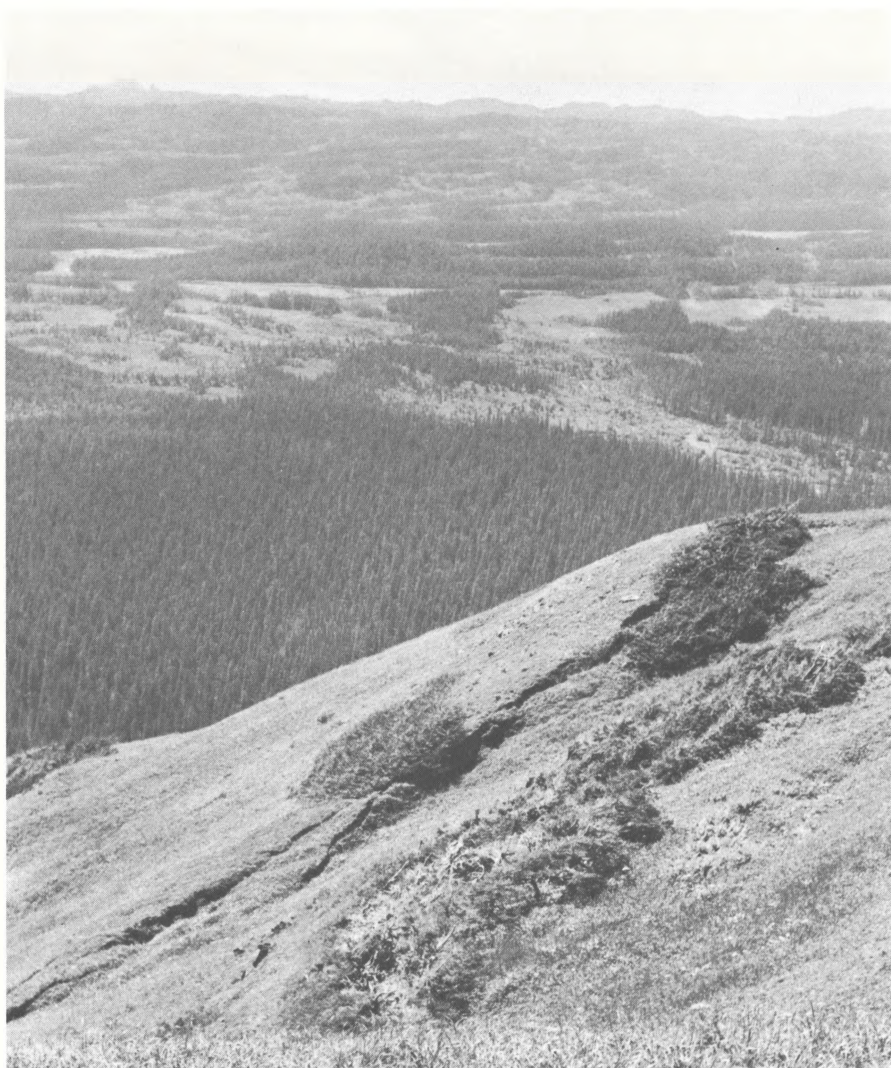
23.—Minor normal faults along a preexisting linear groove on a steep ridge slope. The downhill side is uplifted 16 inches. Patton River valley visible in the background.

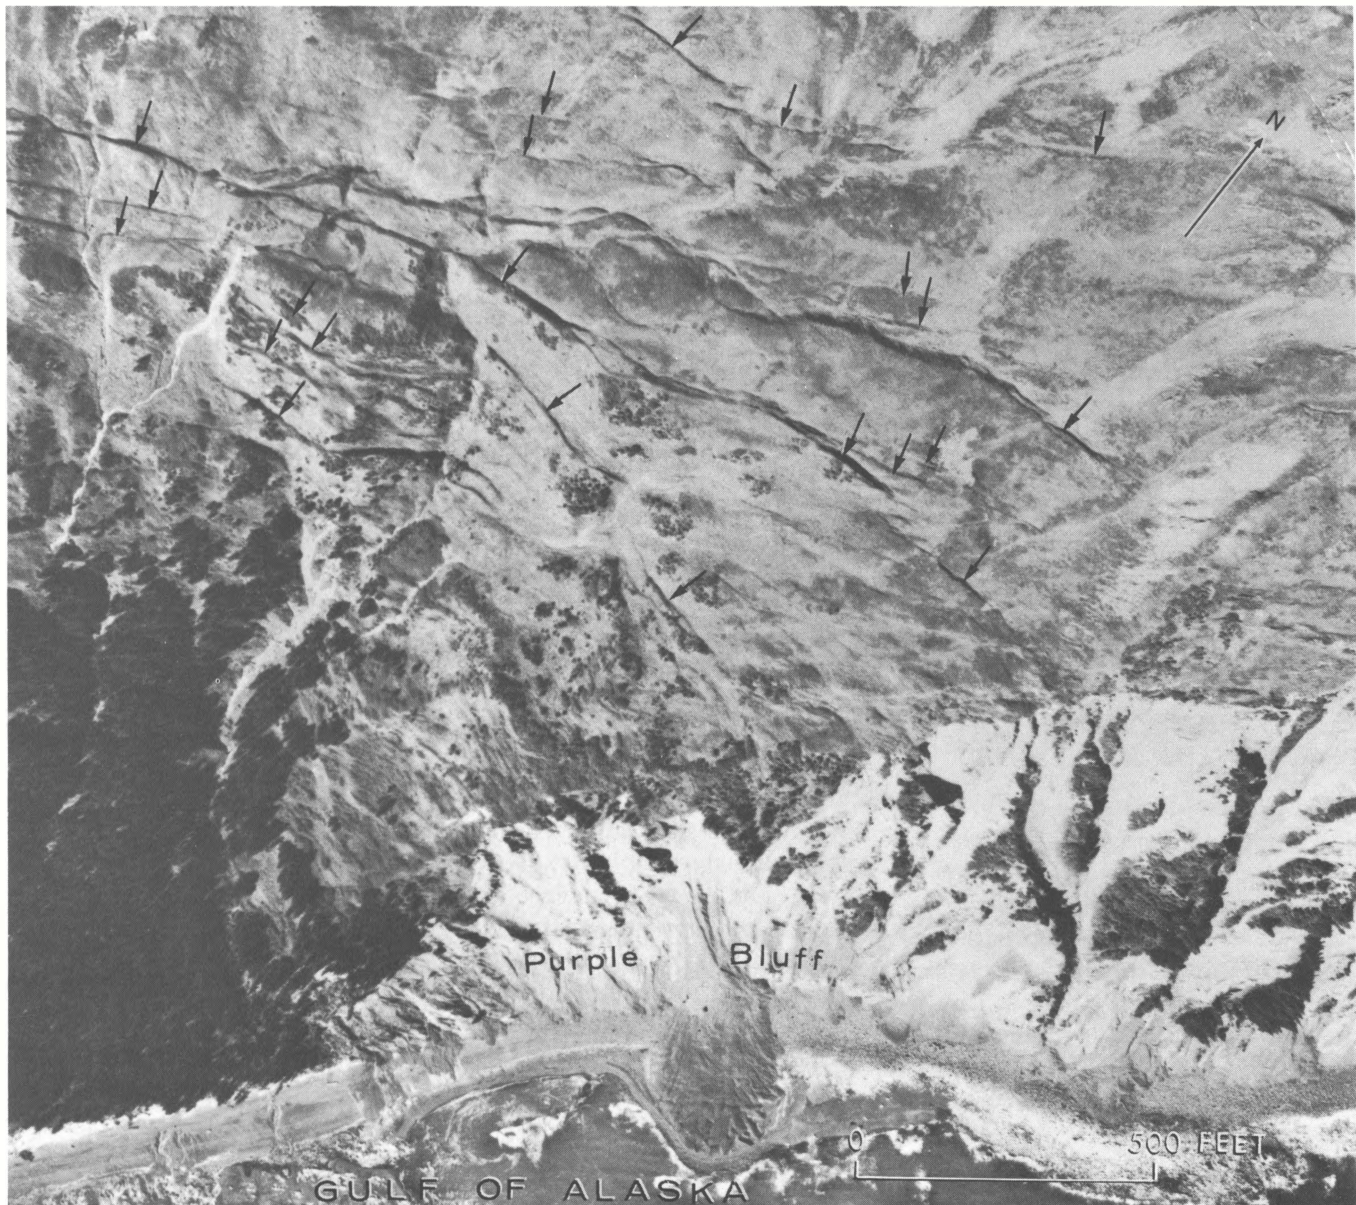
24.—Vertical aerial photograph in the vicinity of Purple Bluff showing conspicuous lineaments (arrows) along the inferred northeastward extension of the Patton Bay fault. Renewed displacement occurred on some of these lineaments after the 1964 earthquake. A large earthquake-induced landslide may be seen at the base of the high bluff at bottom center. Photograph by U.S. Coast and Geodetic Survey, August 25, 1964.

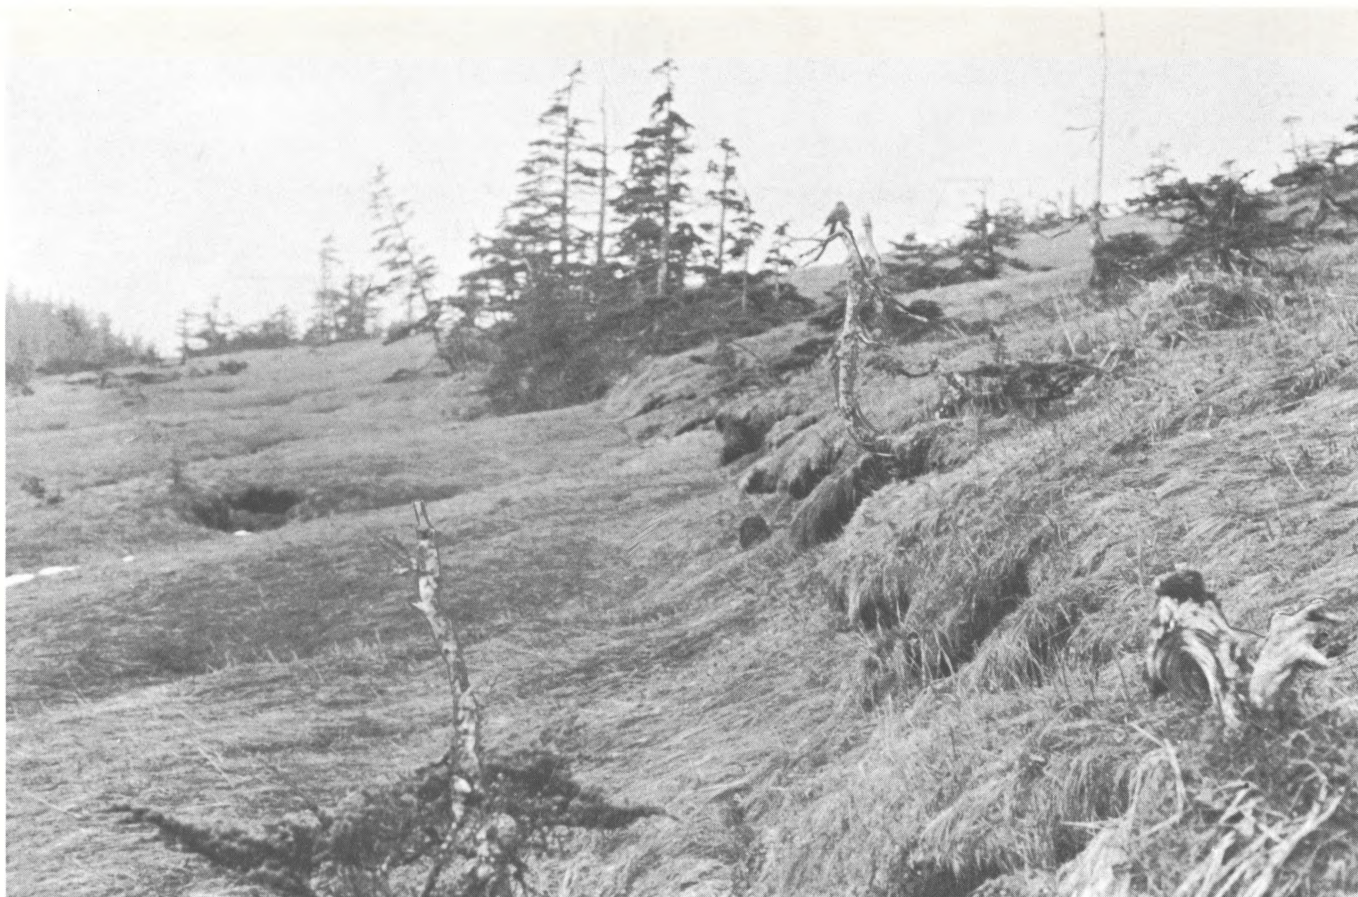
25.—View southwest along Hanning Bay fault. Northwest block (right) has overthrust the southeast block. Note warped surface and overhanging muskeg mat on the scarp in the foreground. Tree in the background has been tilted by the overthrusting. Location shown in figure 27.

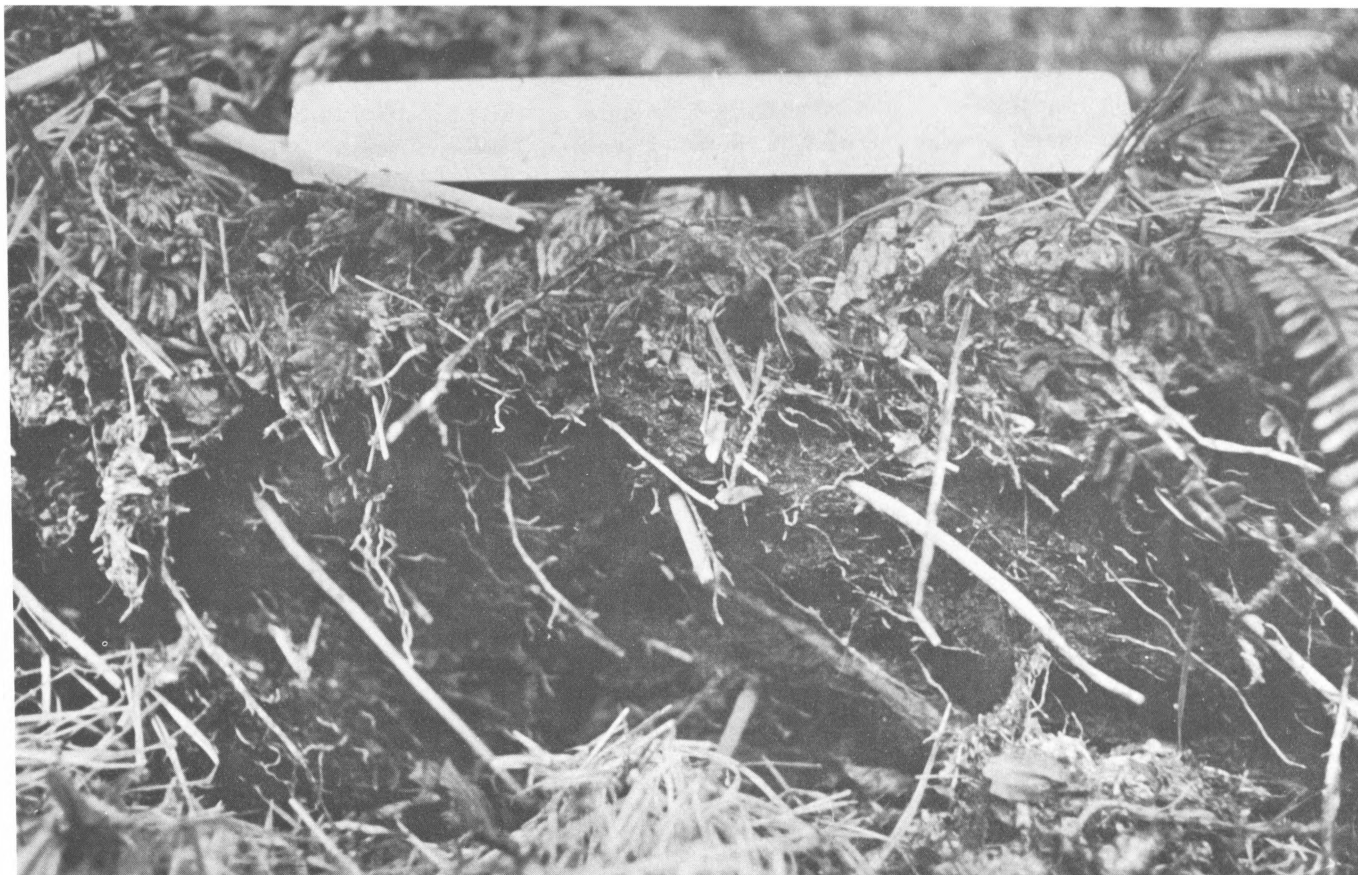
23.—Overhanging scarp of Hanning Bay fault in glacial till dipping 80° northwest. About 4 inches of left-lateral displacement is indicated by the rake of roots extending across the scarp. Scale is $6\frac{1}{2}$ inches long. Location shown in figure 27.

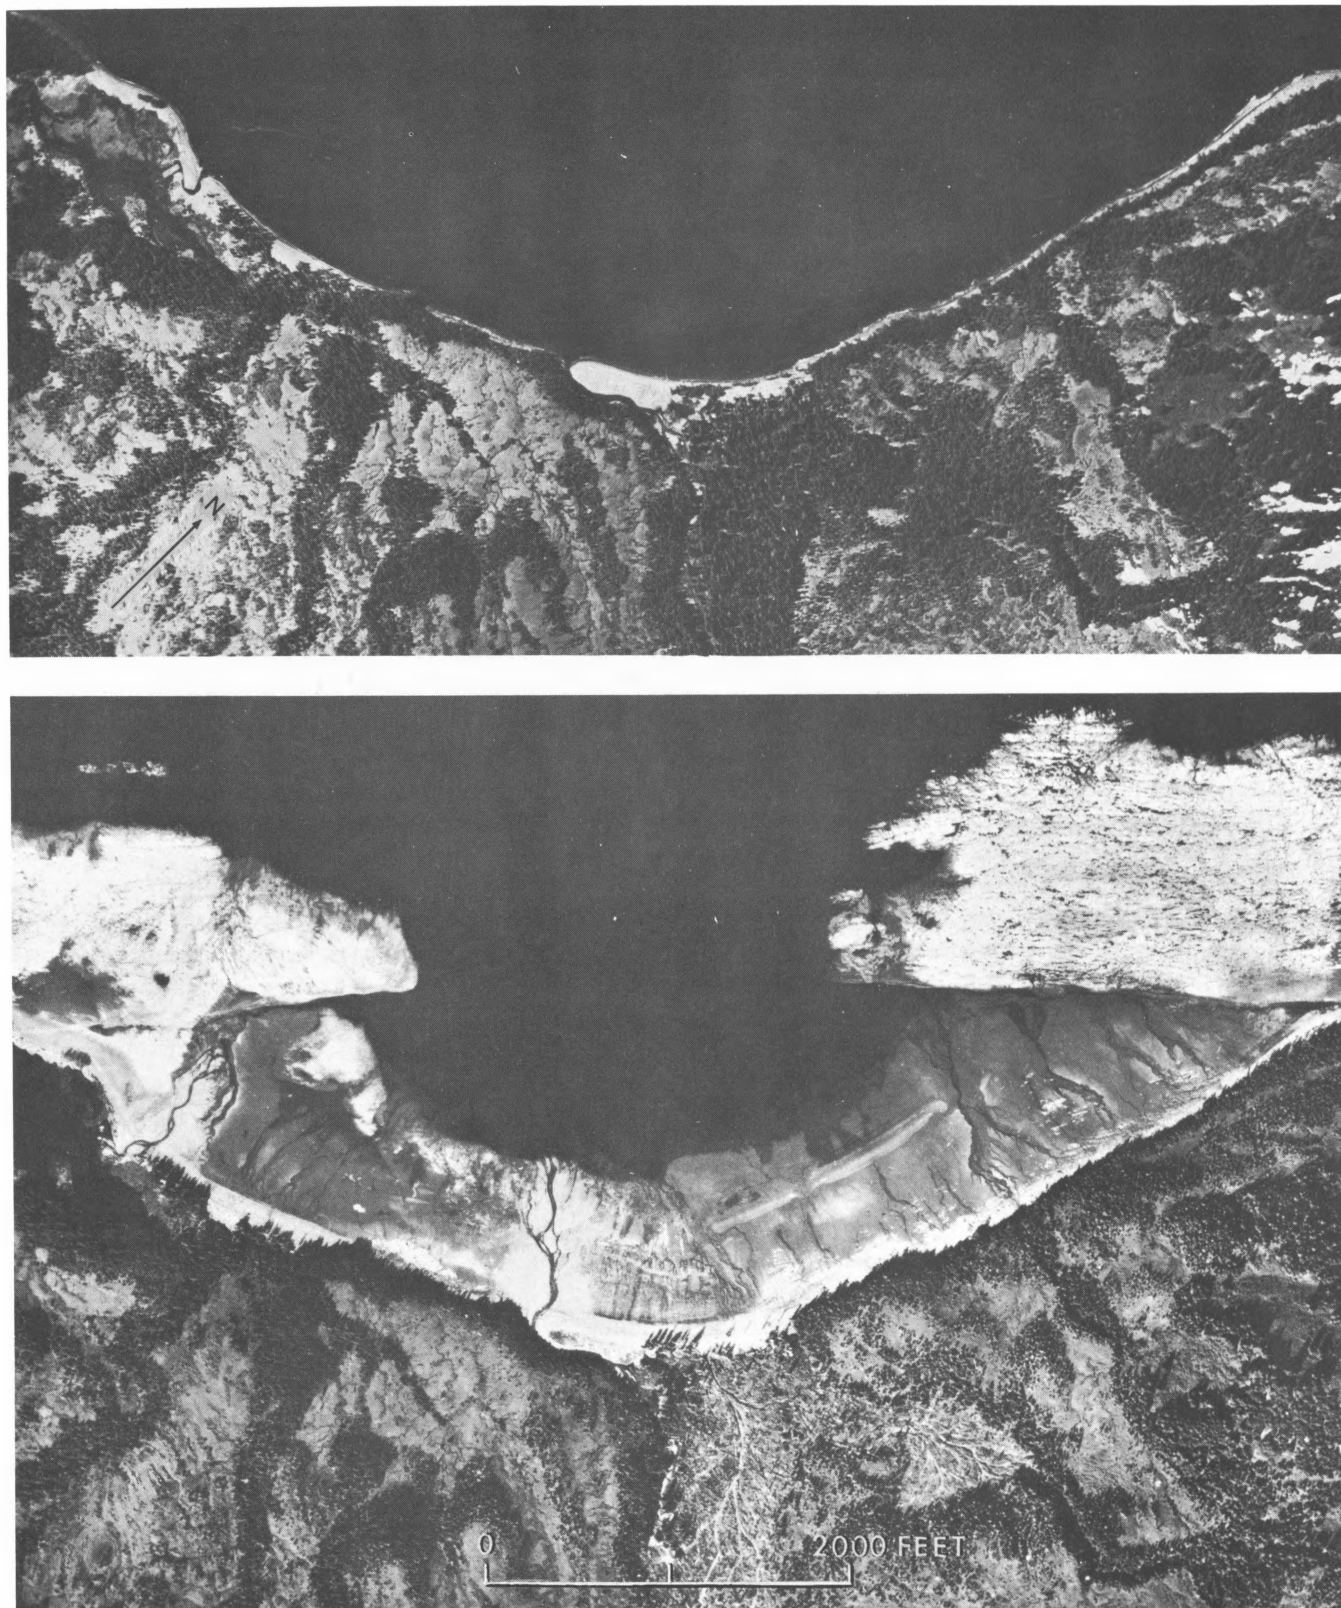
28.—Pre- and postearthquake high-tide shorelines at Fault Cove. The cove was formed by relative uplift of the former sea floor northwest of the fault scarp. The white color on the elevated bedrock surface northwest of the fault results from dessication of calcareous algae and other calcareous marine organisms. Upper photograph by U.S. Forest Service, June 8, 1959; lower photograph by U.S. Coast and Geodetic Survey, April 17, 1964.

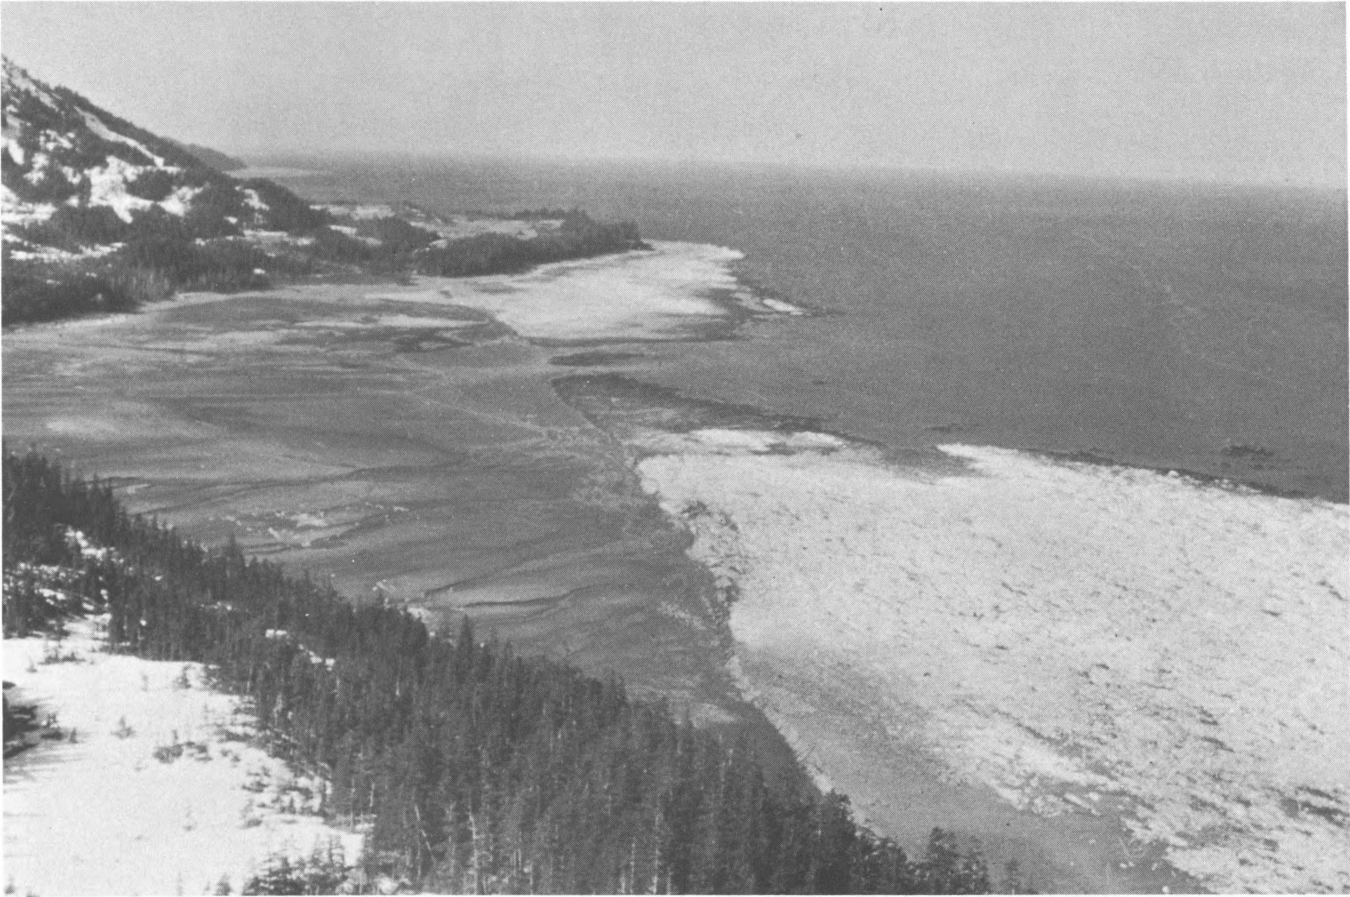
29.—Hanning Bay fault at Fault Cove approximately at low tide. The northwest (right) block is uplifted as much as $16\frac{1}{2}$ feet relative to the southeast block. Both blocks are uplifted relative to sea level. As a consequence, the cove is virtually dry at low tide, and the elevated beach and former offshore deposits are deeply dissected by streams. Veneer of unconsolidated deposits on the former submarine part of the downthrown block accumulated behind a preexisting fault scarp.

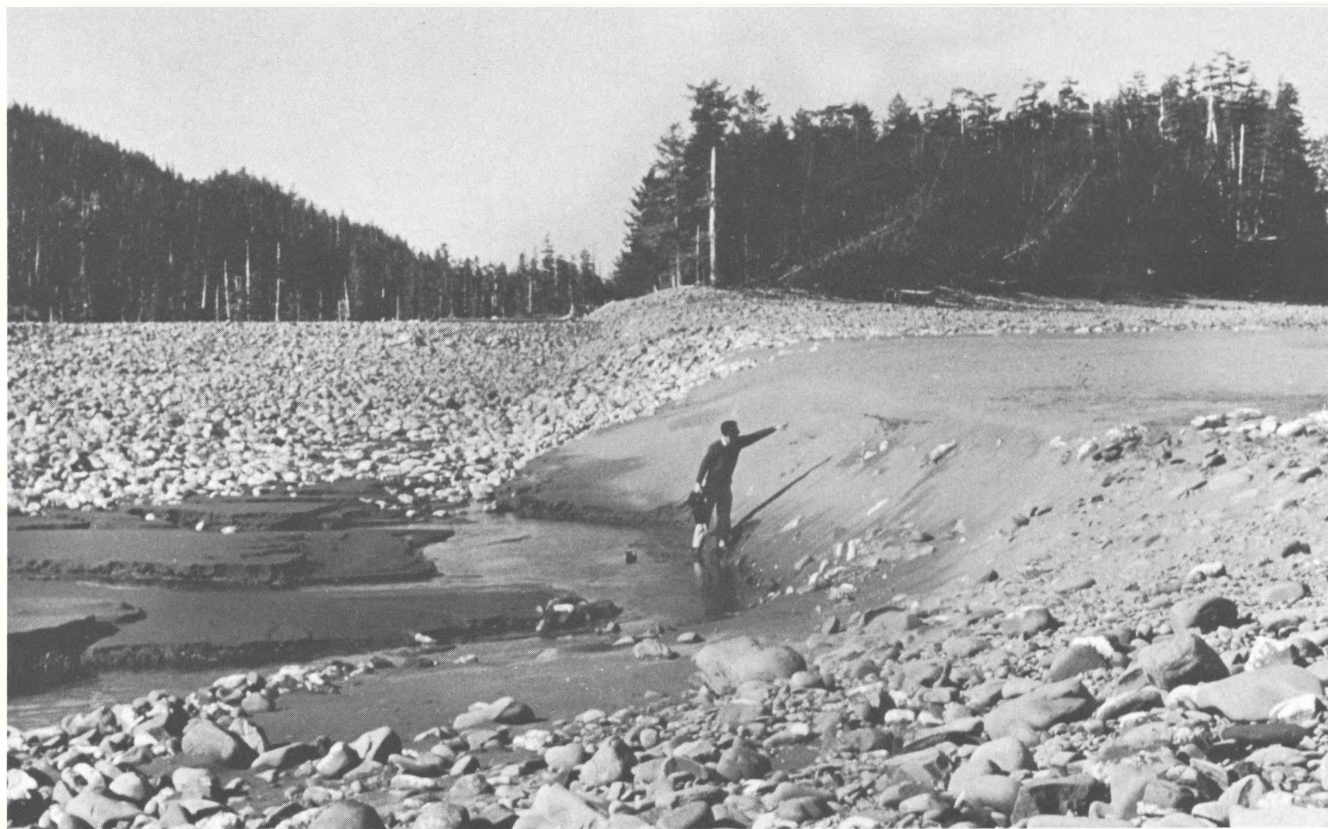
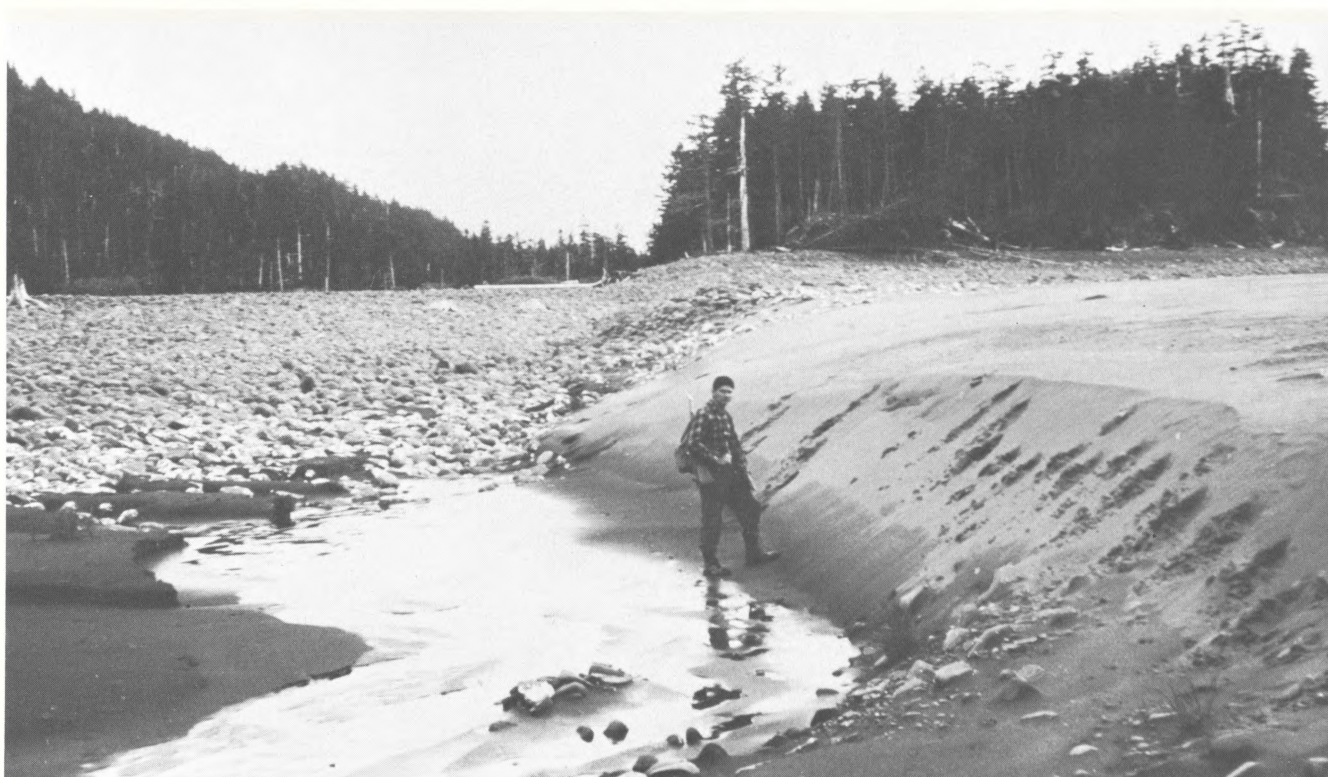
30.—View southwest along Hanning Bay fault. Scarp $8\frac{1}{2}$ feet high has displaced the elevated beach at south side of Fault Cove, and beach deposits draped across the scarp conceal the fault plane. Comparative photographs show that modification of the scarp was negligible between May 30, 1964 (above), and August 4, 1965 (below). Bottom photograph by M. G. Bonilla.

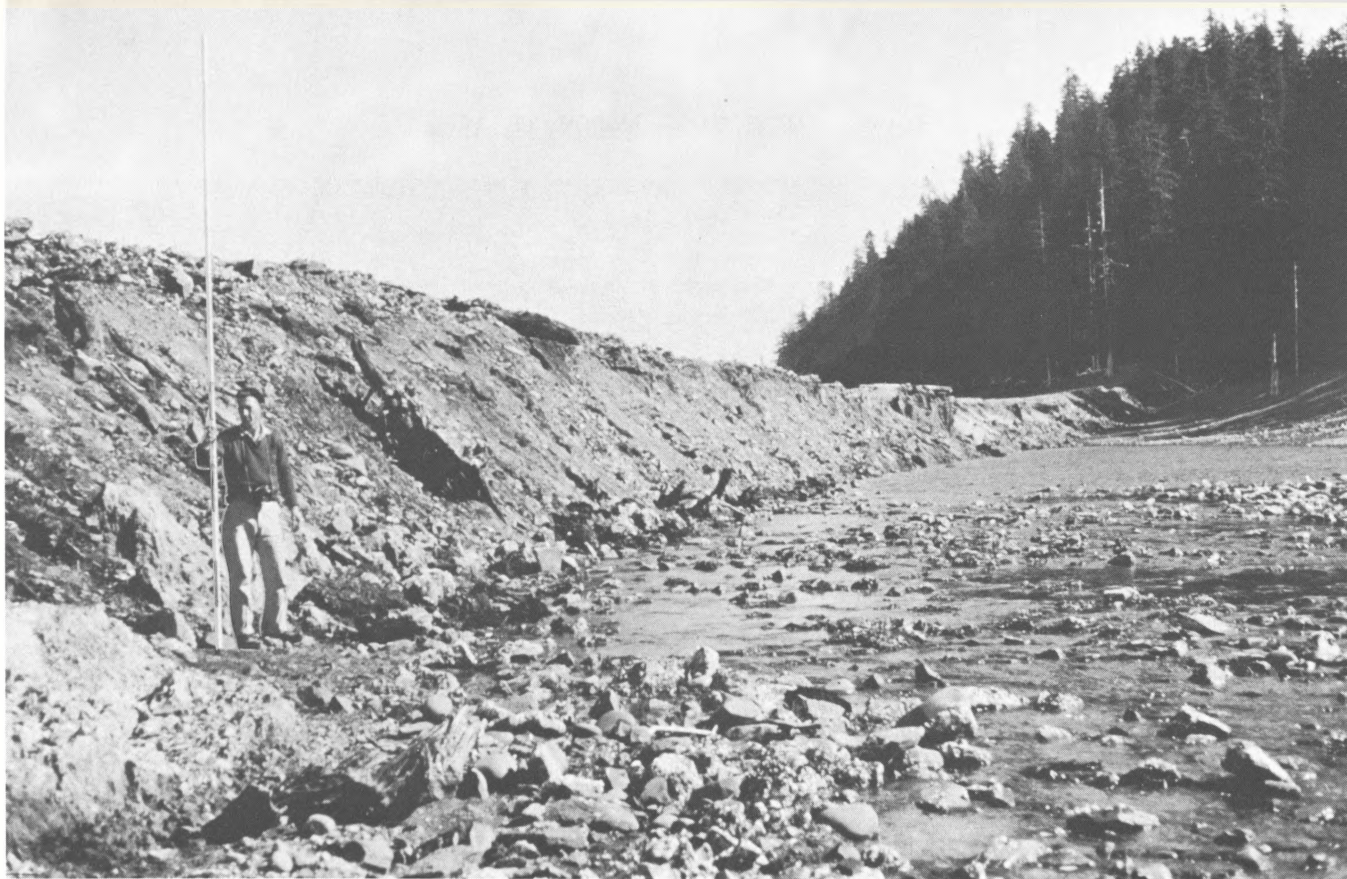
31.—Hanning Bay fault scarp $13\frac{1}{2}$ feet high in bedrock at north side of Fault Cove. The fault dips at about 55° NW. (left), but slumping along the trace has formed a scarp that is nearly vertical or dips steeply southeast. The slumping process is accelerated by erosion along the base of the uphill-facing scarp. Location shown in figure 34.

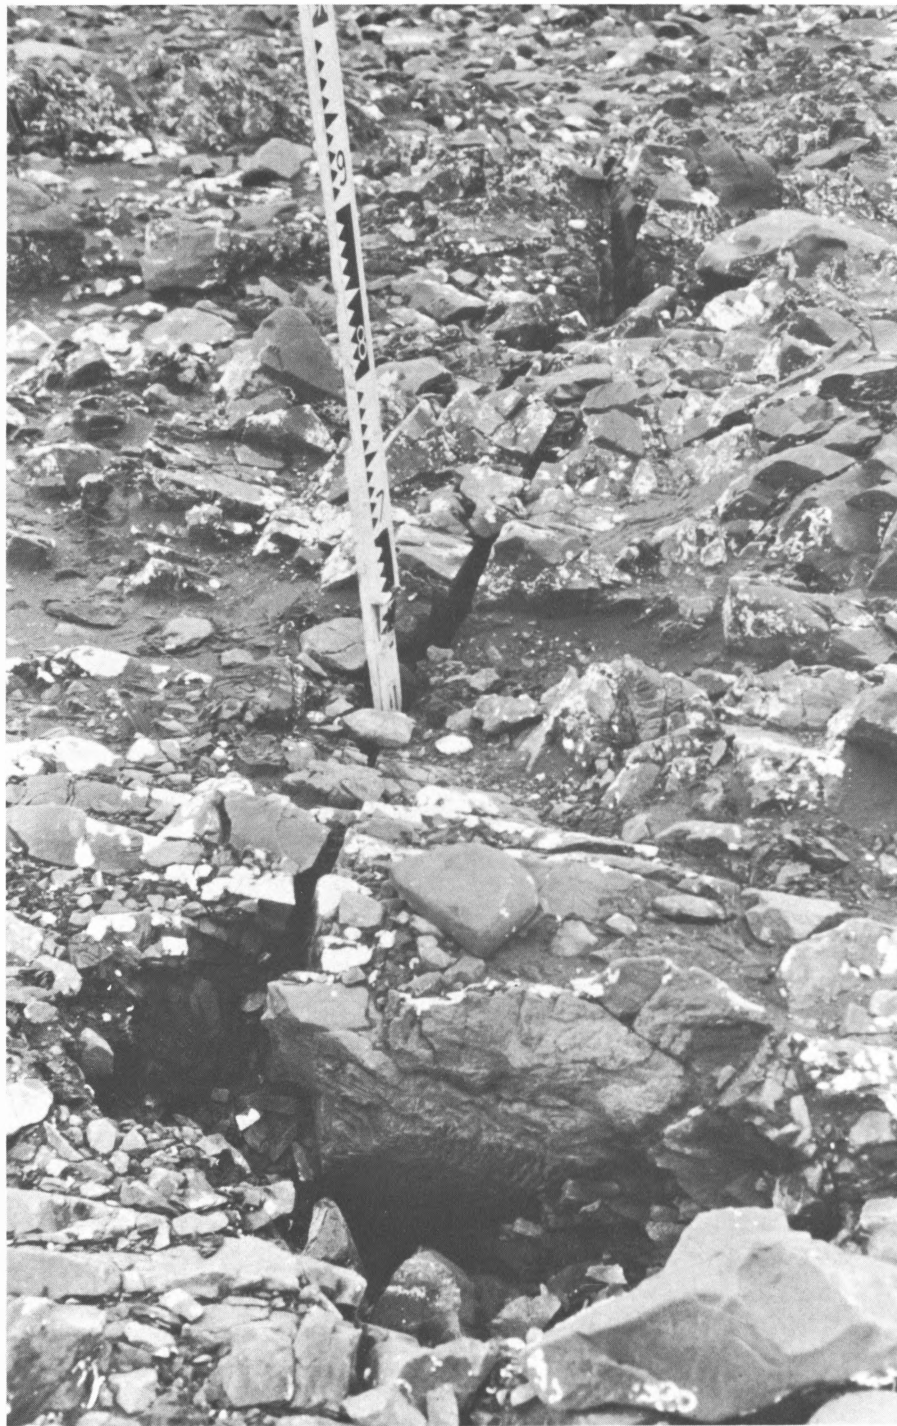
33.—Near-vertical extension crack on uplifted block of Hanning Bay fault at Fault Cove. Crack is 0.2 foot wide and at least 7 feet deep. Hole in foreground is caused by local caving at the intersection of two cracks. Location shown in figure 34.

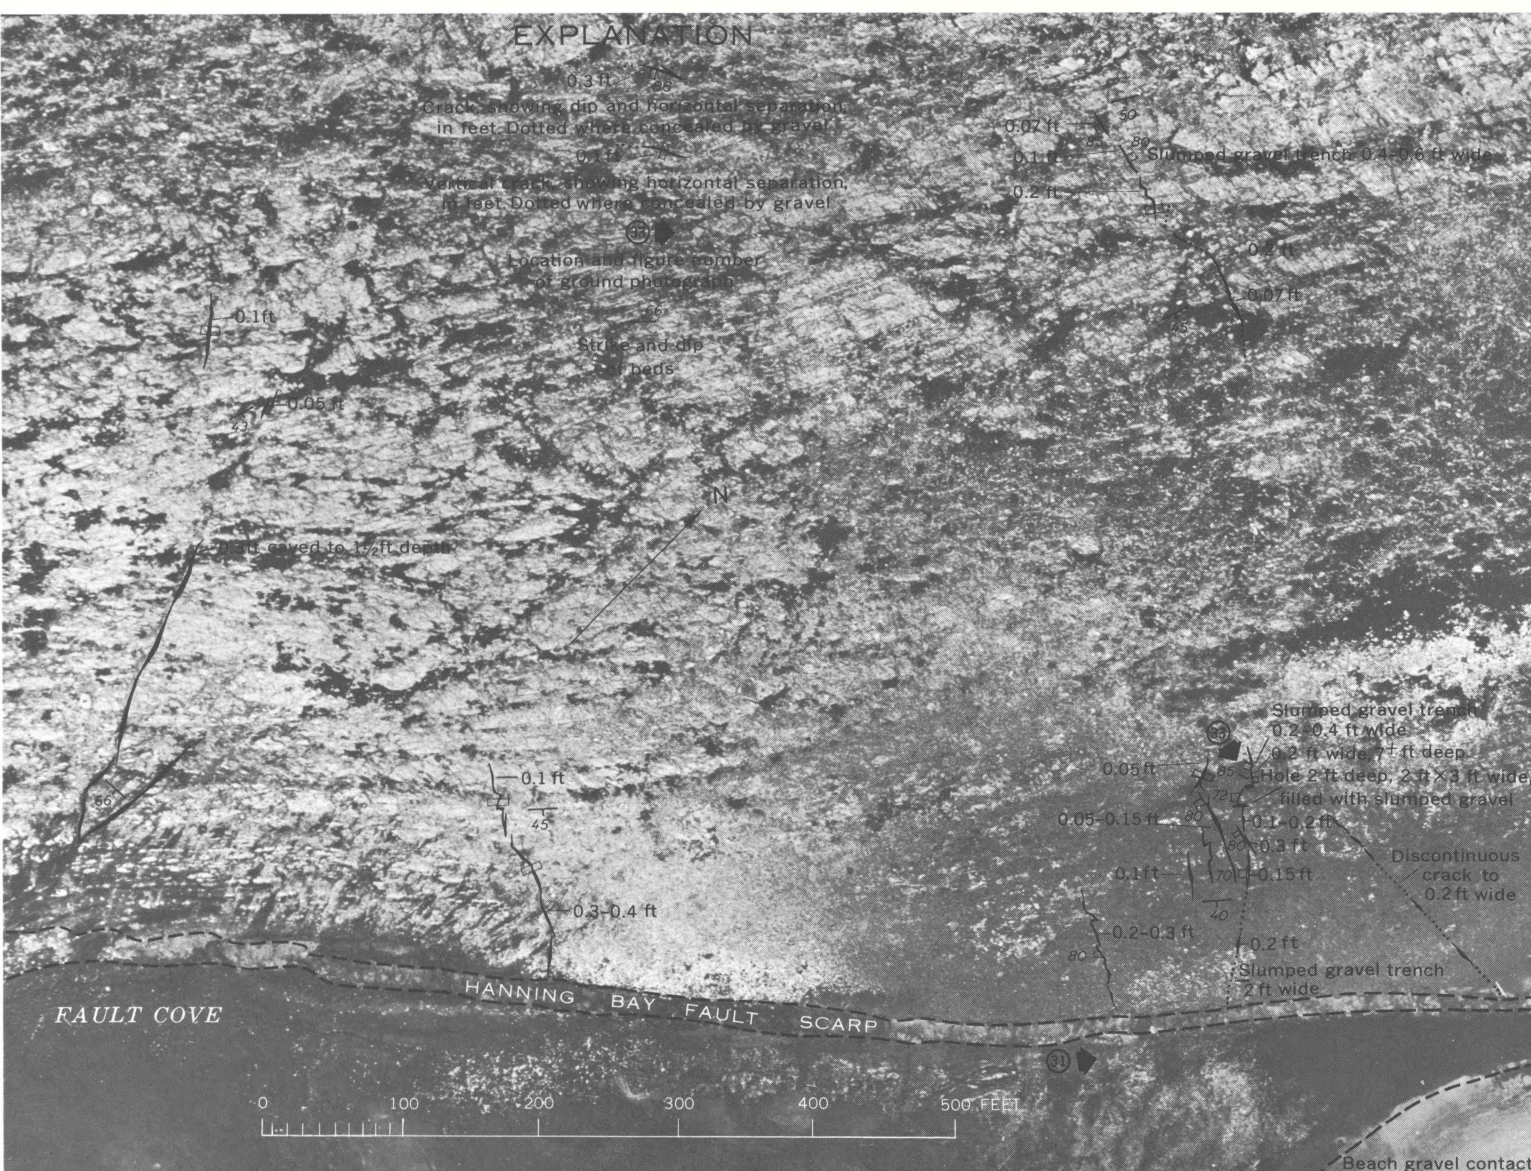
34.—Sketch map of the larger tectonic cracks in the upthrown block of the Hanning Bay fault at Fault Cove. Numerous smaller cracks in the same general area are not plotted. Location of photograph is shown on plate 2. Geology by M. G. Bonilla and George Plafker August 1, 1965. Base photograph by U.S. Coast and Geodetic Survey, July 28, 1964.

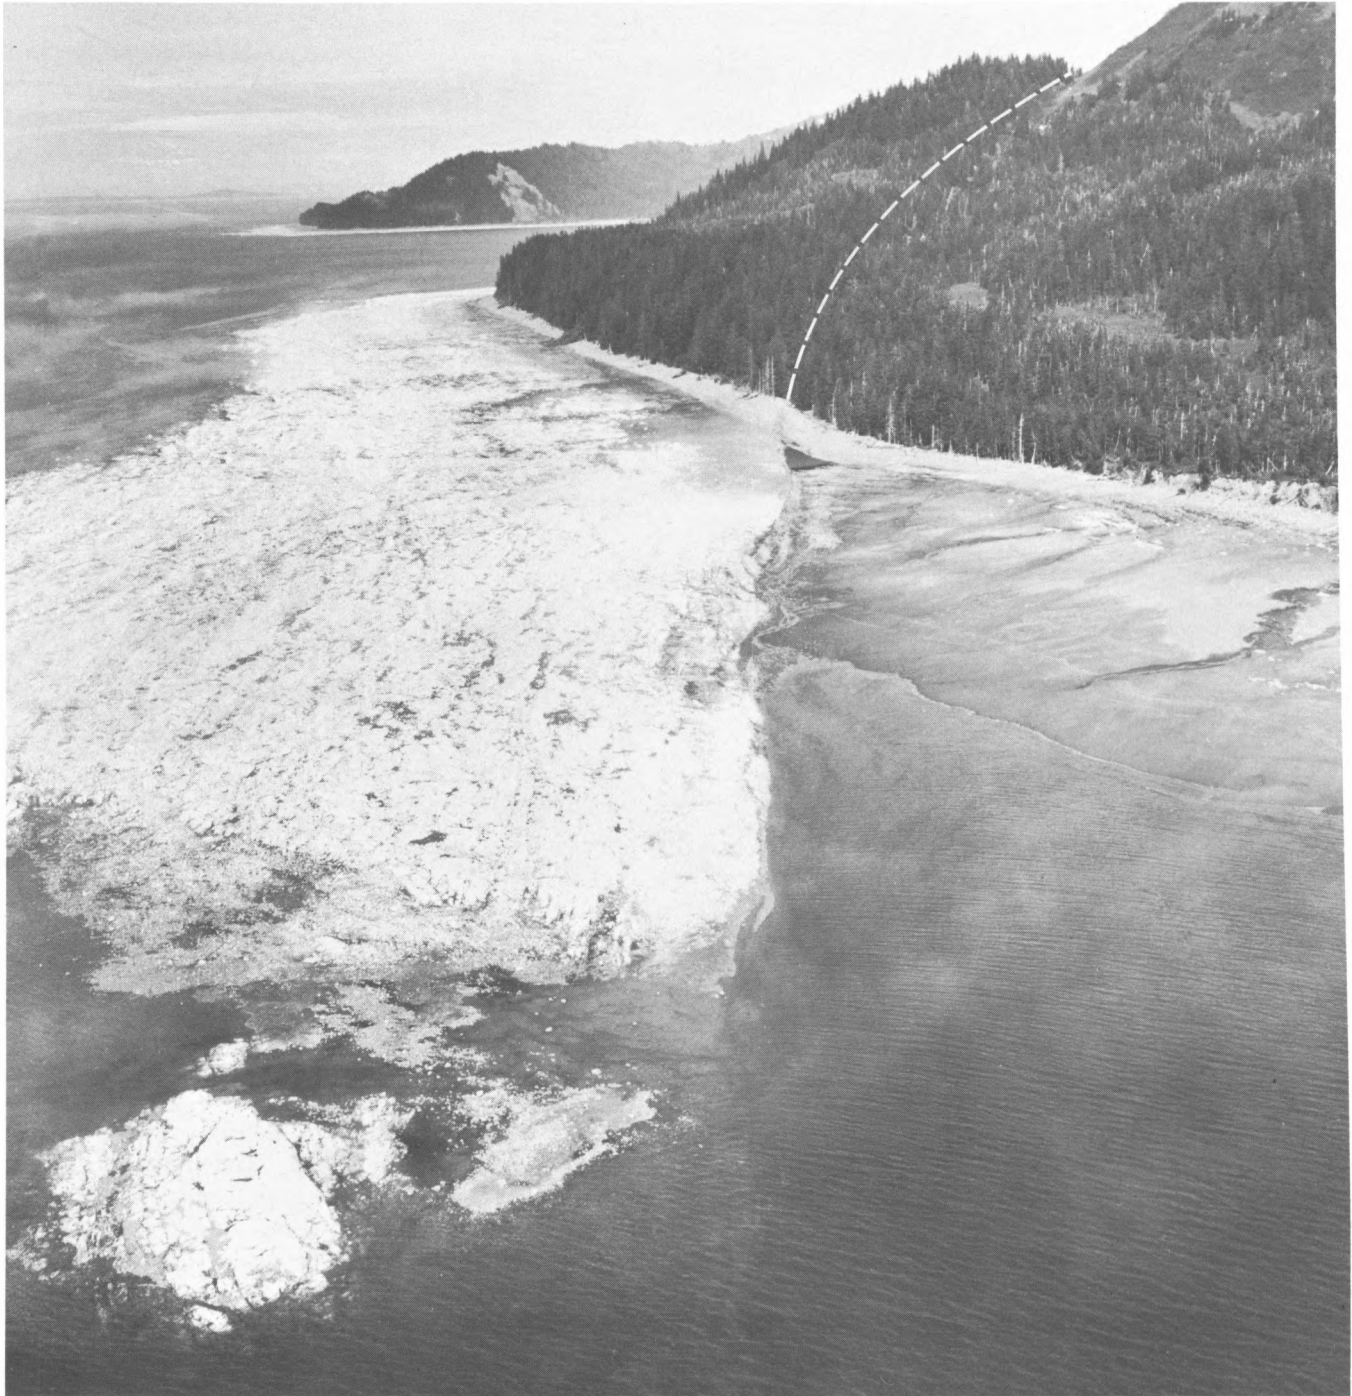
35.—Hanning Bay fault north of Fault Cove. The average 65° -NW. (left) dip of this segment of the fault causes the trace (dashed) to be deflected uphill (right) as it crosses the 850-foot-high ridge between Fault Cove and Hanning Bay. The pond, at the intersection of the fault scarp and the former beach ridge, occupies a closed tectonic depression in the downthrown block.

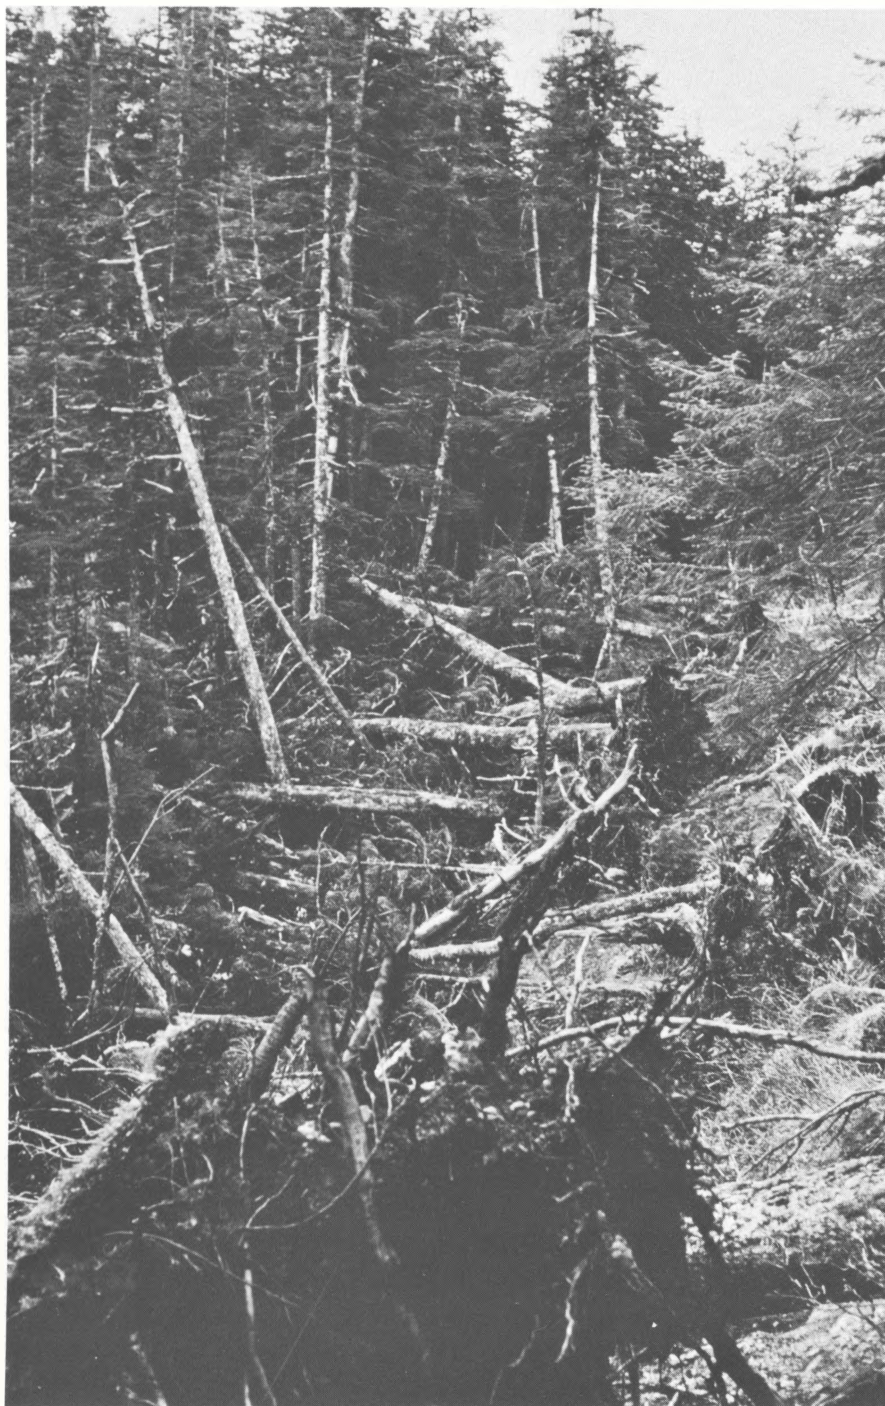
36.—A typical swath of tilted and fallen trees in timbered areas along the Hanning Bay fault. The upthrown block was overthrust from right to left.

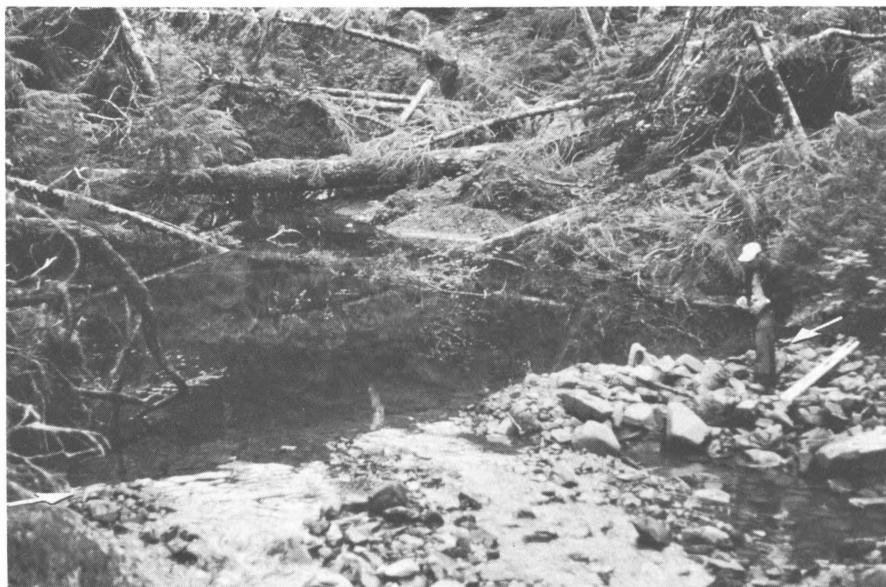
37.—Pond more than 10 feet deep formed where a stream flows across the uphill-facing fault scarp (arrows). Streamflow is toward the observer. Rubble and tangle of fallen trees slid from the steep valley walls.

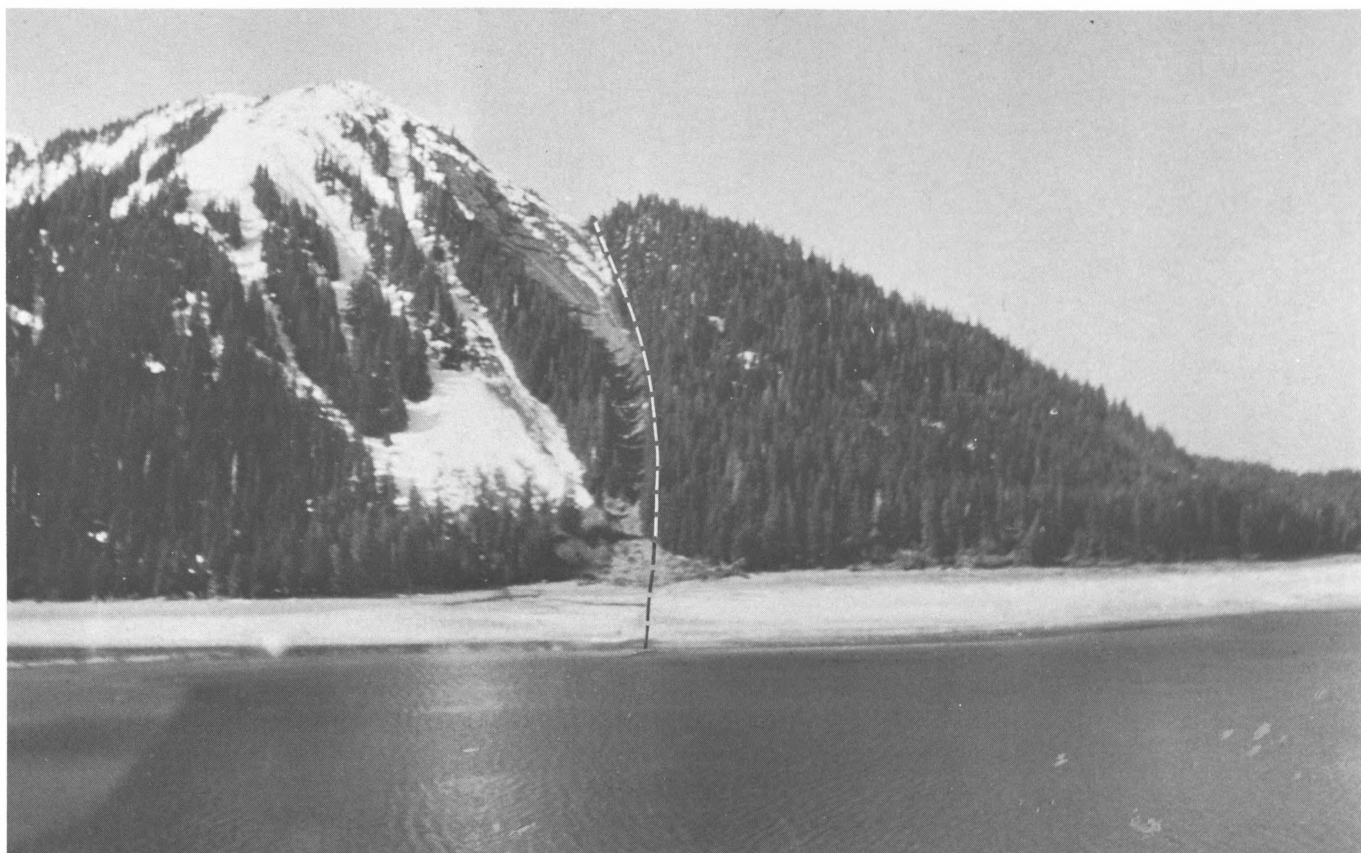
38.—Hanning Bay fault looking southwest from the bay. The fault trace on the ridge is marked by active landslides.
