The Alaska Earthquake

Surface Faults
On Montague Island
Associated with the
1964 Alaska Earthquake

By GEORGE PLAFKER

GEOLOGICAL SURVEY PROFESSIONAL PAPER 543-G

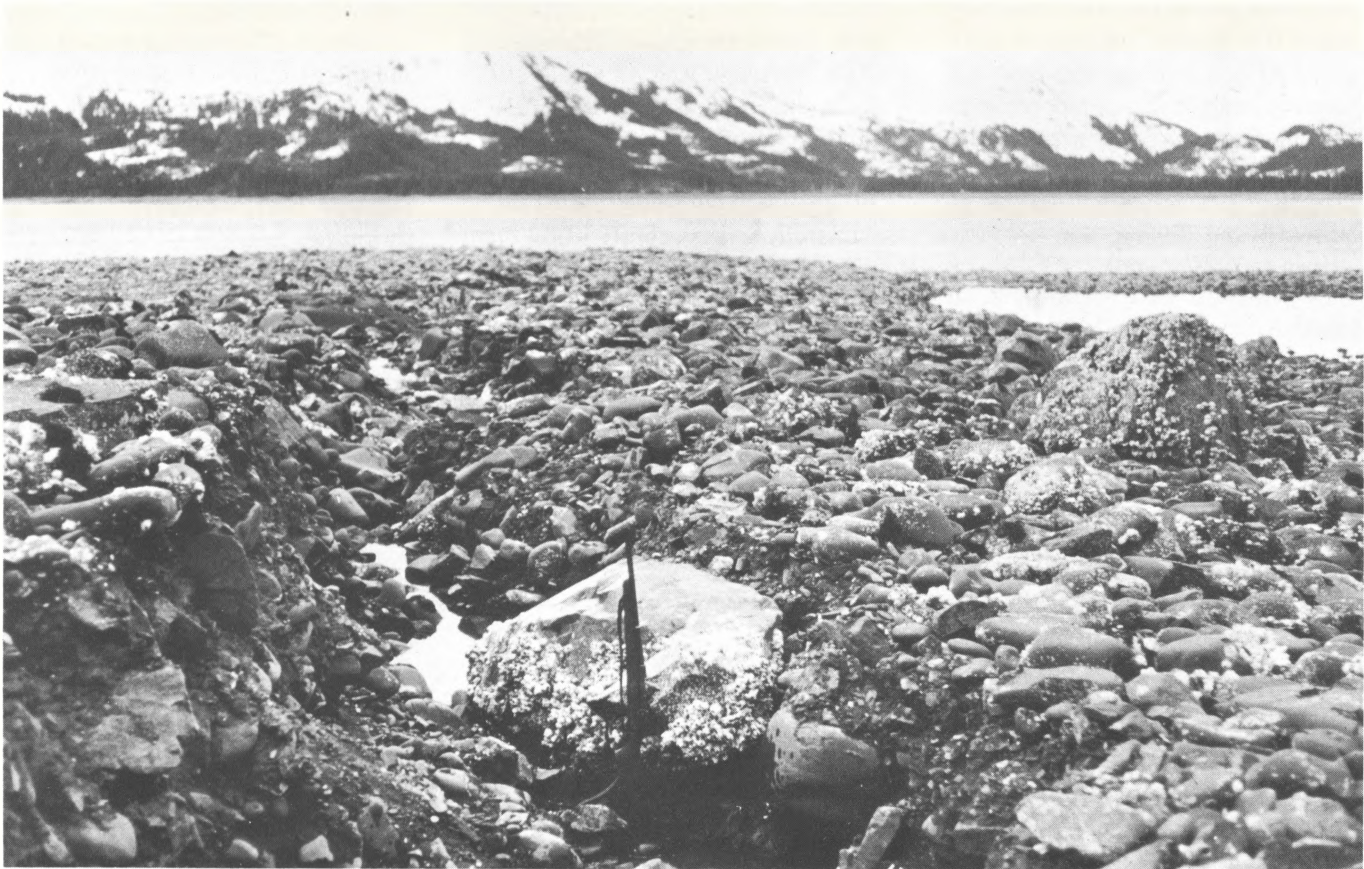
39.—Flexure and scarp with net vertical displacement of 7 feet in boulder-gravel beach along the Hanning Bay fault at south shore of Hanning Bay. Scarp 4 feet high in foreground is at the upper margin, and pond at right side of view is dammed against the base. The fault does not reappear on the north shore of Hanning Bay, which is visible in the background.

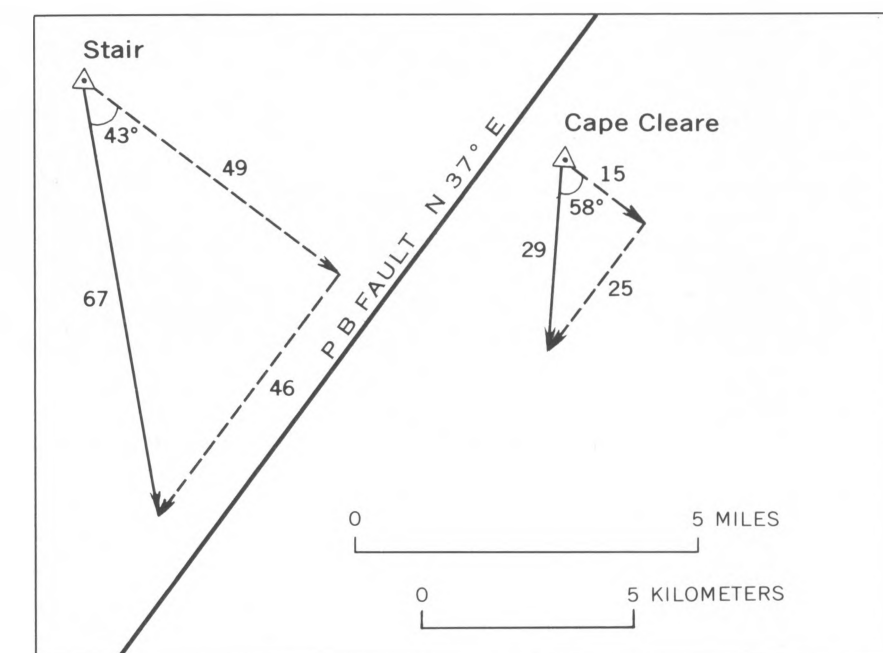
40.—Orientation of horizontal displacement vectors (solid arrows) at triangulation stations Stair and Cape Cleare relative to the average strike of the Patton Bay fault. Dashed arrows are the indicated components of horizontal displacement perpendicular to, and parallel to, the fault. Numerals are horizontal displacement in feet relative to station Fishhook (40 miles northeast of Anchorage), which was held fixed in the adjustment. Triangulation data from Parkin (1966, table 1).
