# The Alaska Earthquake

# Effects of the Earthquake Of March 27, 1964, on Air and Water Transport, Communications, and Utilities Systems In South-Central Alaska

*A description of the disruption and damage that  
all systems sustained from seismic vibrations  
and tectonic changes and from the slides, waves,  
and fires caused by the earthquake*

GEOLOGICAL SURVEY PROFESSIONAL PAPER 545-B

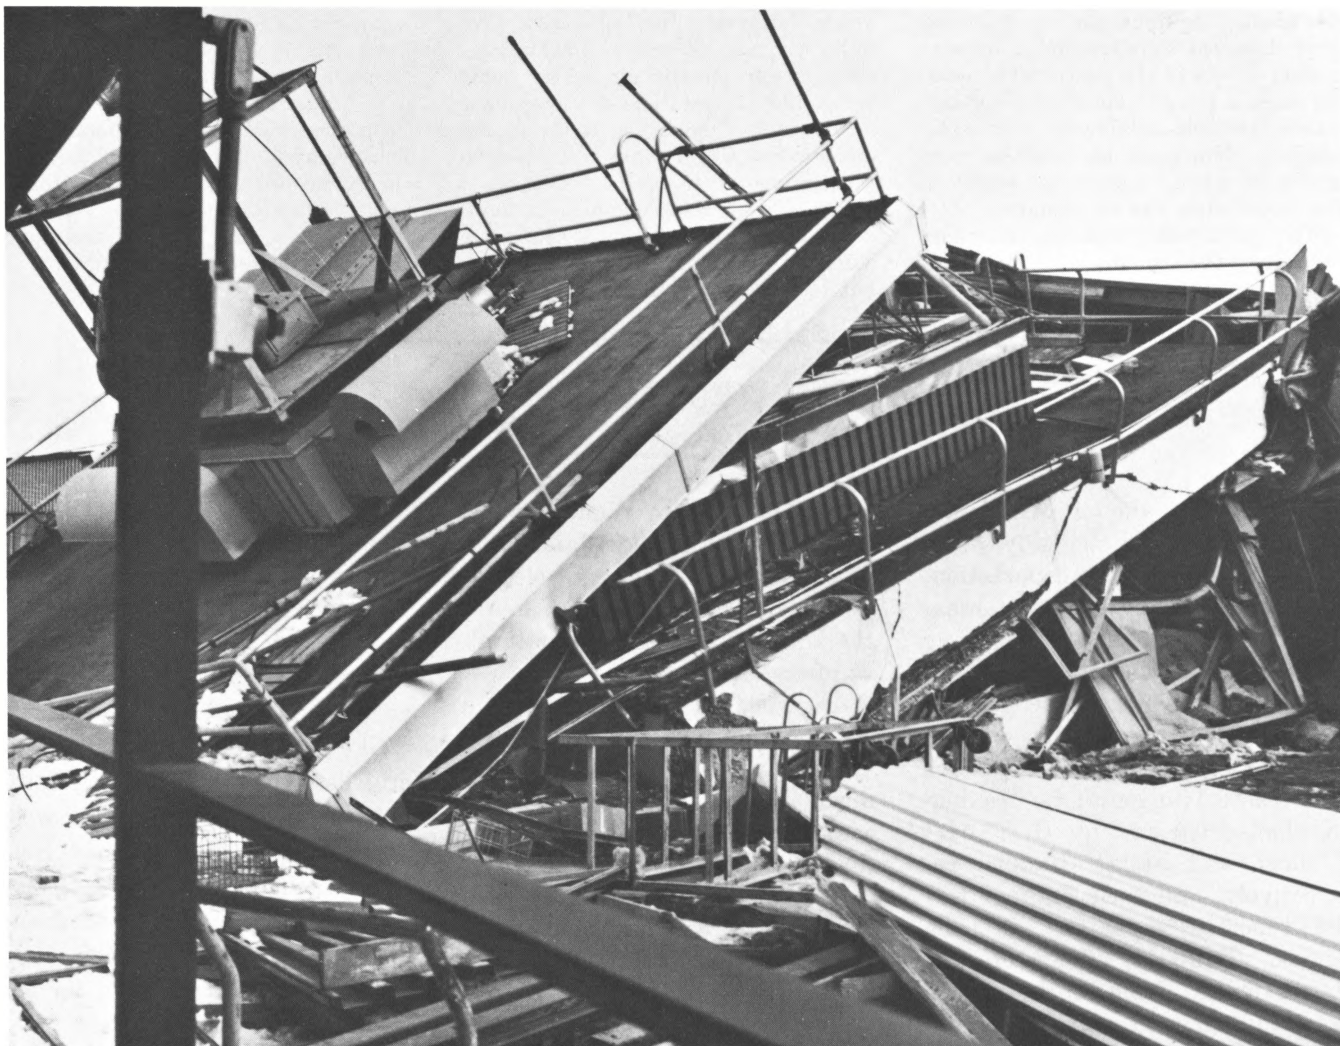
2.—Control tower at Anchorage International Airport, collapsed by earthquake shaking. Photograph by Federal Aviation Agency.

were damaged and their utilities disrupted by seismic shaking. The wrecked control tower at Anchorage International Airport was one of the greatest single losses, caused by vibration, that directly affected the aviation system (figs. 2, 3). Some subsidiary buildings, however, such as the military hospital at Elmendorf Air Base, sustained greater damages in terms of total repair costs. Many runways, aprons, and taxiways were cracked and made uneven by shaking and the resultant differential consolidation of alluvial materials or artificial fill. Hangars, seaplane ramps, and parts of the runways at Kodiak Naval Station were flooded by a series of seismic sea waves, and a few smaller airstrips were either destroyed by waves or were subjected to partial flooding by high tides due to regional subsidence. Despite all these difficulties, total damage to Alaska's air facilities amounted to only a few million dollars, as compared with more than \$100 million worth of damages to the water, rail, and highway systems. More significant than the relatively small dollar losses, perhaps, is the fact that nearly all air facilities were partly or wholly operational within a few hours after the earthquake. This made possible the enormous air transport of people, food, and supplies that were required at once.

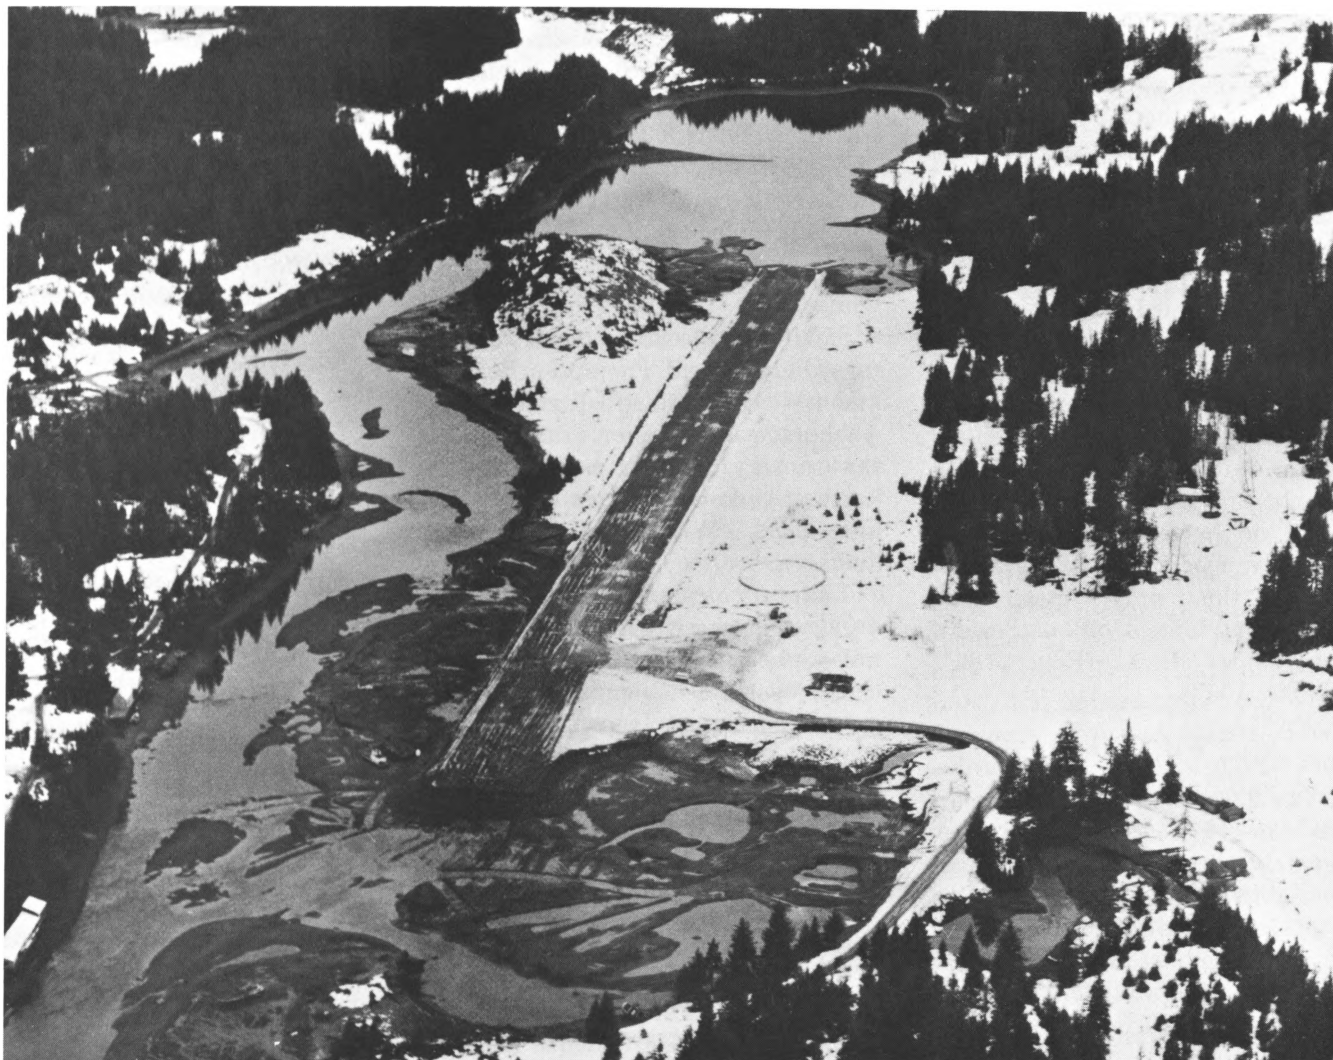
4.—Tectonic subsidence required raising of airstrip at Seldovia. U.S. Army photograph.

be built up as much as 4–5 feet, at an estimated cost of \$600,000, to raise the strip above tide level (fig. 4). Runways at Ninilchik, Kenai, Soldatna, and Hope sustained minor cracks. The airport at Homer was undamaged, but new construction work there was delayed, and made more costly, when the once-ample source of gravel on Homer Spit became difficult to obtain because of tectonic subsidence and consolidation of the spit materials. The only undamaged airstrip on the Kenai Peninsula was the one at Lawing.

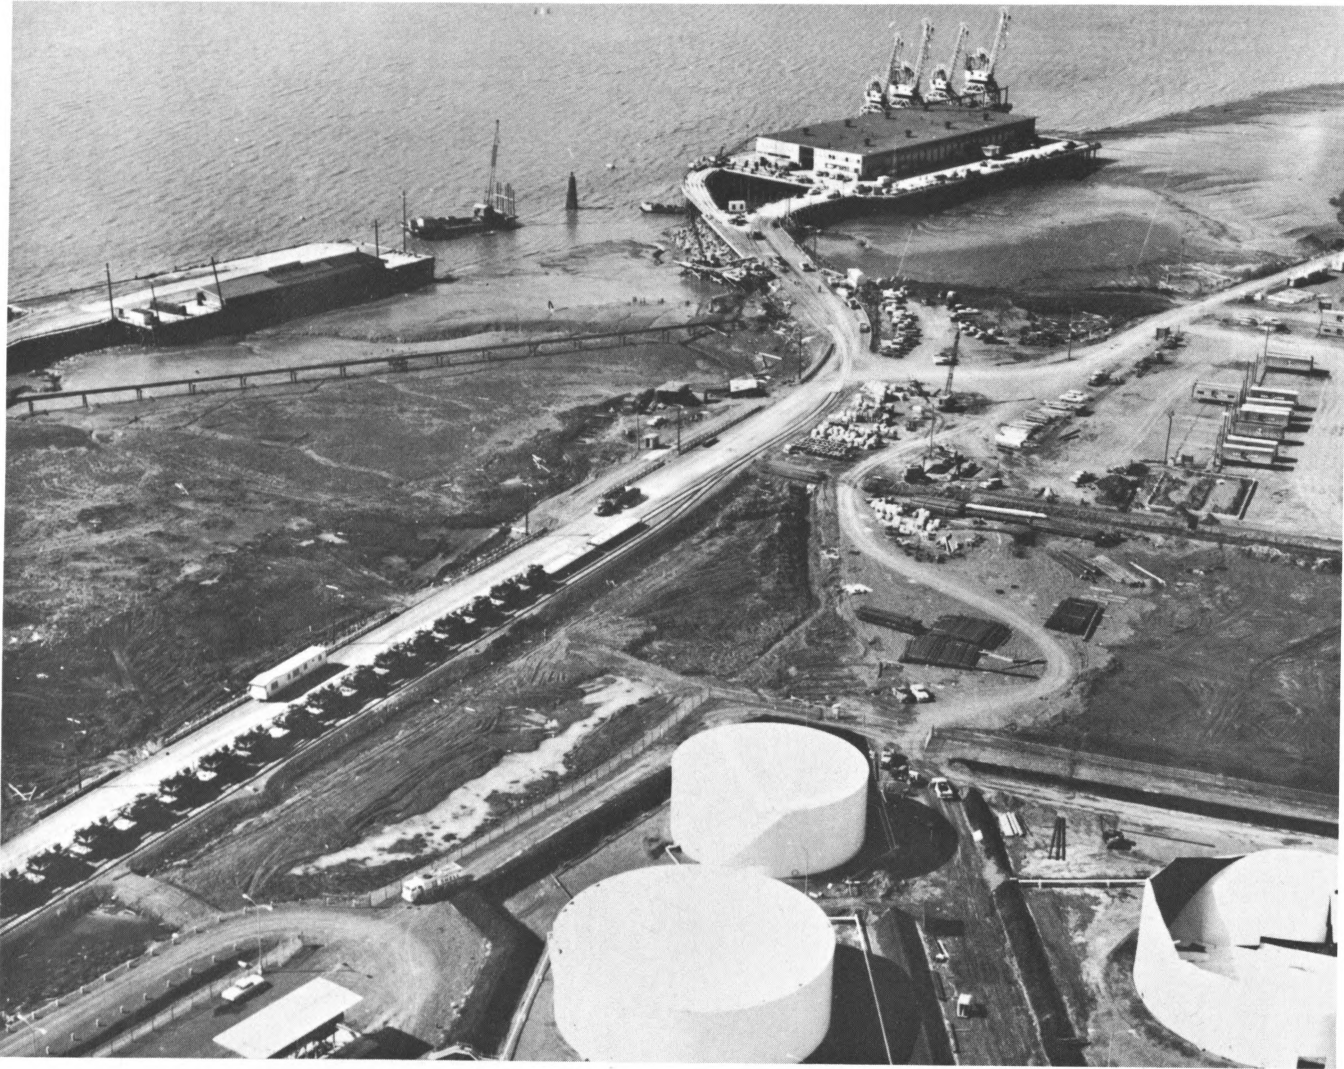
5.—Anchorage municipal wharf area shortly after the earthquake, at low tide. The main dock was only slightly damaged, but the older Army dock (upper left), was ruined. Vibration and ground fractures damaged some structures in the port area, including the petroleum tank (lower right). U.S. Army photograph.

The municipally owned Anchorage wharf is the largest port structure (fig. 5). It consists of two adjacent reinforced-concrete docks on concrete-filled tubular piles. The joint between the two docks was opened 4–12 inches; all four cranes were shaken off their tracks, and their undercarriages and counterweight arms were damaged. The steel-frame transit shed was cracked and twisted but only to a minor degree. Some steel piles broke at their caps; battered H-piles were sprung out of line when the main dock structure shifted its position (Berg and Stratta, 1964; Alaska Construction Consultant Committee, 1964).

The so-called old Army Dock (fig. 5), a timber structure that was already much deteriorated, was made unusable for offloading of private and military petroleum supplies; a temporary petroleum dock was built to replace the old Army Dock, but it was severely damaged by ice and did not last through the following winter. Petroleum pipelines and approach roads and rail lines were broken or twisted by settlement and vibration. A cement bin, 30 feet high and 30 feet in diameter, collapsed on its pedestal. The walls of several petroleum storage tanks developed bulges at ground level. Berg and Stratta (1964) suggested that the bulges may have been caused by an earthquake-induced swirling of the tank contents, which in turn induced large vertical forces acting over a small zone at the base of the cylinder.

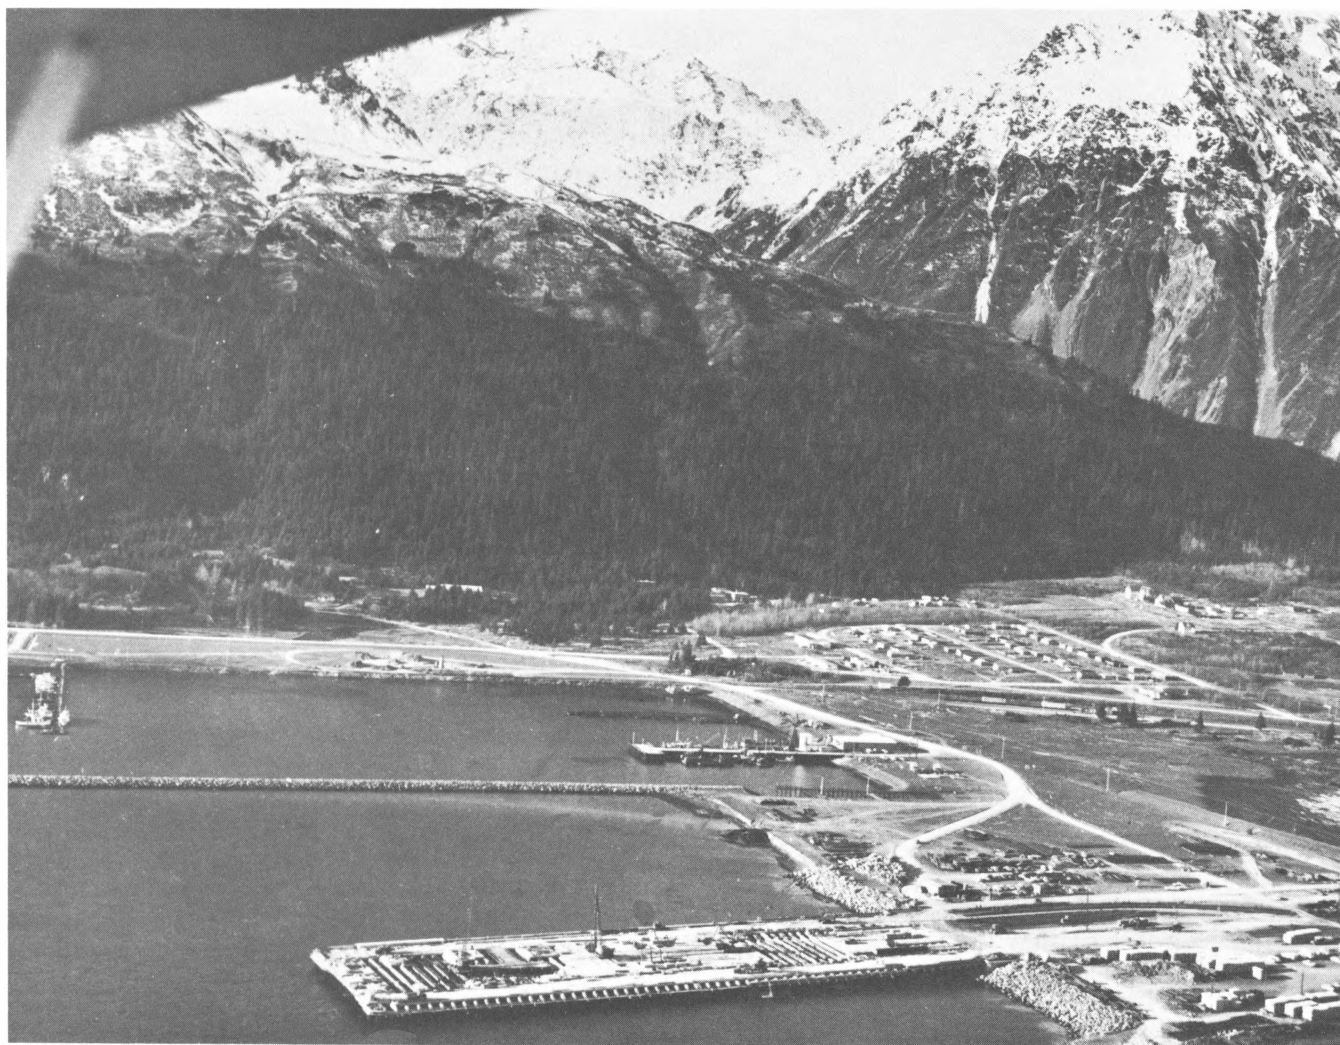
8.—Part of new small-boat basin and nearly completed railroad dock at Seward, November 1965. All former Seward waterfront facilities (to left of picture) were destroyed by submarine slides, waves, and fire. U.S. Army photograph.

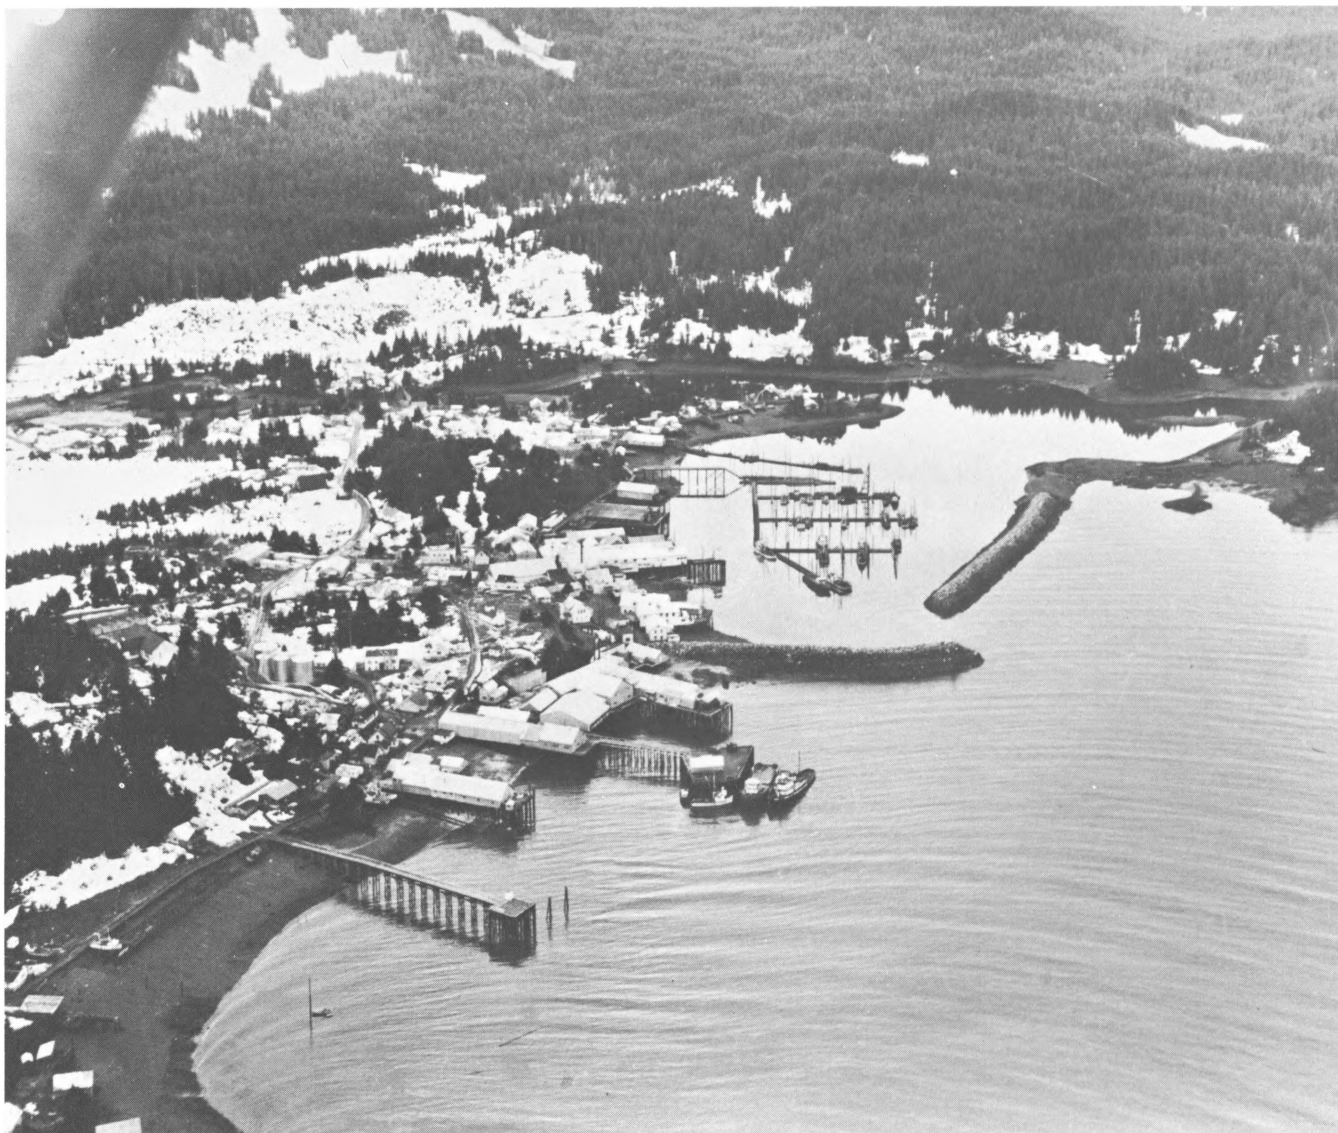
9.—Seldovia at low tide in March 1965, with raised breakwater and small-boat basin in use. Tectonic subsidence submerged boardwalk (curving structure at shore end of docks in foreground) at high tide. The boardwalk has been replaced on new fill. Urban renewal project will alter buildings and utilities to conform with higher water levels. U.S. Army photograph.

protected harbor between Seward and Anchorage that can accommodate ocean vessels (fig. 1). Tectonic subsidence lowered the area about 3.5 feet so that most harbor facilities, including the mile-long boardwalk on which the business section of the town is built, were awash at high tides. The Corps of Engineers built a new breakwater, raised docks, and restored the small-

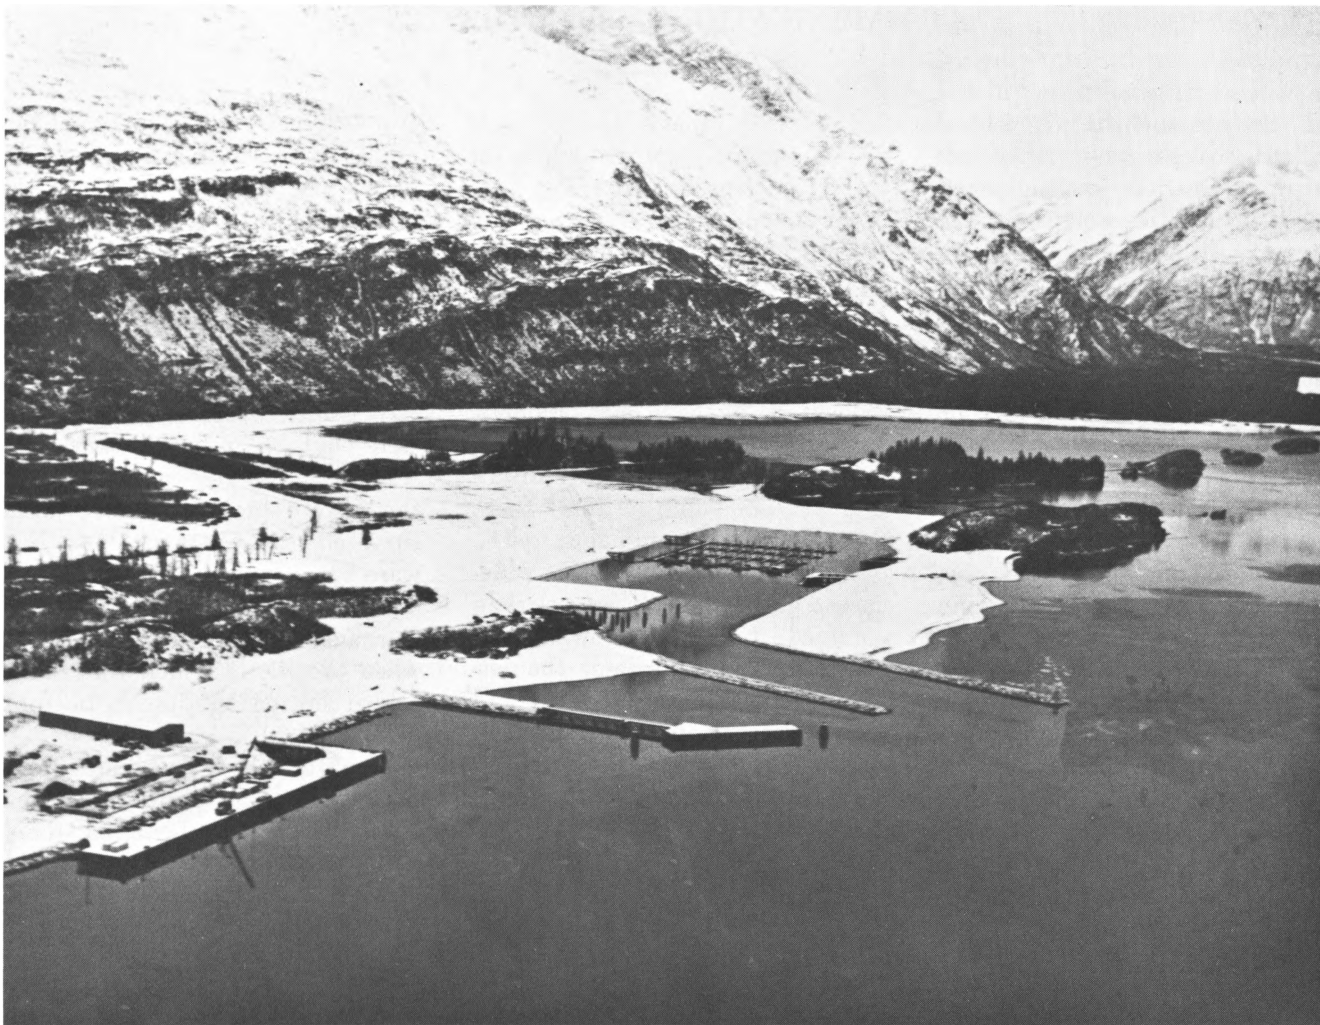
11.—Harbor facilities at new town of Valdez, winter 1966. Townsite is just to left of picture, behind protective bedrock hills.  
U.S. Army photograph.

than the old to be damaged by future earthquakes, and the modern docks and ferry slip that will allow Valdez to resume its place among Alaskan ports are founded on bedrock that is not susceptible to underwater slides (figs. 10, 11; Coulter and Migliaccio, 1936).

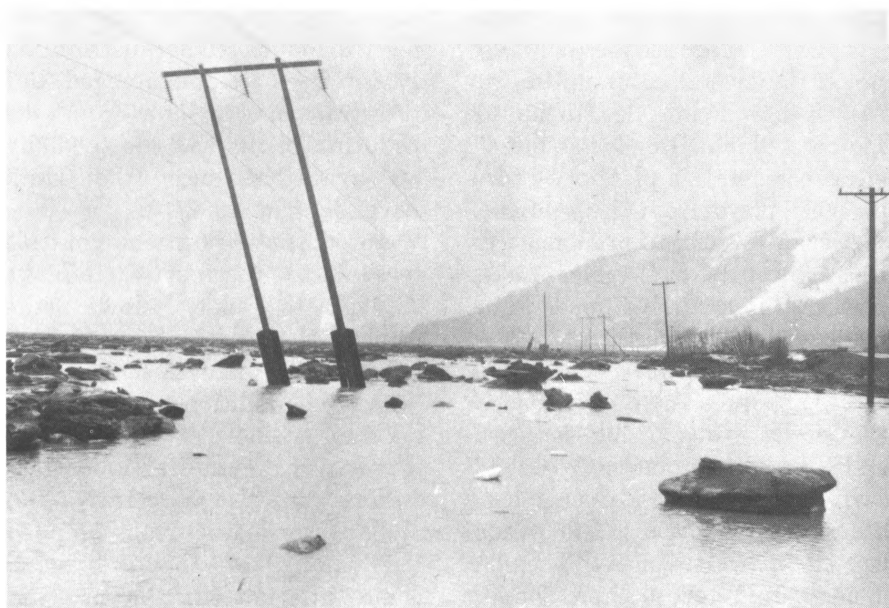
12.—Power and telephone poles along Turnagain Arm were tipped when the silt in which they were embedded was liquefied by earthquake vibrations. Photograph by Chugach Electric Association, Inc.

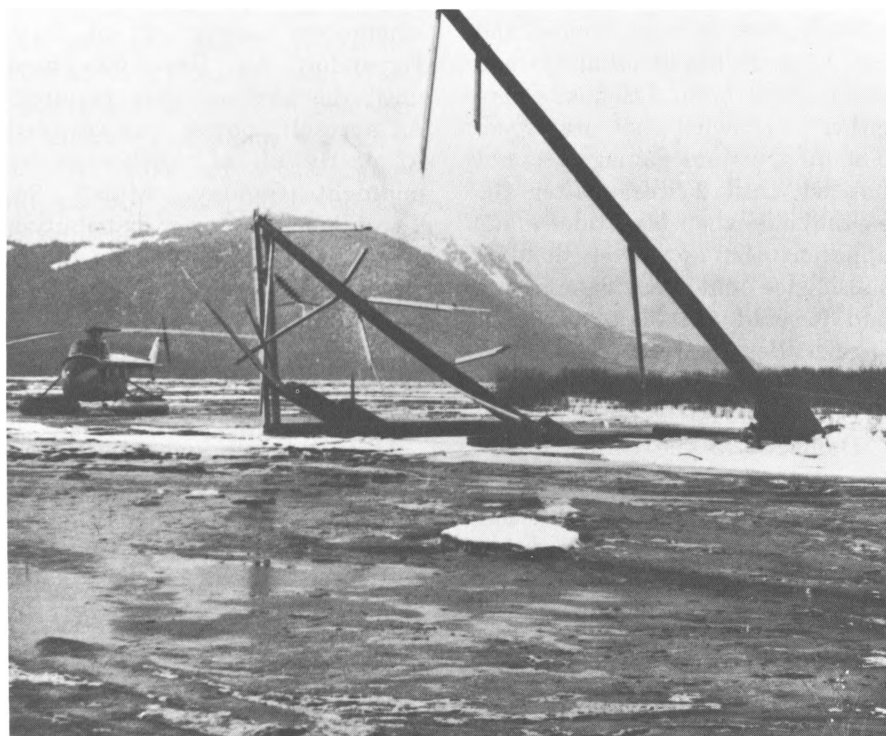
13.—Some power-transmission poles on Turnagain Arm were destroyed by liquefaction of silt foundation and by floating ice. Photograph by Chugach Electric Association, Inc.

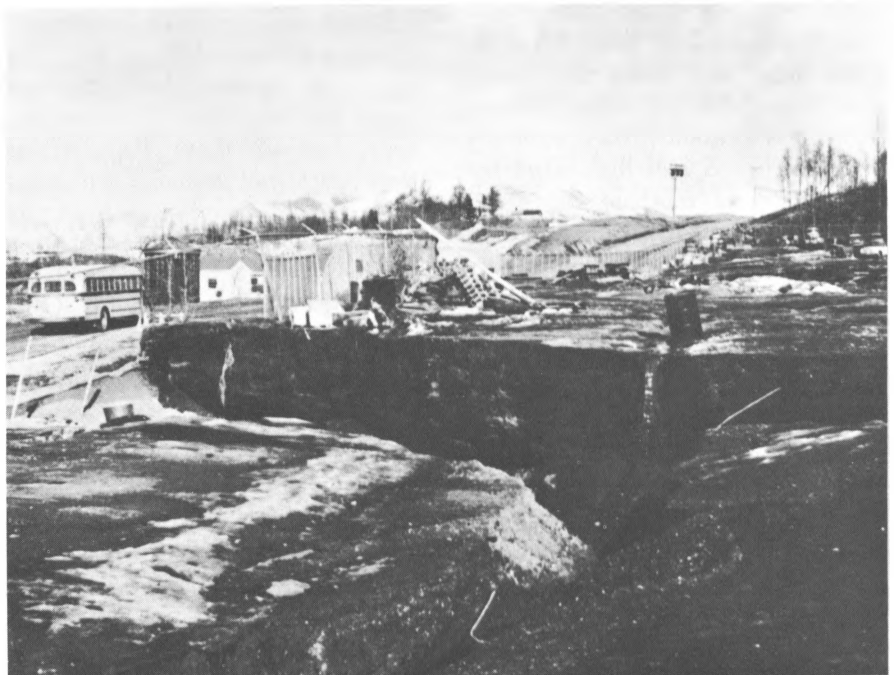
15.—Twelve-inch gas main, supplying fuel for municipal powerplant, was ruptured by landslide at Third Avenue and Post Road, Anchorage. Photograph by W. J. Stump.
