# The Alaska Earthquake

Slide-Induced Waves, Seiching  
And Ground Fracturing  
Caused by the Earthquake  
Of March 27, 1964  
At Kenai Lake, Alaska

By DAVID S. McCULLOCH

GEOLOGICAL SURVEY PROFESSIONAL PAPER 543-A

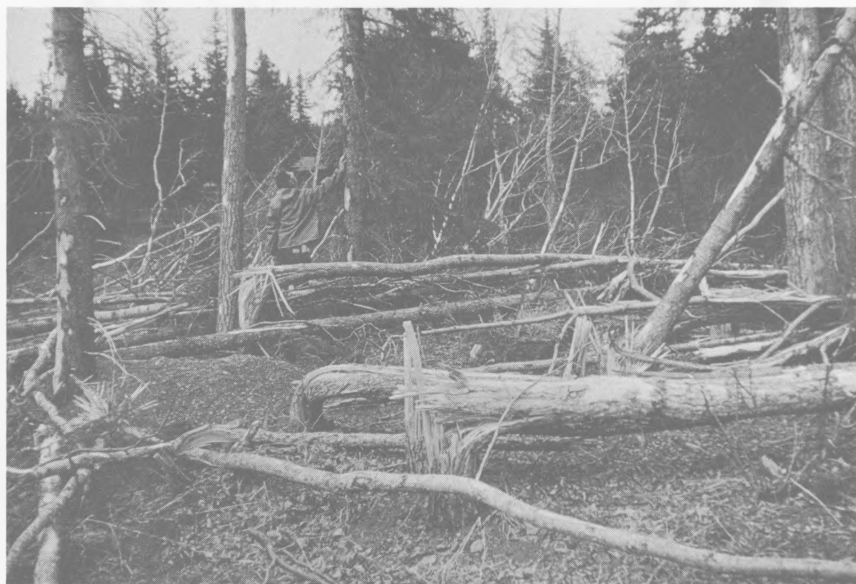
14.—Area washed over by the backfill wave at Lawing. The wave traveled from left to right, breaking down and debarking the trees. Brush in the background was bent to the right. The only branches left on the spruce tree beside the man are on the lee side. The pile of gravel in the left foreground was probably frozen at the time it was carried ashore by the wave.

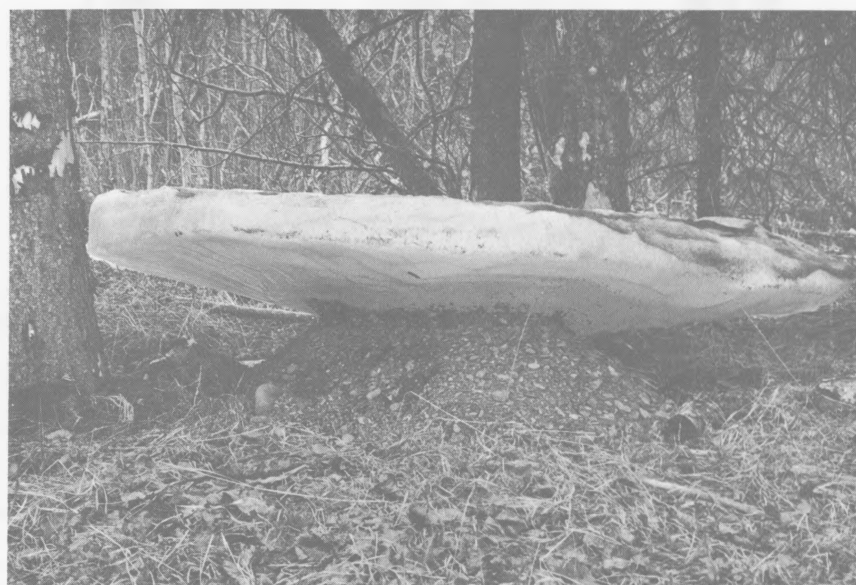
15.—A large block of lake ice to which sediment was frozen when carried ashore by the wave.

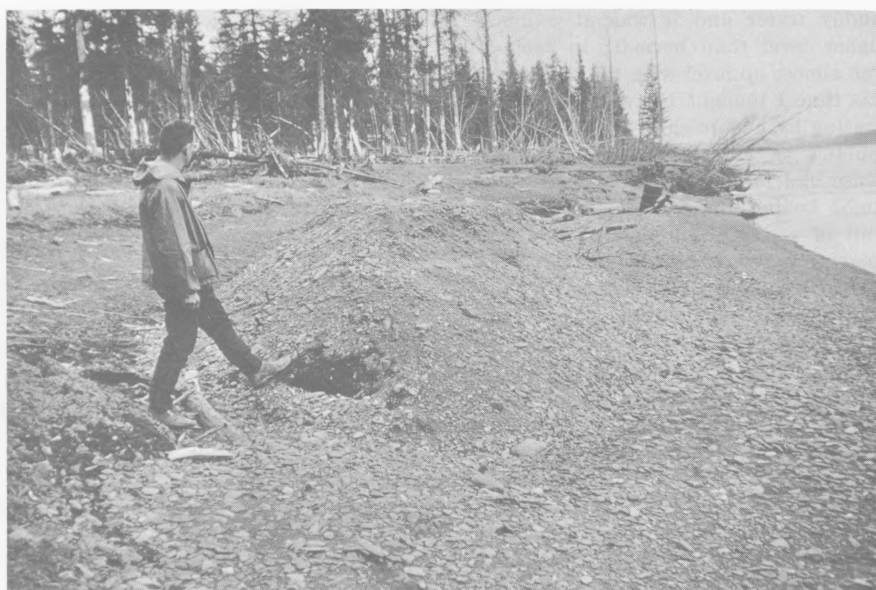
16.—Large block of bedded sandy pebble gravel carried ashore by the wave at Lawing. The slide scarp forms the boundary of the beach to the right; debarked trees in the background.

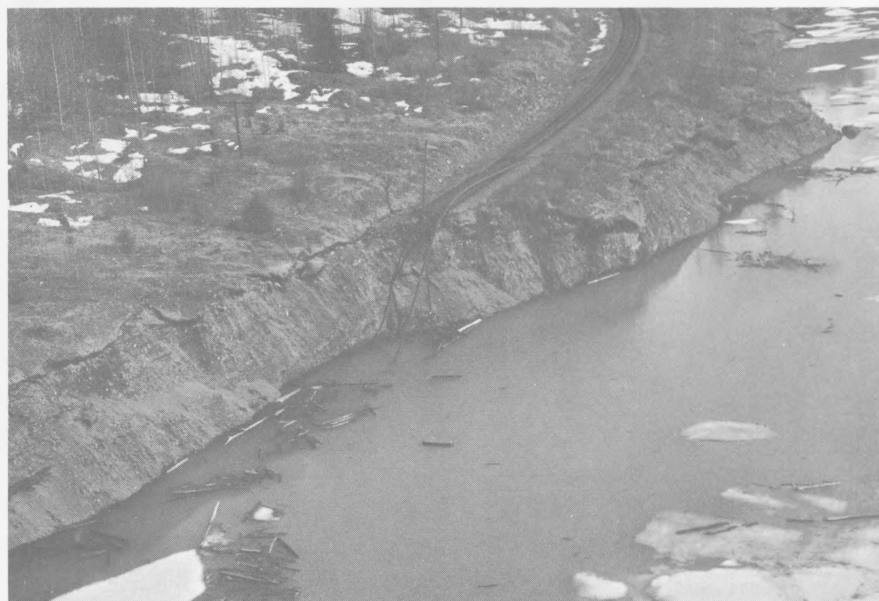
19.—Scarps along the front of Rocky Creek delta produced by many small slump-type slides. The gently dipping coarse sediment is clearly visible. With the exception of the sandy lens at left, most of the sediment is dry.

Rocky Creek has a steep gradient, falling about 4,500 feet in 2 miles. The sediments exposed along the scarps are therefore coarse, poorly sorted sand and sandy gravel. Most of the apparent dips visible on the scarps were estimated to be less than 10°. In mid-May and early August the face of the scarp was dry, except for a few wet lenticular sandy silt beds of short lateral extent and about 6 inches thick (fig. 19). The gravel is composed primarily of angular and subangular tabular pebbles and some cobbles of slaty shale. About 150 feet upslope from the scarp of the slide that carried away the rail line, 8 feet of very sandy gravel is exposed in a shallow borrow pit. The coarse sediment seen in these outcrops is probably representative of the delta as a whole.

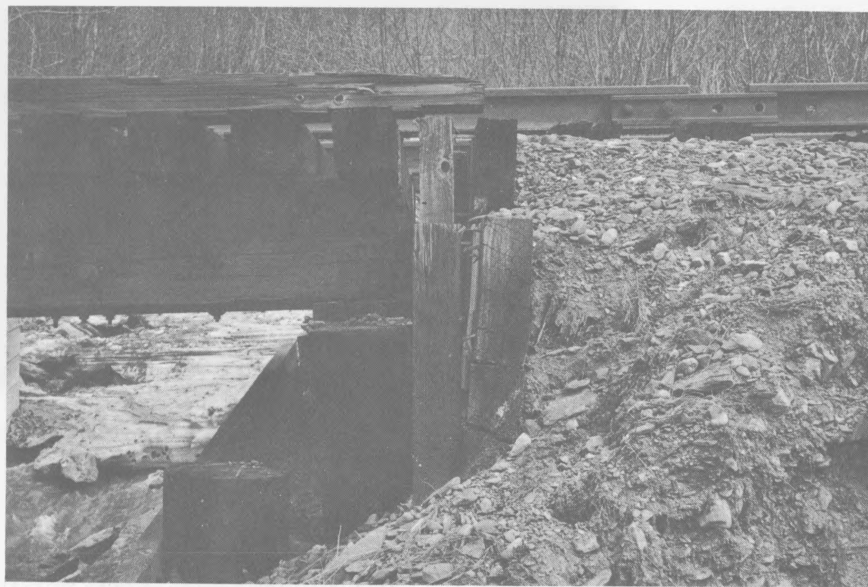
25 (right).—Northeast corner of the railroad bridge on Rocky Creek delta. The stringers rammed the bulkhead and drove the bulkhead timbers away from the fillers during the early part of the shaking. As shaking continued, the underlying sediments of the delta spread laterally and put the bridge and rail line in tension; this tension pulled the stringers part way off the pile cap and sheared the bolts in the track connectors (angle bars).

The track was also put in tension, and the rails were pulled apart endwise on the bridges and adjacent embankments. Expansion joints were opened to their

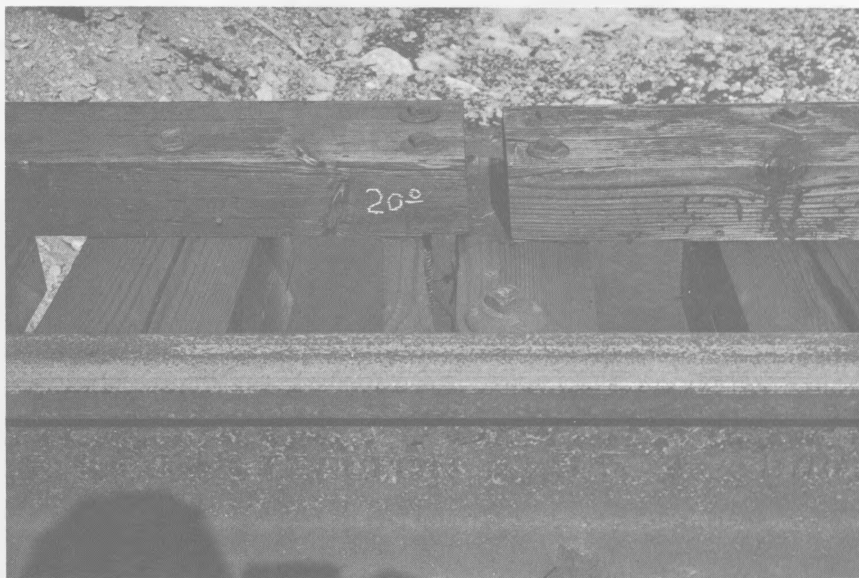
27.—Tension on Lakeview delta railroad bridge pulled guard timbers apart and split a tie.

maximum width, and in several places the tensional force was great enough to shear the bolts in the track connectors (angle bars) (fig. 26). The largest pull-apart was 17 inches at the south end of the Lakeview bridge, and two pull-aparts of 9 inches each were measured on the Rocky Creek bridge. Tension also pulled a guard timber endwise on the Lakeview bridge and split the tie to which it was lag bolted (fig. 27).

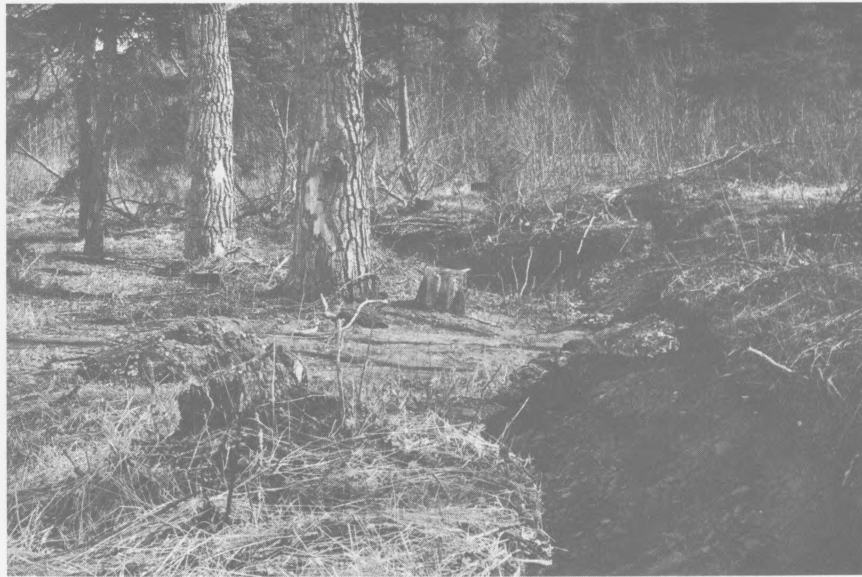
30.—Five-foot high scarp along the back of a rotational slump on Lakeview delta. Kenai Lake lies to the left. The slide-induced wave deposited the small pile of sediment on the dirt road displaced by the scarp and debarked the trees.

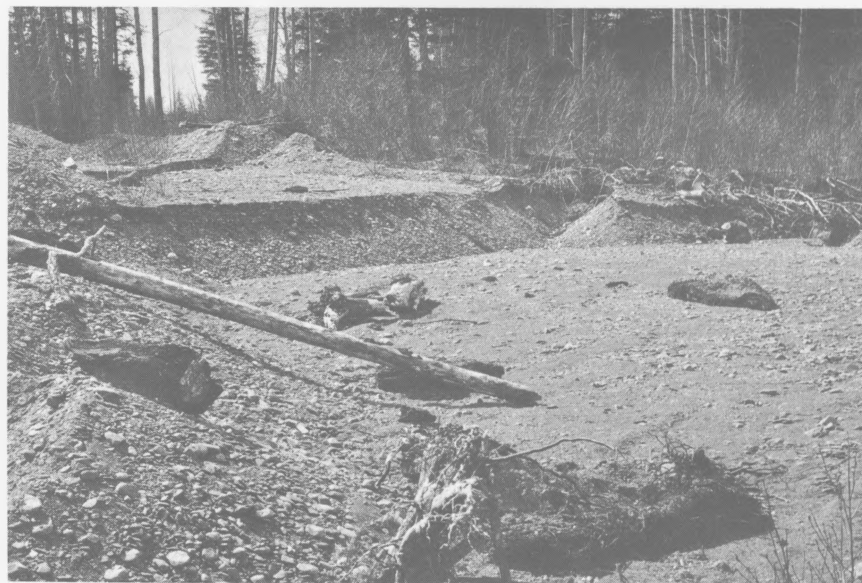
31.—High scarp ( $4\frac{1}{2}$  ft) of a rotational slump on the south side of Victory Creek on Lakeview delta.

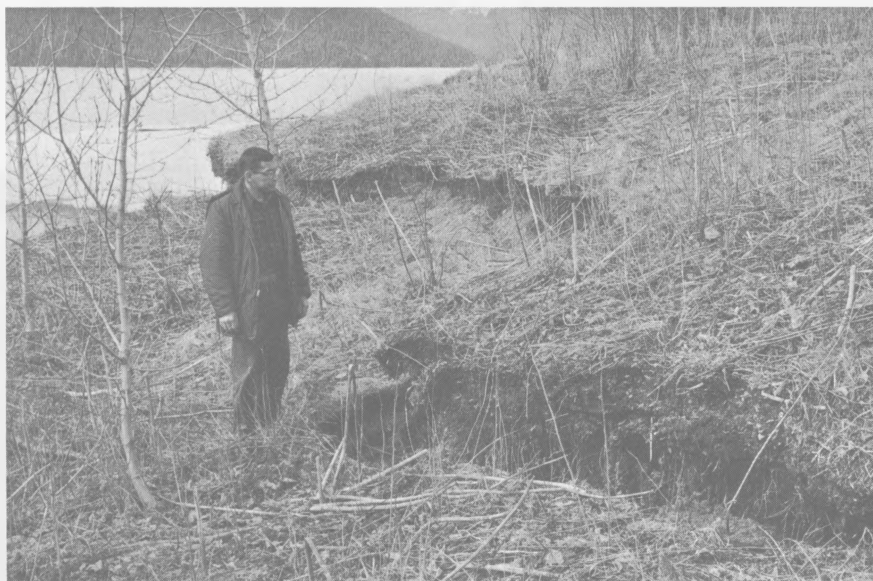
32.—Slump block having some rotation and horizontal separation at the edge of Rocky Creek delta.
