# The Alaska Earthquake

Geologic Effects of the  
March 1964 Earthquake  
And Associated Seismic  
Sea Waves on Kodiak  
And Nearby Islands  
Alaska

By GEORGE PLAFKER and REUBEN KACHADOORIAN

GEOLOGICAL SURVEY PROFESSIONAL PAPER 543-D

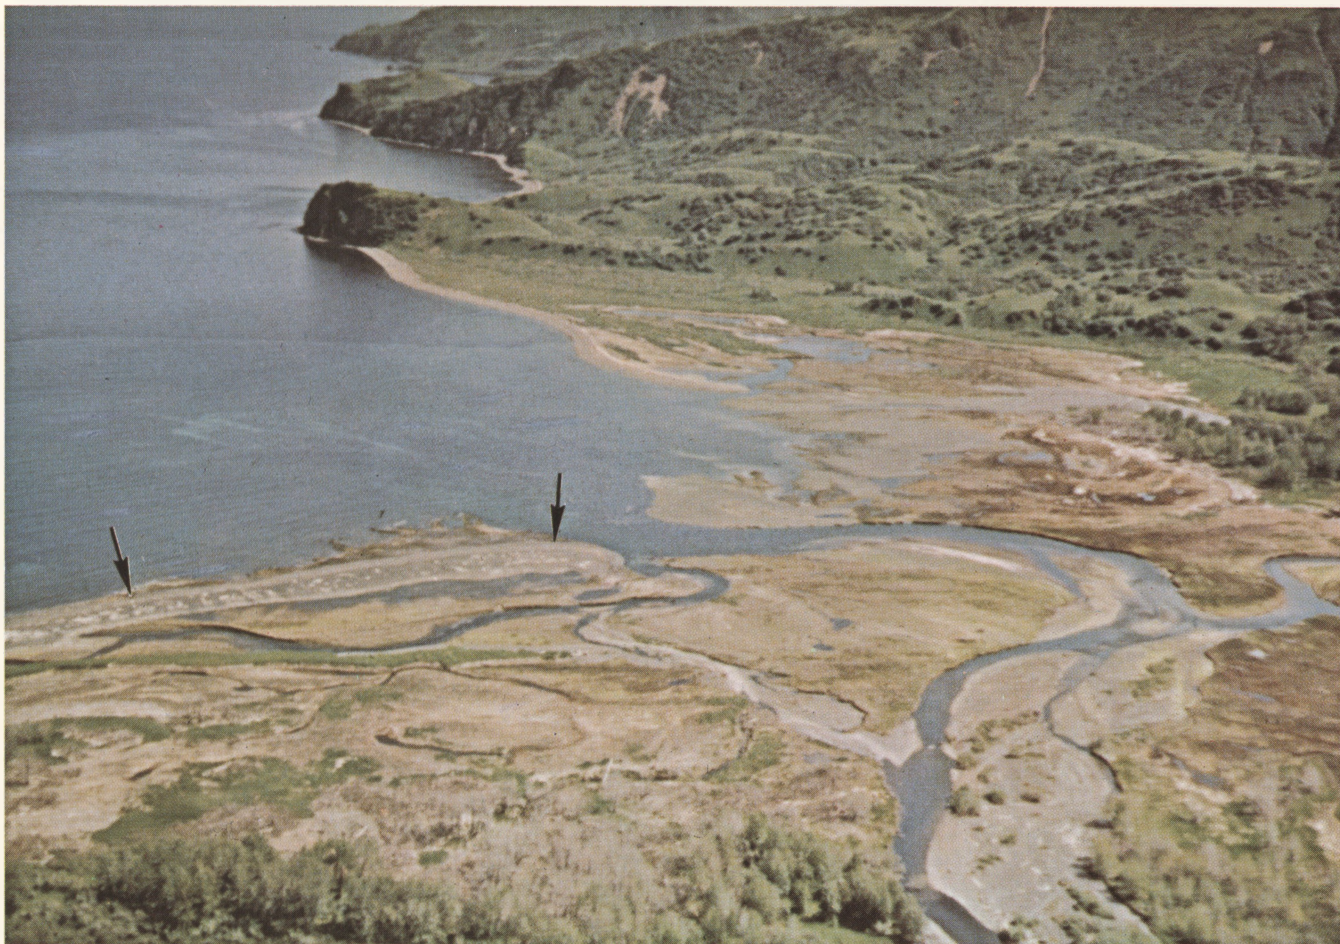
#### DROWNED STREAM ESTUARY AT EAGLE HARBOR ALONG SOUTH SHORE OF UGAK BAY

Extensive brown area of terrestrial vegetation has been killed by salt-water immersion after 4 feet of tectonic subsidence and an unknown amount of surficial subsidence. The gray ridge of beach gravel in the left part of view (arrows) has been eroded back and built up in adjustment to the new higher base level of deposition. The fact that the effects of inundation are scarcely visible along the steep bedrock shore in the background suggests that much of the subsidence at the estuary deposits was surficial rather than tectonic.

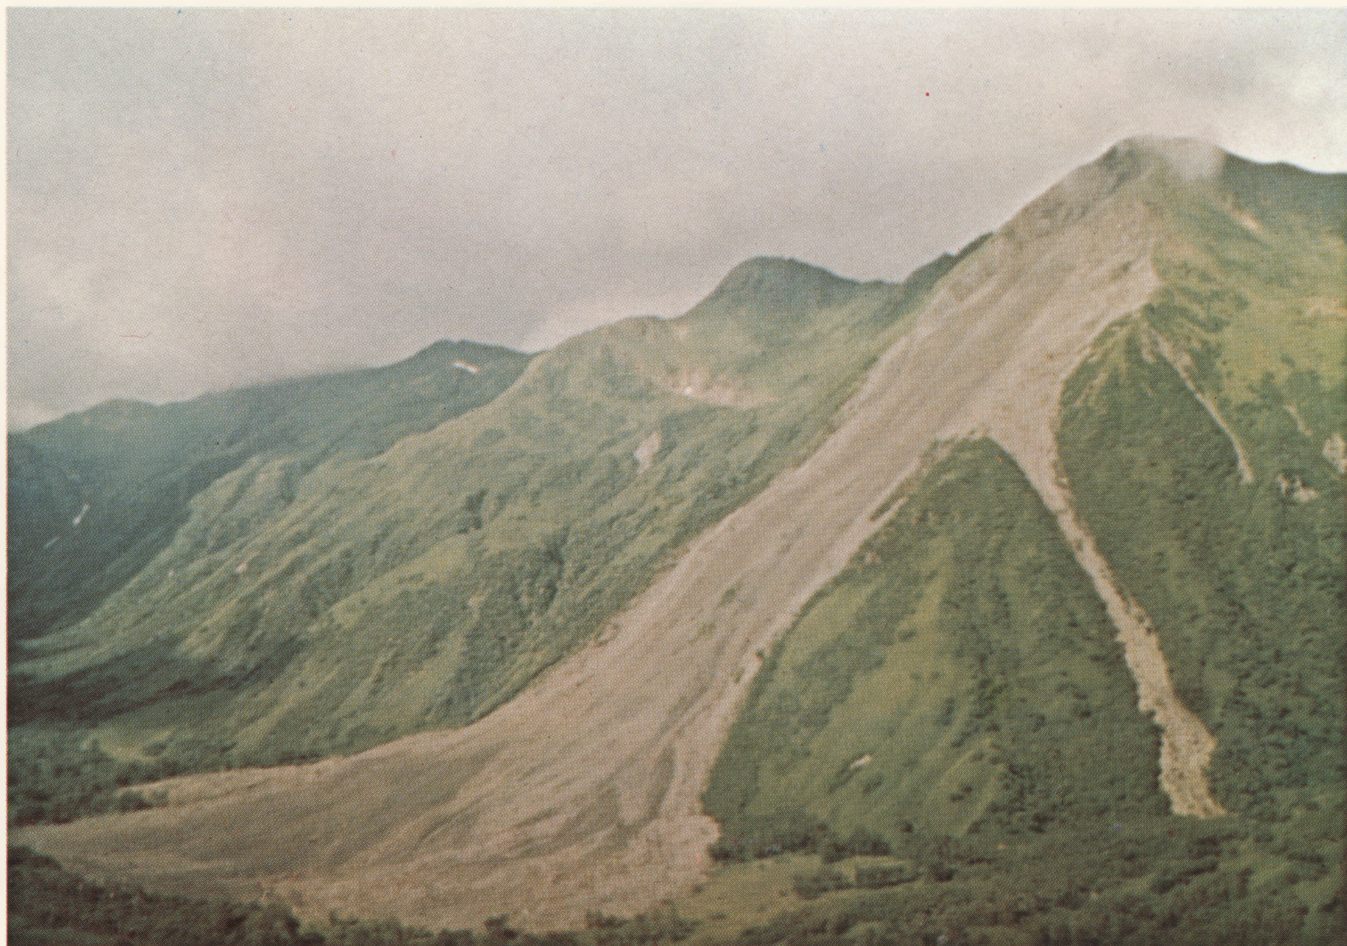
#### DEBRIS AVALANCHE ON THE PENINSULA BETWEEN UGAK AND KILIUDA BAYS

A slide of Tertiary rocks from the 1,500-foot-high peak at upper right flowed into the uninhabited valley below at about 300-foot altitude where it spread out as a debris lobe roughly 1,500 feet across. The narrow streak of light-colored debris in the lower right corner is part of the slide mass that overflowed the near flank of the landslide scar.

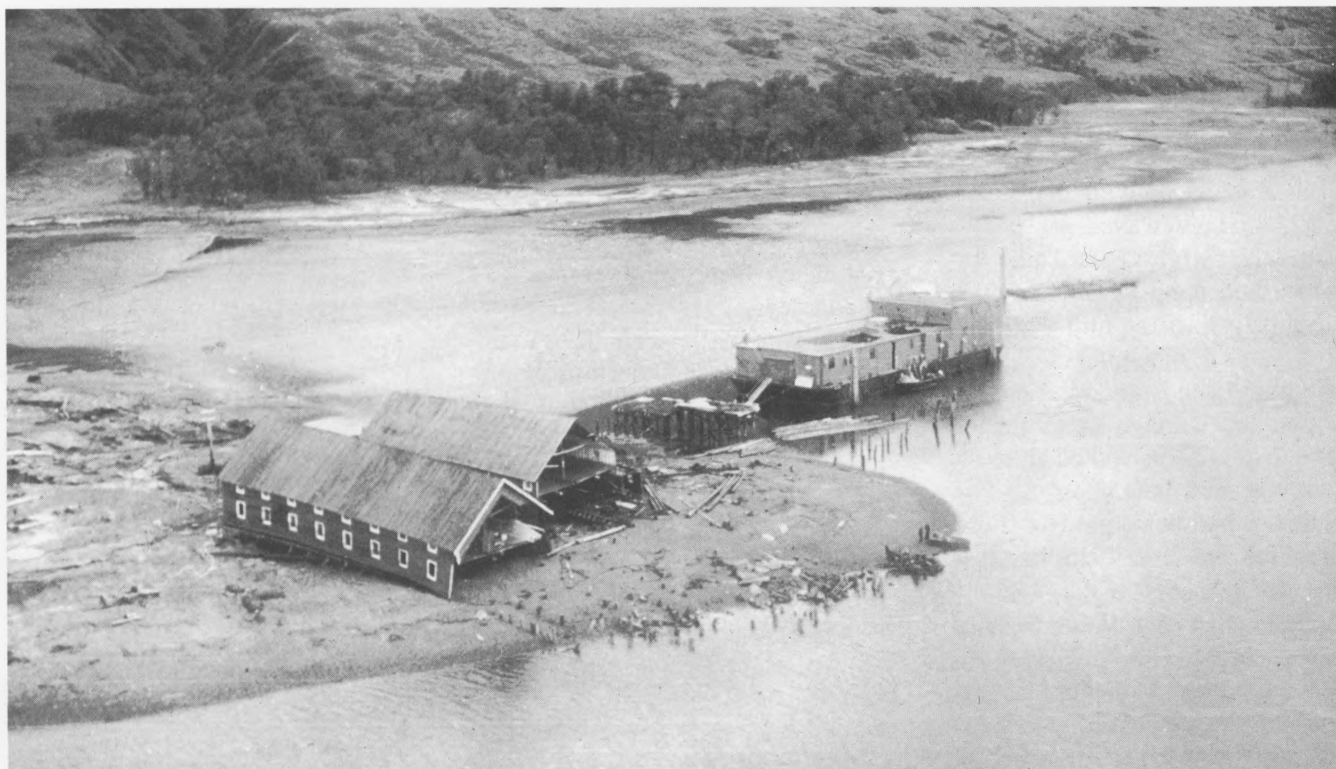
6.— The Kadiak Fisheries cannery site in Shearwater Bay along the north shore of Kiliuda Bay. Cannery buildings in the foreground were split during the earthquake and the seaward parts of the structures were later washed away by seismic sea waves. The former locations of the buildings and dock are outlined by timber pile foundations in the beach and water. The entire beach is now inundated at high tide as a result of about 4 feet of tectonic subsidence and 2-10 feet of surficial subsidence of the beach deposits. The barge behind the cusp is a floating cannery that replaces the destroyed facility on land. Location of cannery shown on figure 5.

posits throughout the islands. In these areas, structural damage resulted mainly from foundation failure attributable to partial liquefaction, differential settlement, and cracking of unconsolidated deposits and artificial fill. The sole structural failure reported in the area was the partial collapse of the main building of the Kadiak Fisheries cannery located on a beach cusp on Shearwater Bay along the north shore of Kiliuda Bay. The structure split in half when it was shifted off its piling foundation according to the cannery watchman, Mr. Sergei Pestrikoff. The piling was driven into beach gravel that was partially liquefied during the earthquake (fig. 6). The fallen section was later washed away by the seismic sea waves.

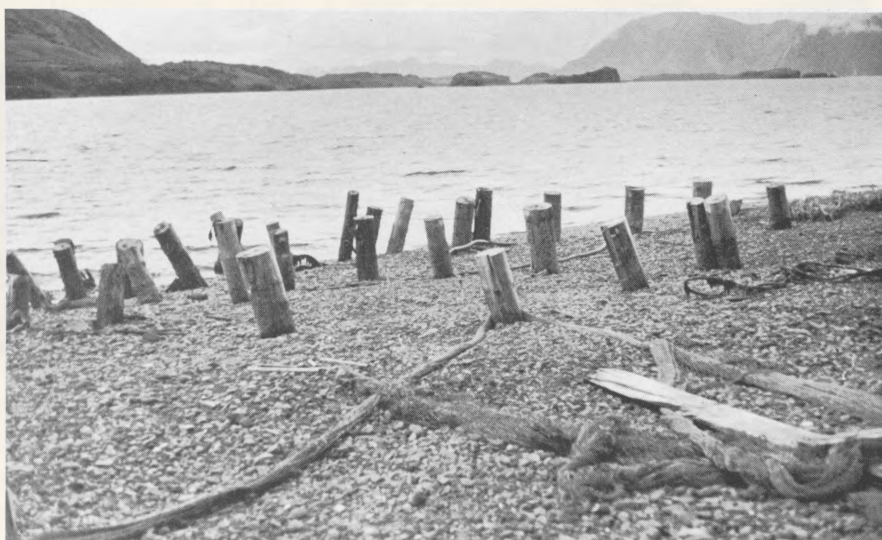
7. — Timber pile foundation at Kodiak Fisheries cannery site. Pronounced tilting of unbroken piling is indicative of lateral motion of the piling through 10–15 feet of beach gravel. Piling tops formerly level are now 7.8 feet lower at the seaward end of the cannery site than in the foreground owing to local settlement of the distal part of the beach culsp. Bent drift pins in the piling tops indicate that the cannery moved southward (away from the observer) off the piling.

ed subsidence was  $5\frac{1}{3}$  feet at the shipway piling to the right (north) of the cannery buildings. This subsidence, 2 feet more than that at a bedrock site 1 mile to the south, indicates surficial settlement of about 2 feet relative to bedrock. Furthermore, measurement of the difference in height of the tops of the piling that previously supported the destroyed part of the cannery indicates that an additional 7.8 feet of surficial settlement occurred towards the tip of the culsp (fig. 7).

The site is now submerged at high tides, and the facilities have been replaced by a floating cannery. Ground cracks as much as a foot wide reportedly crisscrossed the cusp after the earthquake. Mr. Edward Pestrikoff, the cannery watchman, saw cracks form in the ground during the earthquake and saw water ejected as high as 6 feet. Reduction of shear strength of the unconsolidated deposits through partial liquefaction is suggested by the manner in which the foundation pilings shown in figure 7 were tilted without being broken when the cannery building collapsed.

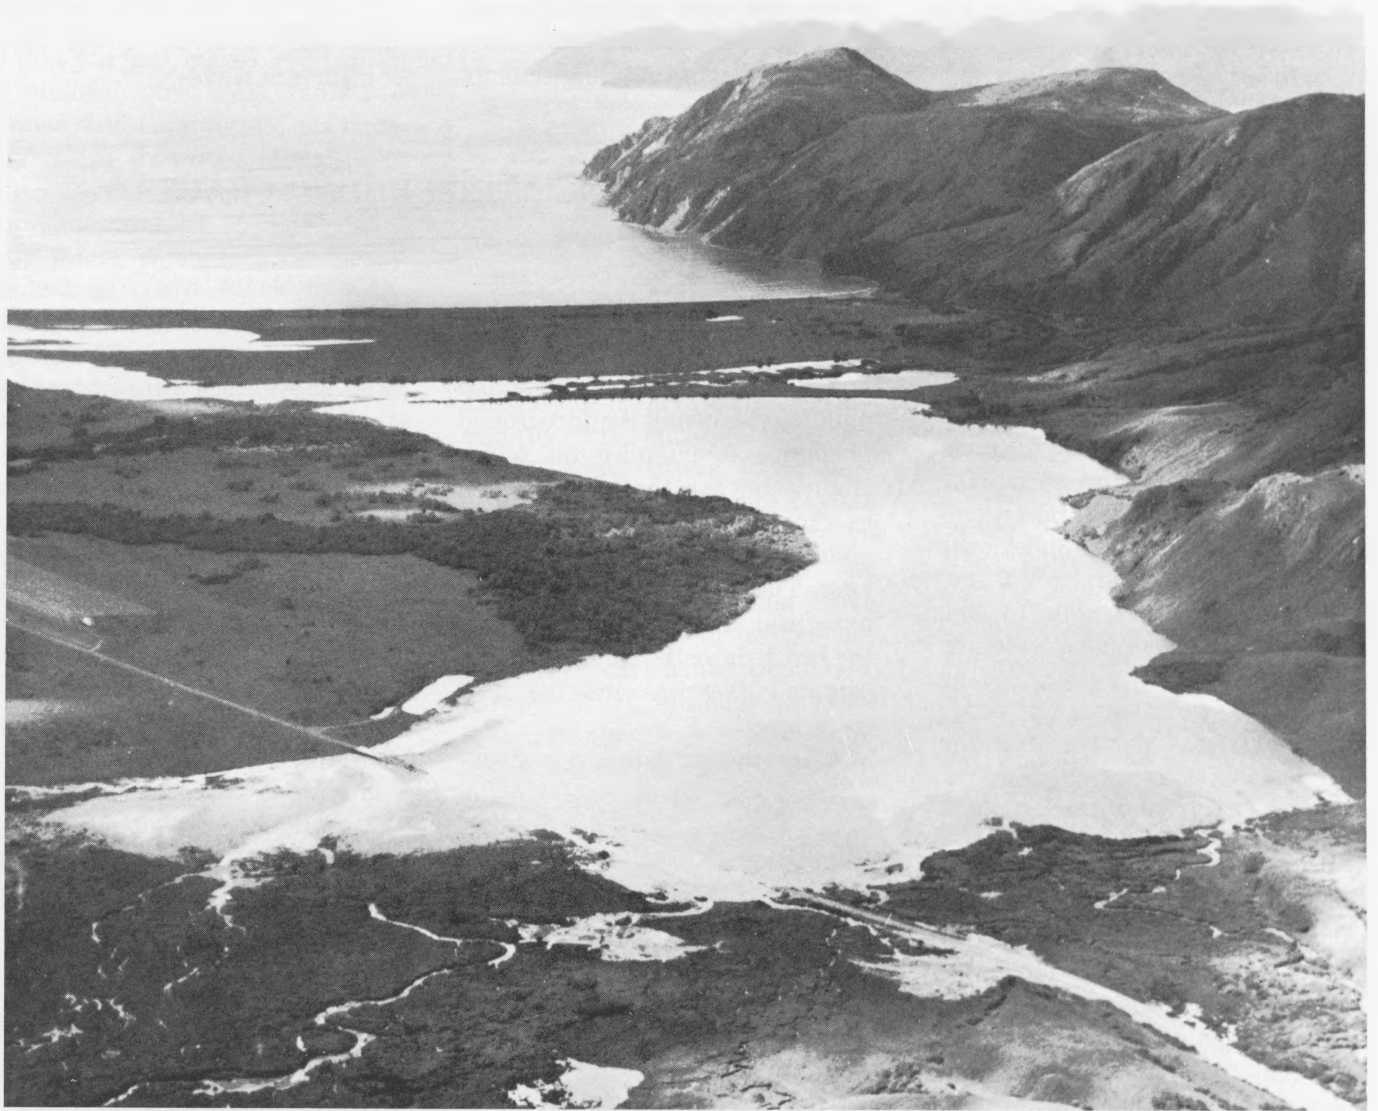
8. — Road near the head of Lake Rose Tead submerged by about 5 feet of surficial subsidence of inlet-stream deltaic deposits. Ugak Bay is visible in the background. Photograph by Alaska Department of Fish and Game.

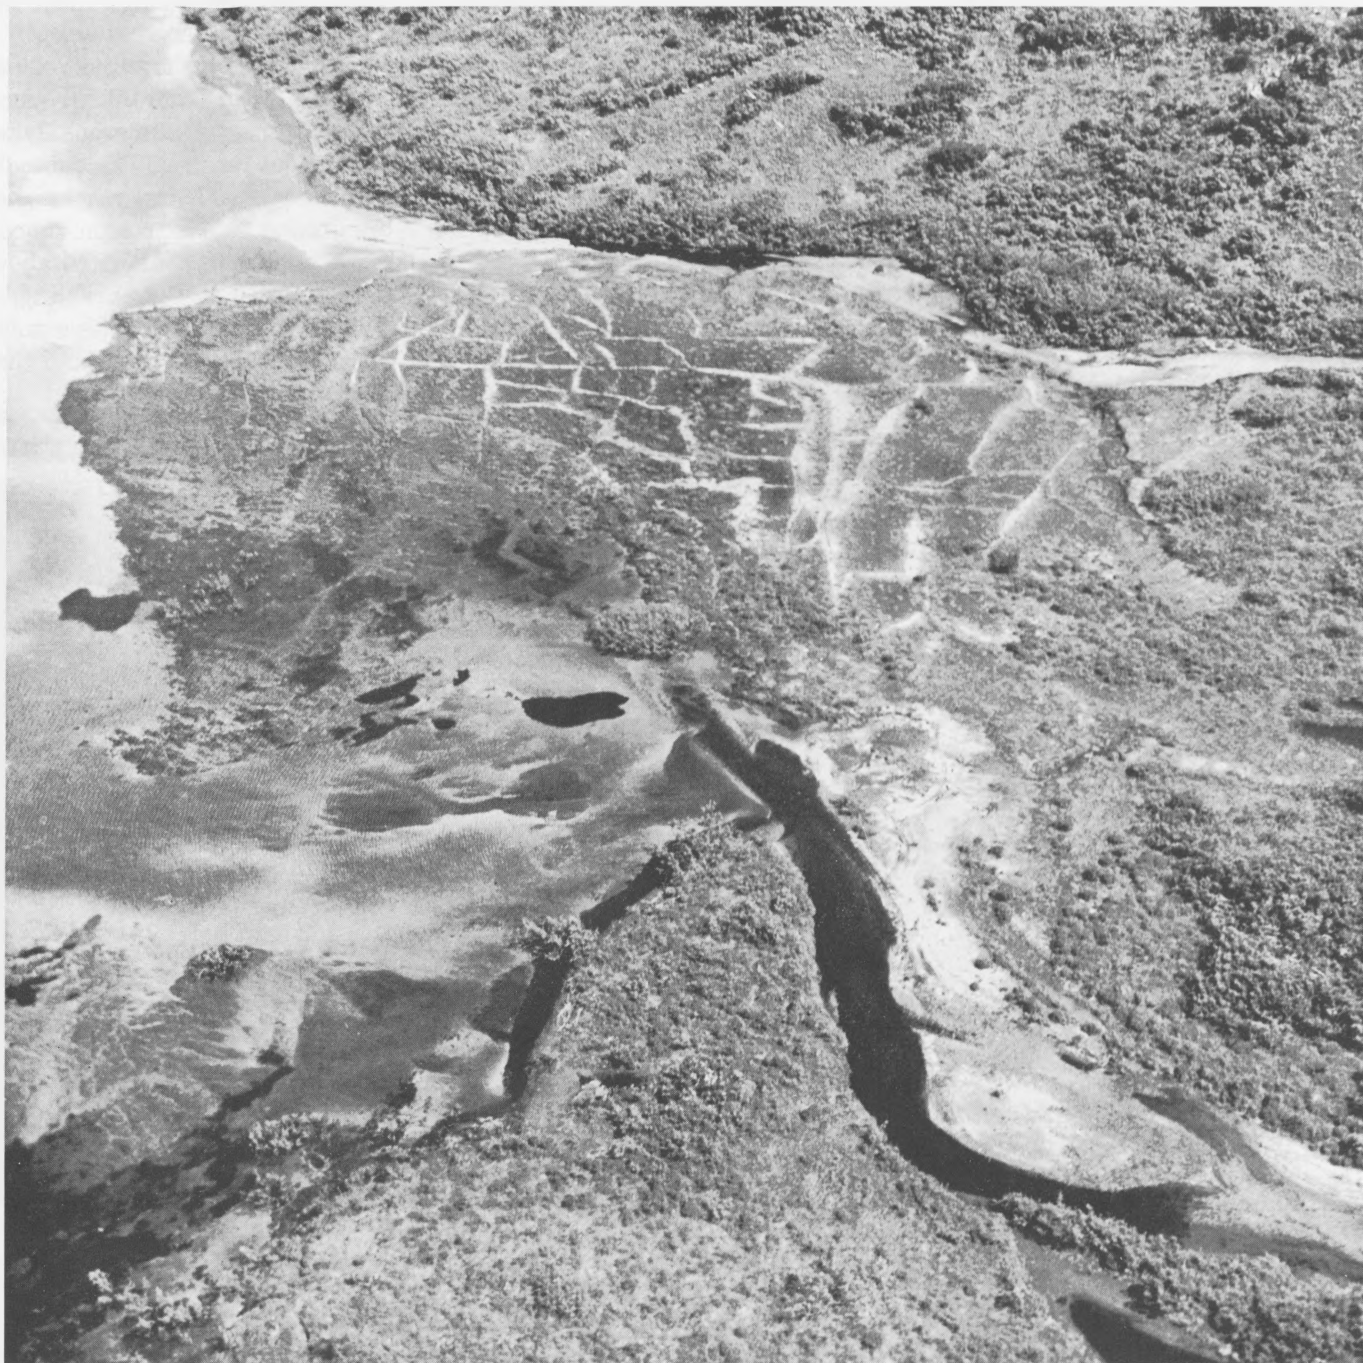
9.— Inlet delta at the head of Terror Lake showing inundation of slumped and cracked delta margin and linear cracks defined by light-colored pumiceous ejecta. Photograph by F. O. Jones.

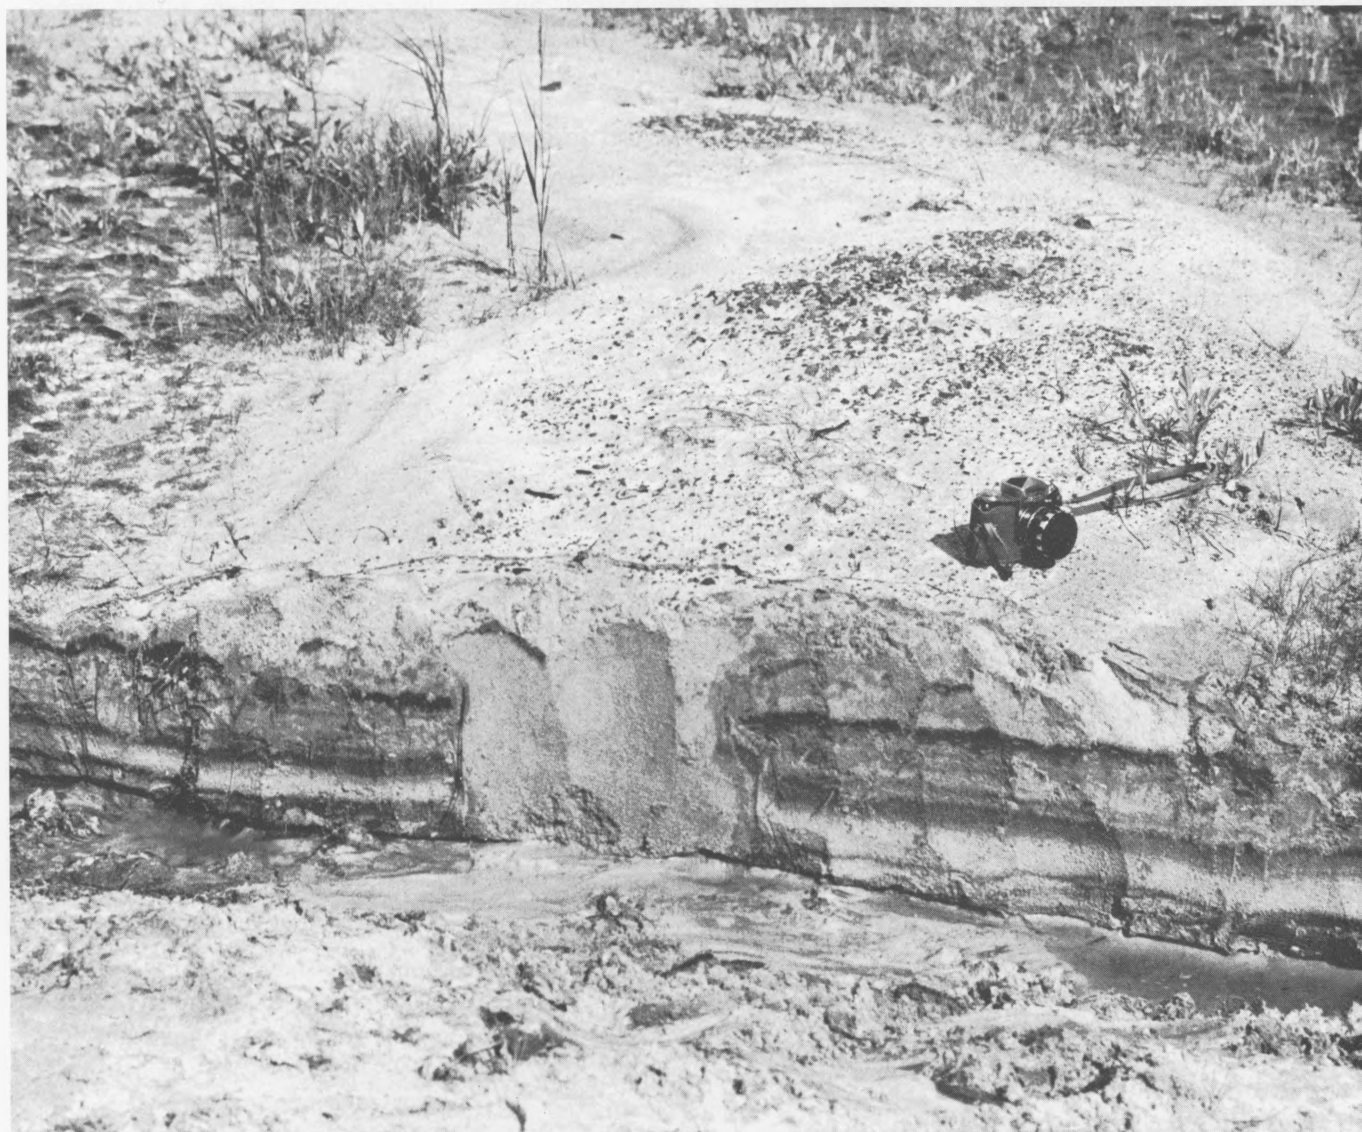
10.—Sectioned extension crack 1 foot wide at head of Terror Lake showing light-colored fine- to medium-grained pumiceous sand ejecta at surface and subsurface clastic dike. Photograph by F. O. Jones.

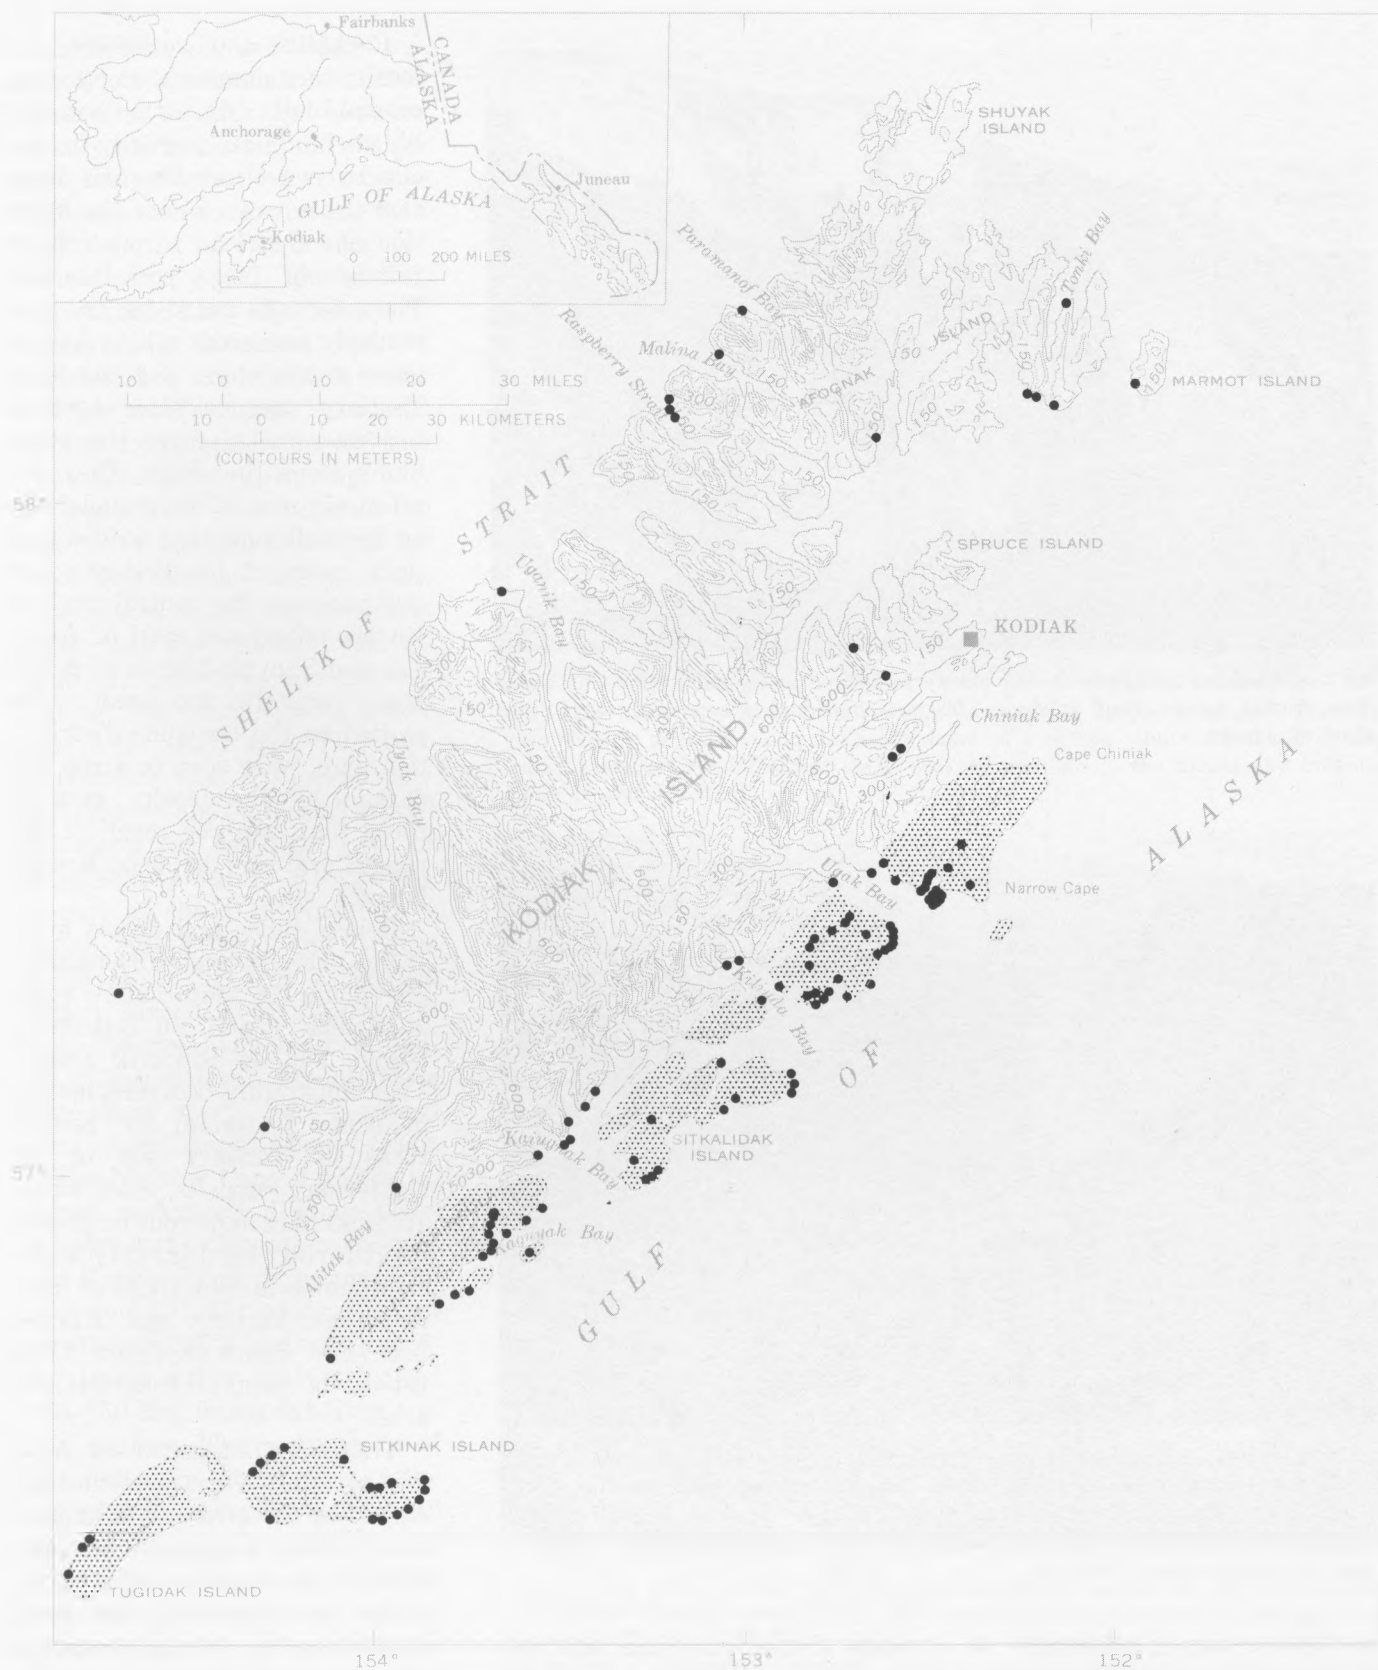
11. — Generalized distribution of the larger landslides and soil slips triggered by the March 27, 1964, earthquake on Kodiak and nearby islands. Areas underlain by rocks of Tertiary or probable Tertiary age are shaded.

Numerous snow avalanches and debris avalanches of snow-rock mixtures are visible on aerial photographs of the steep slopes at higher altitudes along the rugged backbone of Kodiak Island. They are not shown on figure 11 because the postearthquake aerial coverage was inadequate to permit photogeologic mapping of their distribution. Furthermore, most of the avalanches at high altitudes were obscured by new snowfall by the time this study was initiated 3½ months after the earthquake.

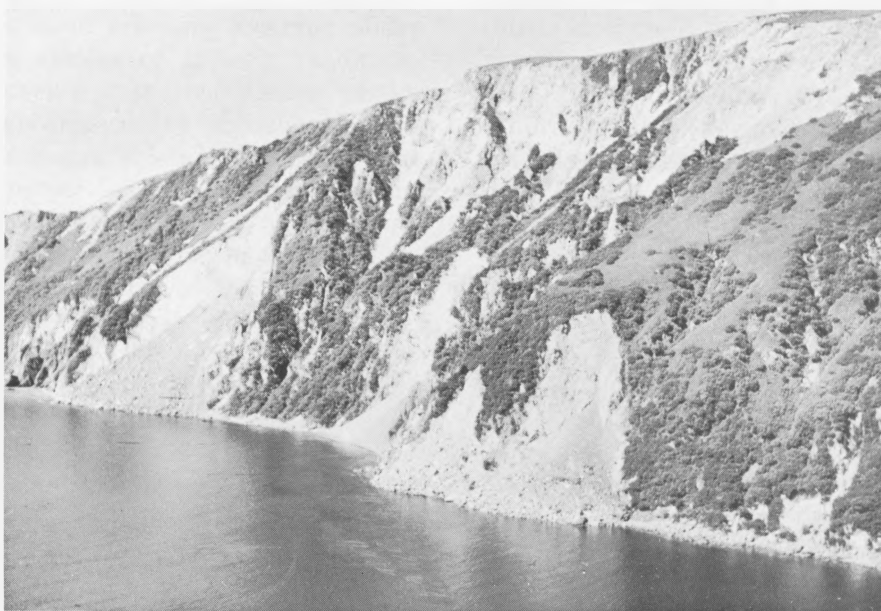
12.— Rockslides in tightly folded blocky sandstone along north shore of Ugak Bay, Kodiak Island. Bluff is about 1,000 feet high and is exposed to surf from Gulf of Alaska.

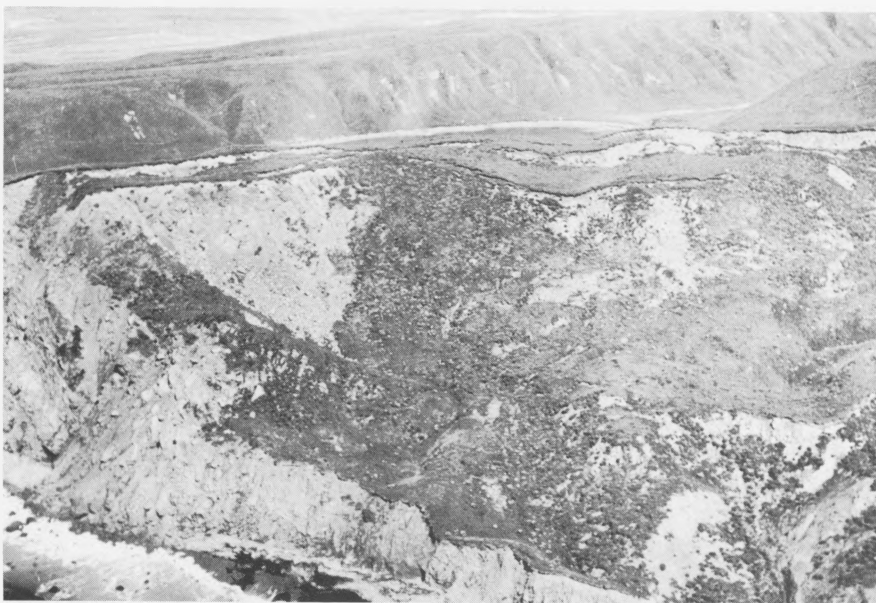
13.— Reactivated large debris slide in sedimentary rocks of middle Tertiary age along the south shore of Sitkinak Island. Note the characteristic steplike transverse scarps, displacing surface vegetation at head of the slide. A small rockfall covers part of the beach in lower left of photograph. Vertical height of slide mass is approximately 300 feet.

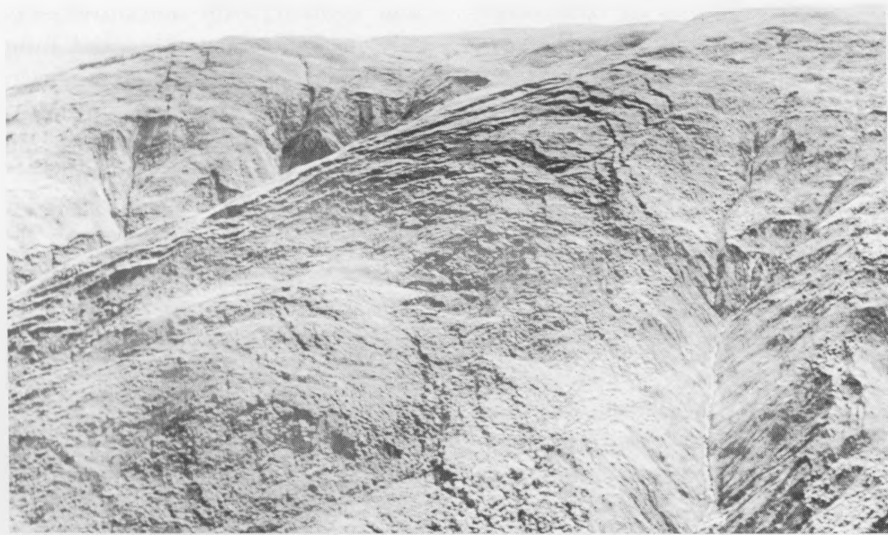
14. — Earthflow resulting from soil slip or slump in deeply weathered Tertiary sedimentary deposits along the north shore of Sitkinak Island. The head of the slide is marked by numerous small scarps; the foot is the hummocky bulbous mass in the lower left corner.

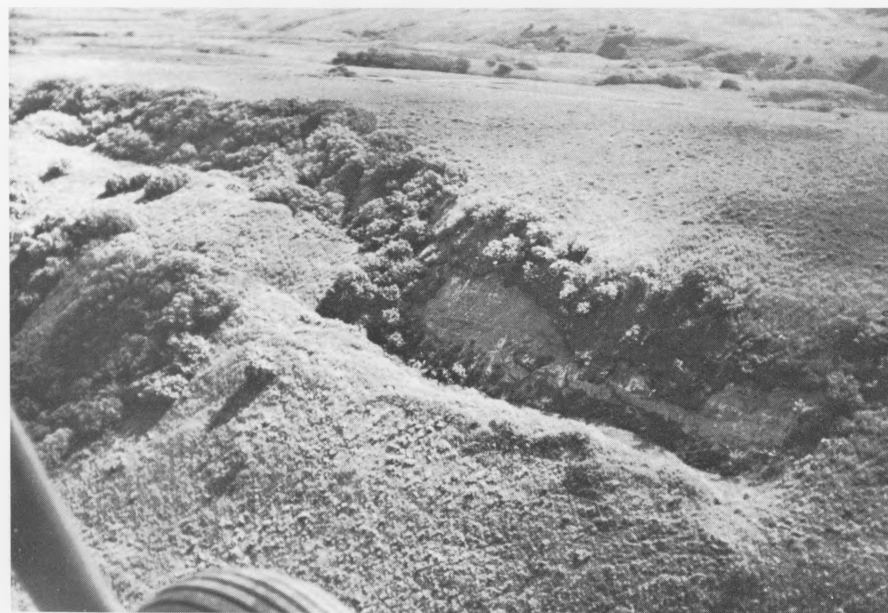
15. — Main scarp at the head of a large rotational slump in Tertiary deposits on Narrow Cape, Kodiak Island. The landslide is approximately 1,400 feet long and 125–150 feet high. The rock mass at the left slid 8–15 feet downslope along a surface of rupture, the main scarp of which trends diagonally across the photograph. Note the headward tilt of the original surface on the upper part of the slide mass and draping of the vegetation mat over the crown of the main slide.

The Narrow Cape landslide involved moderately dipping, poorly indurated sedimentary rocks of late Tertiary age. It occurred on slopes of  $15^{\circ}$ – $35^{\circ}$  along a structurally controlled northeast-trending linear valley that is incised 125–150 feet into a flat-lying erosion surface. The main scarp of the slide (fig. 15) broke at the top of the southeast valley wall along a distance of roughly 1,400 feet. The slide mass slumped down on the northwest side as much as 15 feet with headward tilting along a surface of rupture that intersected the surface on the valley floor 125–150 feet be-

low. Open tension cracks and shallow grabens are abundant on the erosion surface headward from the main scarp. The slide toe is characterized by transverse pressure ridges and small overthrusts in the surface mat of muskeg vegetation. The brush-covered hummocky topography of the lower part of the slide surface and the chaotic internal structure suggest that earlier gravity movement has taken place.

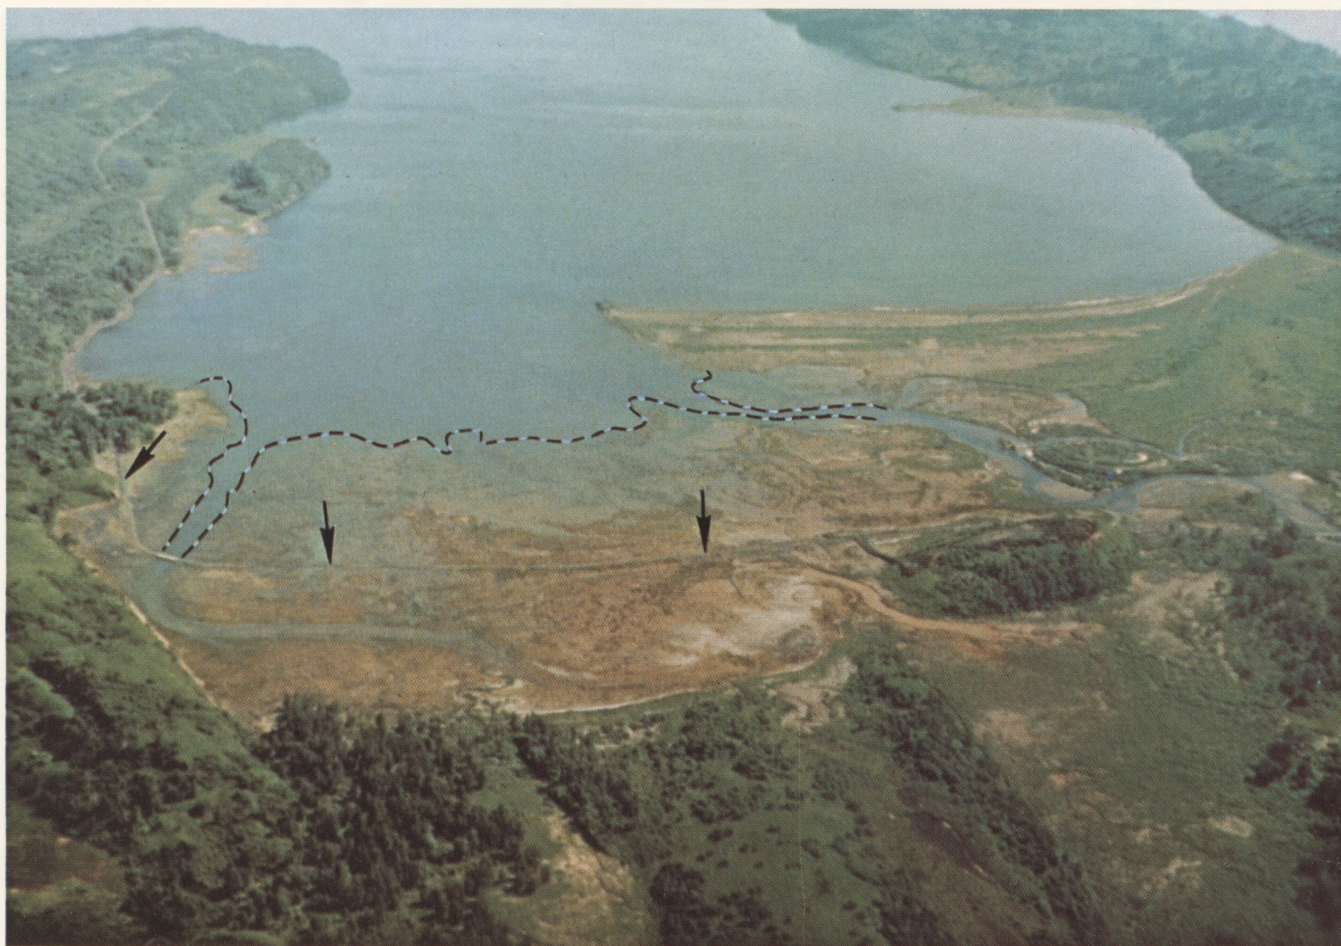
### SUBSIDENCE AT MIDDLE BAY

Extensive inundation at the head of Middle Bay resulting from 5 feet of tectonic subsidence and an unknown but substantial amount of surficial subsidence. Arrows indicate the approximate location of remnants of the Kodiak-Chiniak highway. Dashed line shows the approximate preearthquake mean high-water shoreline which has been shifted about half a mile landward.

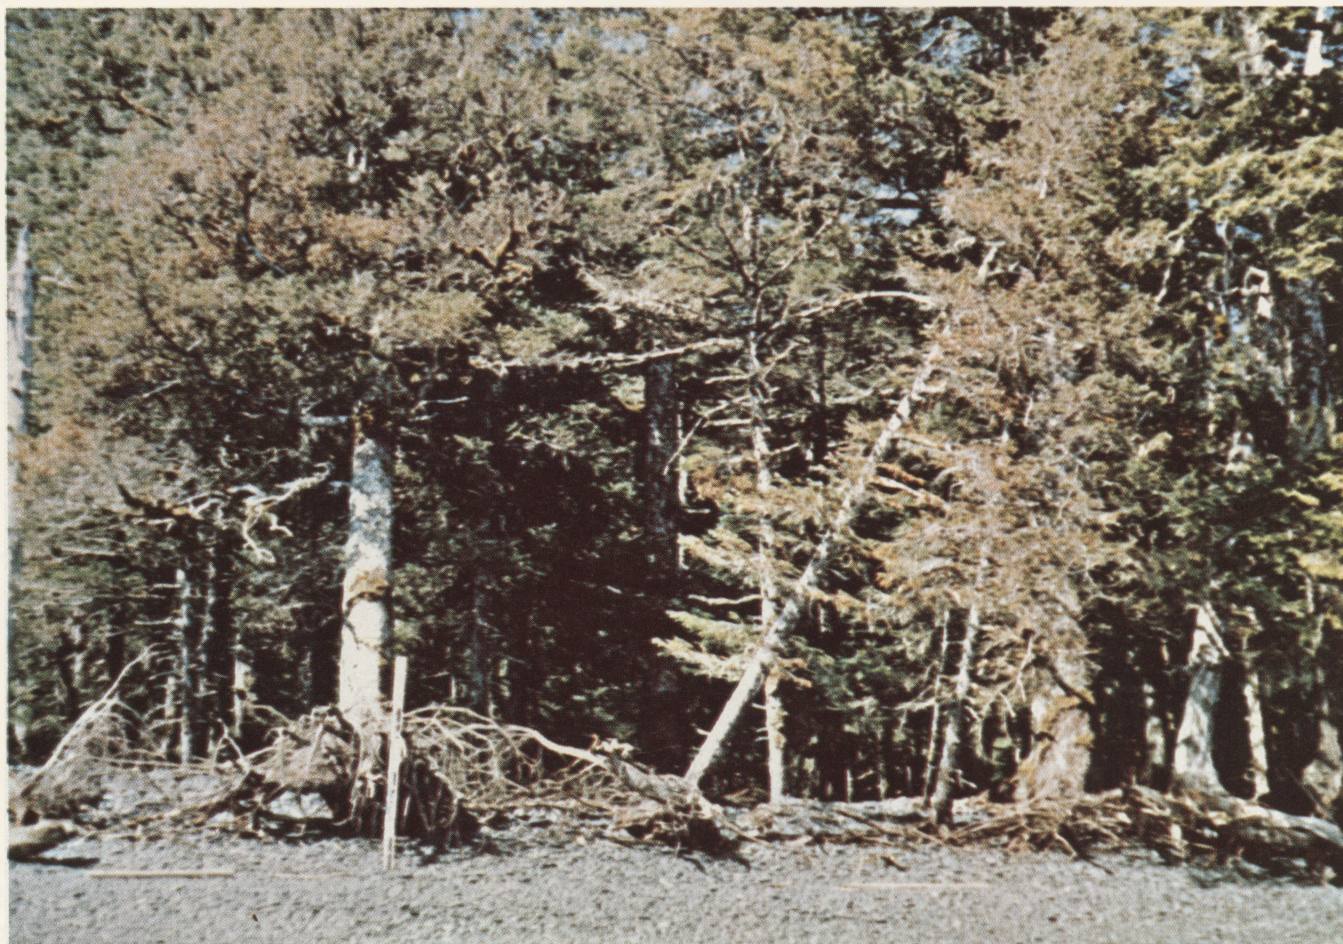
UNDERMINED TREES ON BARRIER BEACH IN IZHUT BAY, AFOGNAK ISLAND

Accelerated wave erosion in an area of about 5 feet of tectonic subsidence caused this damage. Foliage of trees along shore has turned brown from salt-water immersion of the roots.

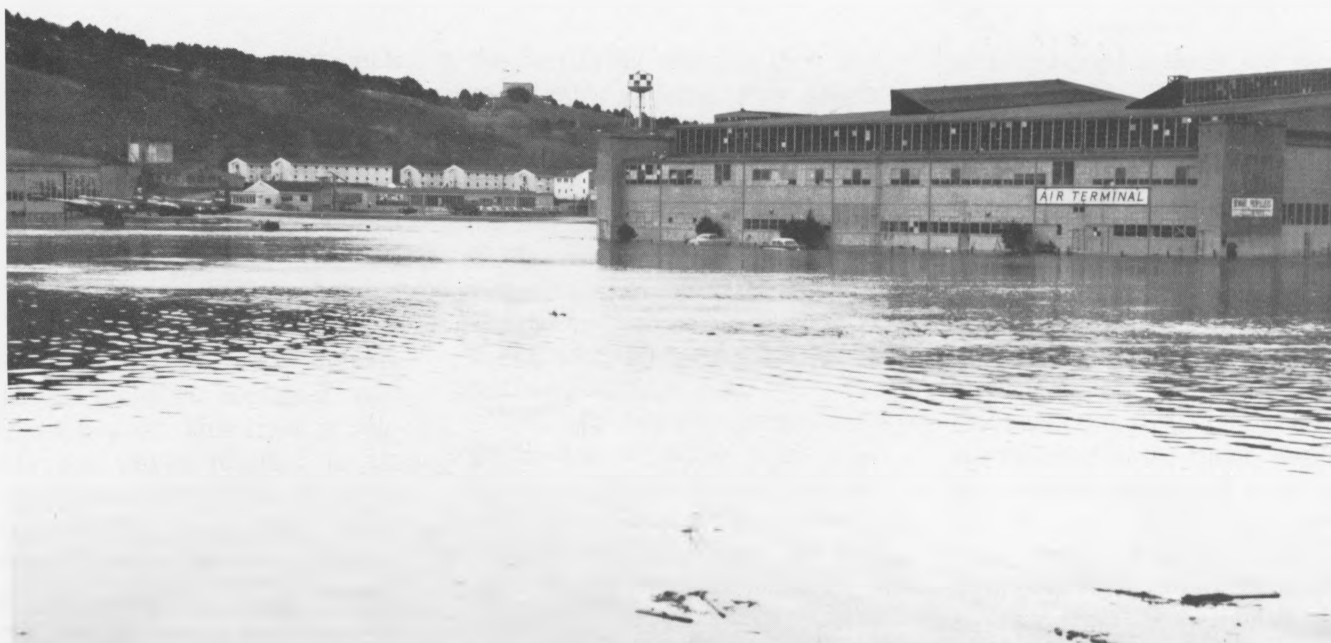
19. — Seaplane ramp at Kodiak Naval Station along shore of Womens Bay showing approximate high-water level reached by first wave. Note calm water surface. Aircraft parked in front of hangar at left center were later moved to high ground and saved. Photograph by U.S. Navy.

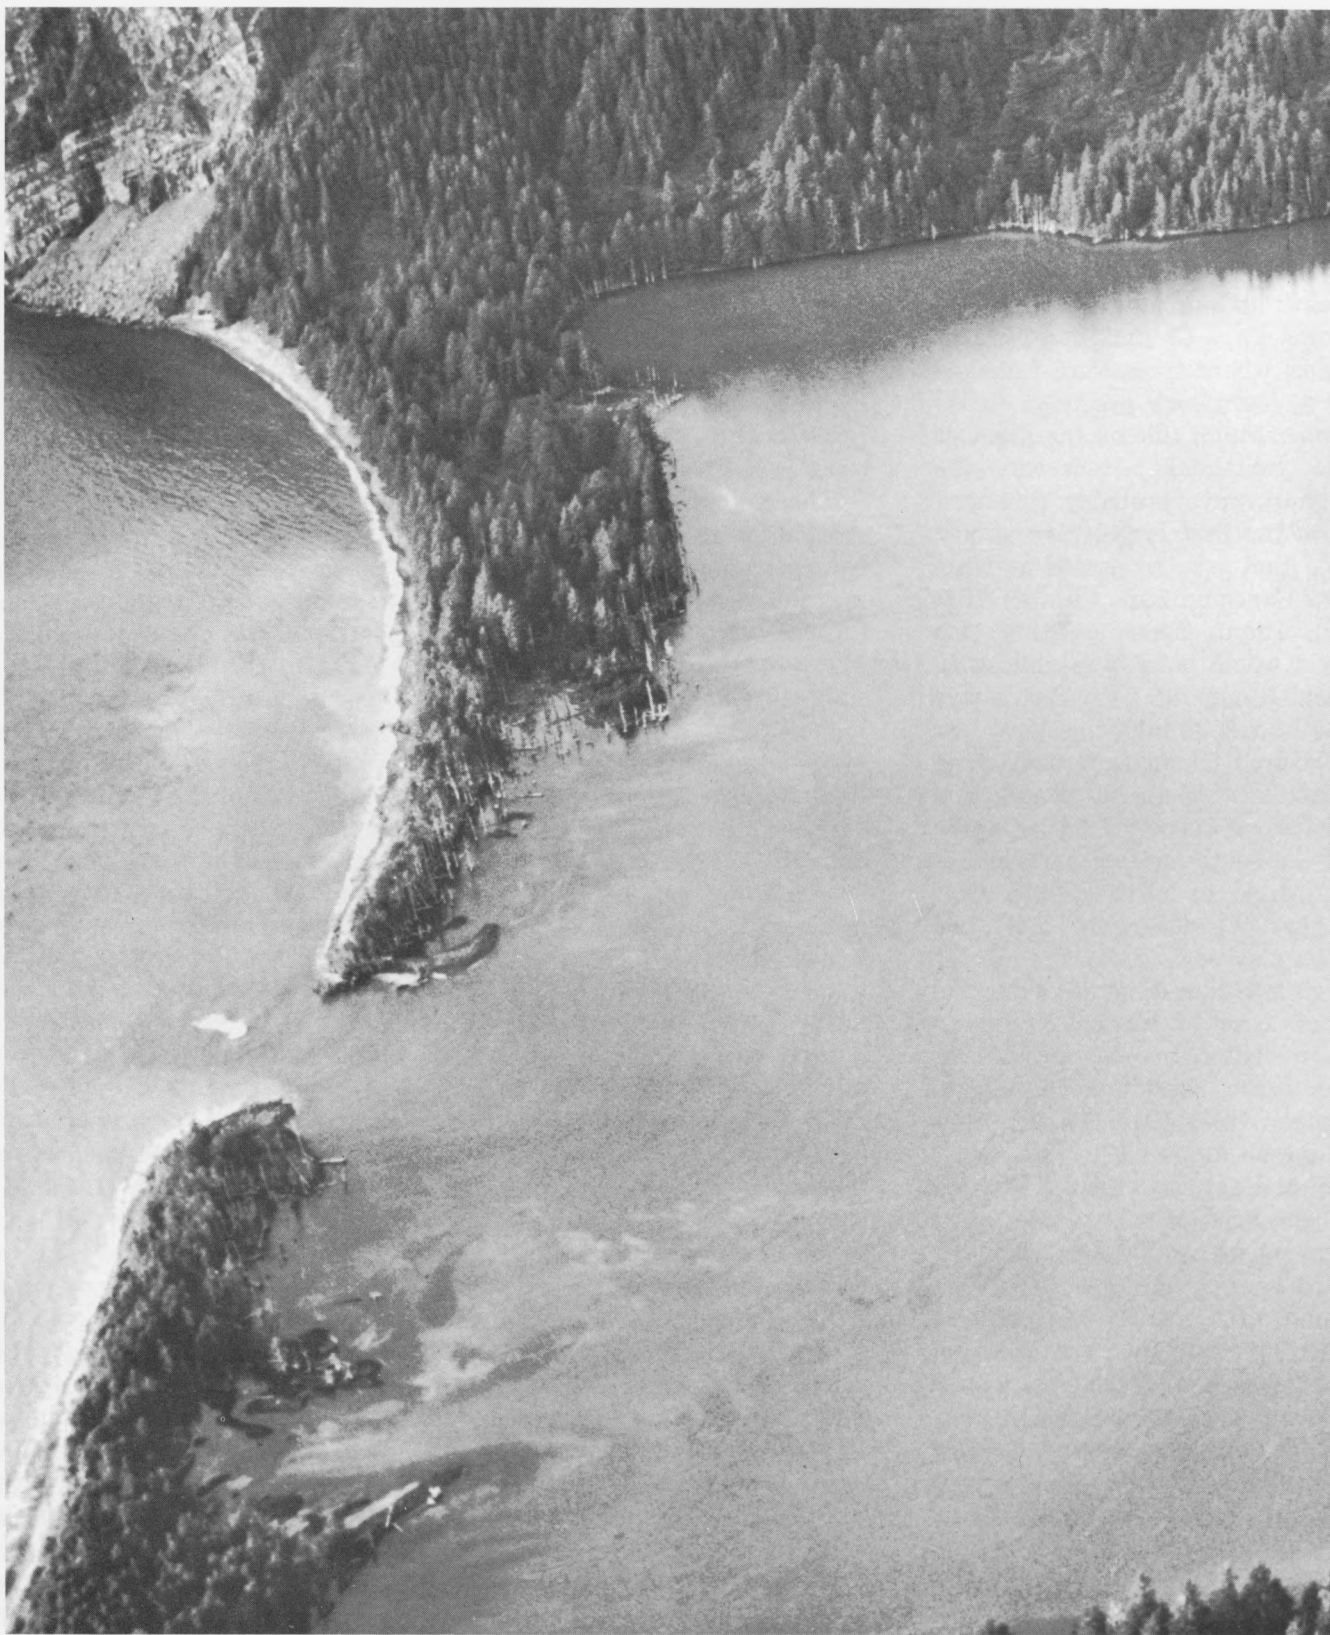
20.— Opening torn by seismic sea waves in the barrier beach of a large lake along the shore of Izhut Bay on Afognak Island. Channel scour and subsidence of at least 6 feet permit sea water to enter the basin at all stages of tide. Note partially submerged trees along inner margins of the beach spits, and small new rockslide along bluff in background. Photograph by Alaska Department of Fish and Game.

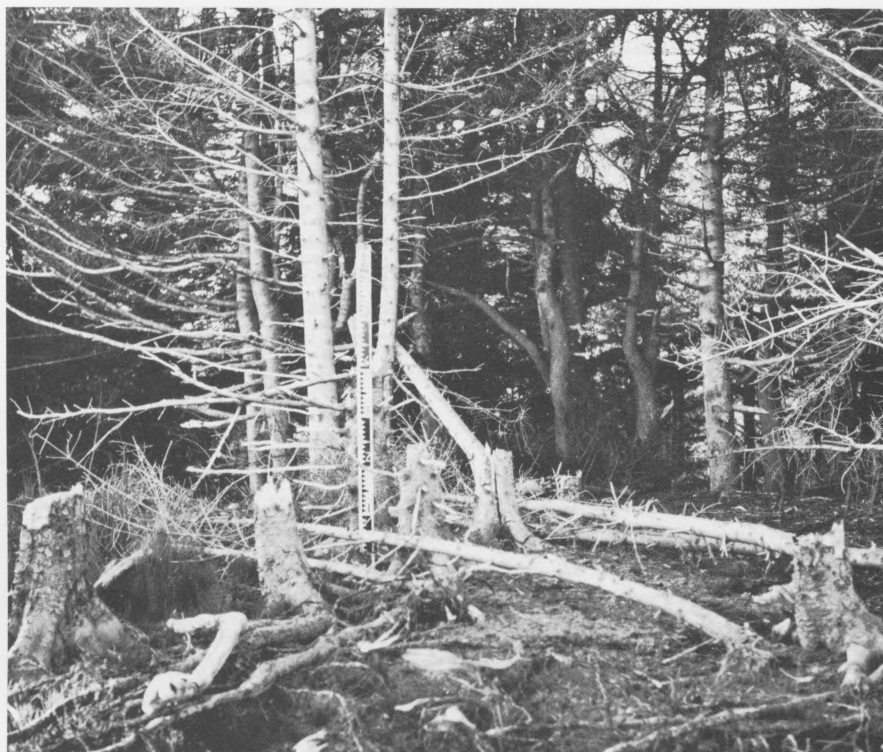
21. — Shoreline damage between Narrow Cape and Cape Chiniak caused by driftwood-laden seismic sea wave. Spruce trees as much as 8 inches in diameter were broken off at about 30 feet altitude. Limbs were broken and trunks scarred to a measured altitude of 42 feet above lower low water. Crowns of downed trees point in direction of water movement.
