# The Alaska Earthquake

Geologic Effects of the  
March 1964 Earthquake  
And Associated Seismic  
Sea Waves on Kodiak  
And Nearby Islands  
Alaska

By GEORGE PLAFKER and REUBEN KACHADOORIAN

GEOLOGICAL SURVEY PROFESSIONAL PAPER 543-D

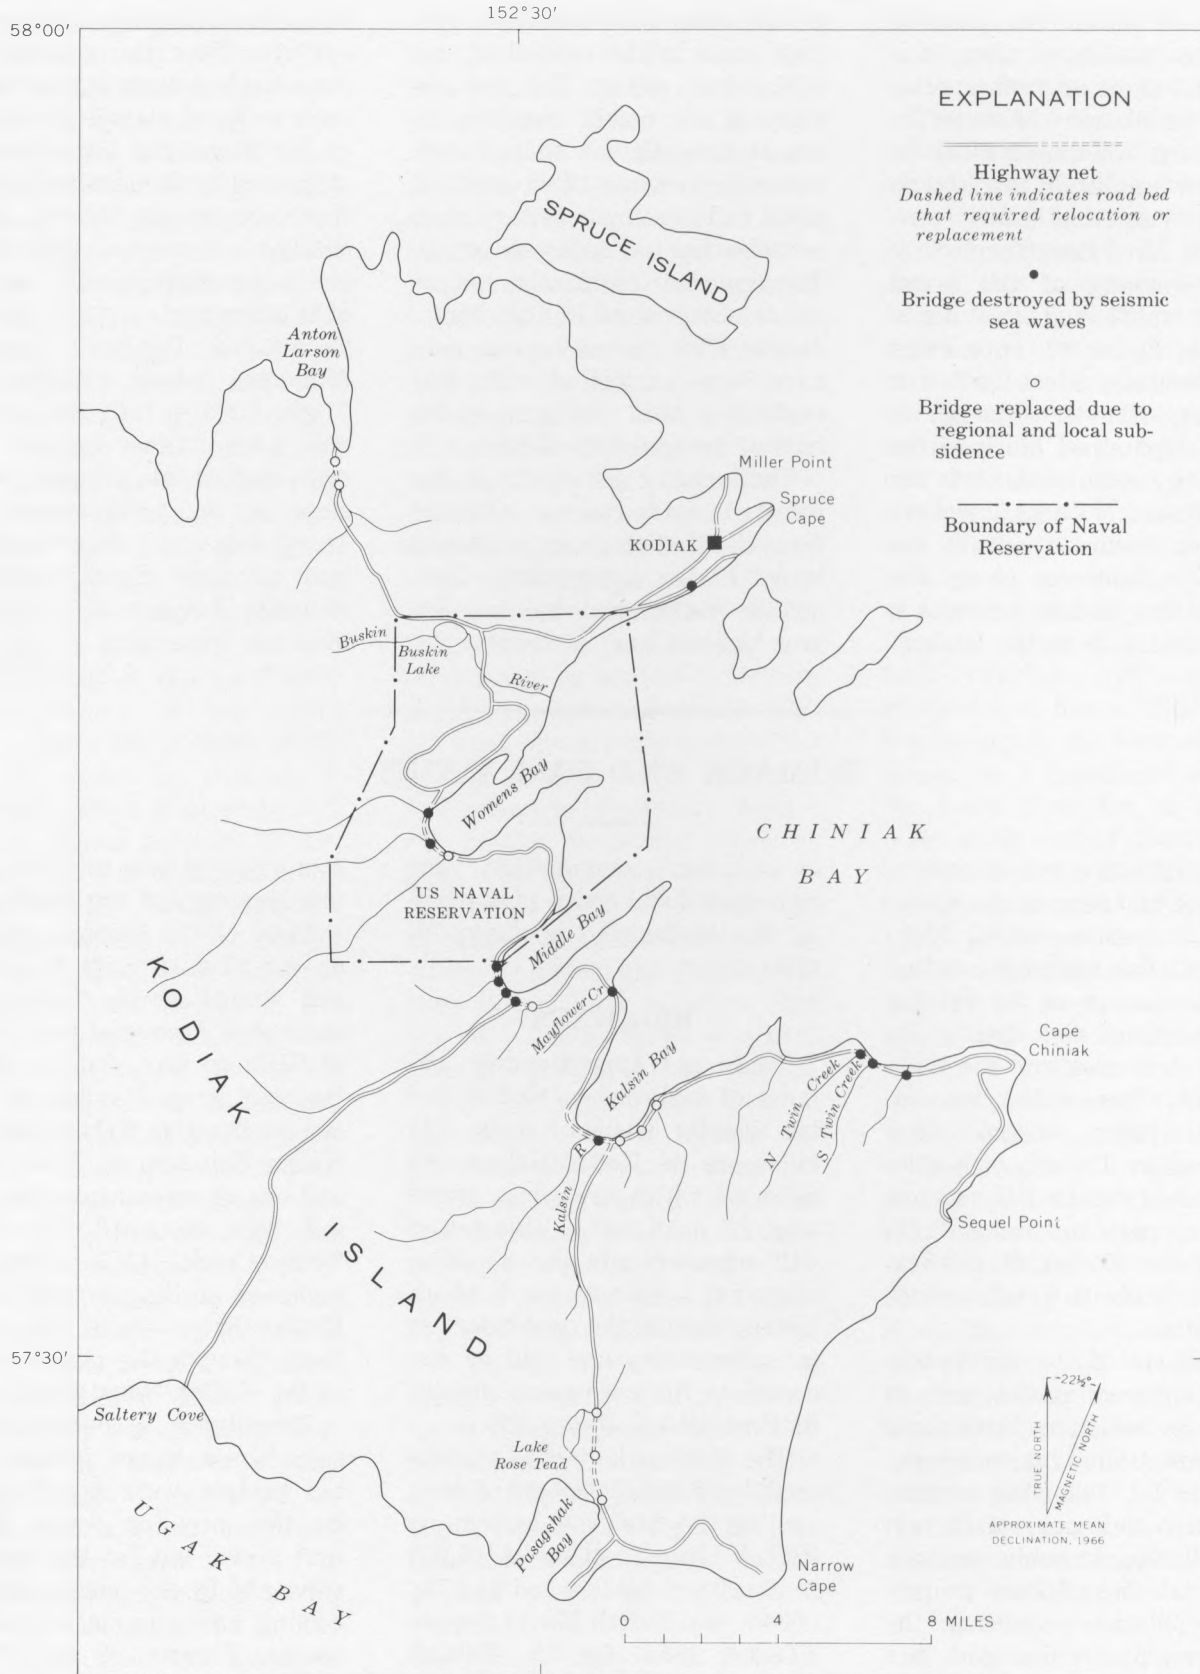
22.— Earthquake damage to major highway routes on Kodiak Island.

In addition to those that were destroyed, five bridges on the Chiniak highway had to be replaced either because they were underwater during high tide or because their approaches needed realignment. The bridges that required replacement (indicated by open circles on fig. 22) are at Womens Bay, Middle Bay, and Kalsin Bay.

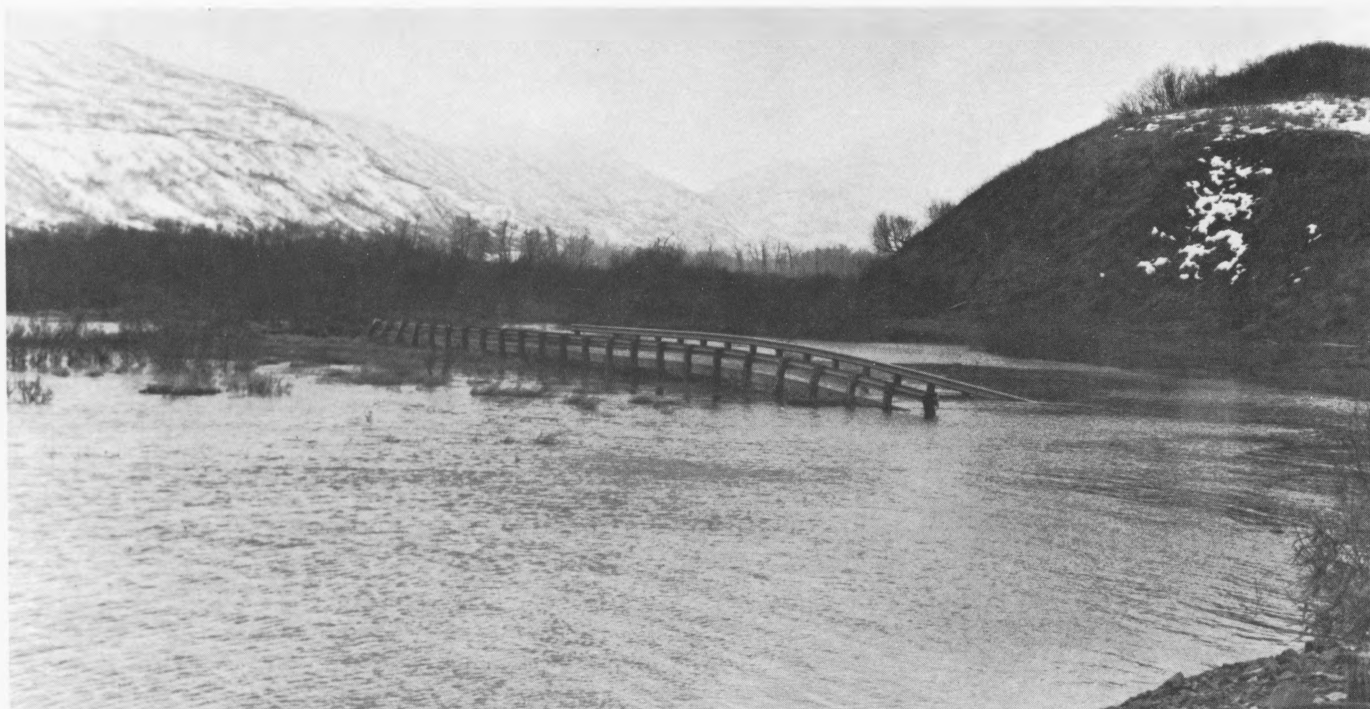
23. — Bridge at Womens Bay destroyed by seismic sea waves. Deck of bridge collapsed owing to destruction of piles. Compare with fig. 24. Photograph by U.S. Navy, March 30, 1964.

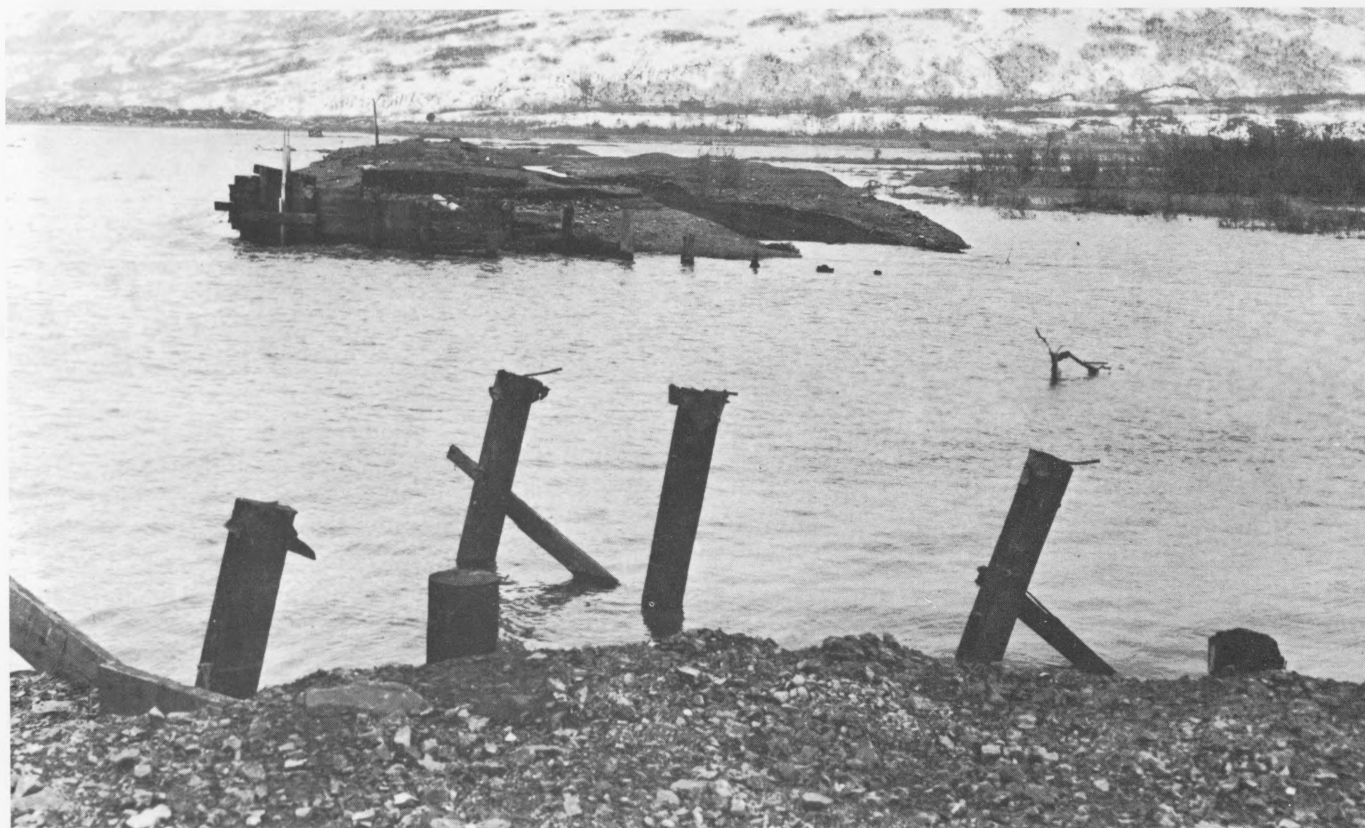
24. — Deck of highway bridge at Womens Bay washed away by seismic sea waves. Photograph by U.S. Navy, March 30, 1964.

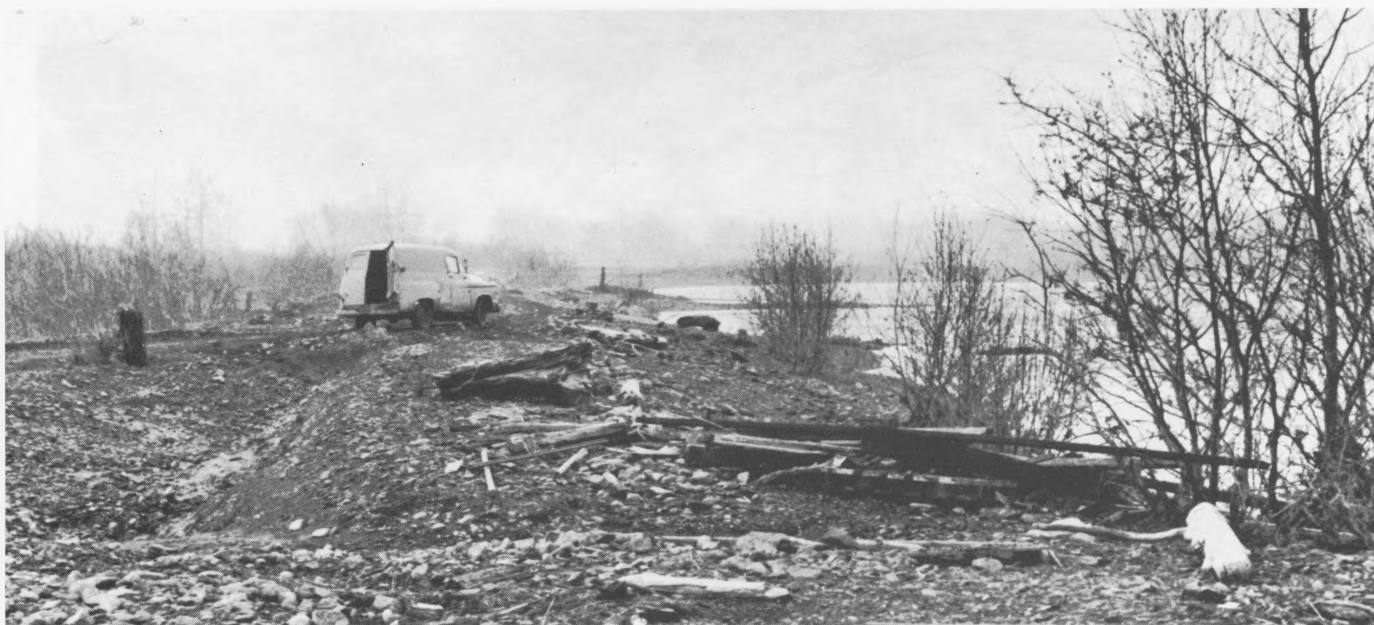
25. — Section of roadway along Chiniak highway at Womens Bay destroyed by seismic sea waves. Photograph by U.S. Navy, March 30, 1964.

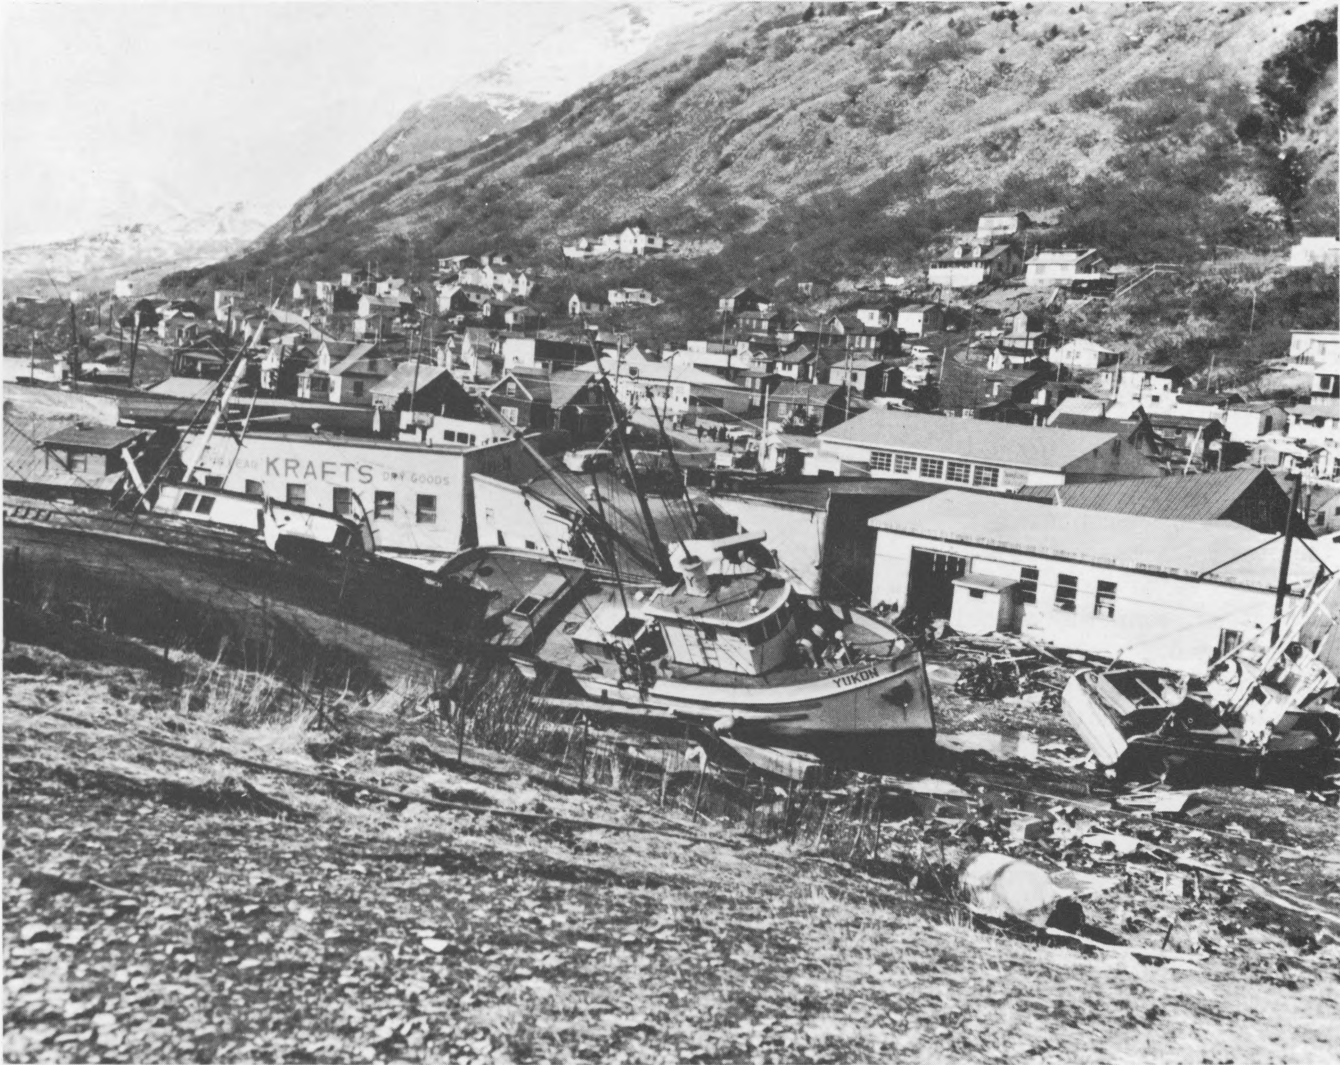
26. — Chaotic condition of the commercial section of the city of Kodiak following inundation by seismic sea waves. The small-boat harbor, which was in the left background, contained an estimated 160 crab and salmon fishing boats when the waves struck. Photograph by U.S. Navy, March 30, 1964.

tirely dependent, suffered devastating losses of processing facilities, vessels, and gear. Three canneries at Kodiak and one at Uzinki were destroyed by seismic sea waves, and one other cannery and a cold-storage plant at Kodiak were severely damaged. The Kodiak Fisheries cannery at Shearwater Bay was damaged by seismic shock during the earthquake, after which it was virtually destroyed by the waves. Estimated value of the structures and the finished products they contained is \$2,610,000.

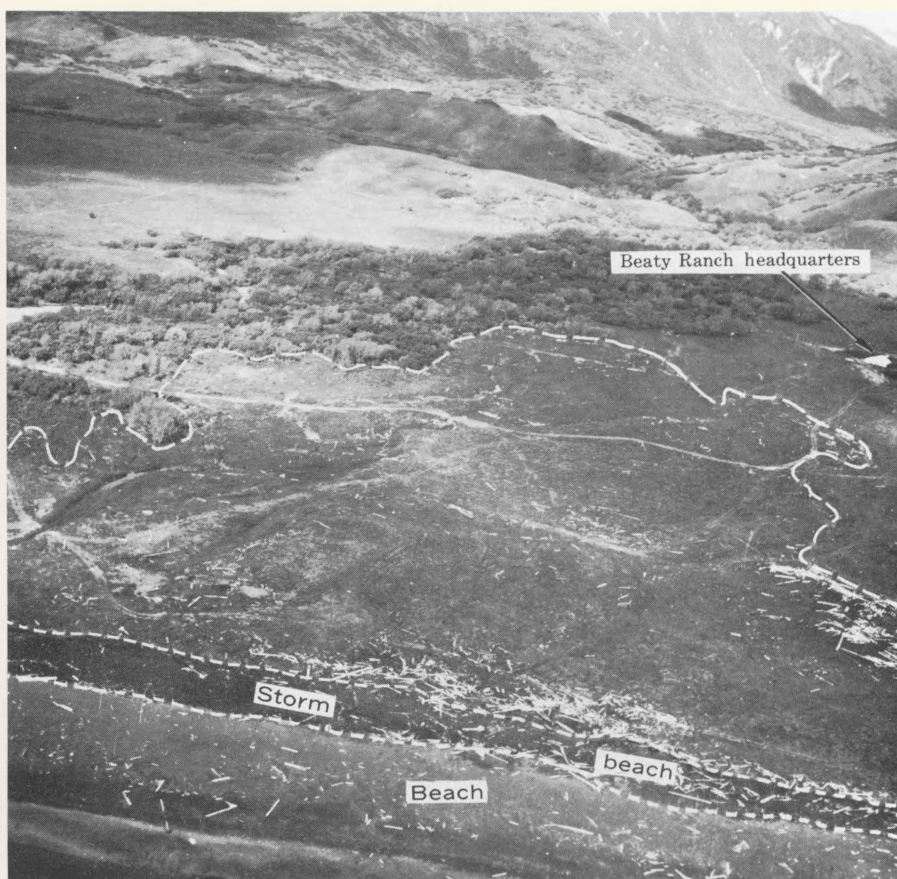
27. — Part of Beaty Ranch showing extent of wave inundation, as indicated by light-colored debris. Ranch buildings are a quarter of a mile from the shoreline.
