# Effects of the Earthquake Of March 27, 1964 At Anchorage, Alaska

BY WALLACE R. HANSEN

*A description and analysis of the damage resulting from seismic vibration, ground cracks, and especially landslides in Alaska's largest city*

GEOLOGICAL SURVEY PROFESSIONAL PAPER 542-A

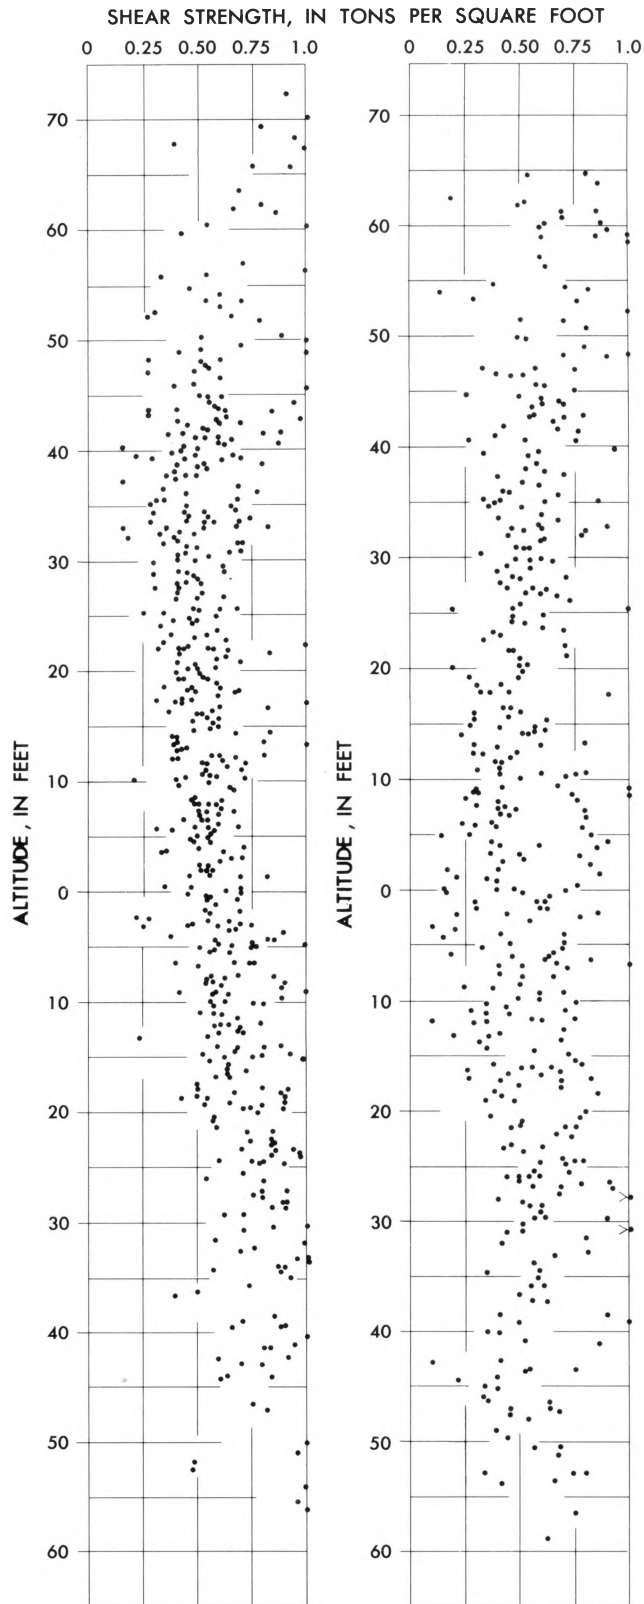
Shear strength was measured in torsional-vane-shear tests, undrained triaxial tests, consolidated-undrained triaxial tests, and consolidated-drained triaxial tests; strain, stress, volume change, and pore-water pressure were recorded throughout the tests (Shannon and Wilson, Inc., 1964, p. 28). The results of vane-shear tests for the Fourth Avenue and Turnagain Heights slide areas are shown in figure 8. Triaxial tests performed on the clay generally correlated well with the vane-shear tests within the ranges of strengths at which failure was prevalent. Tests correlated well in the range 0.4 to 0.5 tsf (tons per square foot), but for clays of higher strength, the triaxial tests generally yielded somewhat higher values than the vane tests. Most of the samples of clay from critical depths in the landslides had initial shear strengths between 0.2 and 0.7 tsf, and in this range the ratio of torsional-vane-shear-test results to triaxial-compression-test results is generally between 0.7 and 1.5 (Shannon and Wilson, Inc., 1964, p. B8). This ratio indicates a fairly good correlation between test methods. In any event, the vane-shear-test results shown by the graphs of figure 8 clearly demonstrate the generally lower shear strength of the clay at intermediate depths as compared with shallower and deeper layers.

8.—Summary of torsional-vane-shear strengths of selected borings, Bootlegger Cove Clay, from Fourth Avenue slide area (left) and Turnagain Heights slide area (right). Simplified from Shannon and Wilson, Inc. (1964, pl. B15).

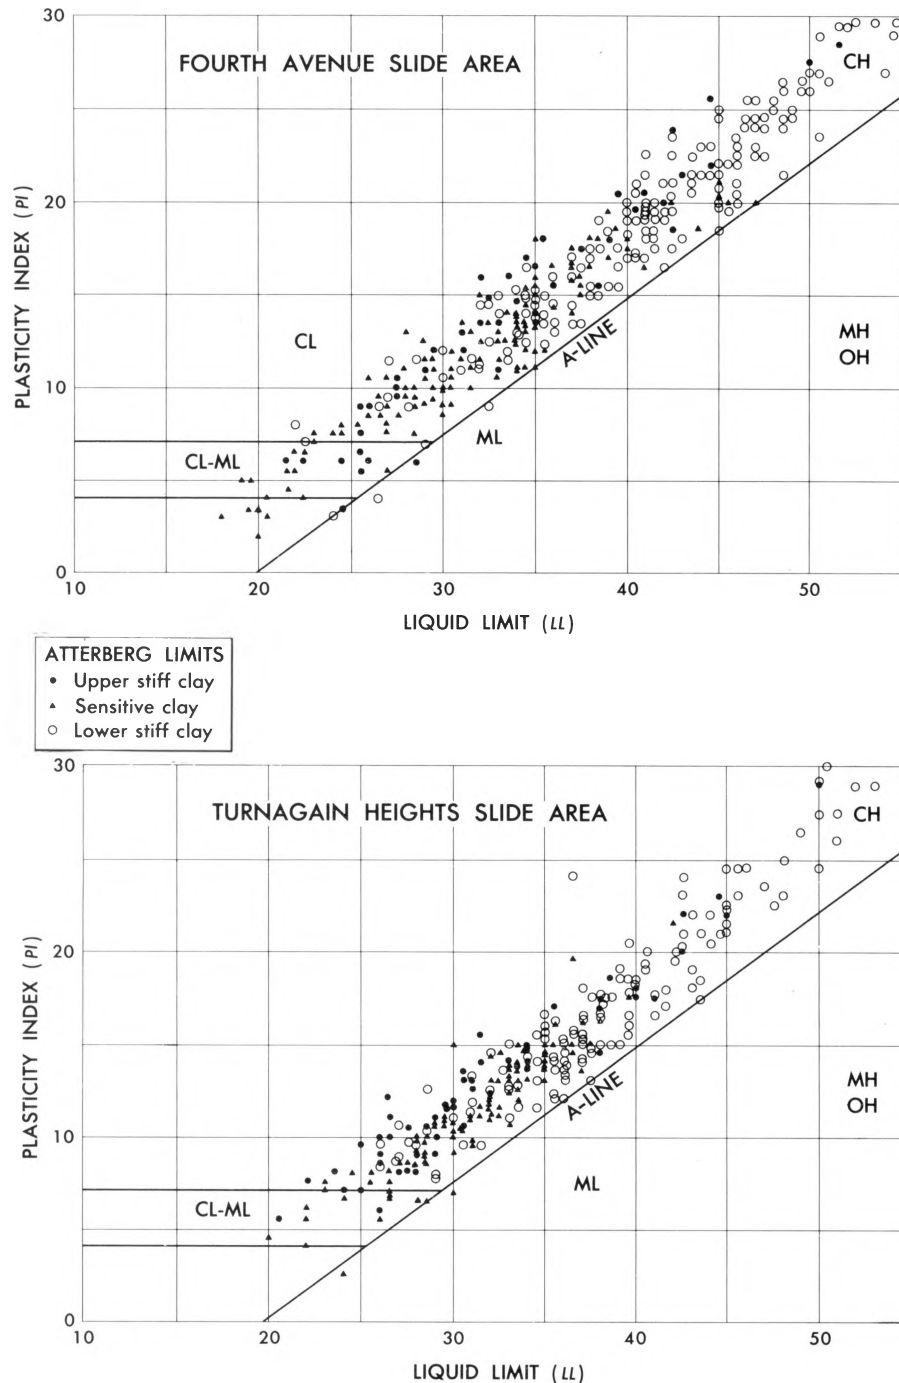
9.—Plasticity charts from selected borings, Bootlegger Cove Clay, Fourth Avenue and Turnagain Heights slide area. Reprinted from Shannon and Wilson, Inc. (1964, pl. B16). CL, inorganic clay of low to medium plasticity; ML, inorganic silts and very fine sand; CH, inorganic clay of high plasticity; MH, inorganic silt; OH, organic clay.

Shannon and Wilson, Inc. (1964). These charts show generally higher plasticity indices and liquid limits for the lower stiff clay than for the upper stiff clay or the sen-

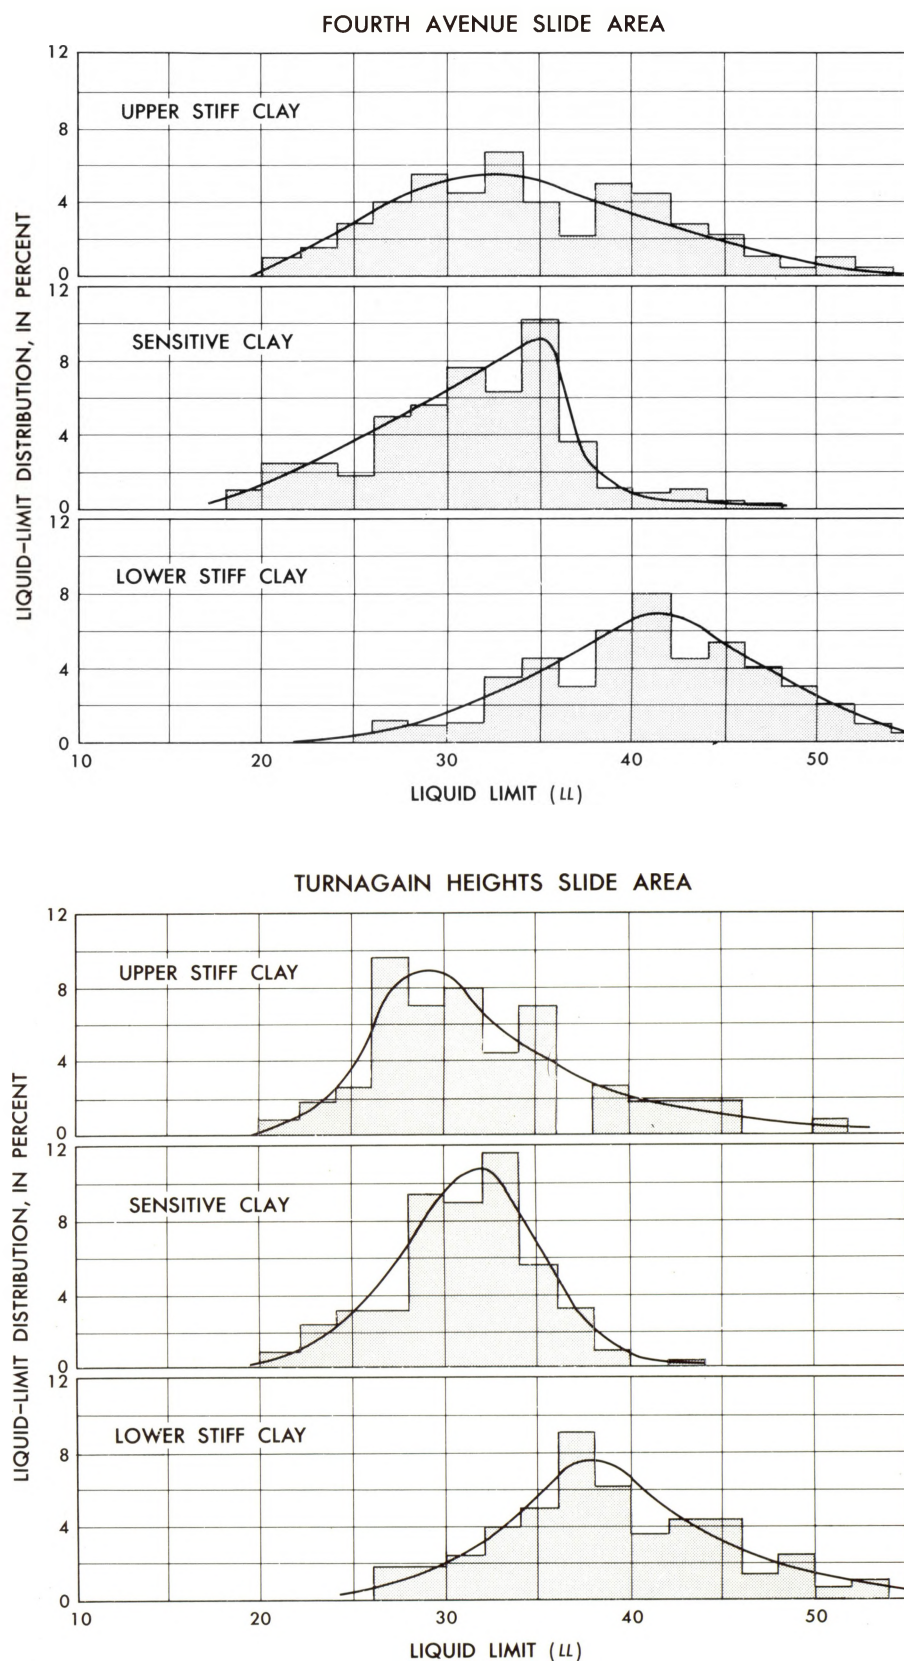
The statistical liquid-limit distribution curves (fig. 10) show the distinctions between the three zones of the Bootlegger Cove Clay in the Fourth Avenue and Turnagain Heights areas. These curves bring out the differences between the upper stiff zone and the sensitive zone, and also the higher liquid limit of the lower stiff zone. The statistical relationship of sensitivity to liquid limit is shown by figure 11. In general, about 80 percent of the soil samples tested had liquid limits within the range of 22 to 48 percent, regardless of their vertical position in the formation. About 80 percent of the liquid limits of the sensitive clay range from 22 to 38 percent, and about 80 percent from the lower stiff clay range from 32 to 50 percent. As sensitivity increases, the upper limit of the liquid limit decreases. Most clay samples of sensitivities greater than 10 had liquid limits in the range of 20 to 40 percent, and no sensitive-clay sample had a liquid limit above 45 percent. For sensitivities greater than 40, the range of liquid limits was only 22 to 28 percent (Shannon and Wilson, Inc., 1964, p. B11). Several samples analyzed had a natural-water content greater than their liquid limits.

10.—Statistical liquid-limit distribution curves from selected borings, Bootlegger Cove Clay. Reprinted from Shannon and Wilson, Inc. (1964, pl. B16).

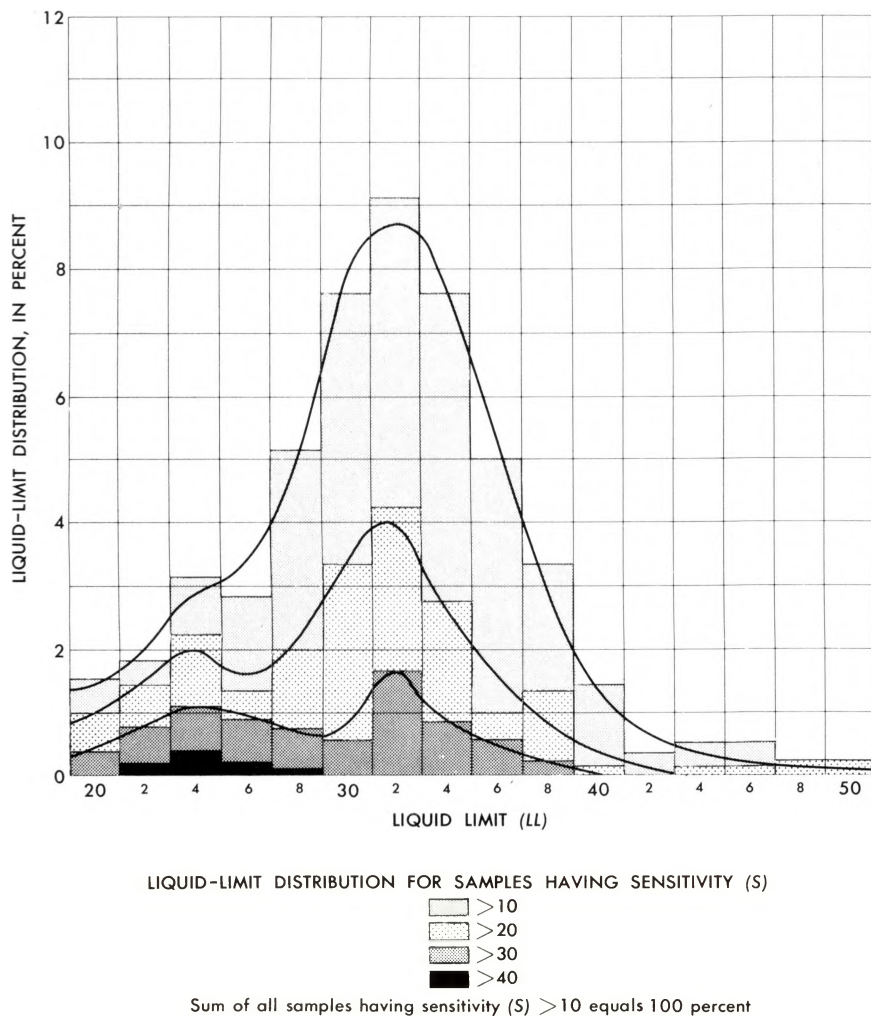
11.—Liquid-limit sensitivity distribution curves, Bootlegger Cove Clay. Reprinted from Shannon and Wilson, Inc. (1965, pl. B17).

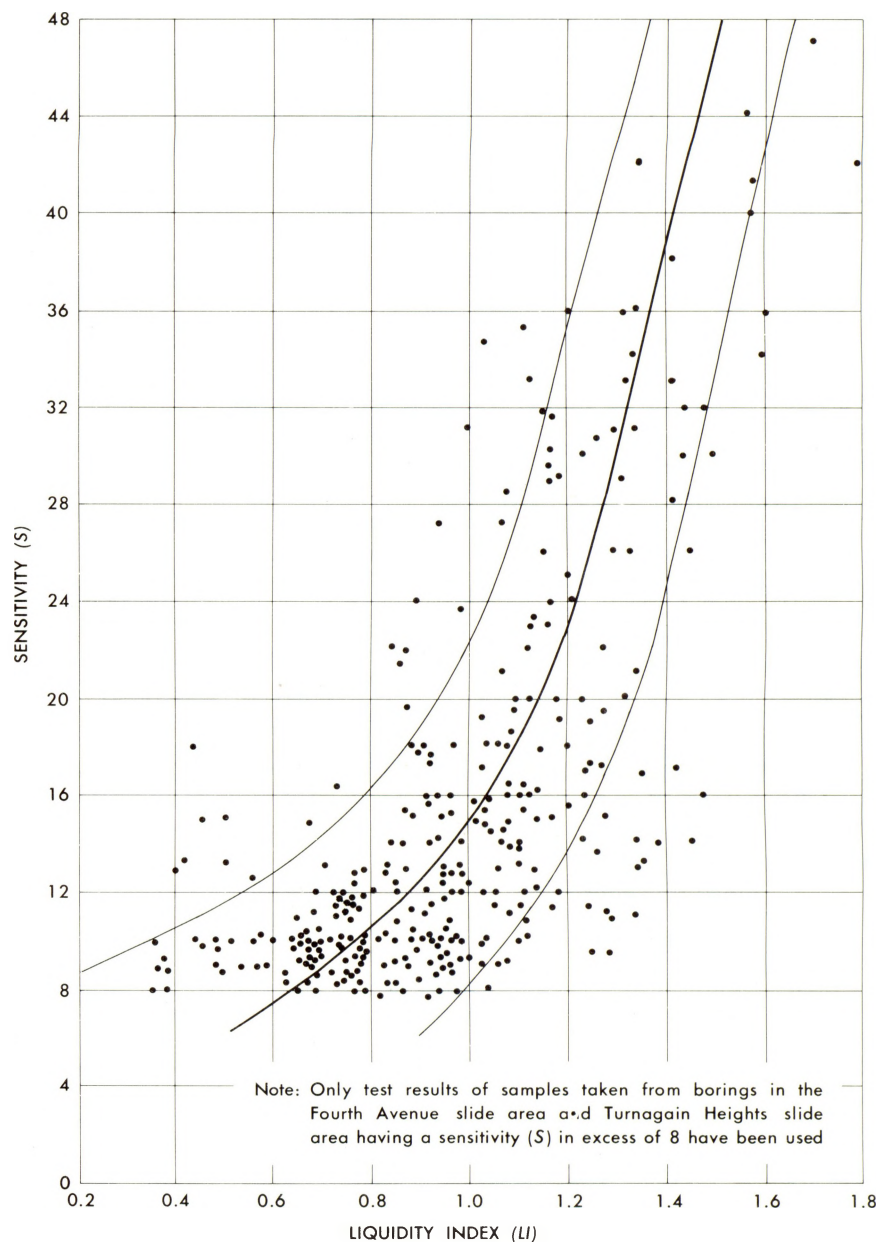
the liquid limit minus the plastic limit; that is  $(W_n - PL)/(LL - PL)$ . For the Bootlegger Cove Clay, it was found that in most soils having a water-plasticity ratio greater than 1.0 the liquid limit ranged from 20 to 40 percent, and in soils having a water-plasticity ratio greater than 2.0 the liquid limit lay in the range 19 to 27 percent. A direct correlation also was found between sensitivity and the water-plasticity ratio (Shannon and Wilson, Inc., 1964, p. B11, pl. B17; see fig. 12, next page). Thus in the Bootlegger Cove Clay a high water-plasticity ratio is related to low shear strength, high

sensitivity, and high susceptibility to failure.

12.—Relation between sensitivity and liquidity index (water-plasticity ratio), Bootlegger Cove Clay. Reprinted from Shannon and Wilson, Inc. (1964, pl. B17).

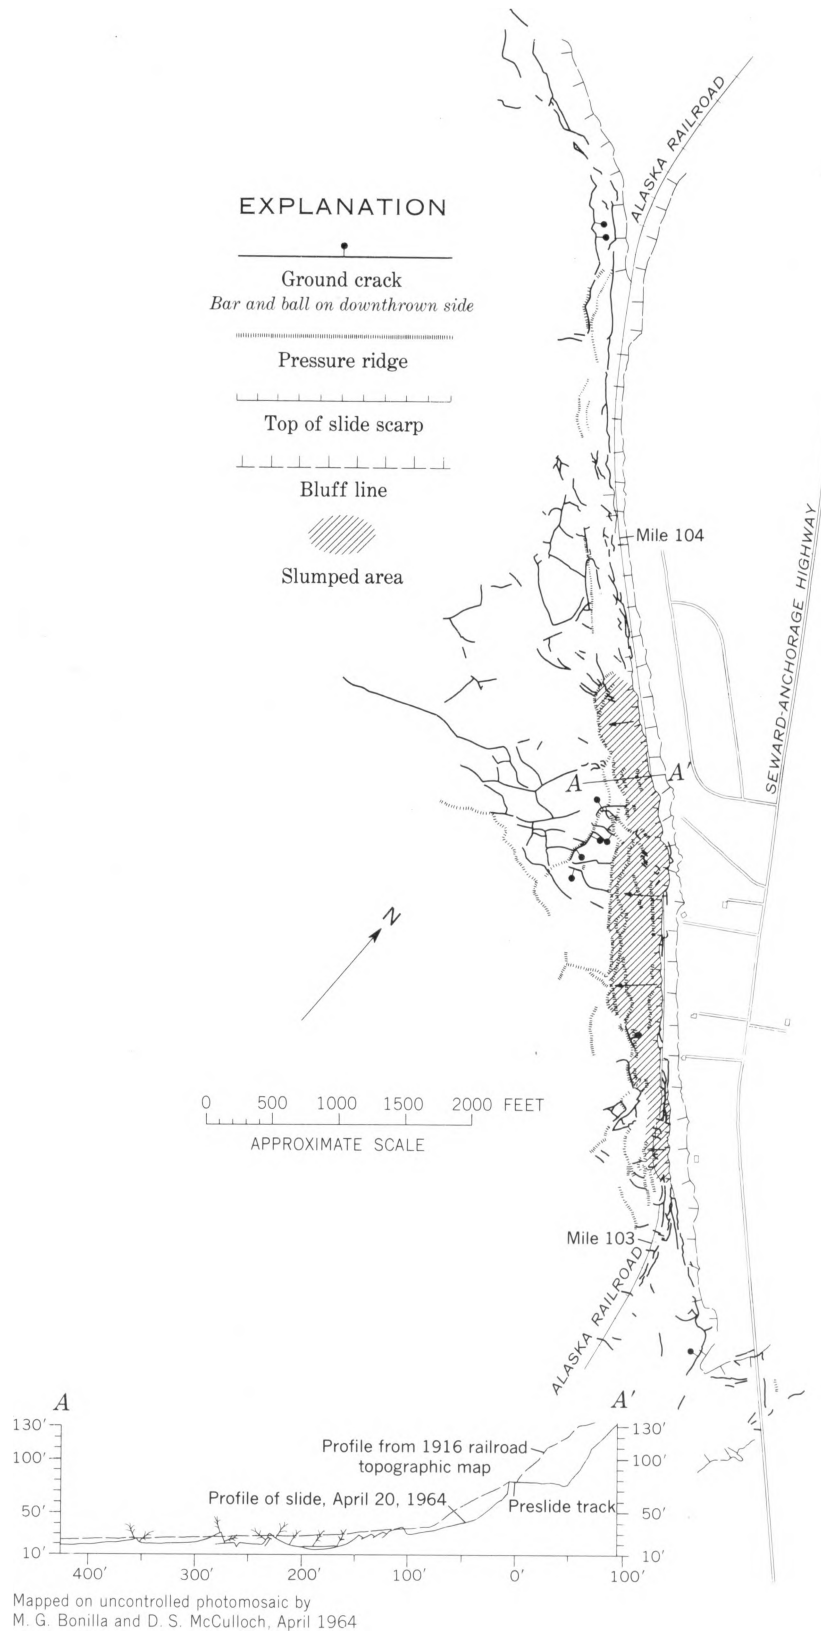
17.—Map and profile of Potter Hill landslide area near Anchorage, Alaska.

sisted of elongate fragmented slump blocks rotated backward and broken into many pieces toward the base of the slope. In places at the toe, they turned into earth and mudflows derived partly from the intertidal silt of Turnagain Arm and partly, perhaps, from the clay-silt-sand sequence in the lower part of the bluff.

The mechanics of sliding has been investigated by D. S. McCulloch and M. G. Bonilla (written commun., 1964). They concluded that sliding was initiated by failure and flowage of material from the base of the slope. Higher parts of the slope slumped and disintegrated as a consequence. Flowage may have occurred in the modern estuarine silt at the base

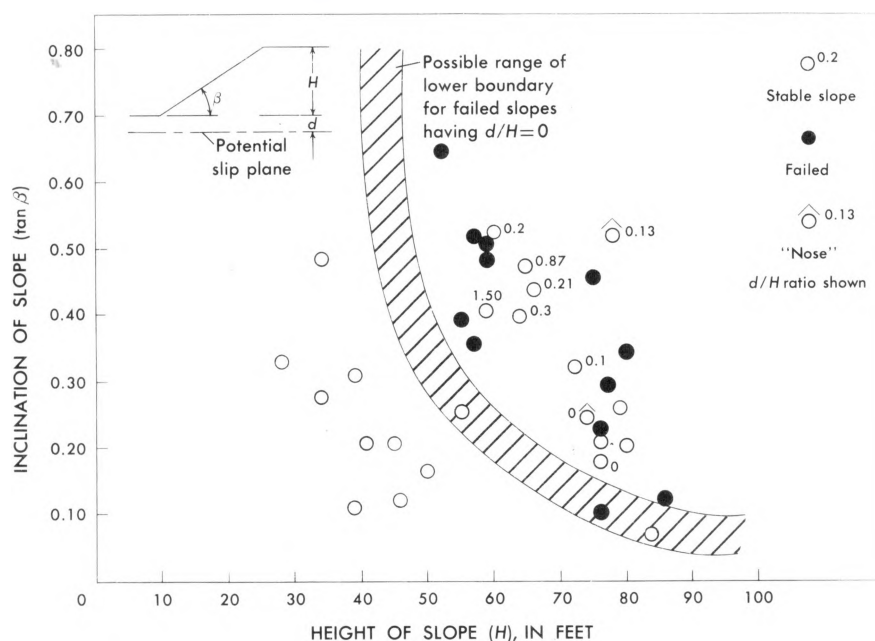
23.—Slope stability chart. Reprinted from Shannon and Wilson, Inc. (1964, pl. 7.1).

slope-to-height ratios within the same area of the chart as slopes that failed seems to point up the modifying influences of other factors such as soil-strength profile and water content. A low slope underlain by soil having a high water-plasticity ratio, for example, may be more susceptible to failure—may have a lower safety factor—than a high slope underlain by soil having a low water-plasticity ratio. In a unit of time, other factors being equal, a salient should drain and desiccate more rapidly than a recess; hence it should be more stable.

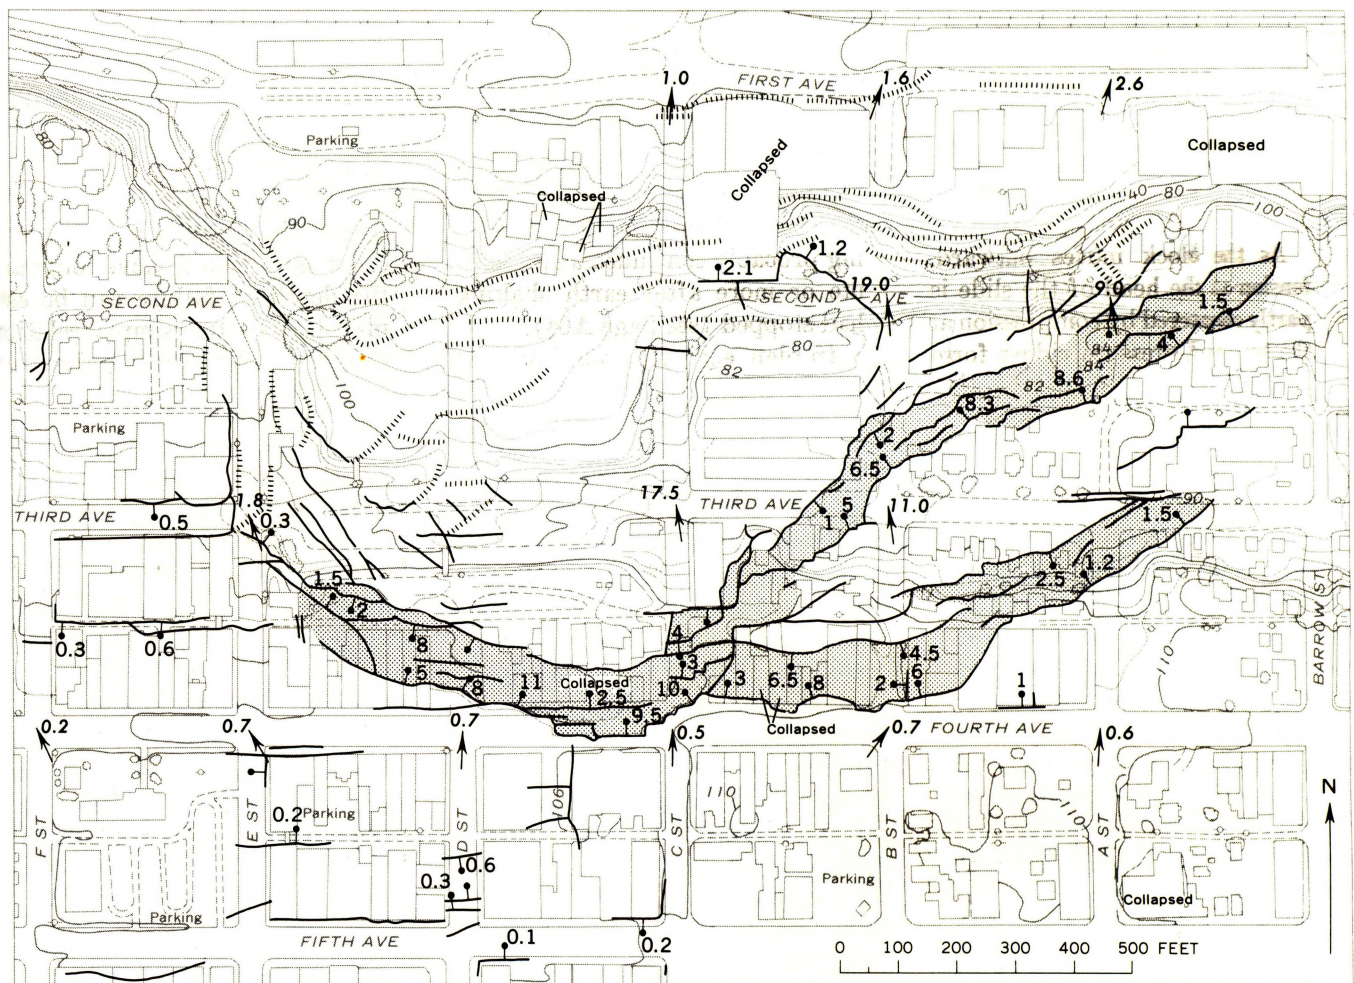
The Fourth Avenue slide involved all or parts of 14 city blocks in a roughly oval area of about 36 acres, containing perhaps 2 million cubic yards of earth, centered at the north side of downtown Anchorage (fig. 25). It was bounded headward on the south by Fourth Avenue, on the west by E Street, on the north approximately by First Avenue, and on the east somewhat indefinitely by Barrow Street. Its length north to south in the direction of slippage was about 1,050 feet; east to west it was about 1,800 feet across. Strong fracturing and related ground displacements extended  $1\frac{1}{2}$  blocks (about 450 feet) or so south of the slide proper, where considerable damage was inflicted on buildings,
