THE ALASKA EARTHQUAKE, MARCH 27, 1964:
EFFECTS ON COMMUNITIES

Effects of the Earthquake Of March 27, 1964 At Whittier, Alaska

By REUBEN KACHADOORIAN

GEOLOGICAL SURVEY PROFESSIONAL PAPER 542-B

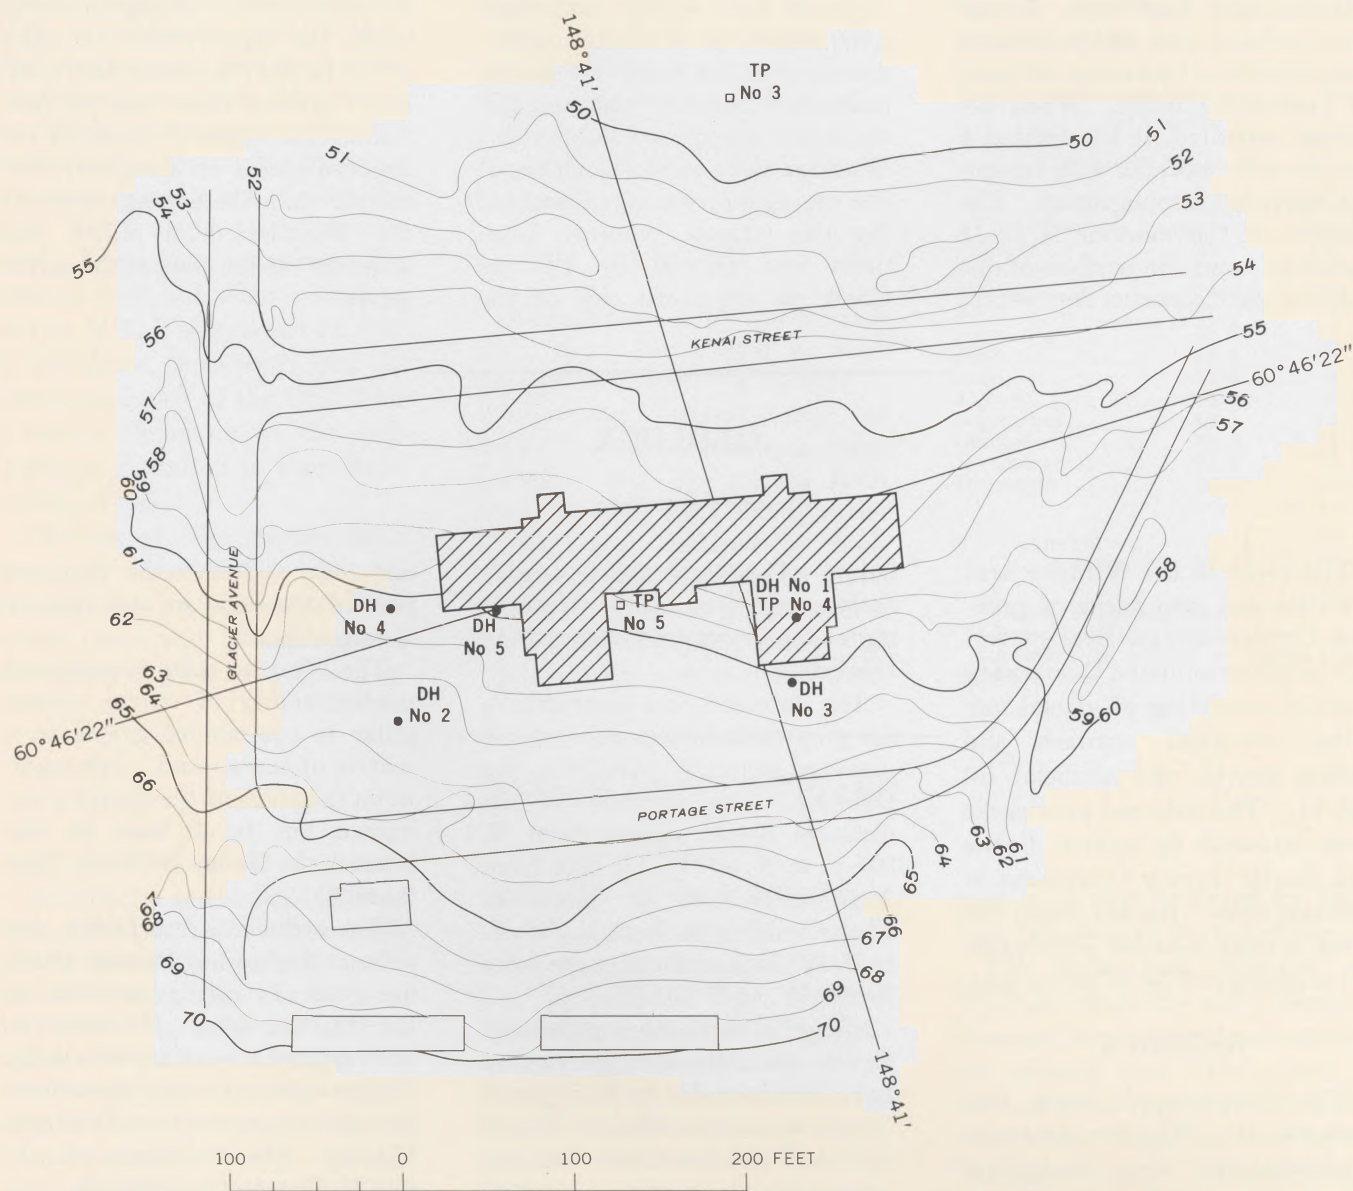
The Whittier delta is composed predominantly of coarse, subangular to subrounded gravel in a matrix of coarse sand. The maximum thickness of the gravel is unknown but is at least 44 feet beneath the Hodge Building (figs. 2 and 3).

2.—Map showing Hodge Building, surrounding area, and location of drill holes. Graphic logs of these holes are shown in figure 3.

The Hodge Building, a reinforced-concrete 14-story structure 265 feet long and 50 and 110 feet wide (figs. 2 and 3), rests on at least 44 feet of unconsolidated sand and gravel. The building was constructed as three structural monolithic units connected by 8-inch expansion joints. In the corridors, metal jumper plates spanned the 8-inch joints; on the exterior, the joints were secured by a weather seal. The long dimension of the building was parallel to the predominant east-west direction of the seismic motion;

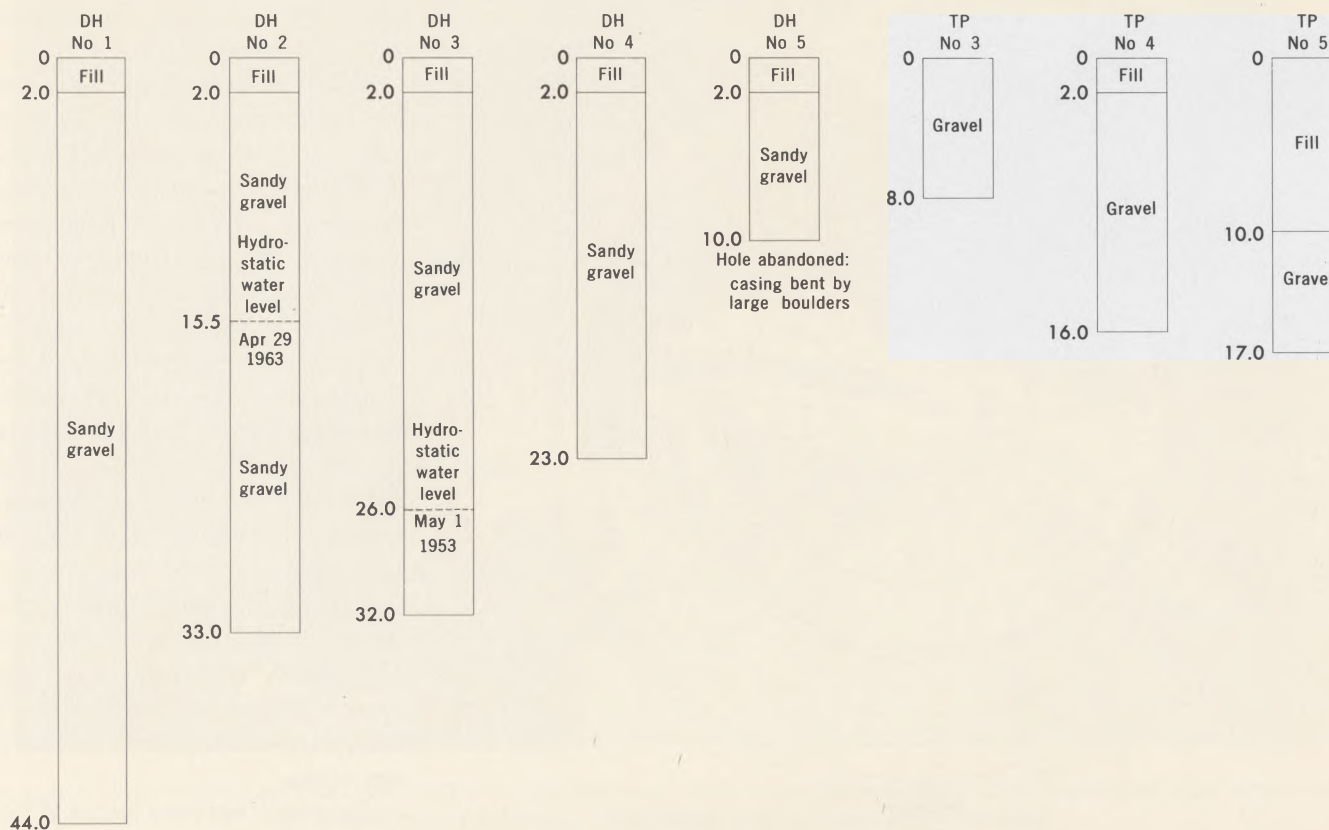
3.—Graphic logs of drill holes (DH) and test pits (TP) in the Hodges Building area. Location of holes and pits are shown in figure 2.

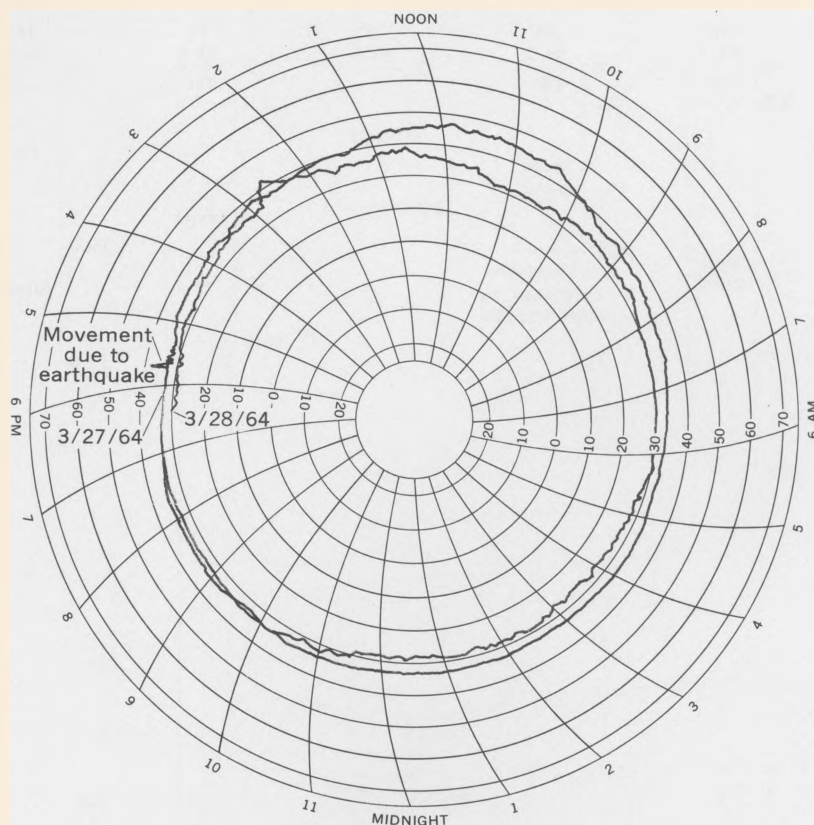
4.—Chart of outside-air temperature from automatic recording device in salt-water pumphouse in Whittier.

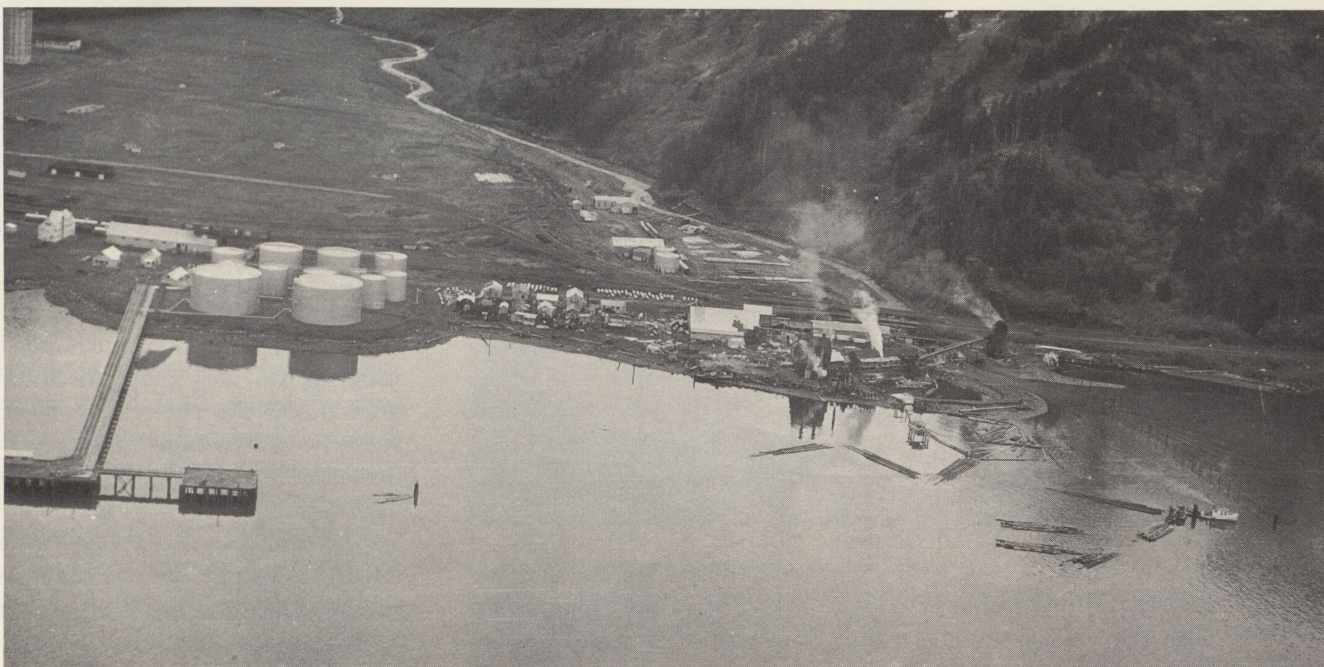
6.—Preearthquake aerial view, looking south, of Union Oil Co. fuel-storage tanks and Columbia Lumber Co. Photograph by U.S. Army, June 7, 1963.

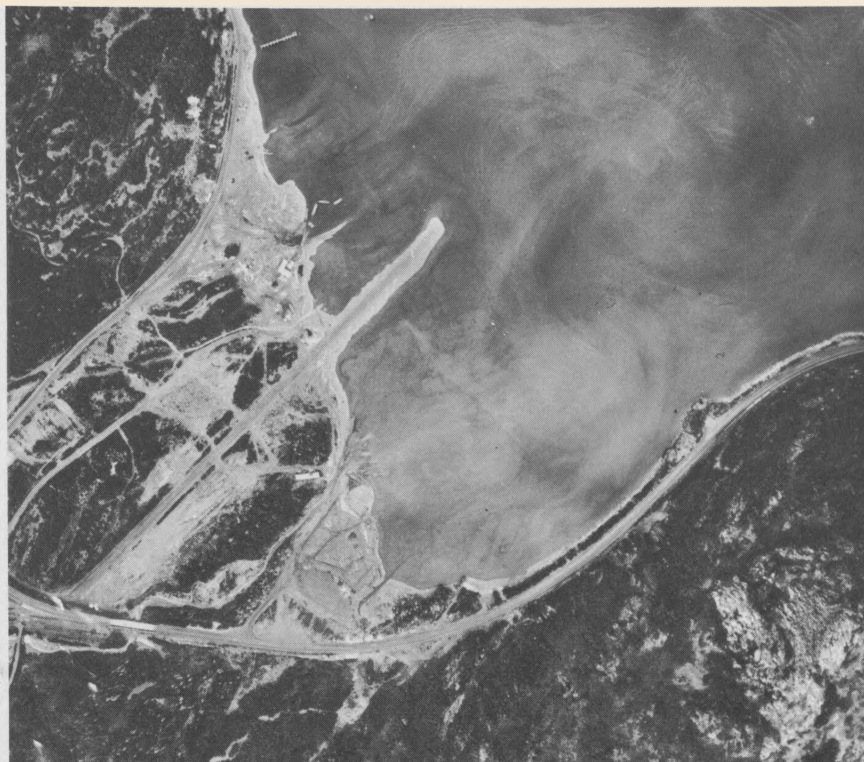
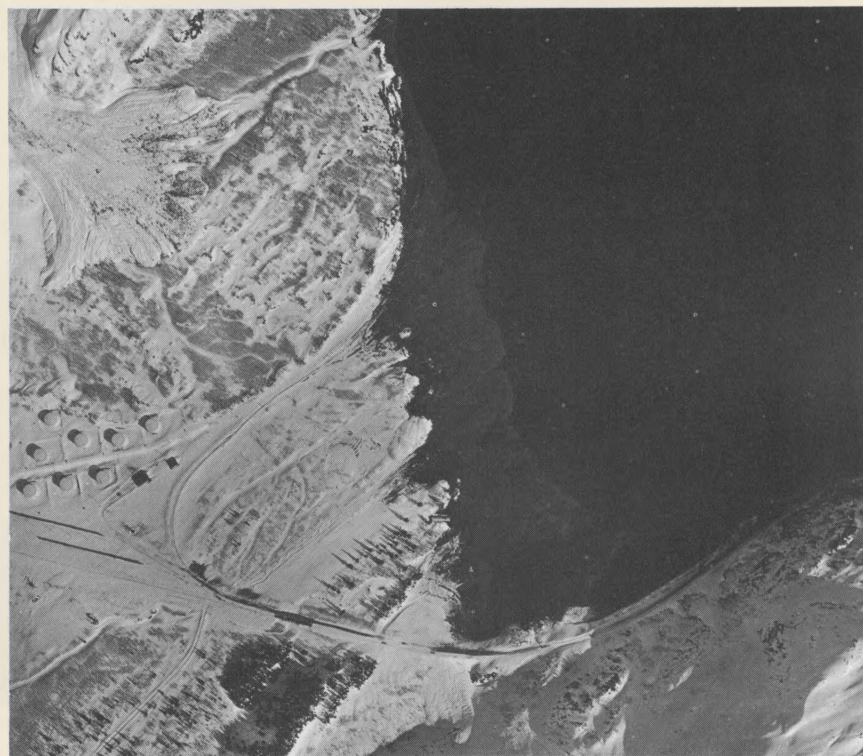
Seven different factors related to the earthquake were responsible for the extensive damage in the Whittier area. These include (1) a change in land level, (2) seismic shock, (3) fracturing of fill and unconsolidated deposits, (4) differential subsidence due to compaction, (5) landslides, (6) waves generated by submarine landslides, and (7) fire. A large avalanche fell on the moraine at the head of Passage Canal; it consisted chiefly of snow debris and did no harm. Plate 1 indicates the nature and extent of damage by seismic shock, compaction, landslides, waves, and fire. Figures 8 and 9 are prequake and postquake aerial photographs of much of the Whittier area.

9.—Vertical aerial photographs of delta at west end of Passage Canal. Top, Pre-quake; photograph by Bureau of Land Management, September 23, 1963. Bottom, Postquake; photograph by Air Photo Tech, Anchorage, April 1, 1964.

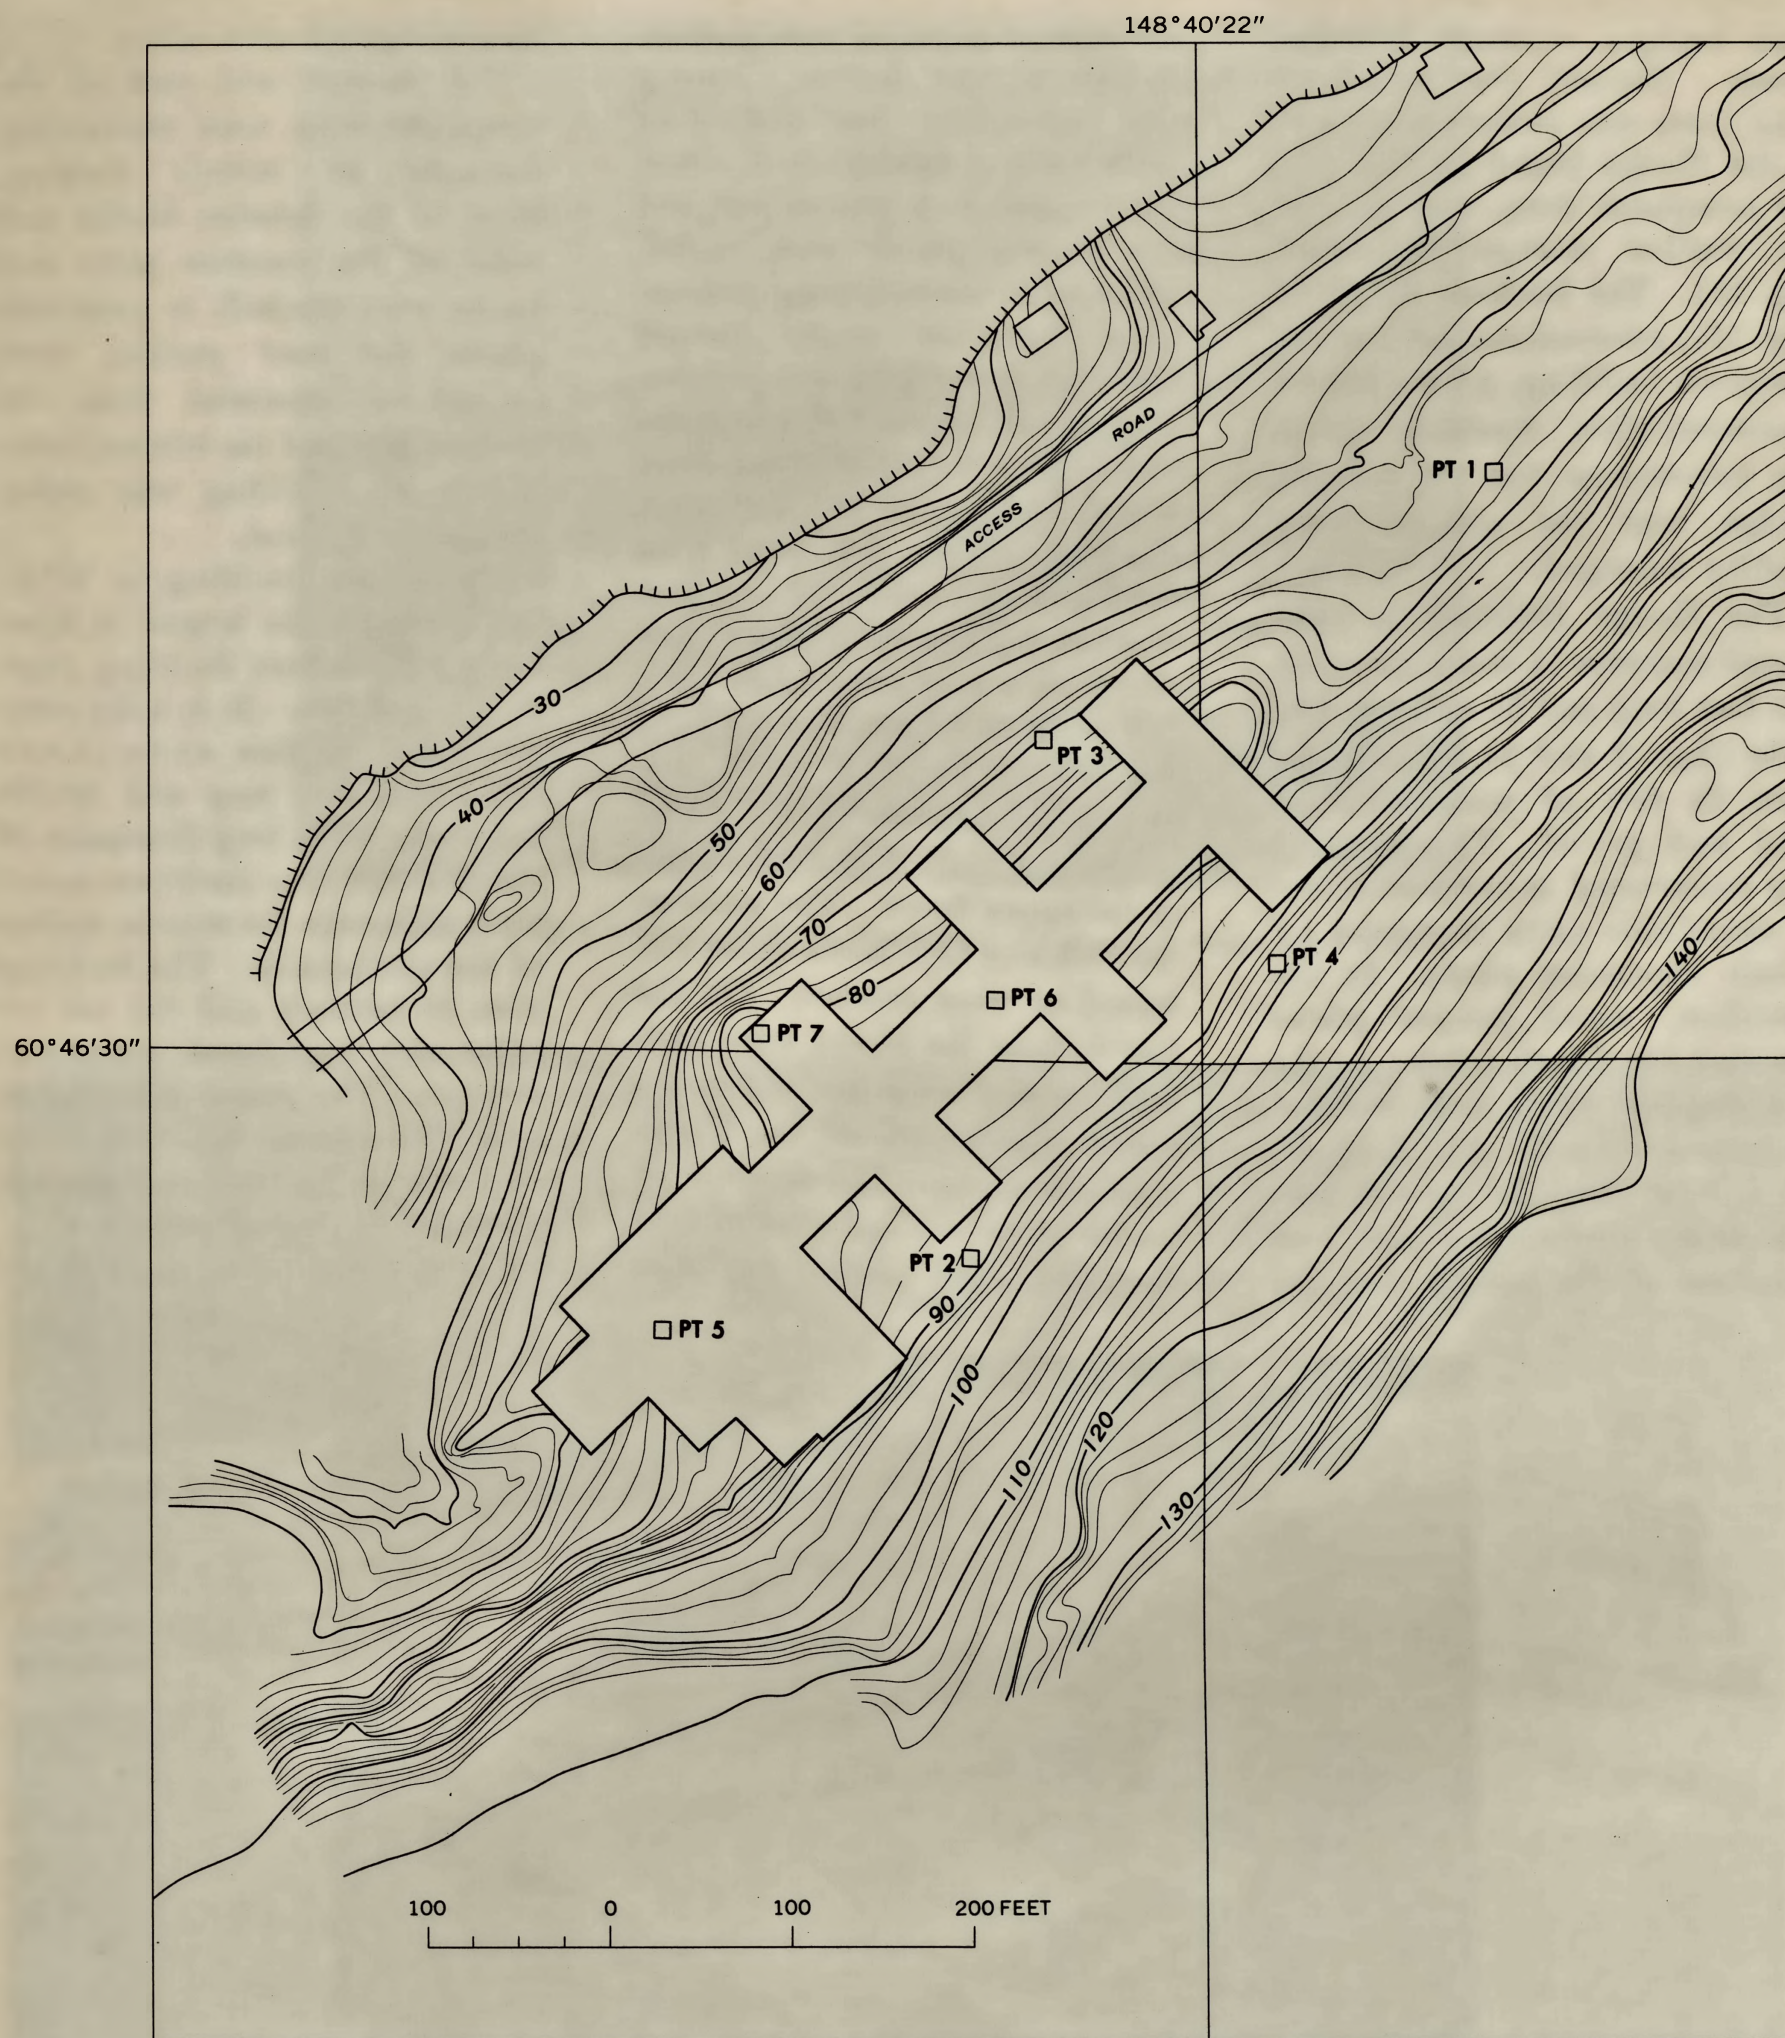
15.—Map showing Buckner Building, surrounding area, and location of test pits (Pt). Graphic logs of these pits are shown in fig. 16.

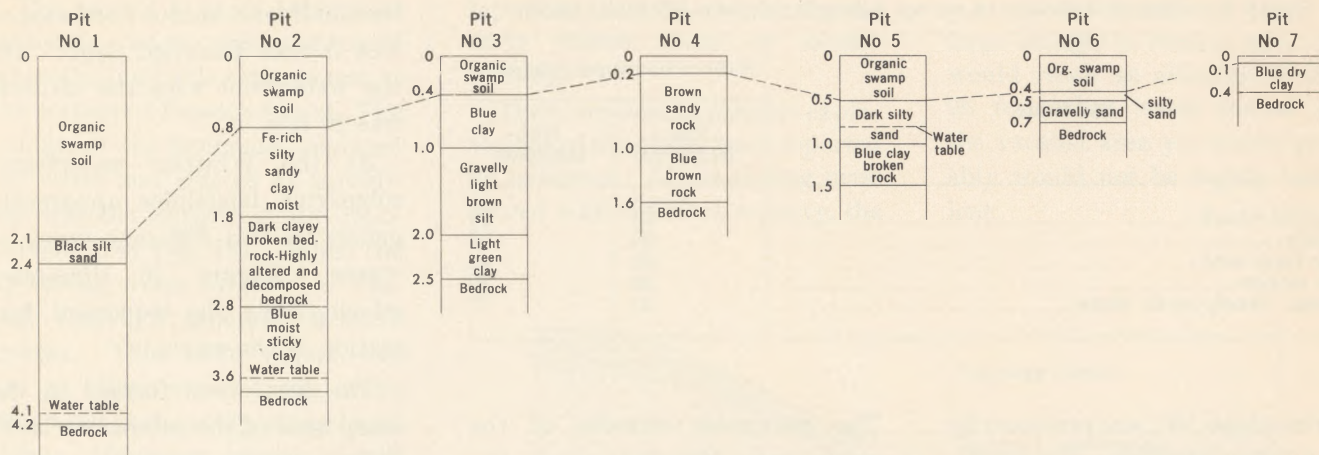
16.—Graphic logs of test pits (Pt) in the Buckner Building area. Locations of the pits are shown in figure 15.

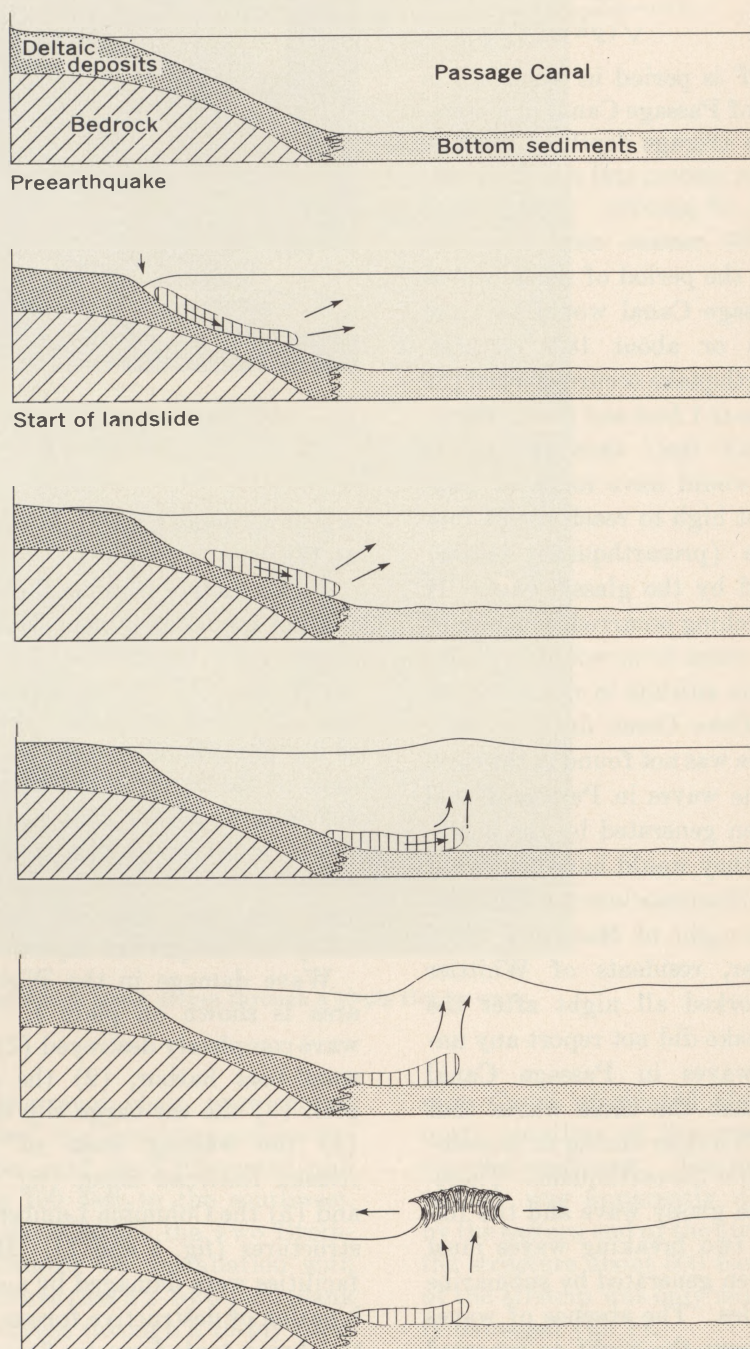
There are several possible explanations of the glassy wave reported by witnesses. If the sliding mass moved with sufficient velocity, the

volume of drawdown could be large enough to form a wave that would reach an altitude of 25 to 26 feet when water rushed into the vacated area yet which probably would not be highly turbulent.

18.—Schematic sections showing generation of waves associated with submarine landslides.

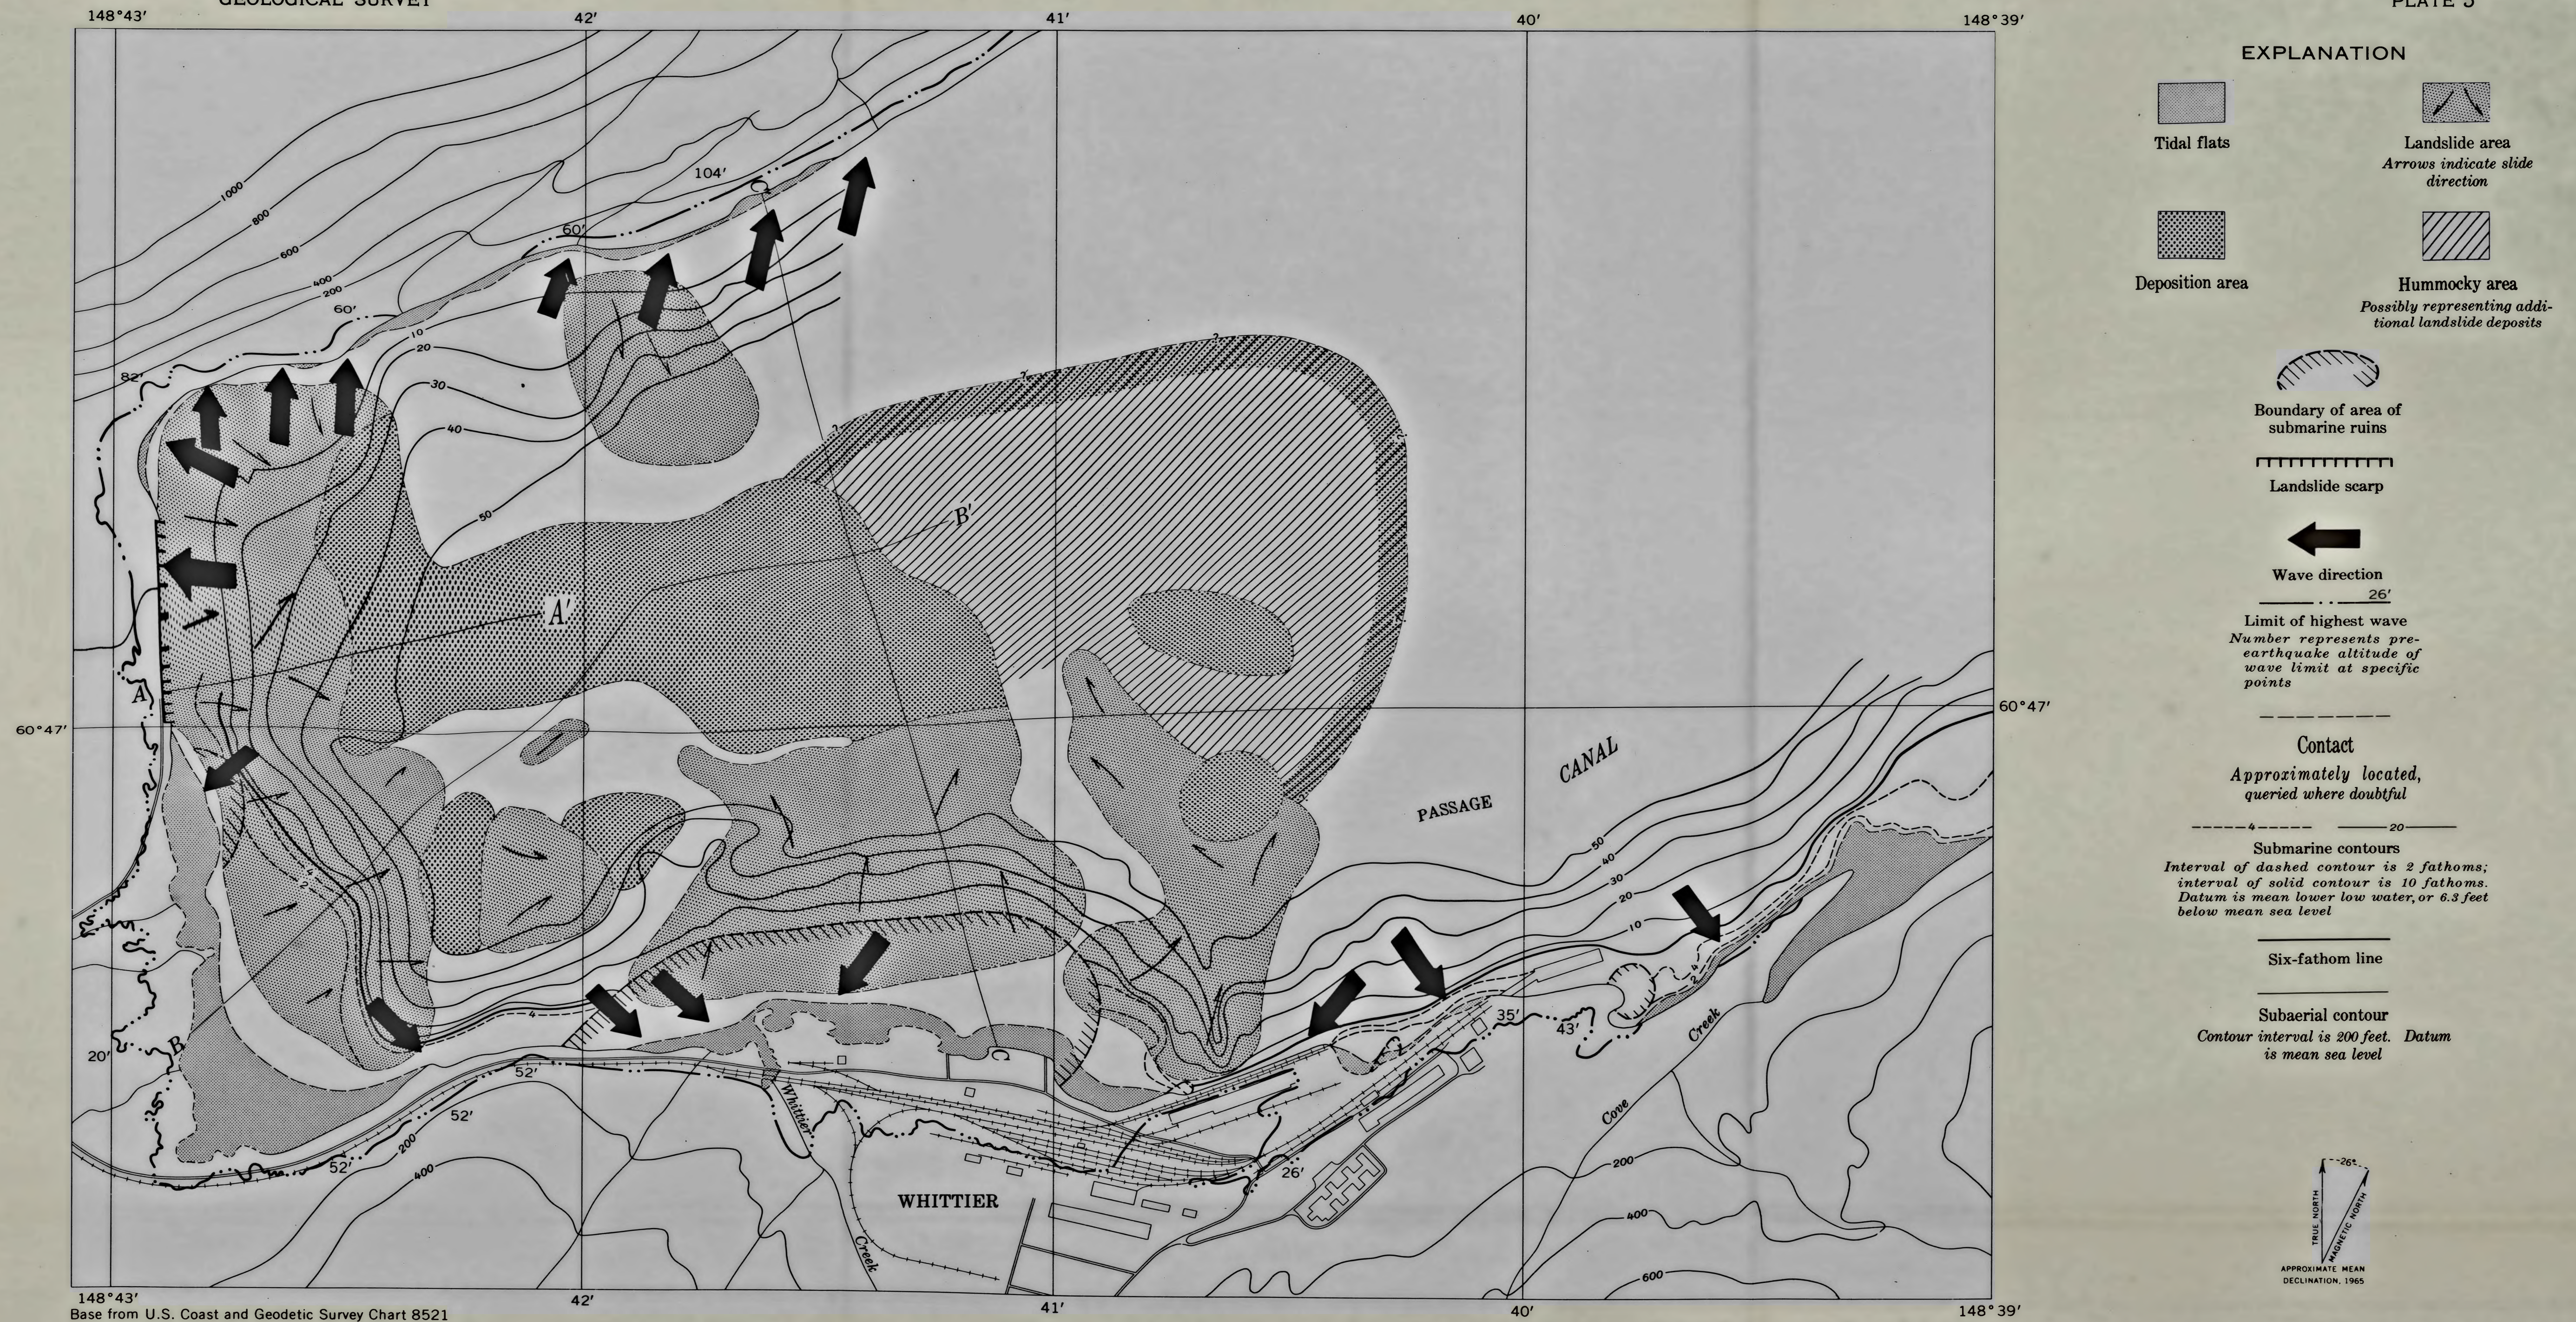
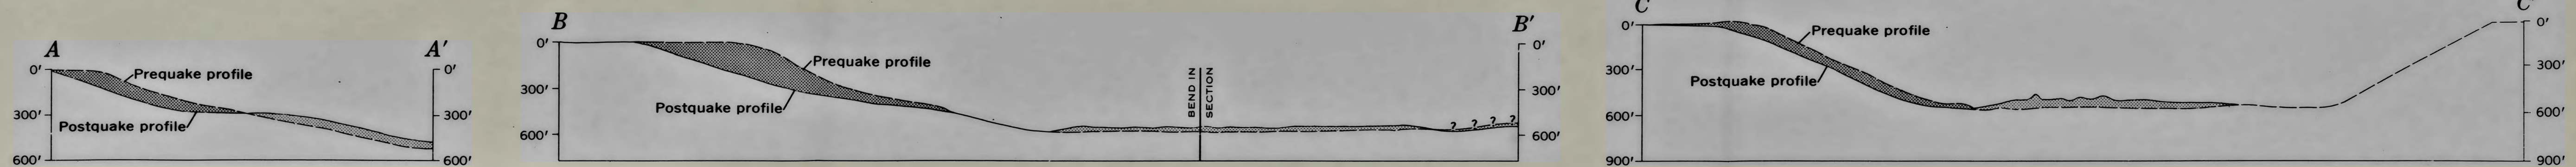
MAP OF WHITTIER, ALASKA, SHOWING POSTEARTHQUAKE SUBMARINE TOPOGRAPHY
WAVE HEIGHT, WAVE DIRECTION, SUBMARINE RUINED AREAS, AND PROFILES

The profiles of the slides and submarine slopes are shown on plate 3, and the changes in degree of slope are shown in table 2 (next page). The landslides occurred on slopes ranging from 20° offshore of the airstrip to 31° at the marginal wharf. The largest change of sub-

Submarine landslides in Passage Canal generated at least two, and probably three, waves. Plate 1 shows the area inundated and destroyed by waves. The direction and altitude of the highest waves are indicated on plate 3. Only the direction of the highest wave in a particular area can be indicated, because a higher wave would destroy any evidence of an earlier lower wave. A lower wave that followed a higher wave would merely rearrange debris.

Profiles based on fathogram soundings in Passage Canal. (The preearthquake profiles are based on data from U.S. Coast and Geodetic Survey Chart 8521. Postearthquake profiles are based on data obtained by the U.S. Geological Survey.)
