The Alaska Earthquake

Effects of the Earthquake Of March 27, 1964 In the Homer Area, Alaska

*A description of the damage caused by landmass
subsidence, earthflows, landslides, seiche waves,
and submarine landslides resulting from the
earthquake in the Homer area, Alaska*

GEOLOGICAL SURVEY PROFESSIONAL PAPER 542-D

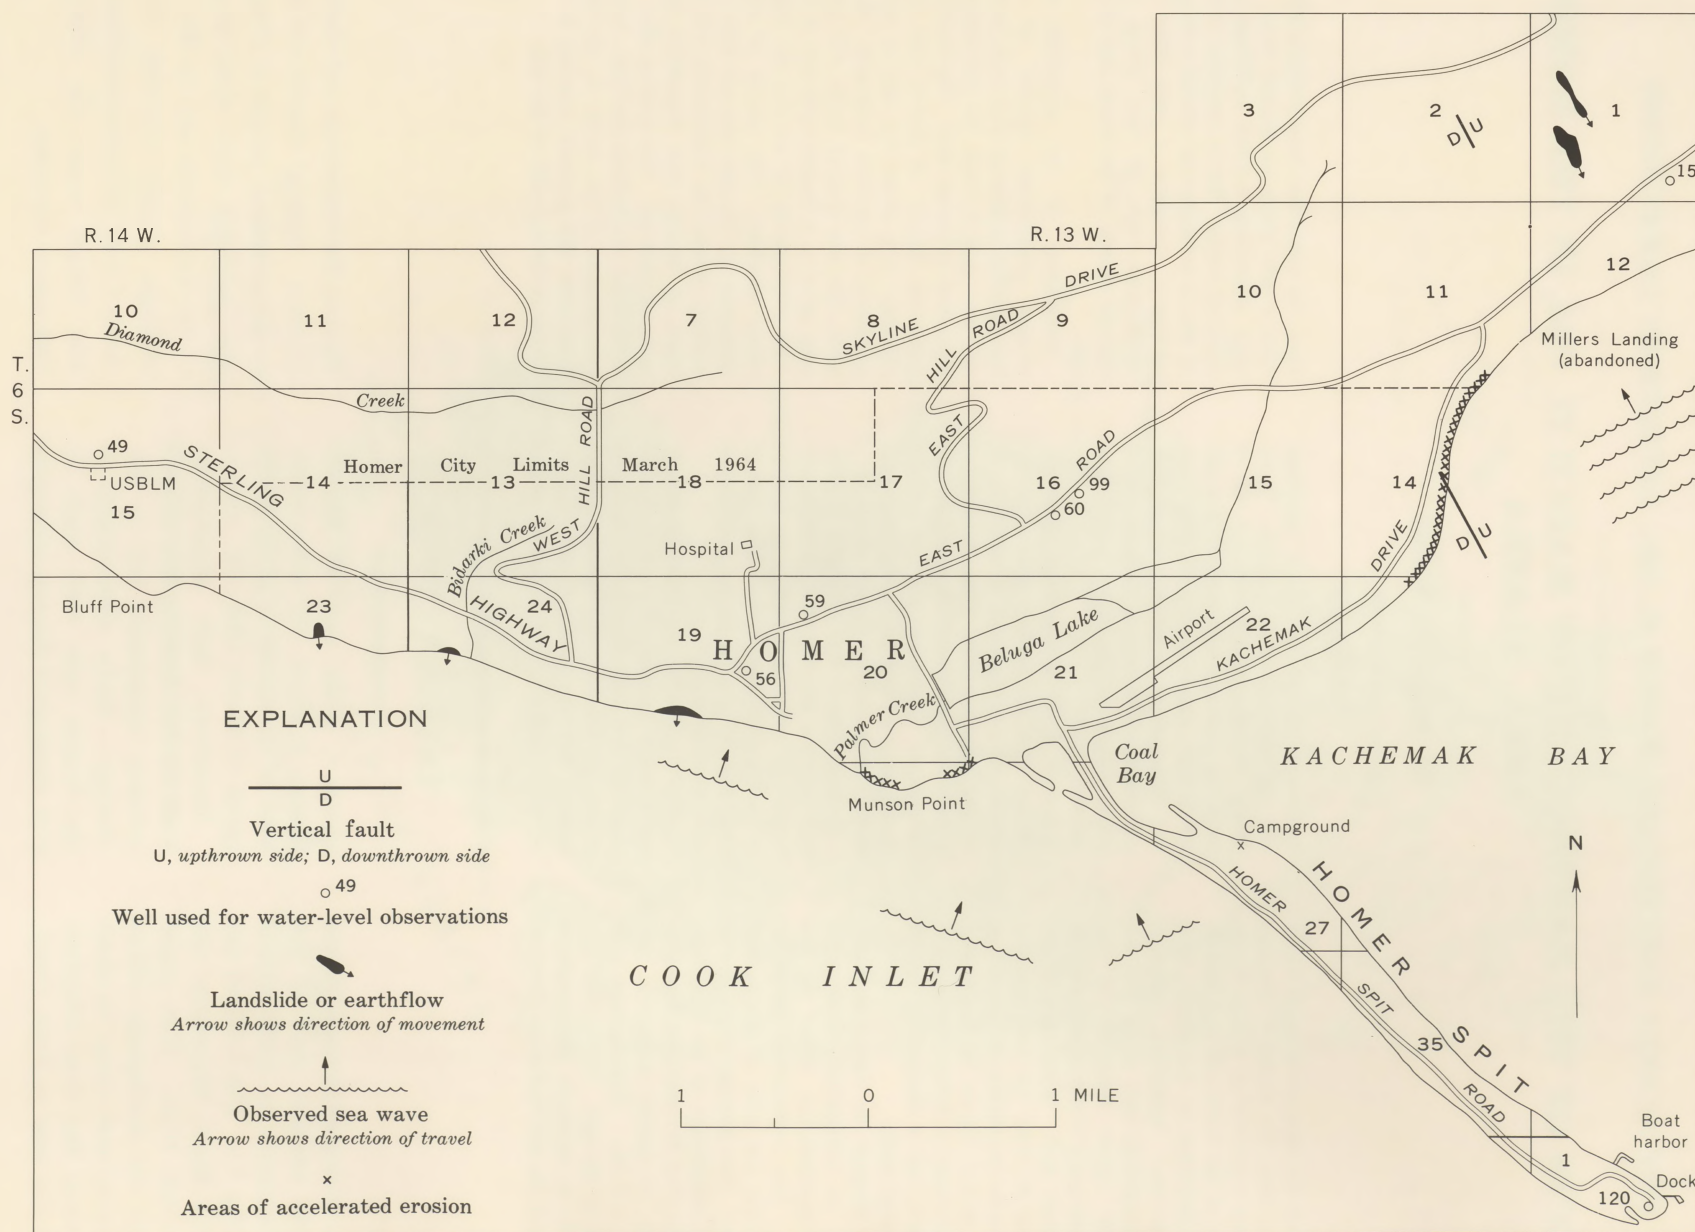
2.—Map of the Homer area showing slide areas, beach erosion points, and locations of wells.

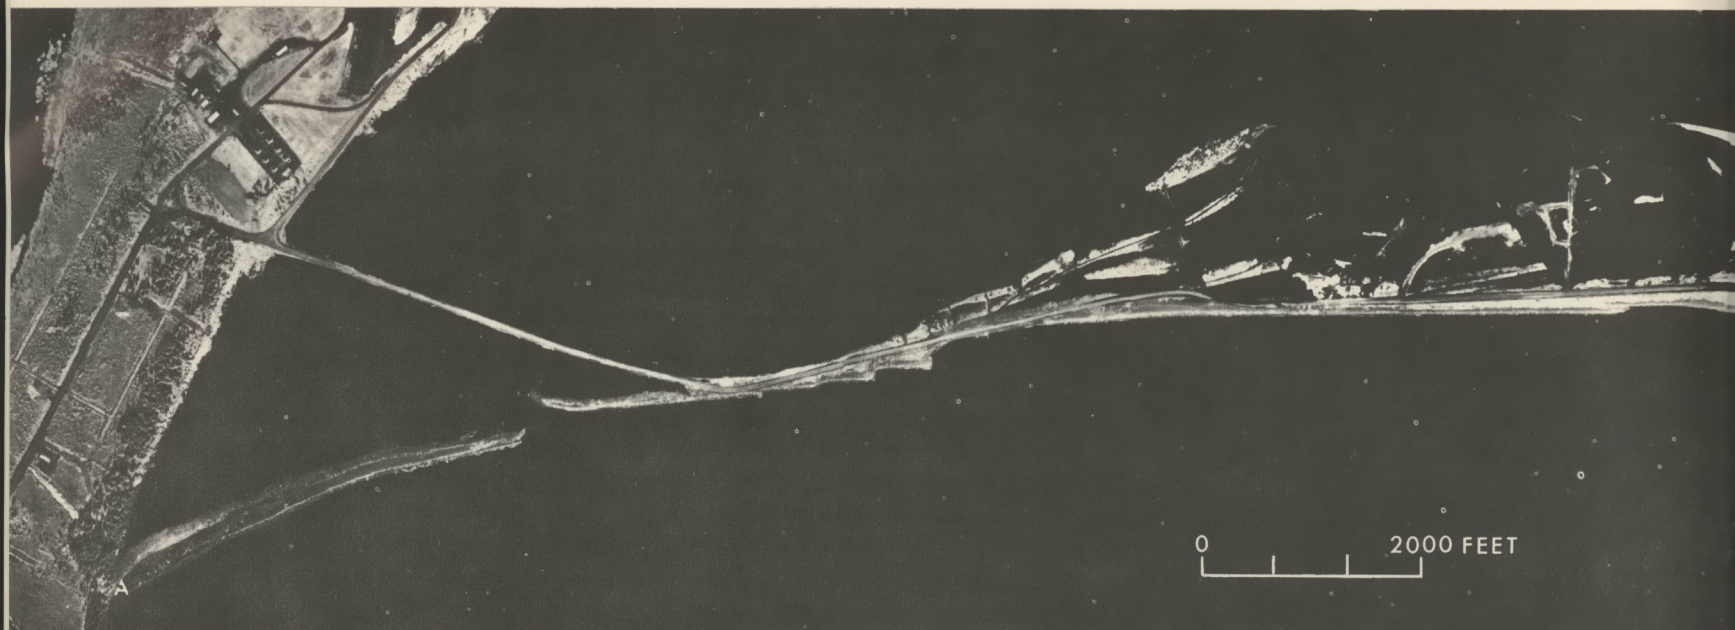
In addition to damage to man-made structures, the subsidence caused a change in the physical relations between the spit and the water surrounding it. As a result, the shape of the spit changed and beach stability was disrupted. The phenomena relating to beach changes on Homer Spit are the subject of the section by K. M. Stanley (p. D20). The extent of high-tide flooding of the spit is shown by Stanley (see fig. 15) in a pair of maps that contrast dry-land exposure on the spit before and after the earthquake. The devastating flooding on the spit immediately after the quake is further illustrated by figures 6 and 7 (on next page), aerial photographs of the spit taken before and after the earthquake.

6—Photomosaic of Homer Spit at high tide on August 8, 1964

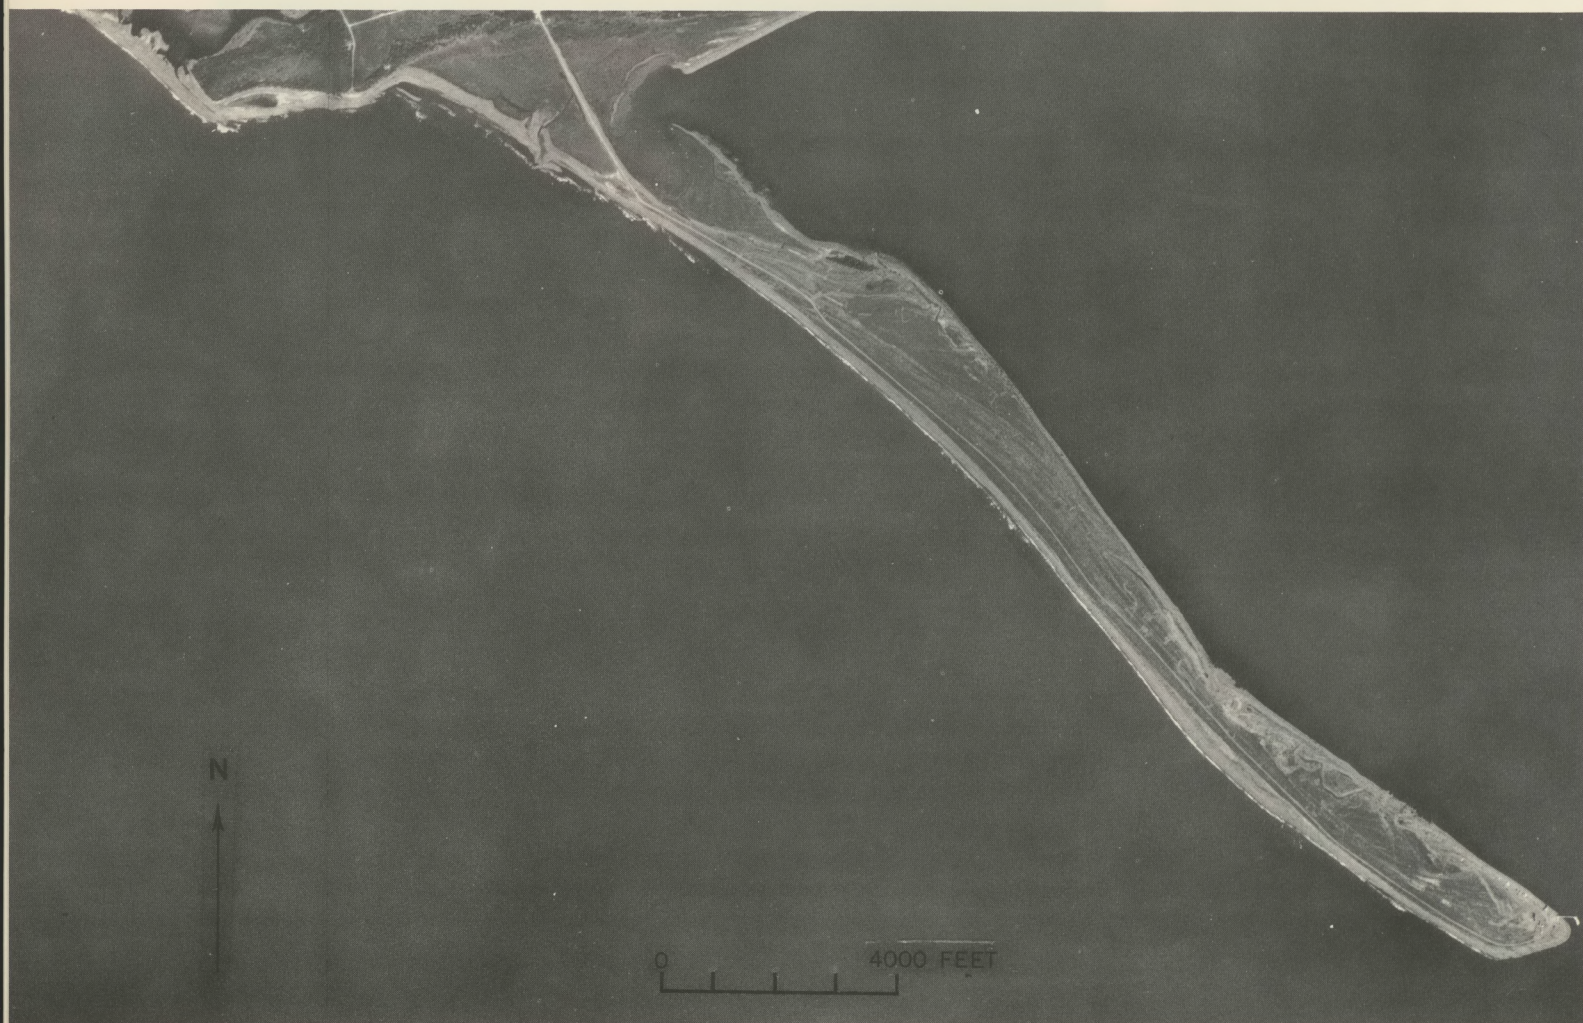
7.—Preearthquake aerial photograph of Homer Spit.

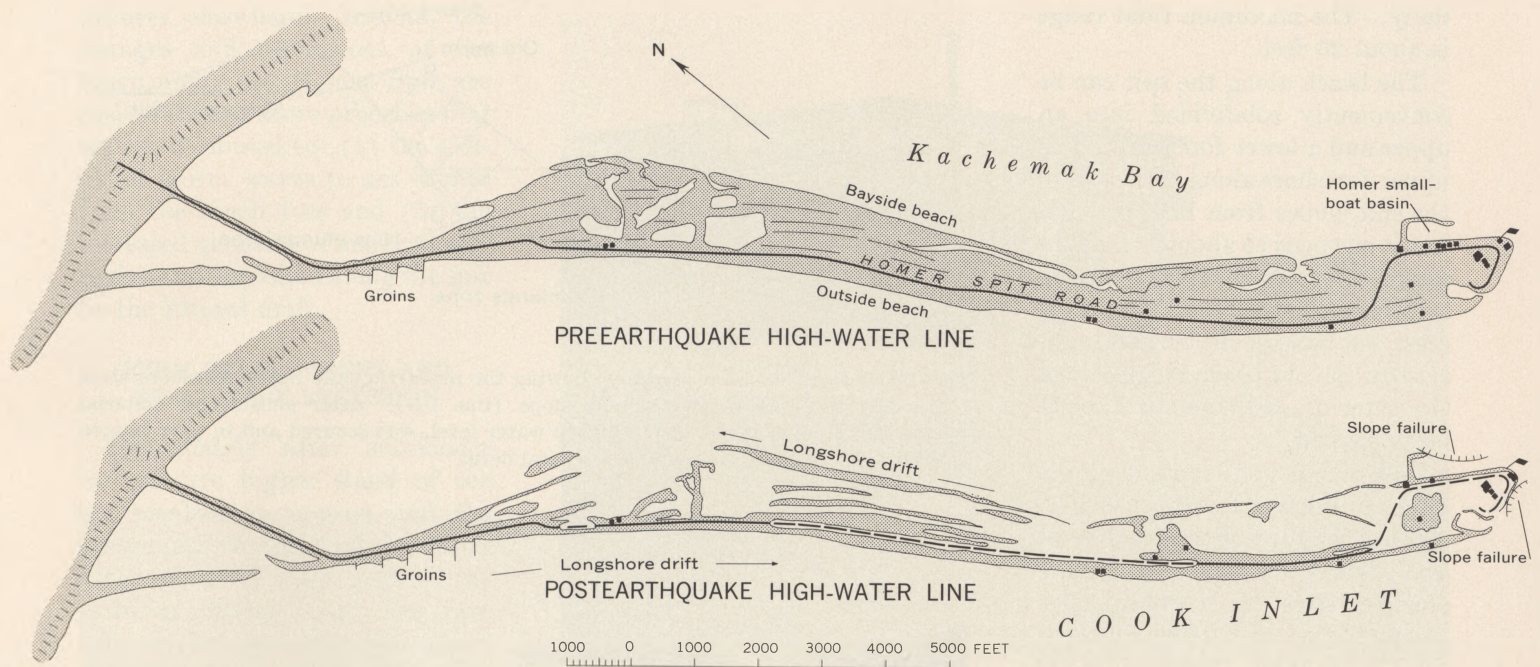
15. Comparison of the high-water line along Homer Spit before and after the earthquake and submergence of March 27, 1964. Light lines on Spit represent old beach berms. High-water line traced from U.S. Army Corps of Engineers aerial photographs, September 1959, and from U.S. Bureau of Land Management infrared photographs, August 1964.

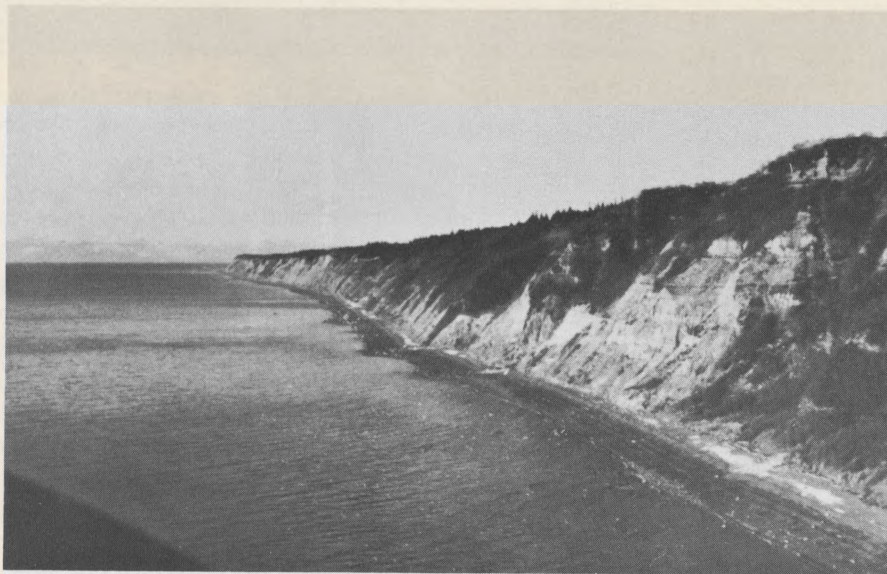
16.—Shoreline west of Homer Spit, probably the source area of material composing the spit.

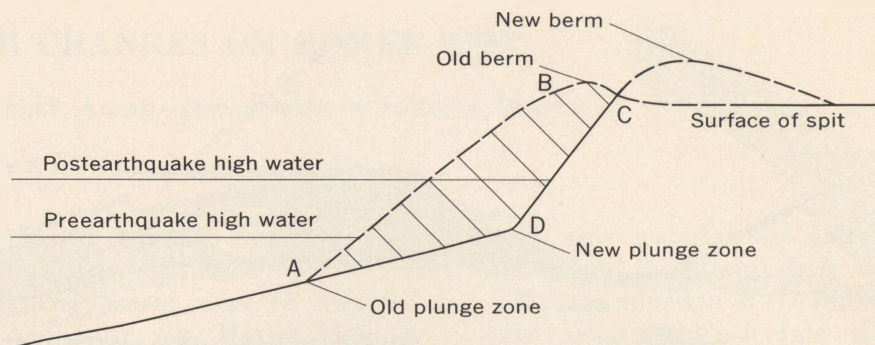
17.—Beach-face recession diagram showing the preearthquake upper foreshore slope (line *AB*) and the postearthquake slope (line *CD*). After subsidence, material within *ABCD*, as a result of the higher water level, was scoured and in part carried onto the spit where it formed a new frontal berm.
