EFFECTS OF THE EARTHQUAKE
OF MARCH 27, 1964
AT SEWARD, ALASKA

Effects of the Earthquake Of March 27, 1964, At Seward, Alaska

BY RICHARD W. LEMKE

GEOLOGICAL SURVEY PROFESSIONAL PAPER 542-E

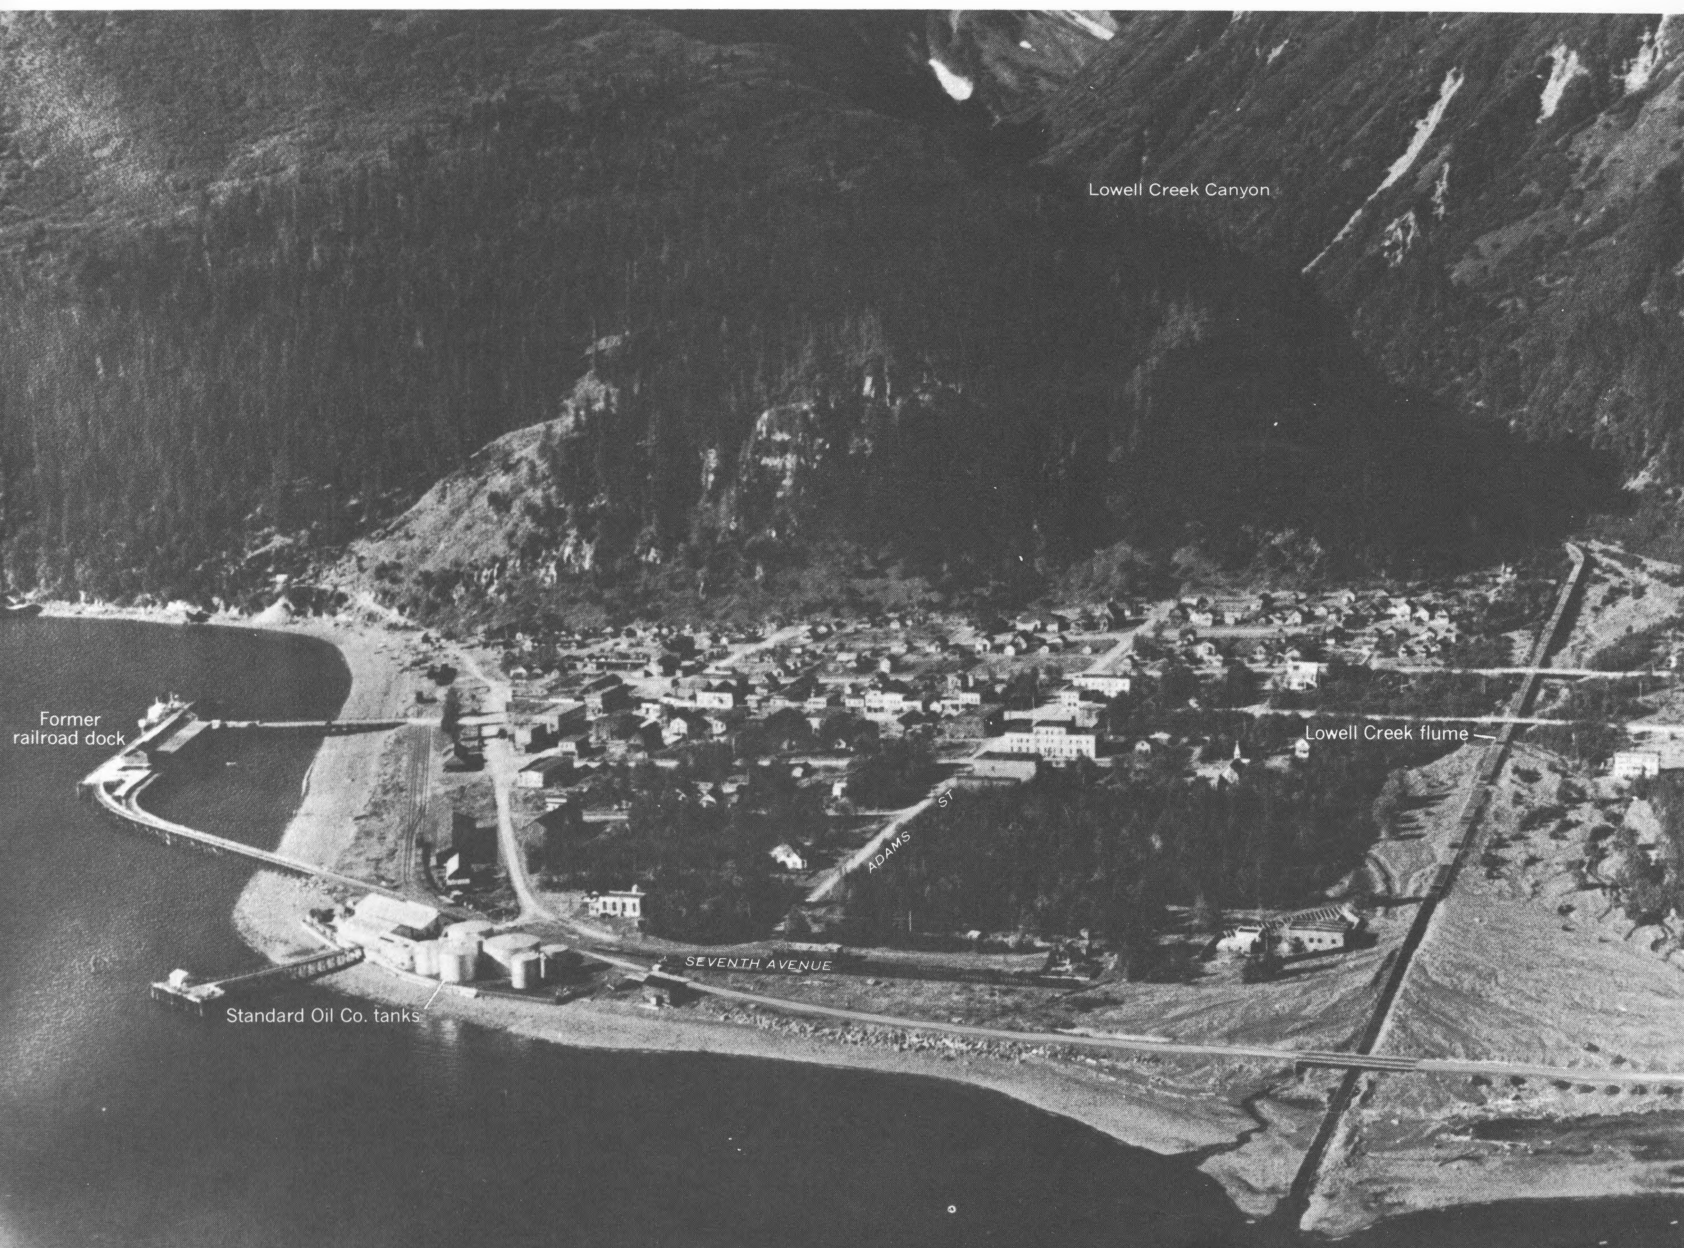
9.—Seward alluvial fan in 1939 showing torrential-type deposition from Lowell Creek after a flood. Photograph by Robert Zentmeyer.

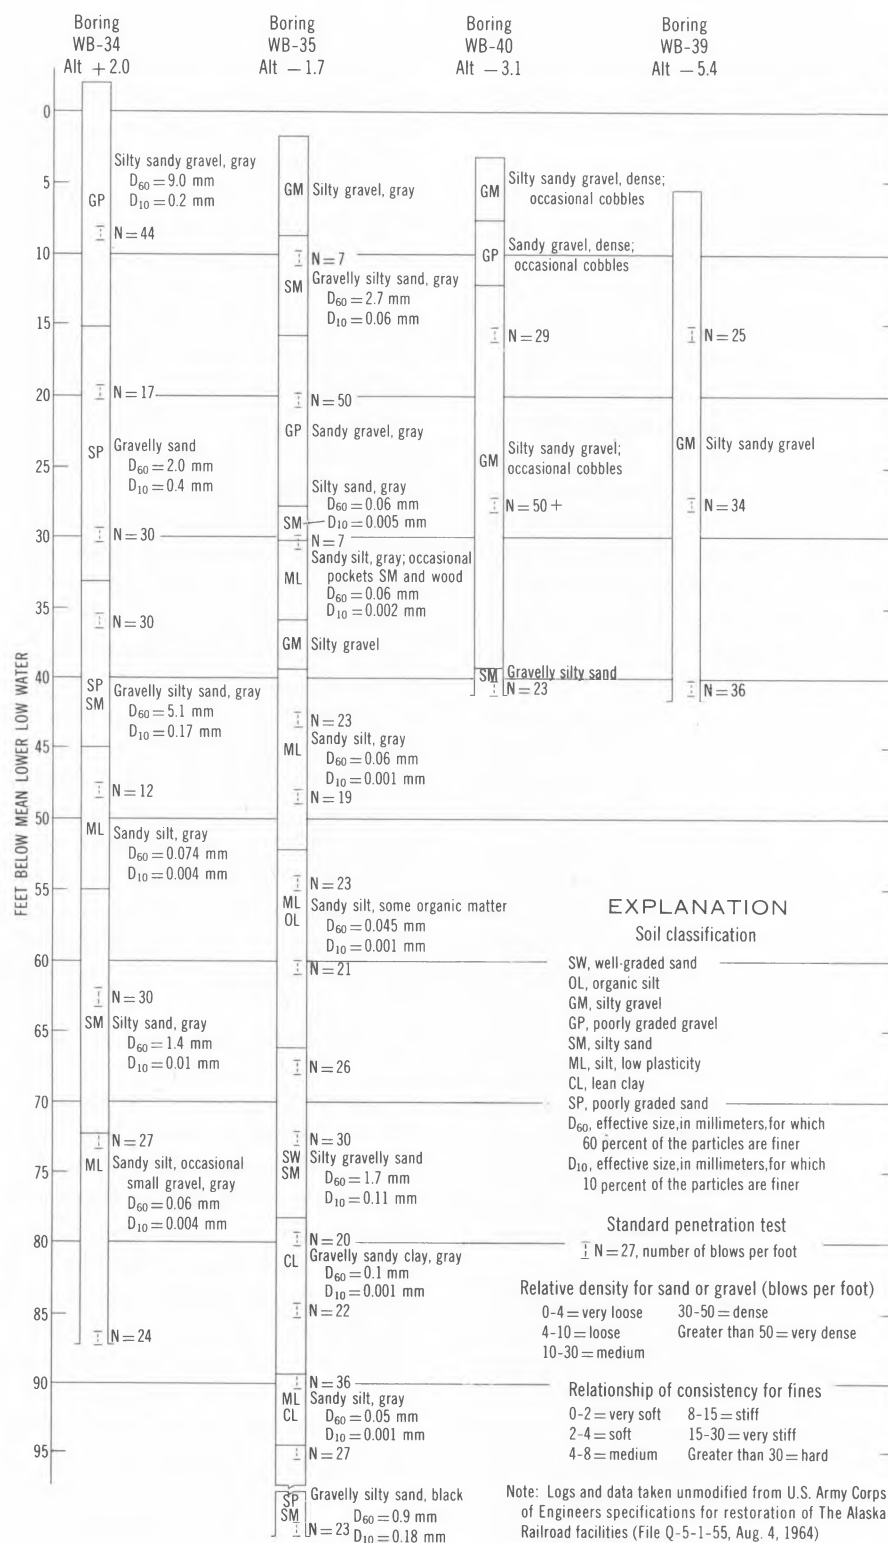
None of the bore holes were more than 100 feet deep and most were less than 50 feet deep. Those on land were 4–9 feet deep. The borings were water-jet holes made by using a pump that developed 450 psi (pounds per square inch) at approximately 20 gallons a minute (Robert H. Moran, U.S. Army, Corps of Engineers, written commun., 1964). The sampler was a 1-inch split spoon on a 2-inch drill rod inside a 4-inch casing. All work was done at the higher stages of the tide when the tidal flats were covered by water. Samples were classified in the field. According to Moran, this method of investigation is both economical and time proven and gives sufficiently accurate information for assessment of dredging character and design of structures. Logs and test data from four offshore borings (fig. 11, next page) show subsurface conditions in the area of the new Alaska Railroad dock.

11.—Offshore borings in the vicinity of the new Alaska Railroad dock. See plate 2 for locations.

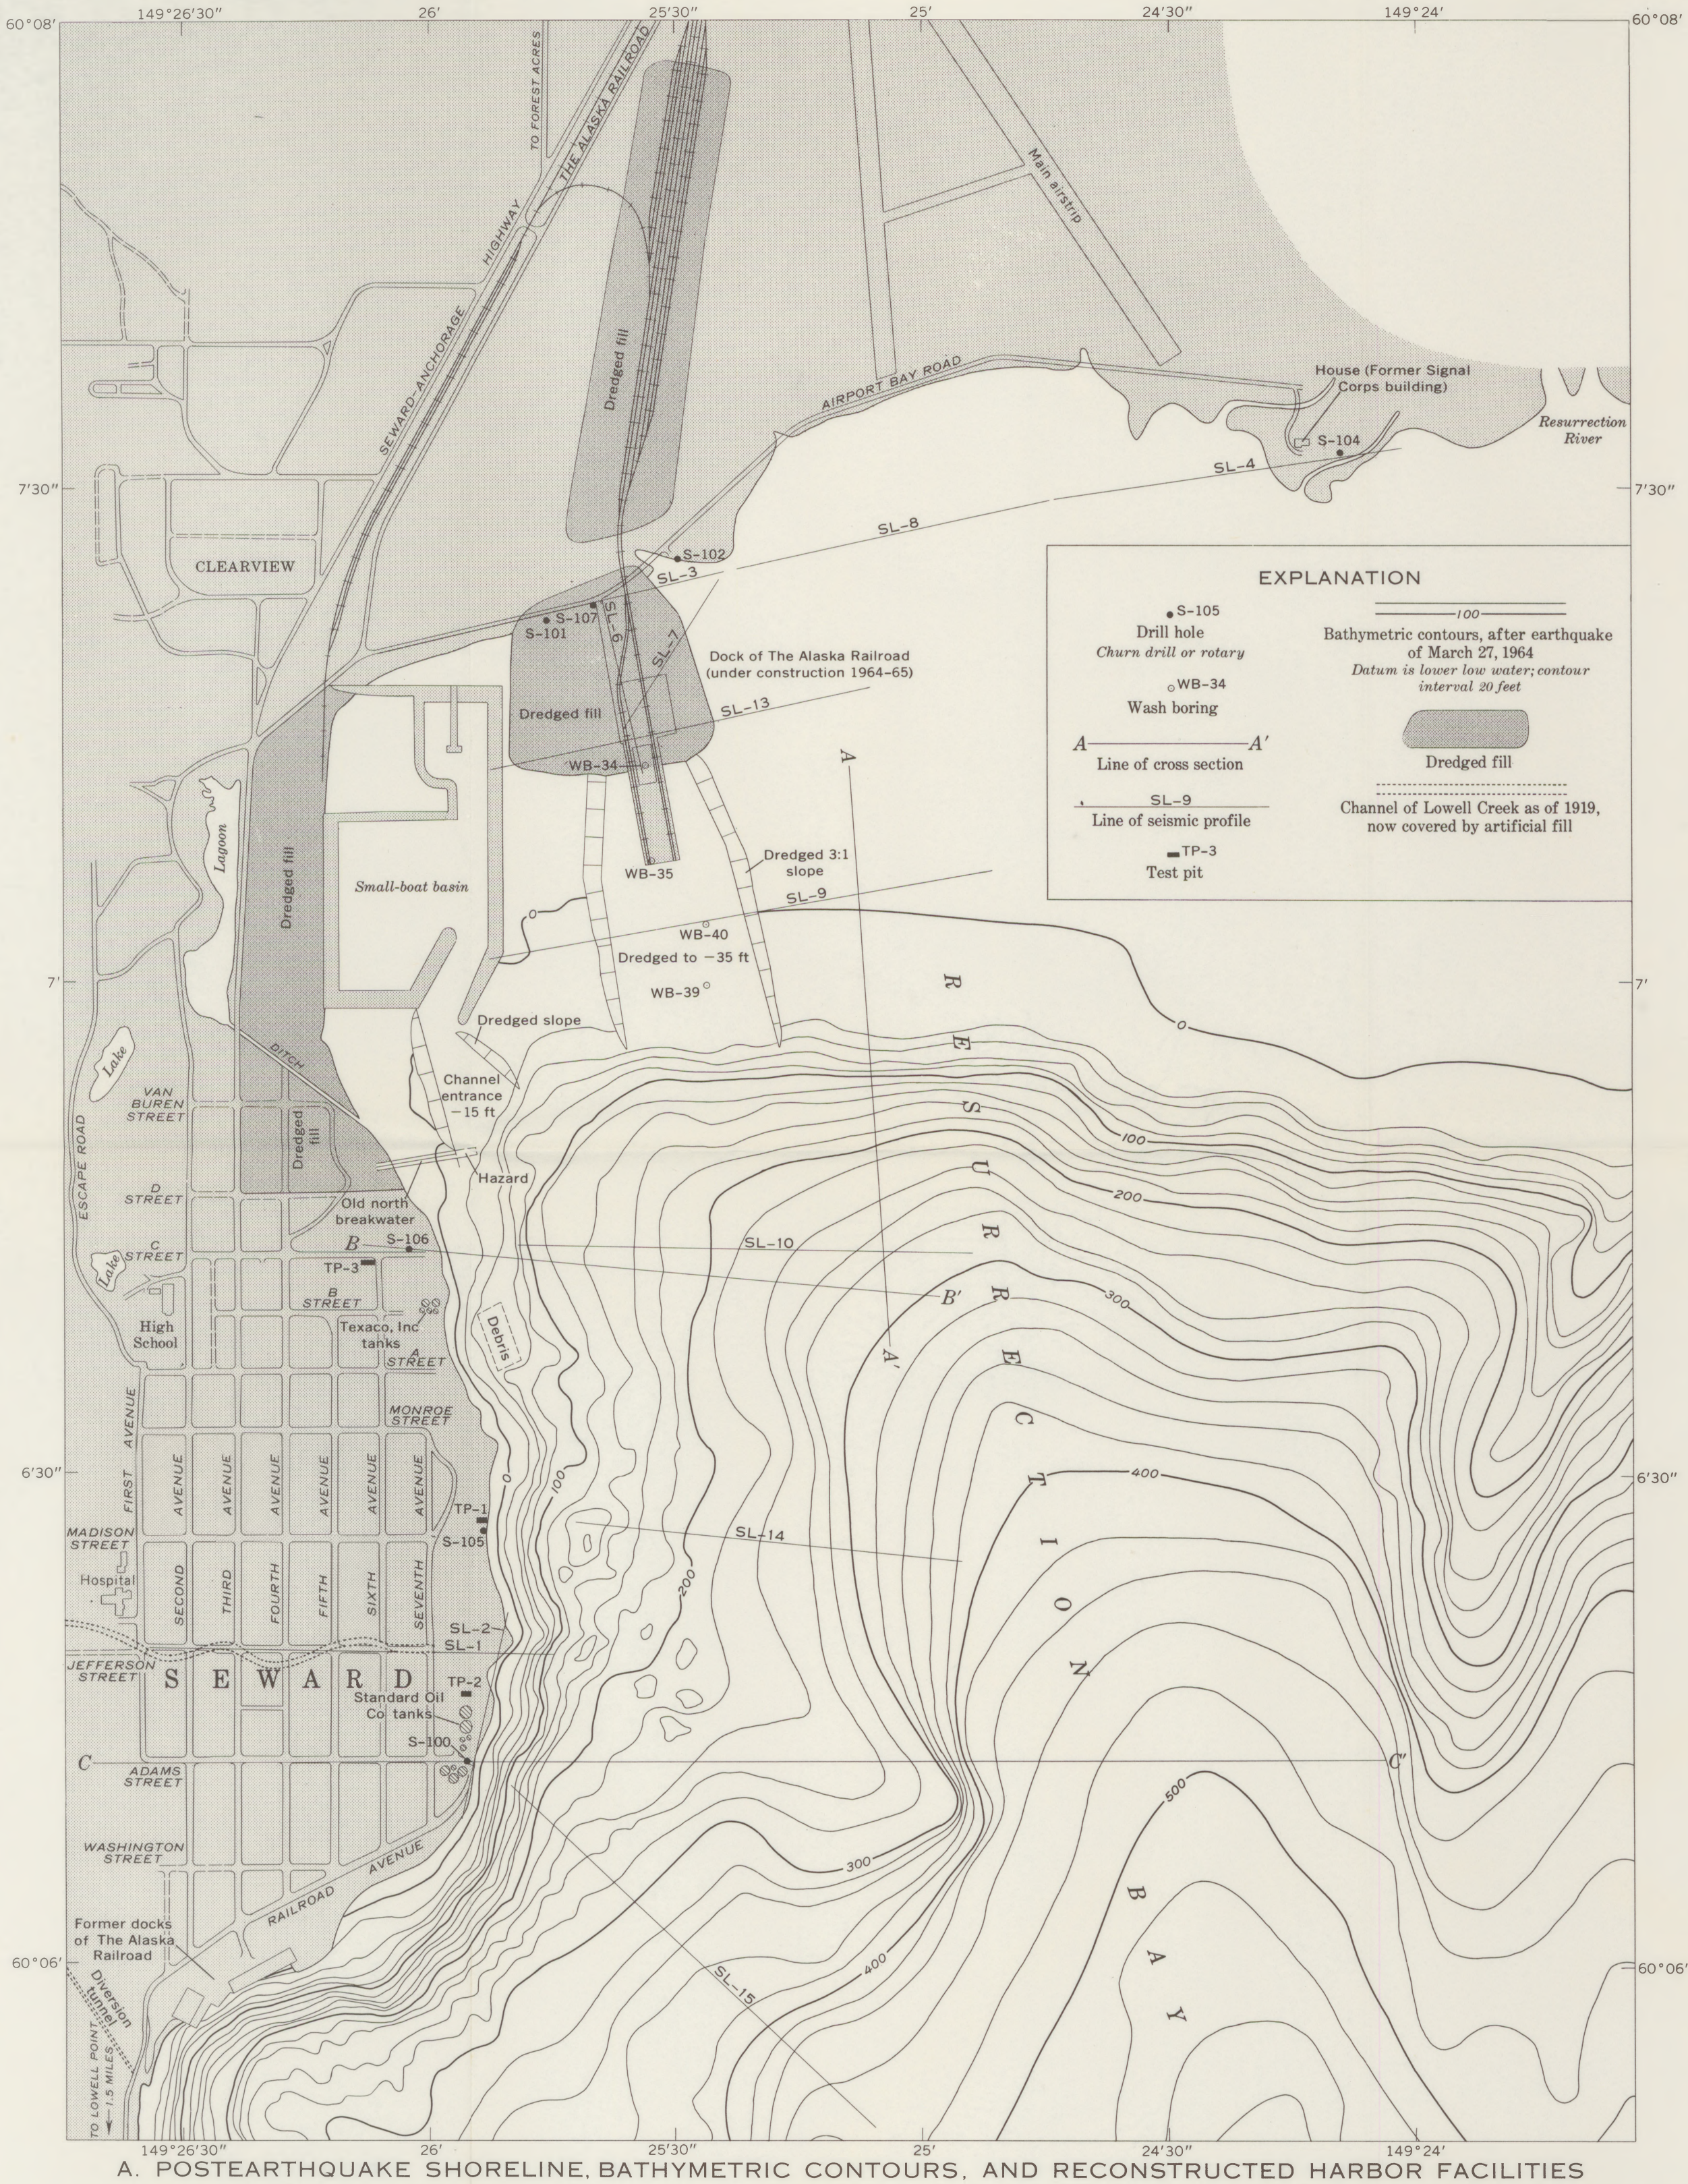
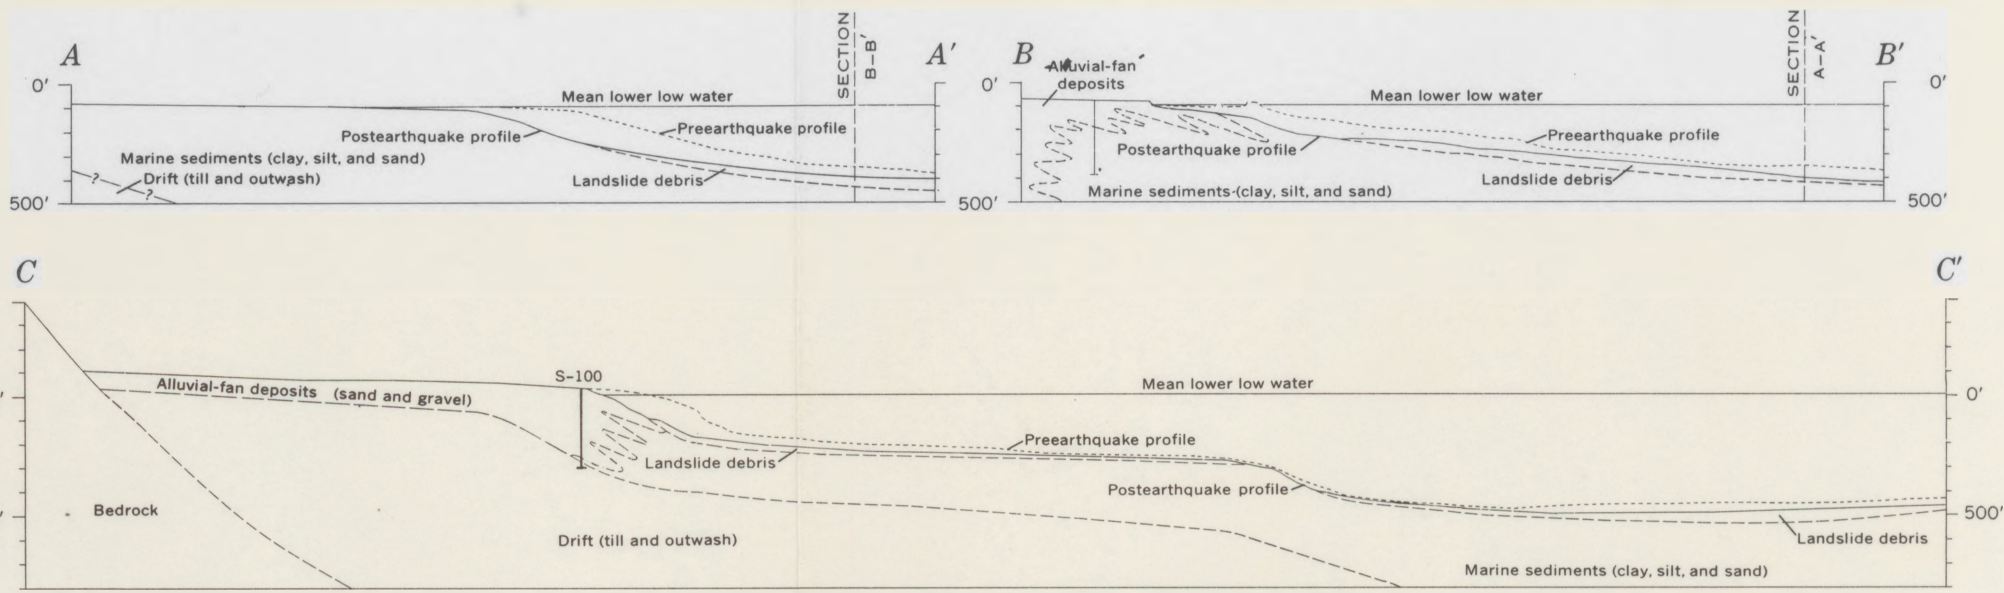
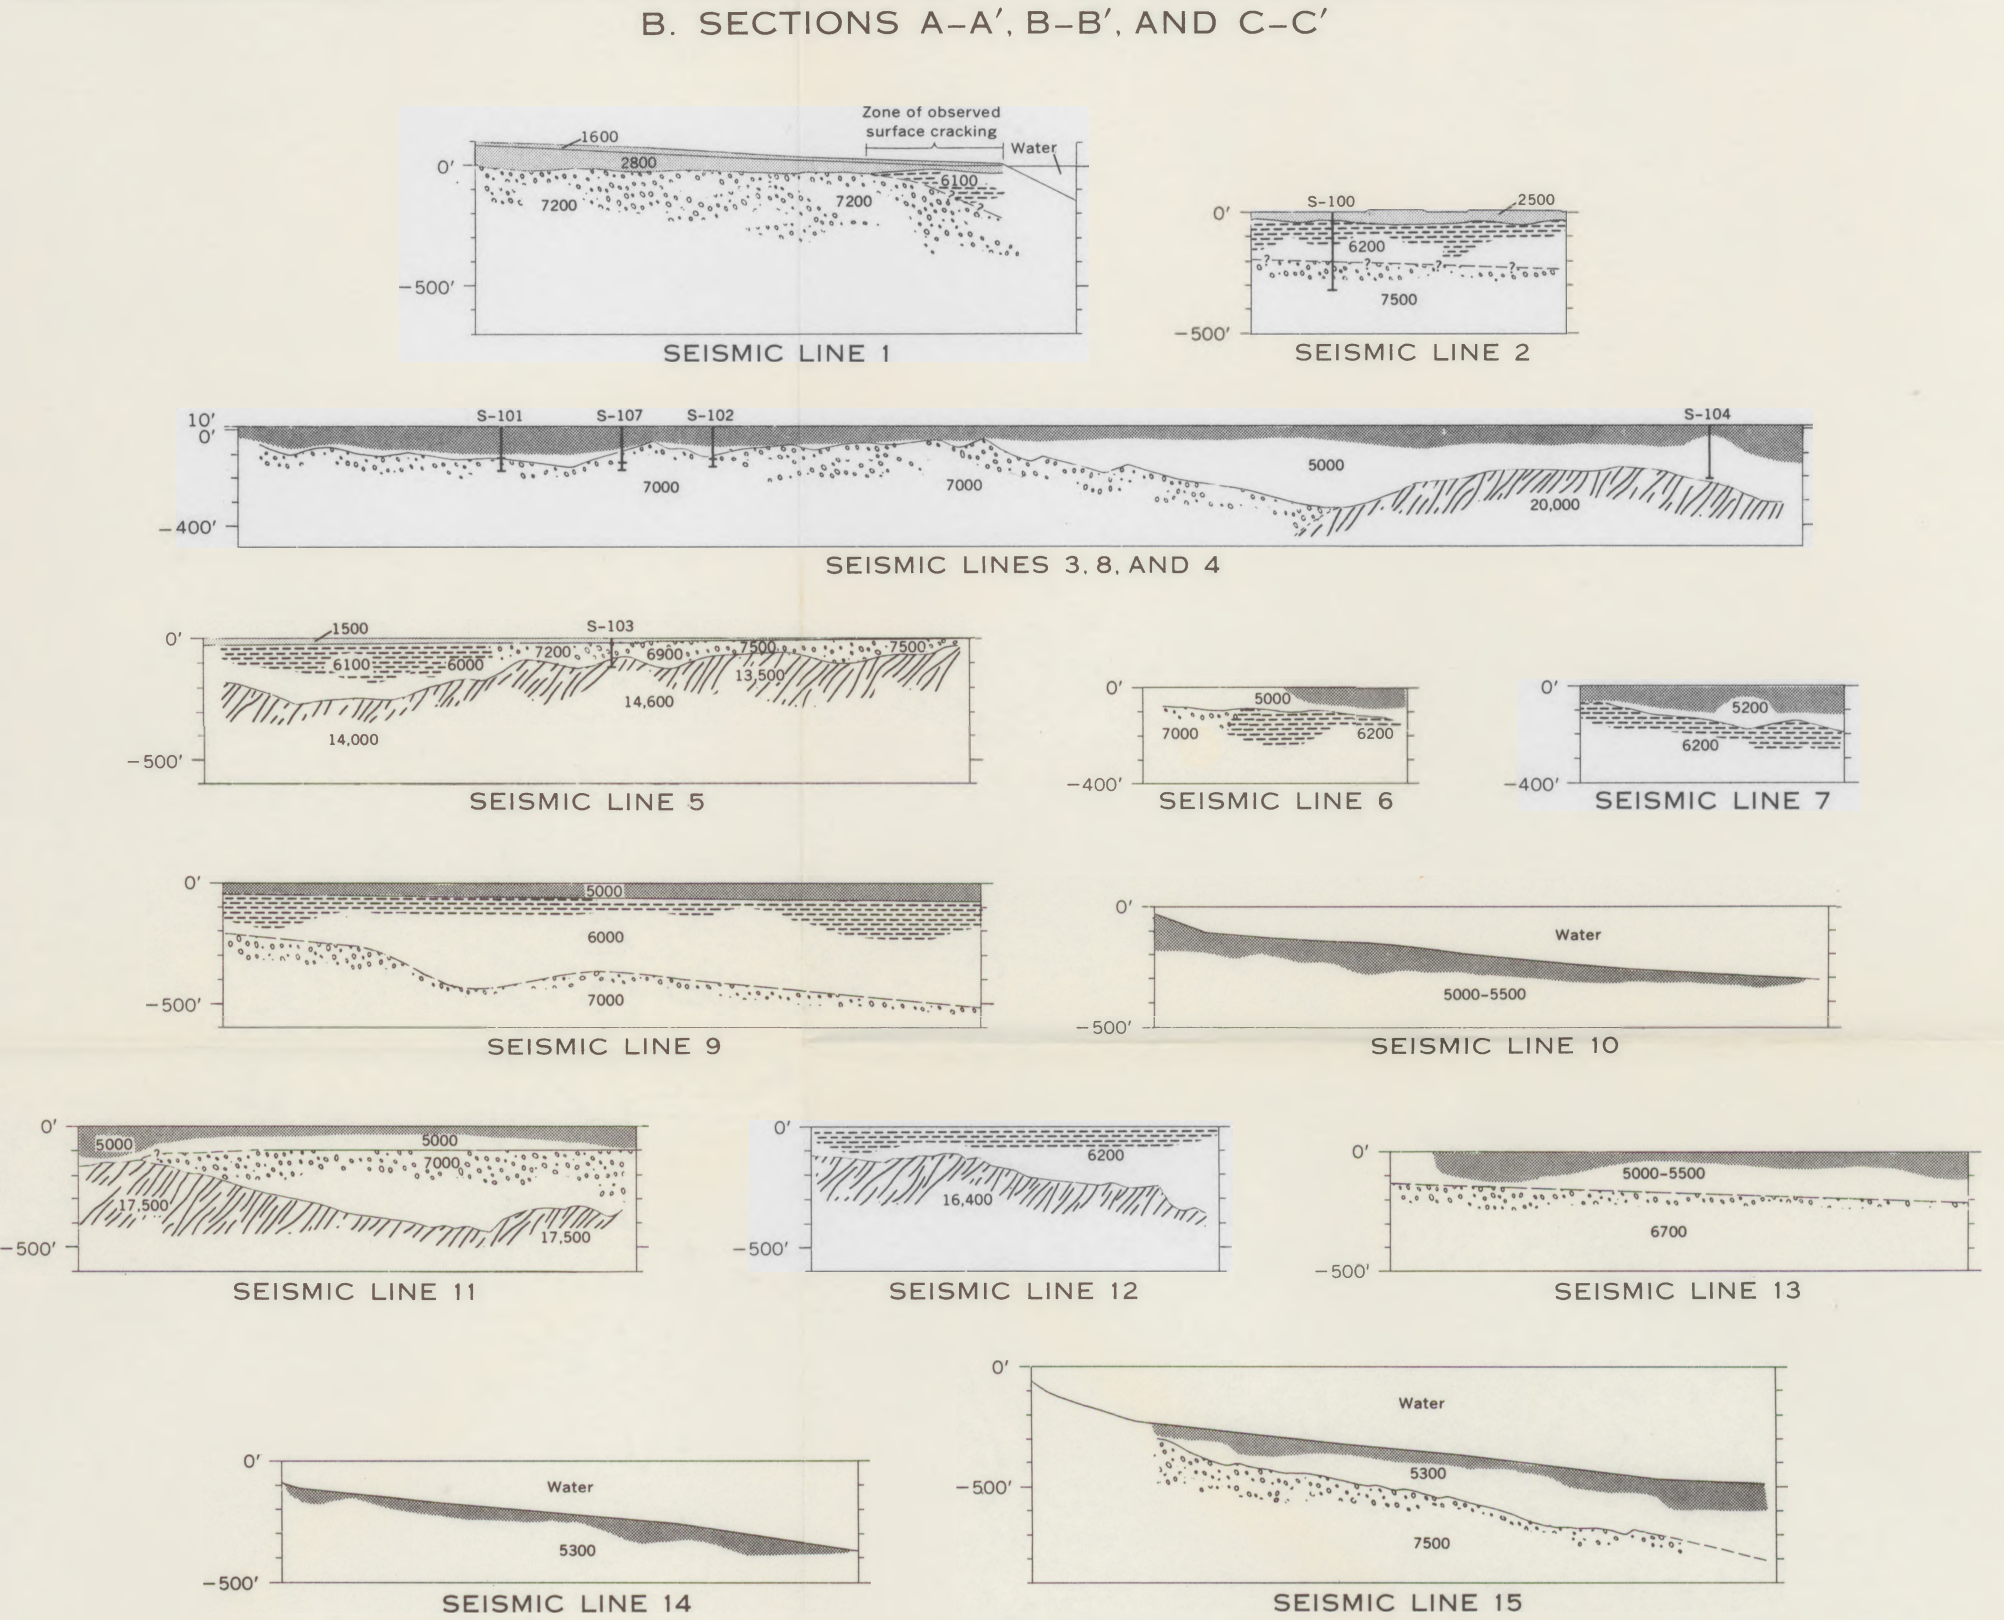
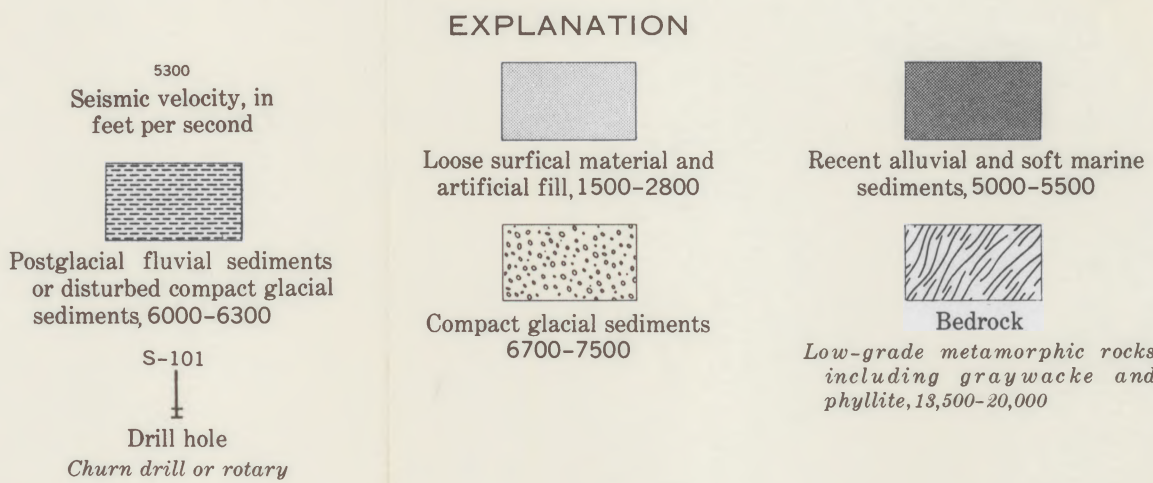
MAP, SECTIONS, AND SEISMIC PROFILES OF SEWARD AND VICINITY, ALASKA

The submarine sliding along the Seward waterfront resulted in marked deepening of the water in the vicinity of the former shoreline. Cross sections *B-B'* and *C-C'* of plate 2 show the pre- and postearthquake profiles of the bay floor in the vicinity of the former Standard Oil Co. dock and the San Juan dock. Water that before the earthquake was 35 feet deep (mean lower low water) off the end of the Standard Oil Co. dock is now 160–180 feet deep; water that was approximately 35 feet deep off the end of the San Juan dock is now 140–150 feet deep. Immediately offshore from the Standard Oil Co. dock area, the average slope of the preearthquake profile to a depth of about 160 feet was about 20°, though locally the slope exceeded 35°. The slope of the postearthquake profile is 25°–30° to a depth of about 180 feet. Between 500

Conditions for failure probably were nearly optimum along the Seward waterfront, where, as shown diagrammatically in cross sections *C-C'* and *B-B'* of plate 2, loose sand and gravel in the distal edge of the alluvial fan intertongue and interlense with marine clay, silt, and sand. Torrential flooding from Lowell Creek canyon has periodically dumped sand and gravel off the distal edge of the fan (fig. 9); during the relatively long intervening periods when only minor quantities of fluvial deposits reached the bay, fine-grained marine sediments were deposited along the steep underwater face of the fan. Drill-hole data indicate that some of the fore-set beds along the distal edge of the fan dip as steeply as 30° and that the chips of phyllite constituting nearly all the sand-size particles are oriented with their flat sides parallel to the bedding.
