The Alaska Earthquake

March 27, 1964

Effects of the Earthquake of March 27, 1964, on the Alaska Highway System

GEOLOGICAL SURVEY PROFESSIONAL PAPER 545-C

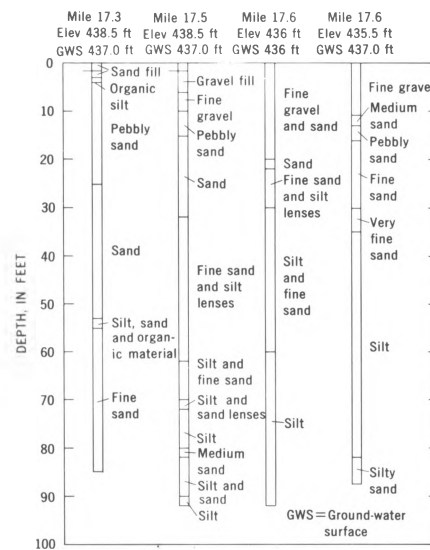
8.—Graphic logs of test holes at Snow River Crossing on Seward-Anchorage Highway. Logged by Alaska Department of Highways.

The Snow River Crossing is underlain by fine sand and silt, covered with a thin veneer of fine gravel (fig. 8). The water table is in many cases at or within a foot of the surface. The fine-grained saturated sediments had very little strength, and, when the seismic shaking struck the area, the sediments failed primarily by liquefaction and lateral spreading or displacement.

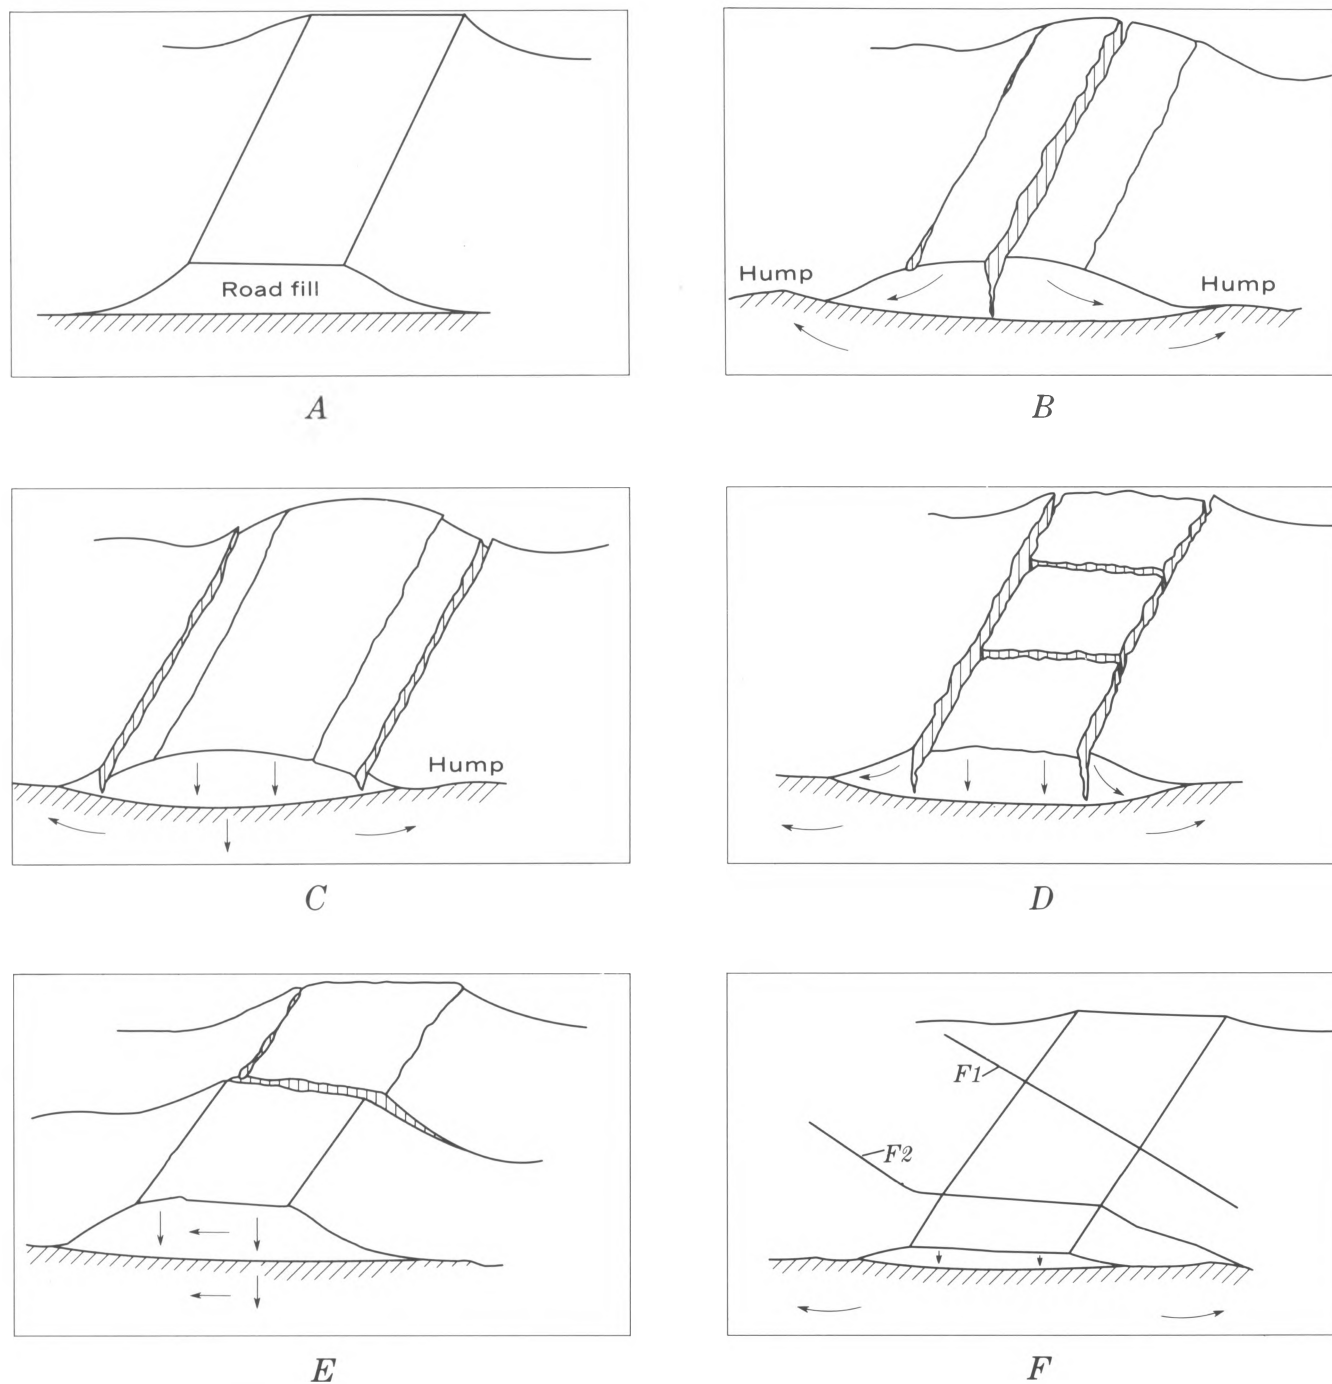
The most conspicuous fractures observed were those normal to the axis of the roadway (figs. 12E, 13); they were extensive along the Seward-Anchorage Highway and on the Richardson, Sterling, and Glenn Highways, particularly in paved sections. These fractures, plus the oblique type shown on figure 12F(2), represent about 90

12.—Schematic drawing of types of fracture generated by earthquake in roadways. *A*, Preearthquake. *B*, Underlying sediments compact and displace laterally. Roadway settles differentially and is moved laterally by underlying sediments; roadway fractures along centerline and is wavy; hump is formed off roadway. *C*, Underlying sediments compact and move laterally; roadway settles and longitudinal fractures develop along edges; roadway also wavy. *D*, Longitudinal fractures form as in *C*; as underlying sediments continue to compact and displace laterally, roadway settles differentially and transverse fractures develop. *E*, Fracture forms owing to horizontal displacement of roadway and underlying sediments; fracture generally originates off roadway. *F*, Fracture forms in original ground oblique to roadway; as it strikes roadway, it either continues at oblique angle (*F1*) or is refracted normal to roadway and, when past roadway, becomes oblique again (*F2*); these fractures occur chiefly in small roadway fills.

Fractures normal to the roadway are due to shear and tension (fig. 12*E*). The fractures due to shear first form in the ground because of mass displacement of the underlying sediments toward a

Failures along the centerline of the highway fill are due to tension (fig. 12*B*). As the roadway and underlying sediments are subjected to seismic shaking, the denser roadway subsides into the

Fractures along the edges and parallel to the roadway (fig. 12*C*,

D) are caused by compaction of the underlying sediments and lateral spreading of the ground. As seen in figure 12*C* the roadway, although wavy from differential compaction, has maintained its integrity. As the roadway is subsiding differentially, it is also being displaced along the axis owing to displacement of the underlying sediment. Thus, normal and longitudinal fractures are due to tension and are confined to the road fill.

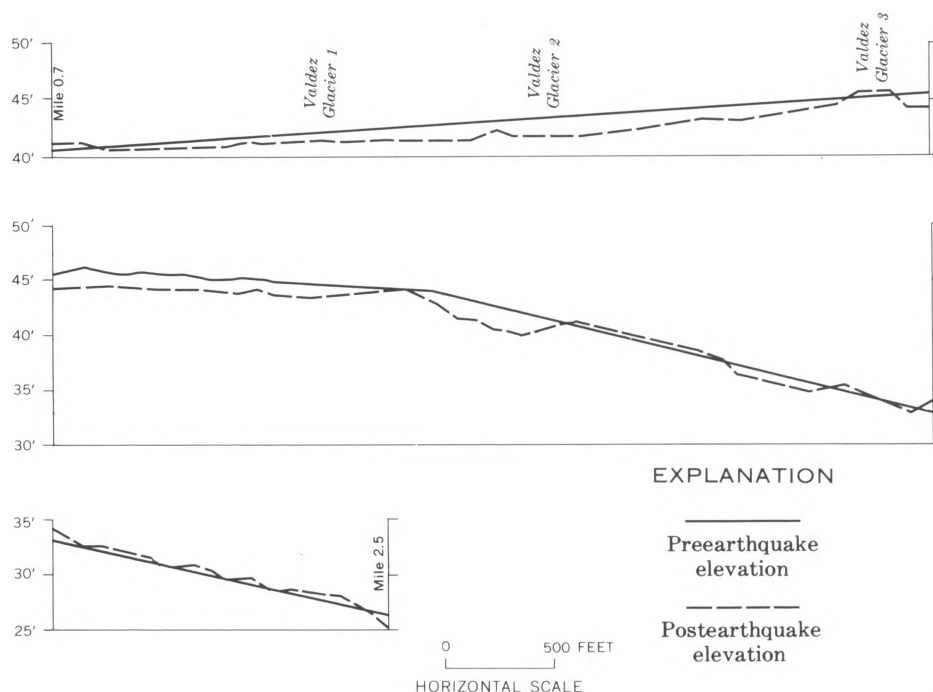
The most spectacular local subsidence occurred (1) on the Richardson Highway between mile 0.0 and mile 5.0, (2) on the Copper River Highway near mile 28.0, and (3) on the Seward-Anchorage Highway at Snow River Crossing and from mile 75.1 to mile 91.0. Figure 17 shows pre- and post-earthquake profiles from mile 0.7 to mile 2.5 of the Richardson Highway; figure 18, pre- and post-earthquake profiles from mile 5.9 to mile 11.0 of the Copper River Highway; figure 19, pre- and post-earthquake profiles from mile 75.1 to mile 85.0 of the Seward-Anchorage Highway; and figure 20, pre- and postearthquake profiles and pier elevations at the Snow River Crossing of the Seward-Anchorage Highway.

17.—Pre- and postearthquake profiles from mile 0.7 to mile 2.5, Richardson Highway. Data from Alaska Department of Highways.

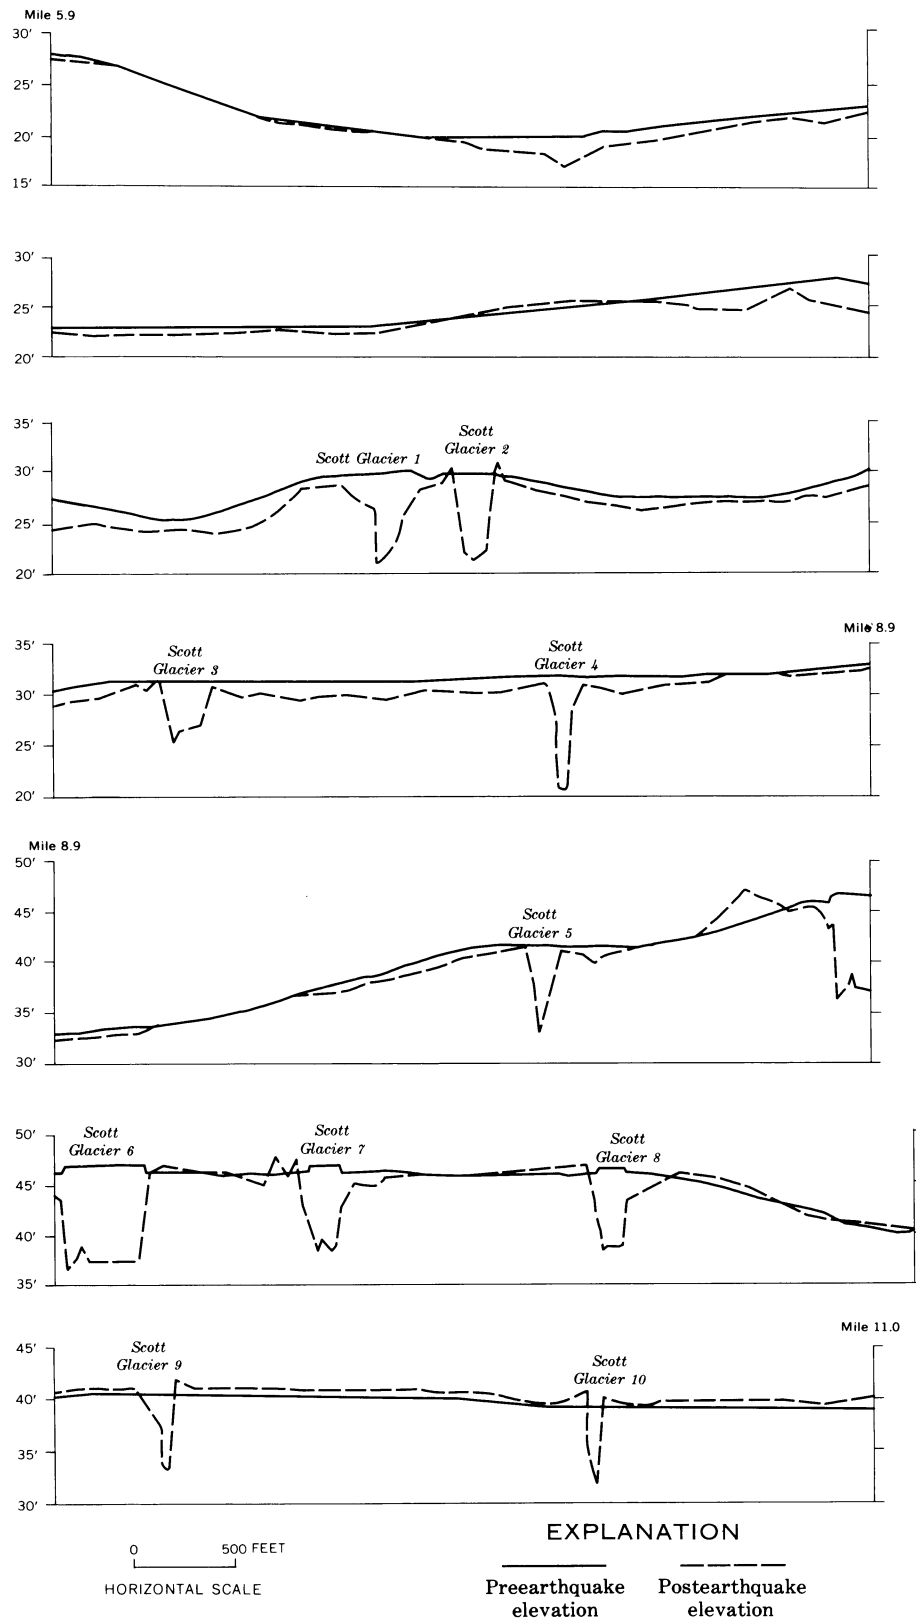
18.—Pre- and postearthquake profiles from mile 5.9 to mile 11.0, Copper River Highway. Data from Alaska Department of Highways.

Pre- and postearthquake profiles for the Copper River Highway are only available from mile 5.9 to mile 13. In this stretch of the highway a maximum local subsidence of 48 inches occurred at about mile 7.6. Here the roadway is underlain by clay, silt, sand, and organic debris (fig. 10). At mile 10.1, where the roadway is underlain by silty gravelly sand and silty

gravel, it did not subside. There was about 18 inches of subsidence at mile 11.0 where the highway is underlain chiefly by silty sandy gravel, sandy silt, and silty sand (all containing organic material; fig. 10); the water table there is about 2 feet from the surface.

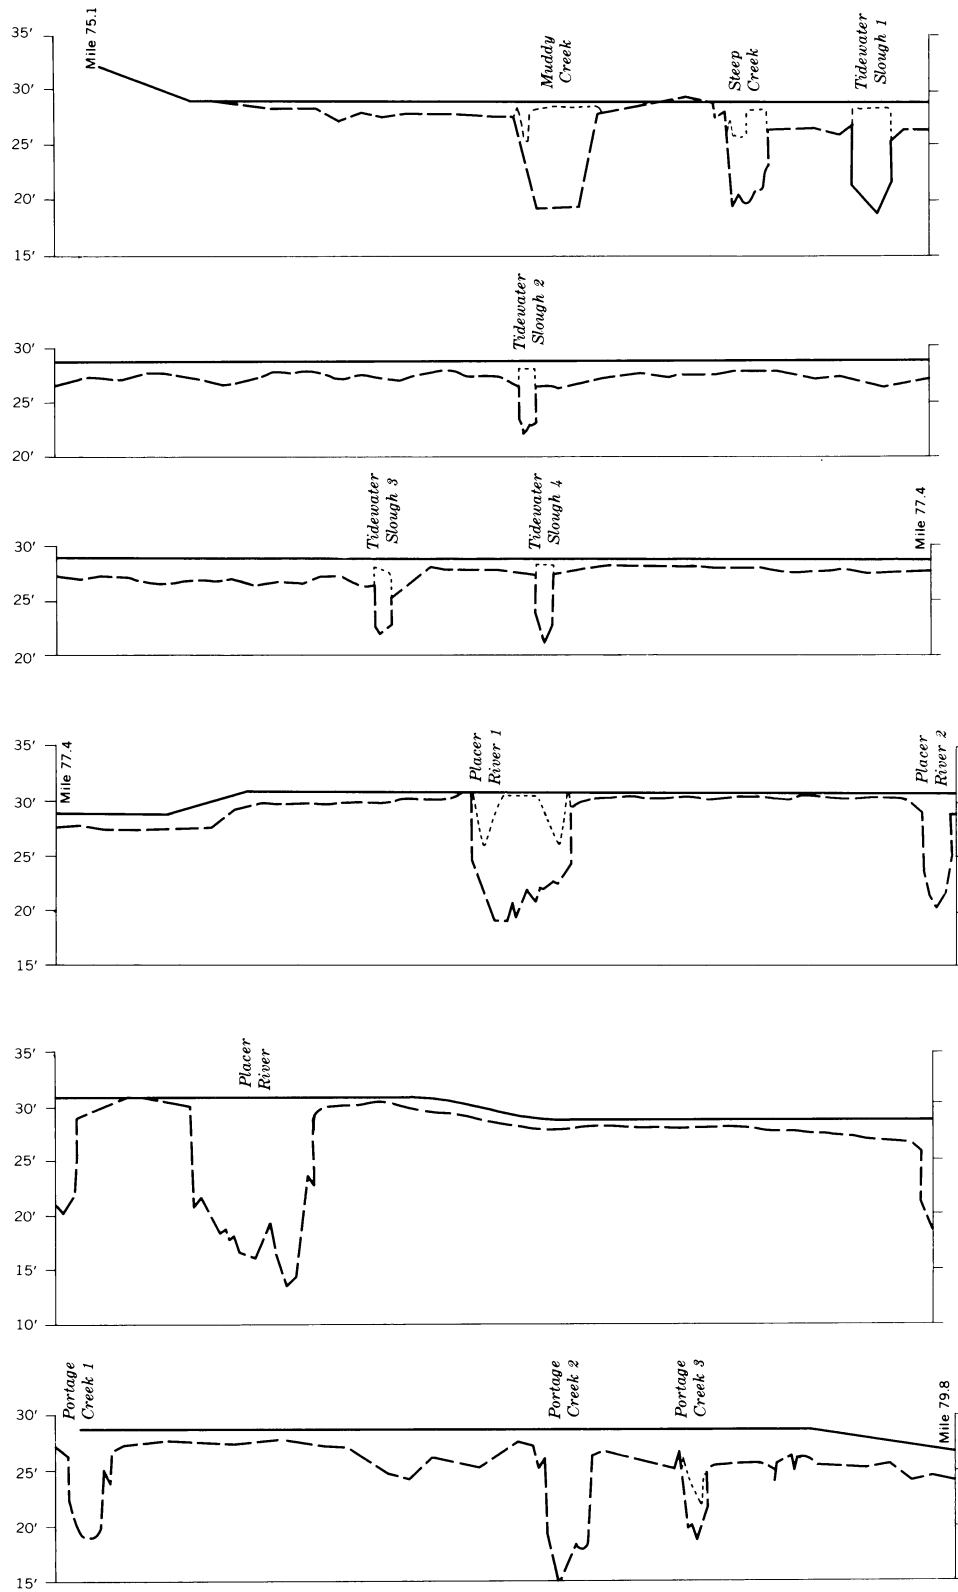
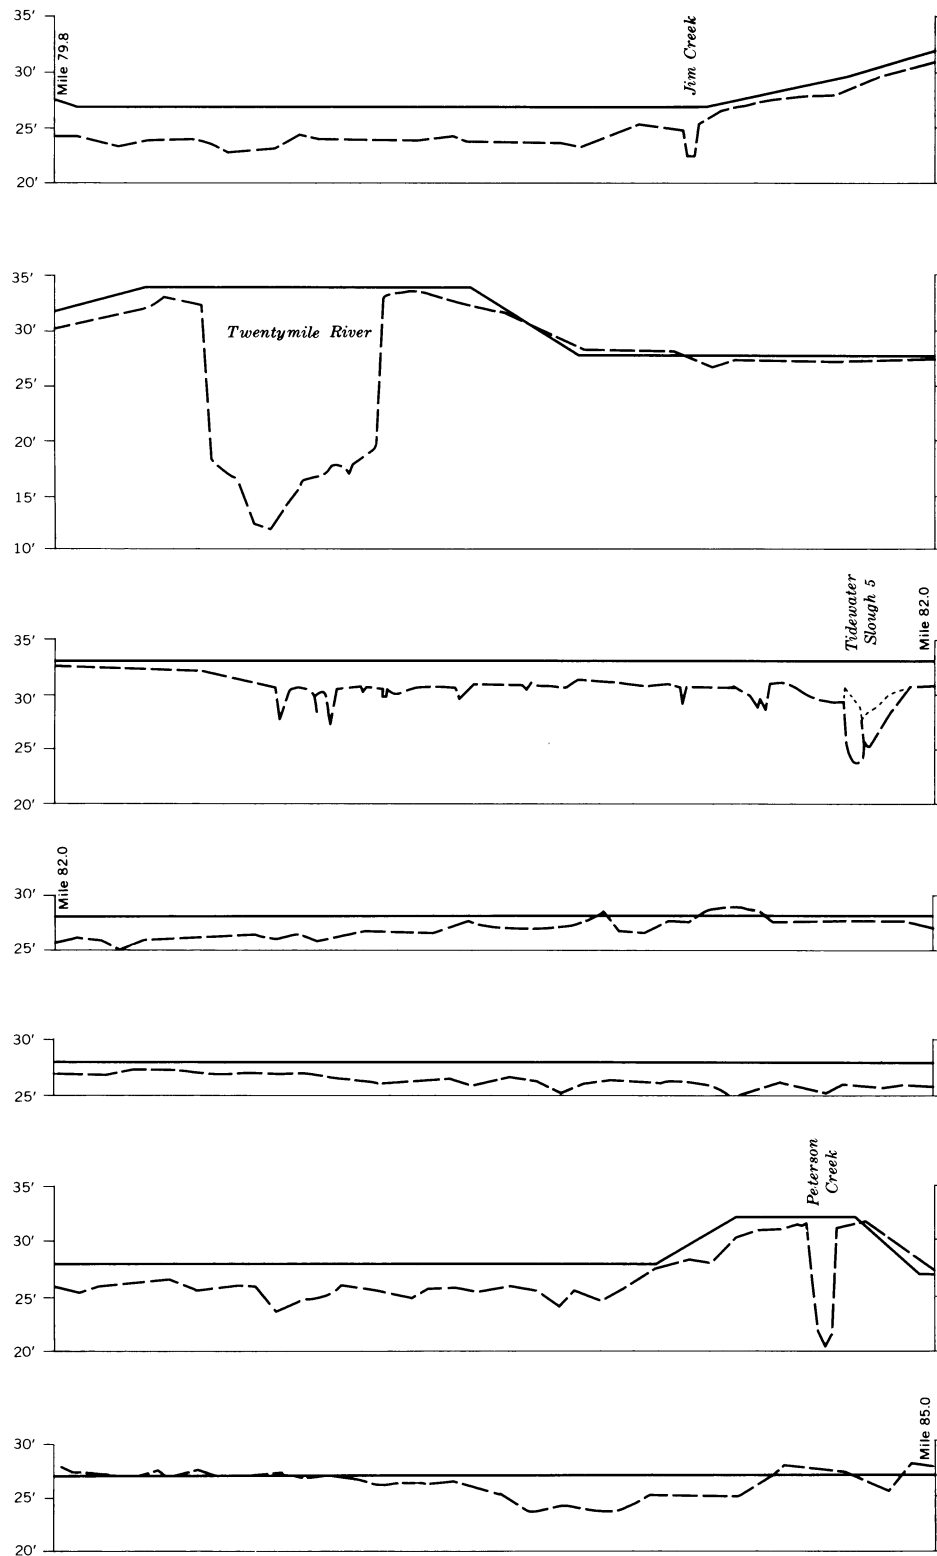
A large amount of local subsidence of the roadway occurred in the Portage area on the Seward-Anchorage Highway. Here a maximum subsidence of 54 inches was measured by the Alaska Department of Highways at mile 79.3 between Portage Creek 1 and

19. (Above and left)—Pre- and postearthquake profiles from mile 75.1 to mile 85.0, Seward-Anchorage Highway. Data from Alaska Department of Highways.

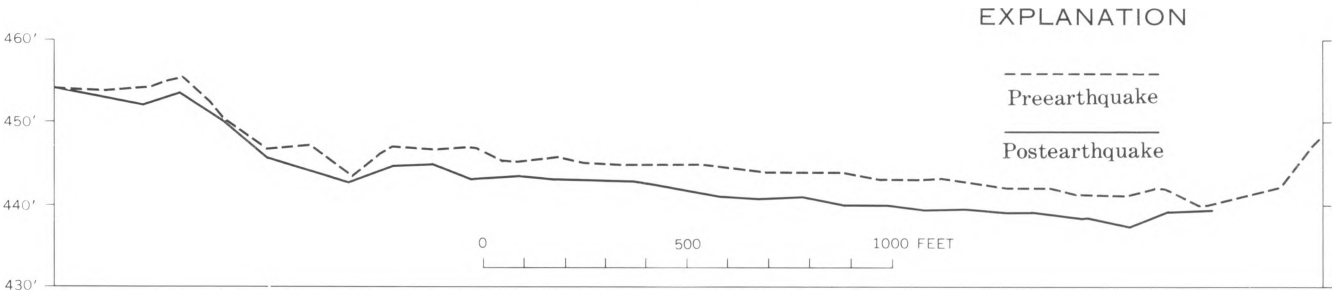
The piers shown on figures 20 and 21, which are part of the new crossing and which subsided as much as 4 feet, rest on 18-inch tubular piles driven to depths of as much as 160 feet. The subsidence of these piers indicates that the underlying sediments either compacted to great depths or that seismic shaking in fine silt liquefied the sediments and allowed the piles to sink. In addition, when the piles at abutment 1 (fig. 20) were pulled, they were found to be distorted and bent by the earthquake below the ground surface.

The roadway fill at the Snow River Crossing prior to the earthquake was from 4 to 7 feet thick. After the earthquake the 4-foot part of the fill had subsided as much as 2 feet beneath the ground surface. The profile in figure 20 indicates that the ground surface subsided about 5 feet. Thus, in places the roadway must have subsided as much as 11 feet, that is, the 4-foot fill subsided 6 feet and

20.—Pre- and postearthquake pier elevations (A) and profiles (B) near mile 17.3 at Snow River Crossing, Seward-Anchorage Highway. Profiles are at east side of Snow River Crossing. Data supplied by Alaska Department of Highways.

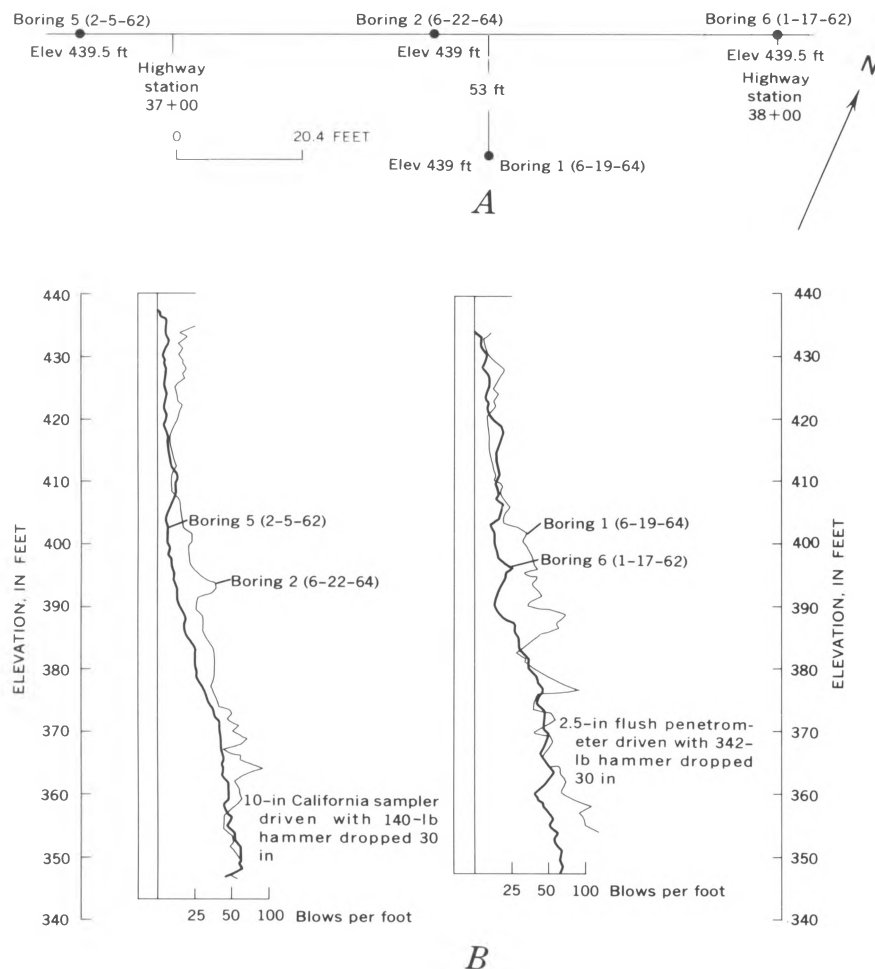
46.—Sketch of boring locations (A) and pre- and postearthquake penetrometer tests (B) at Snow River bridge 605, mile 17.7, Seward-Anchorage Highway. Data after George E. Utermole, Jr., Alaska Department of Highways.
