The Alaska Earthquake

March 27, 1964

Effects of the Earthquake Of March 27, 1964 On the Communities of Kodiak and Nearby Islands

GEOLOGICAL SURVEY PROFESSIONAL PAPER 542-F

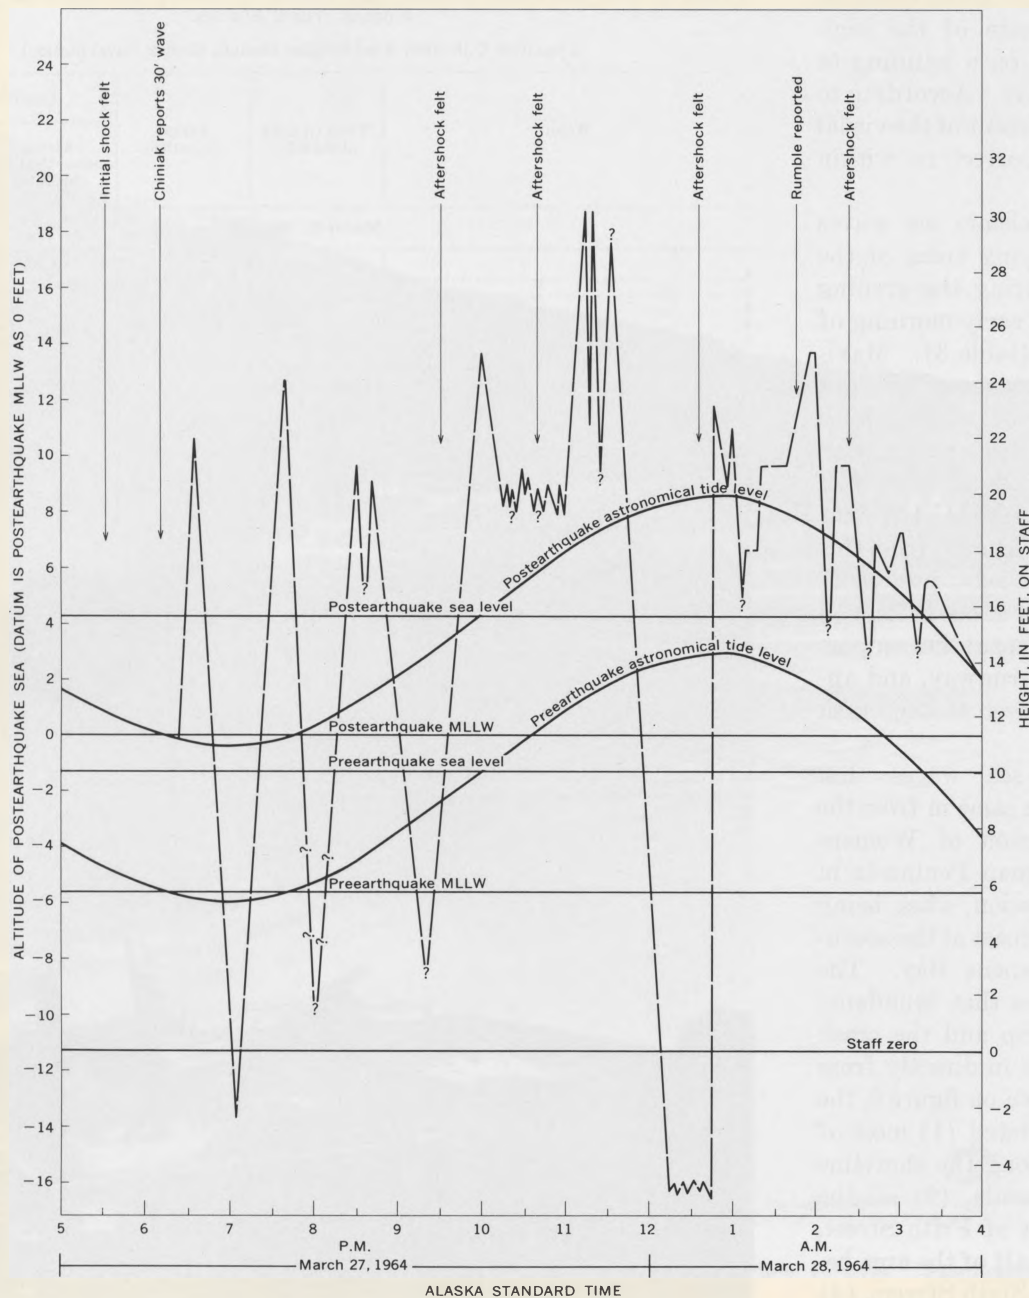
8.—Reconstructed marigram of seismic sea waves at Kodiak Naval Station.

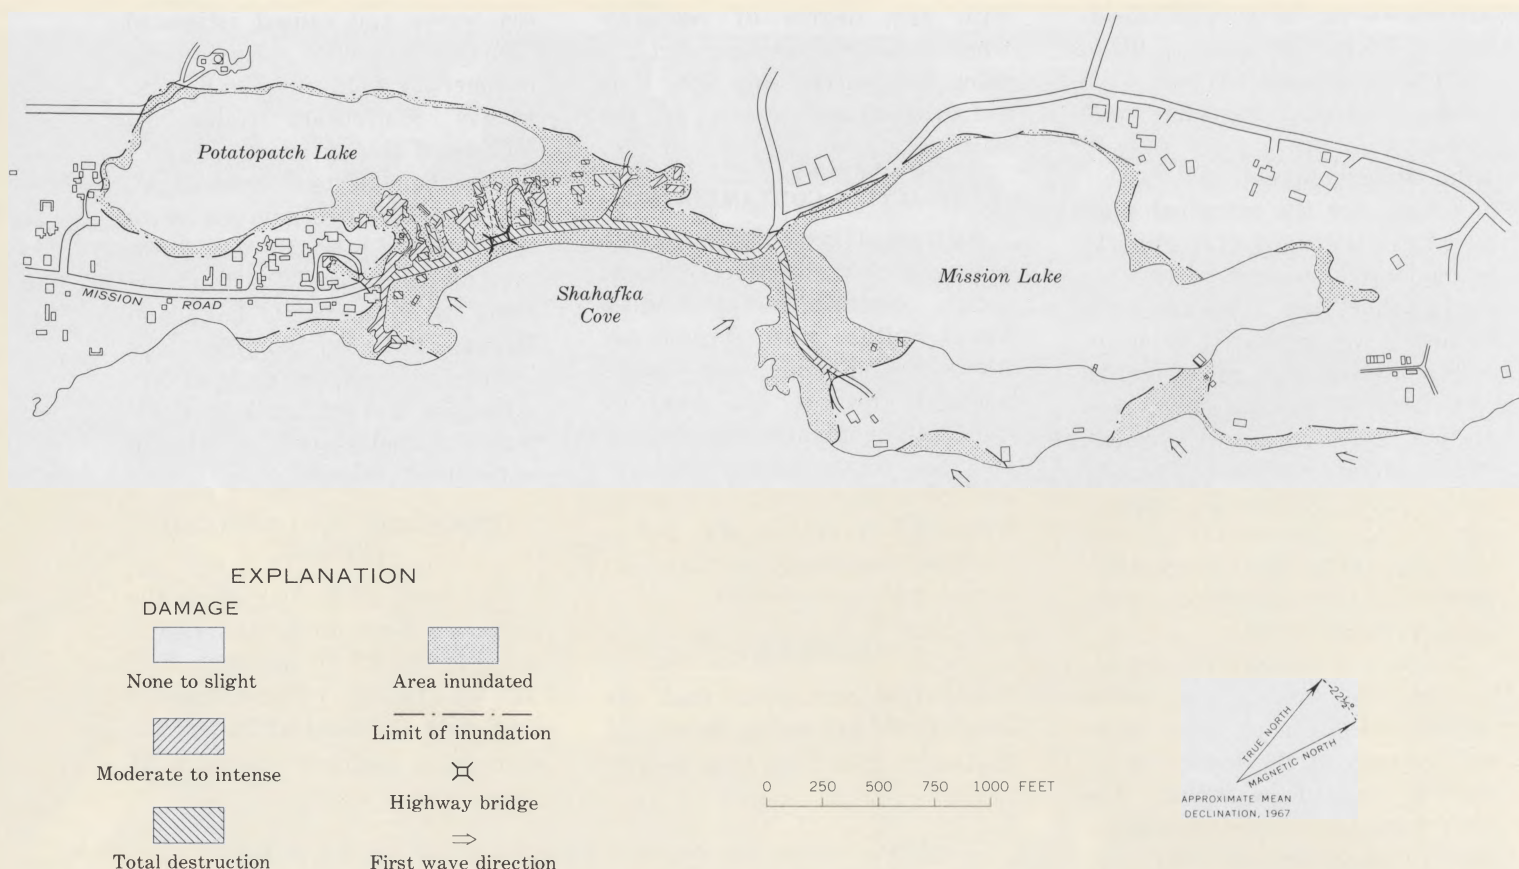
Damage information based on data supplied by James B. Barr, Kodiak, and data collected by U.S. Geological Survey, 1964

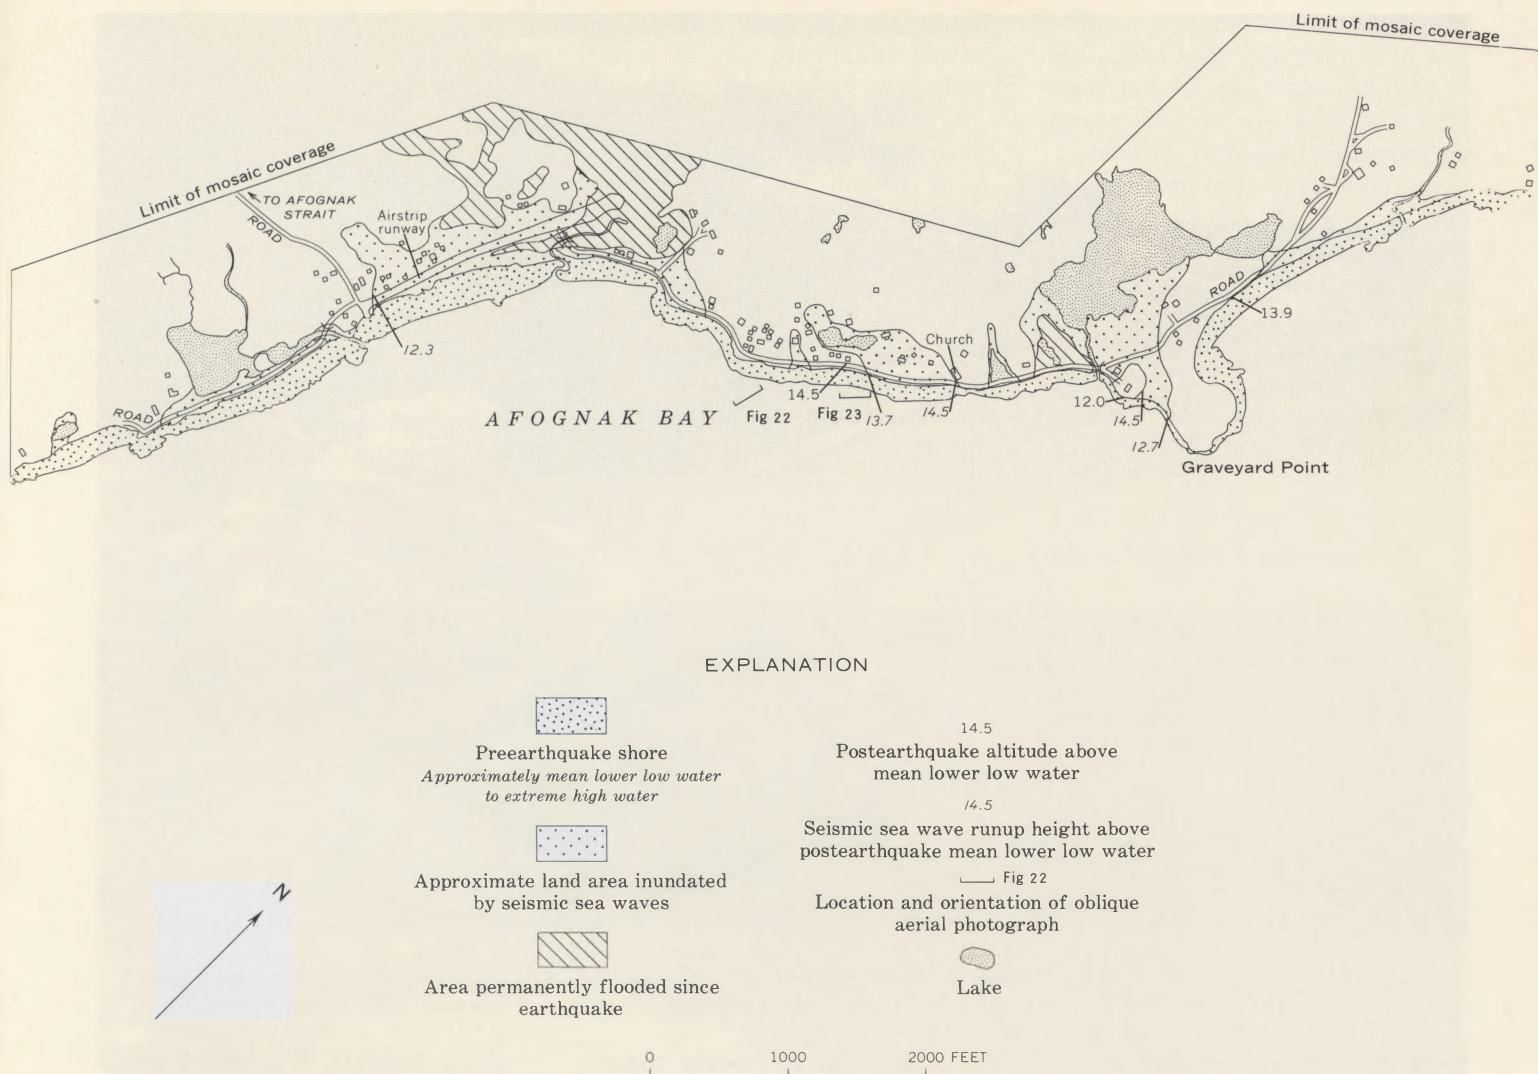
21.—Planimetric sketch map of Afognak showing approximate limits of inundation by seismic sea waves and the areas flooded by ponding behind barrier beaches.

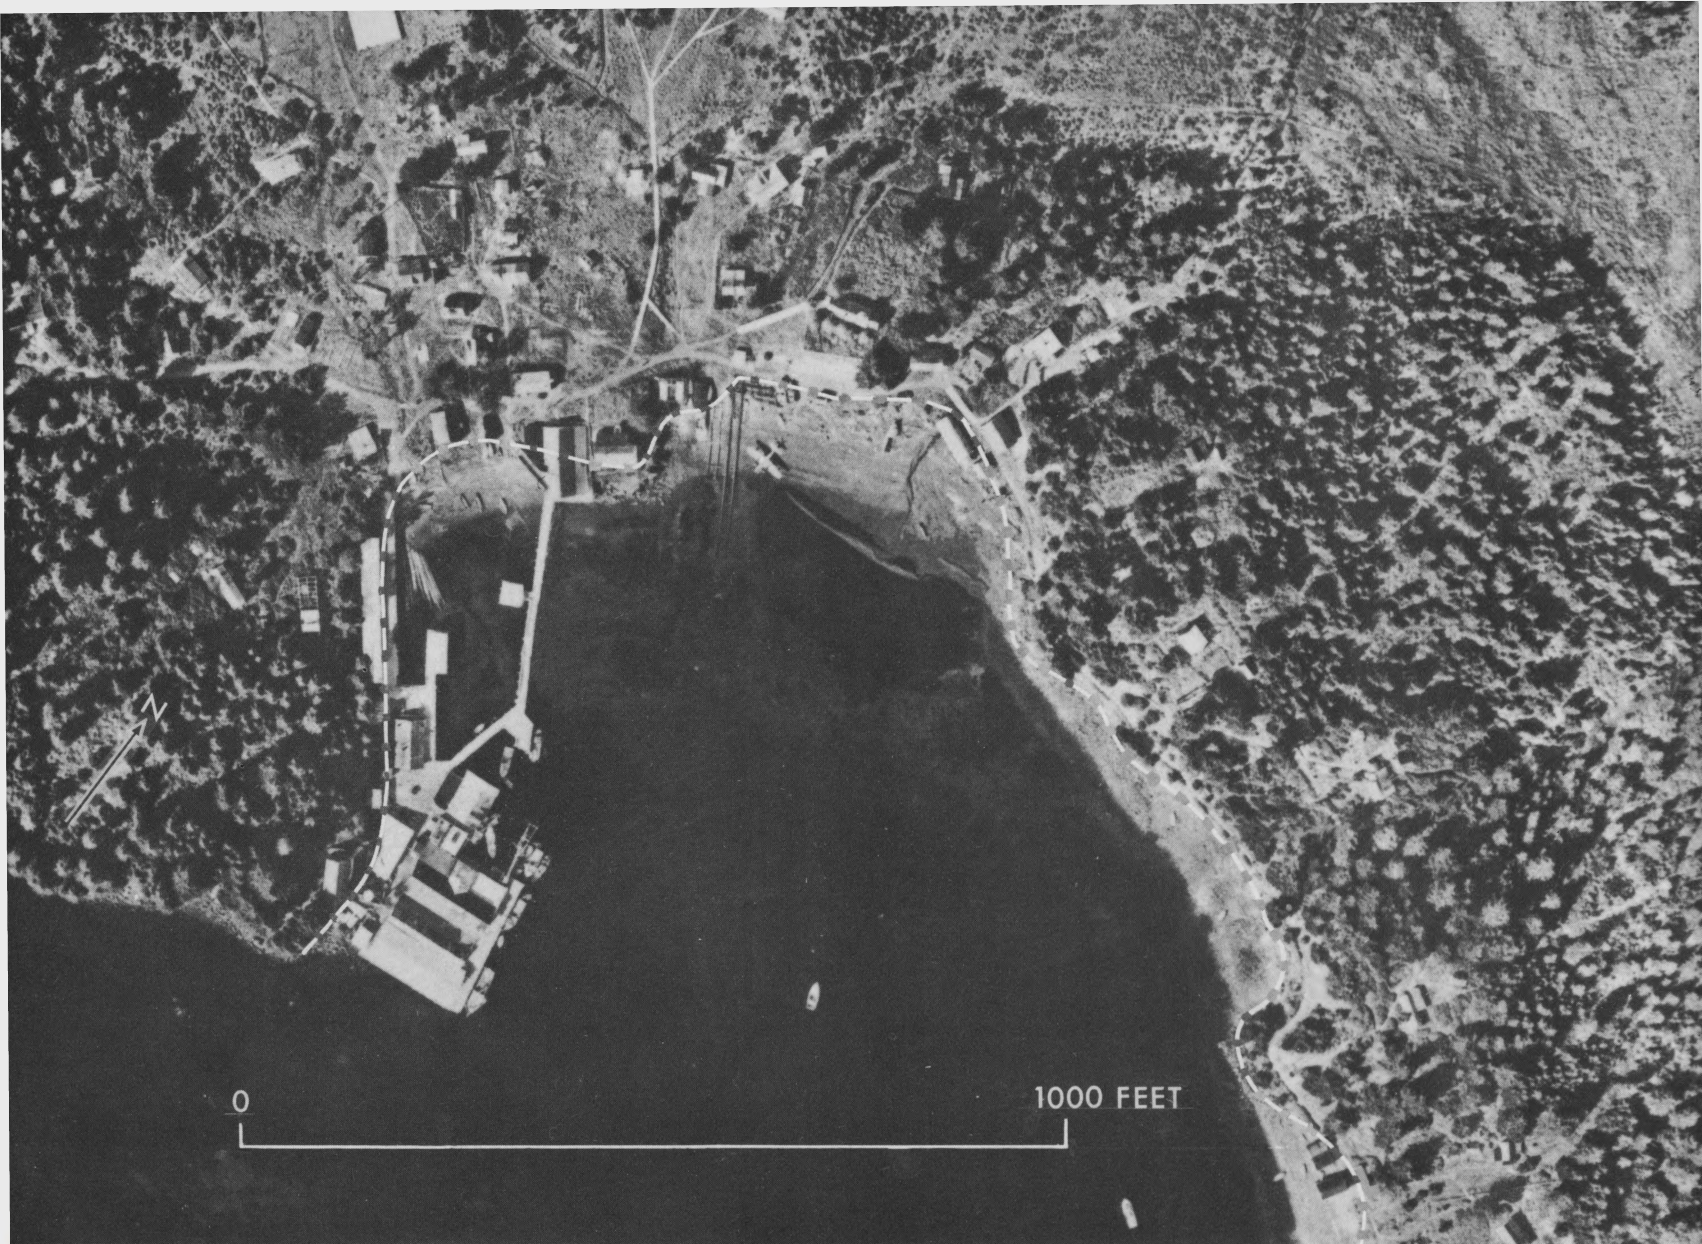
24.—Aerial mosaic of Uzinki in 1962 showing large cannery complex along the waterfront belonging to the Ouzinkie Packing Co. and approximate inland limit of seismic sea wave inundation (dashed line).

mph. The initial wave was followed by progressively higher waves that came in on a flooding tide. The highest wave, which stopped a clock in one residence at 9:27 p.m., was either the third or fourth of the train. By this time the residents had evacuated their homes and fled to the hills behind the village; from there they saw, by moonlight, most of the structures floating away on the highest wave.

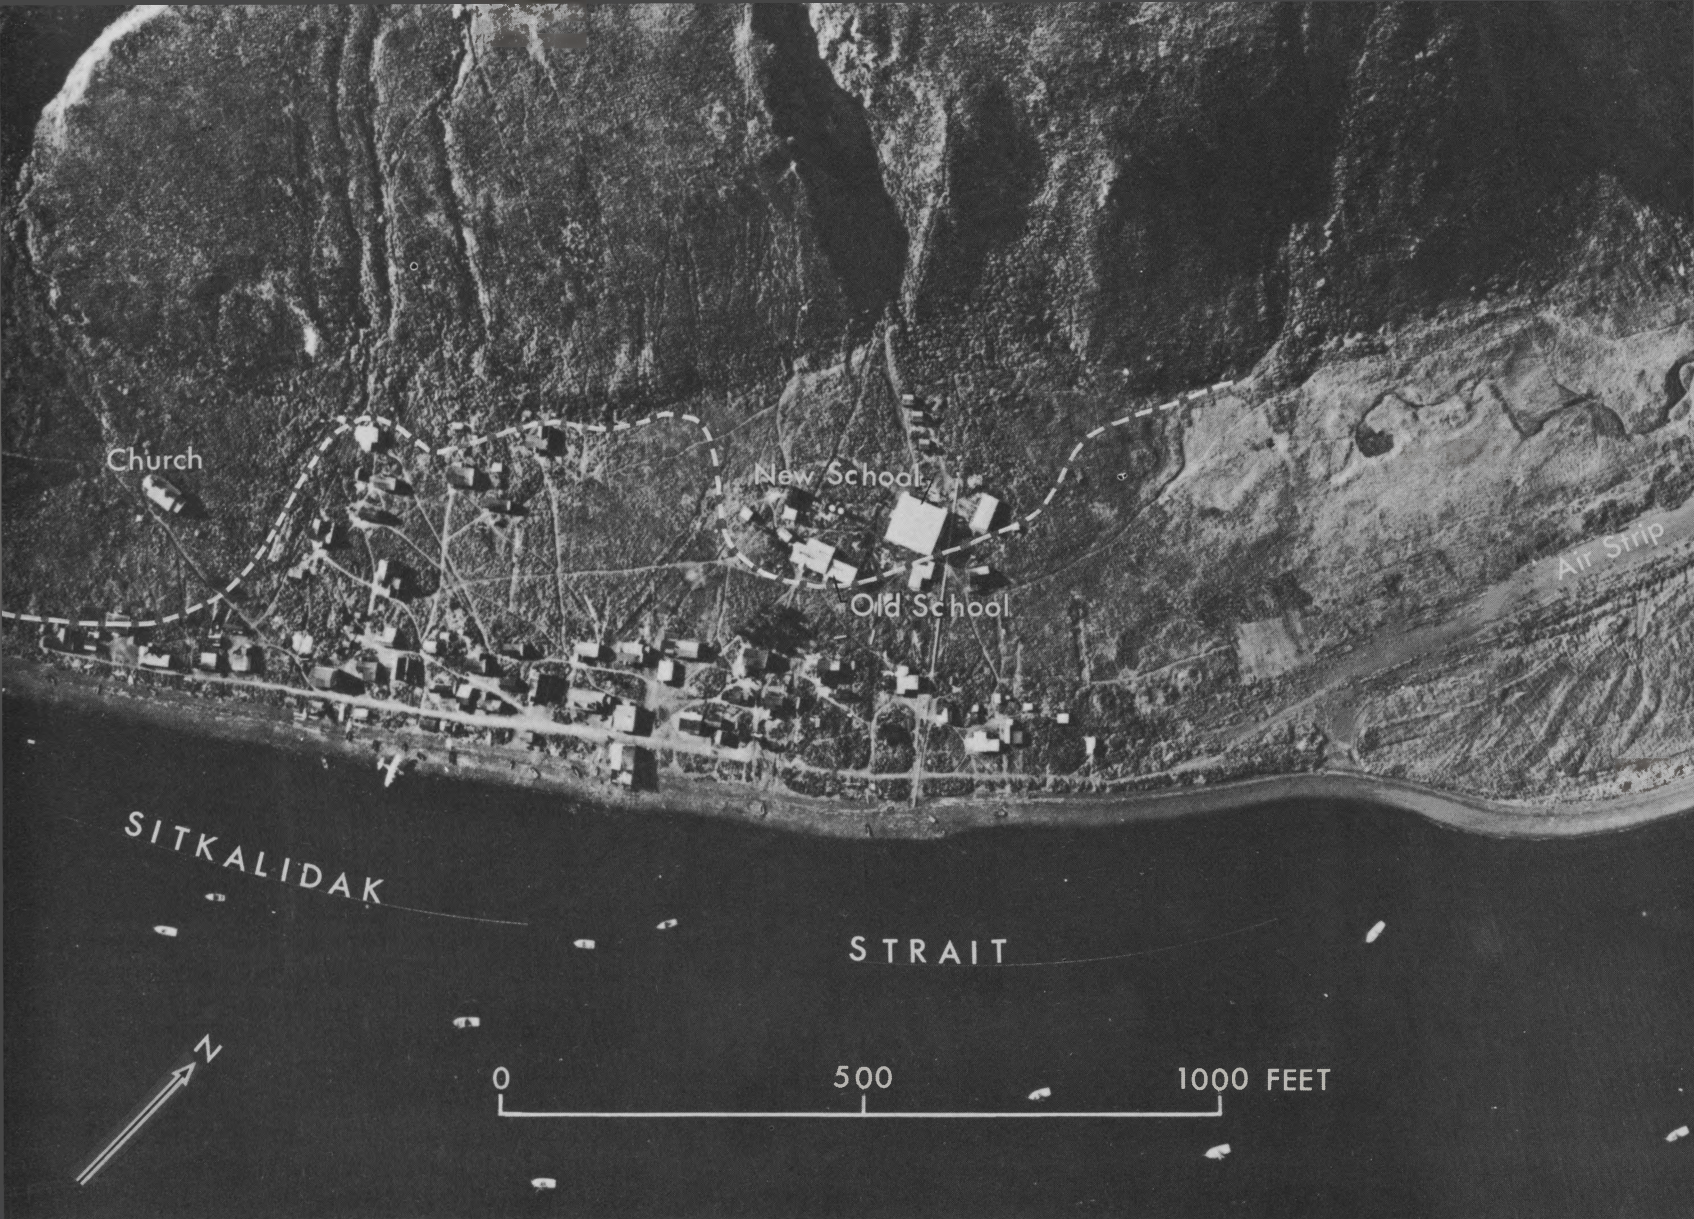
26.—Aerial mosaic of Old Harbor showing approximate inland limit of inundation by seismic sea waves (dashed line). Mosaic by U.S. Bureau of Land Management, 1962.

was no significant structural damage from the tremors to any of the 35 residences—the great destruction was from the seismic sea waves. The schools and Greek Orthodox church came through the shaking completely undamaged. The earthquake effects on structures and their contents suggest that the Mercalli intensity at the village was about VII–VIII, significantly higher than at Kodiak, Afognak, and Uzink. The relatively greater intensity of shaking at Old Harbor is believed to be largely due to local geologic conditions at the village site. Old Harbor is built on a thick alluvial

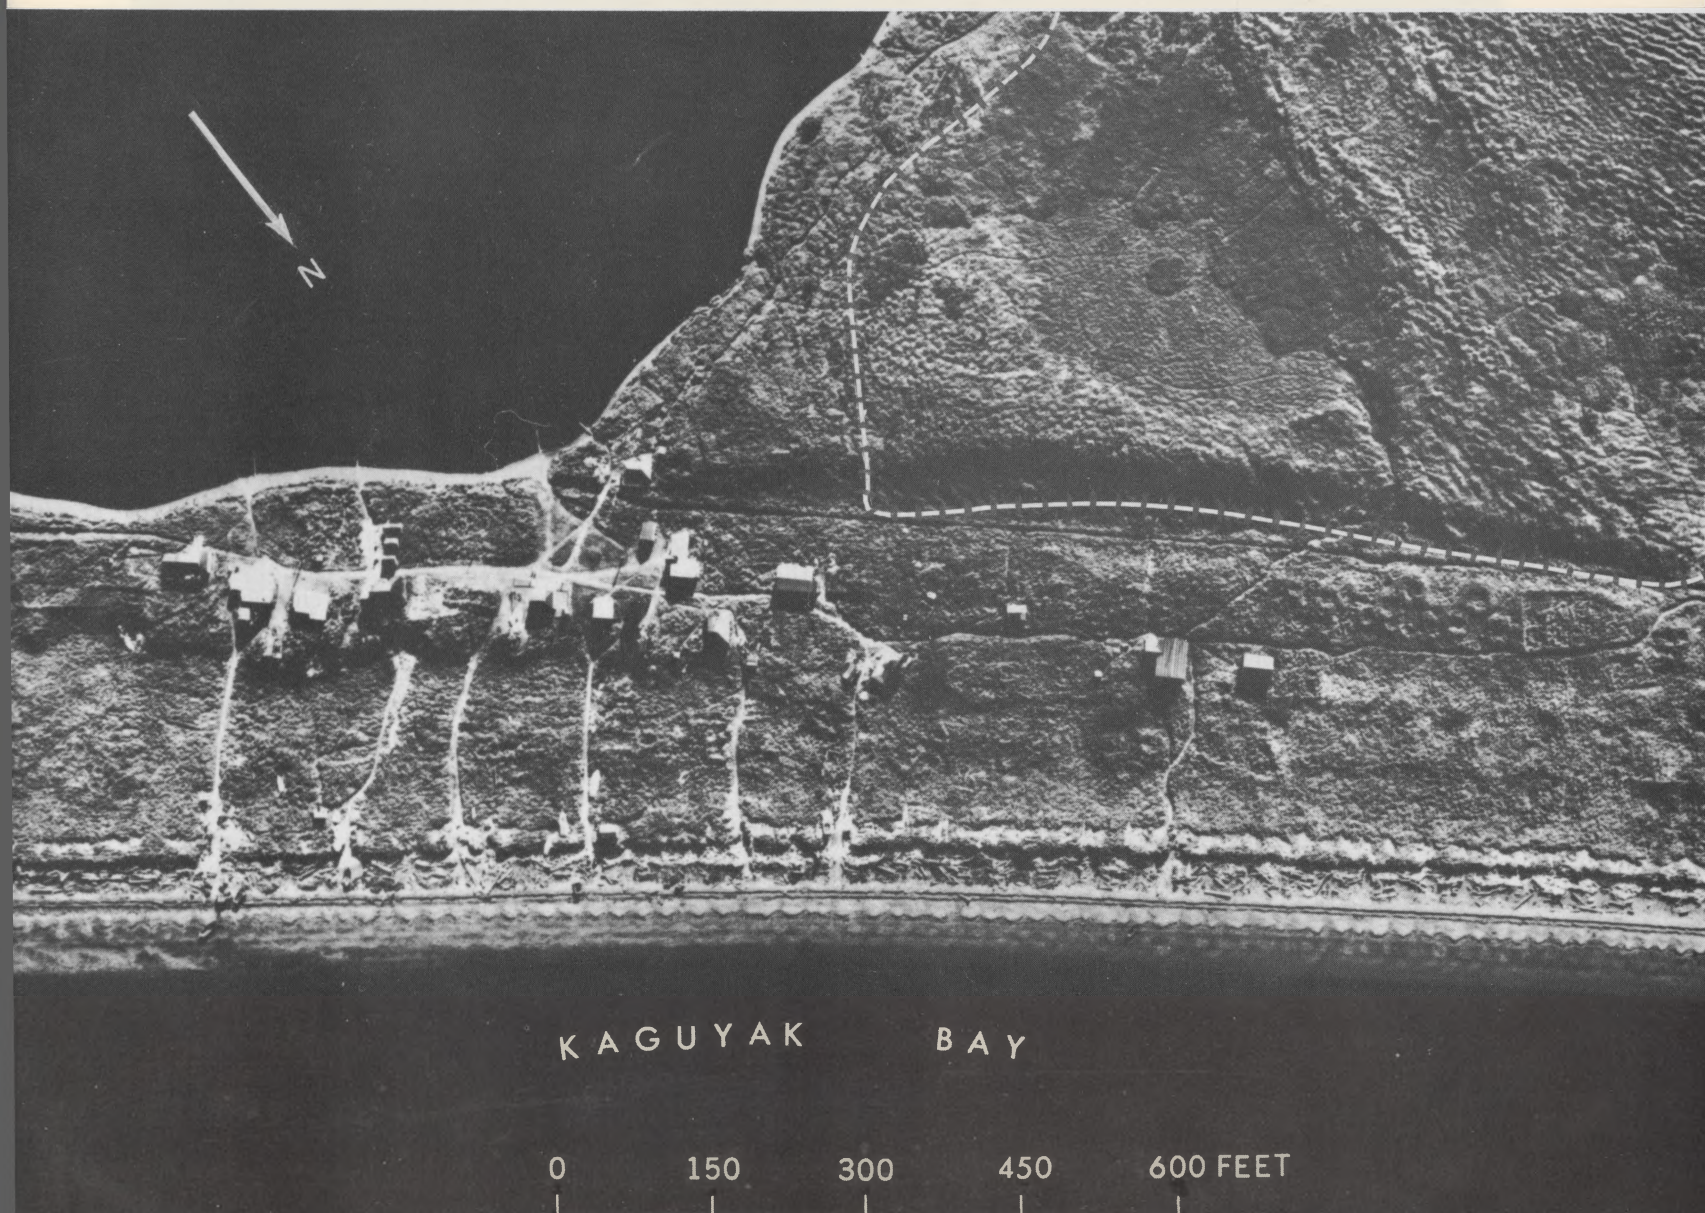
28.—Aerial mosaic of Kaguyak in 1962. Dashed line shows approximate inland limit of seismic sea wave inundation. Mosaic by U.S. Bureau of Land Management.

All the significant earthquake-related damage and loss of life at Kaguyak resulted from inundation by seismic sea waves. The nine residences and their appurtenant structures and the church (fig. 28) were floated from their foundations and were either washed out to sea or were stranded virtually intact as much as half a mile inland (fig. 30). One of several 30-foot salmon trawlers that were in the small-boat anchorage at the mouth of the river (fig. 29) was floated 1.8 miles upstream and stranded. Flooding of the village site also caused brine pollution of

The approximate extent of wave inundation at the village site, as indicated by the distribution of debris, is shown in figure 28. Maximum measured runup height on the hill behind the village was about 25 feet above the postearthquake MLLW. If the highest wave occurred at the same stage of tide as the highest wave at Old Harbor, its runup height above normal tide level would have been about 21 feet, almost twice that of the waves at Kodiak, Afognak, and Old Harbor. This unusual runup at Kaguyak must be related

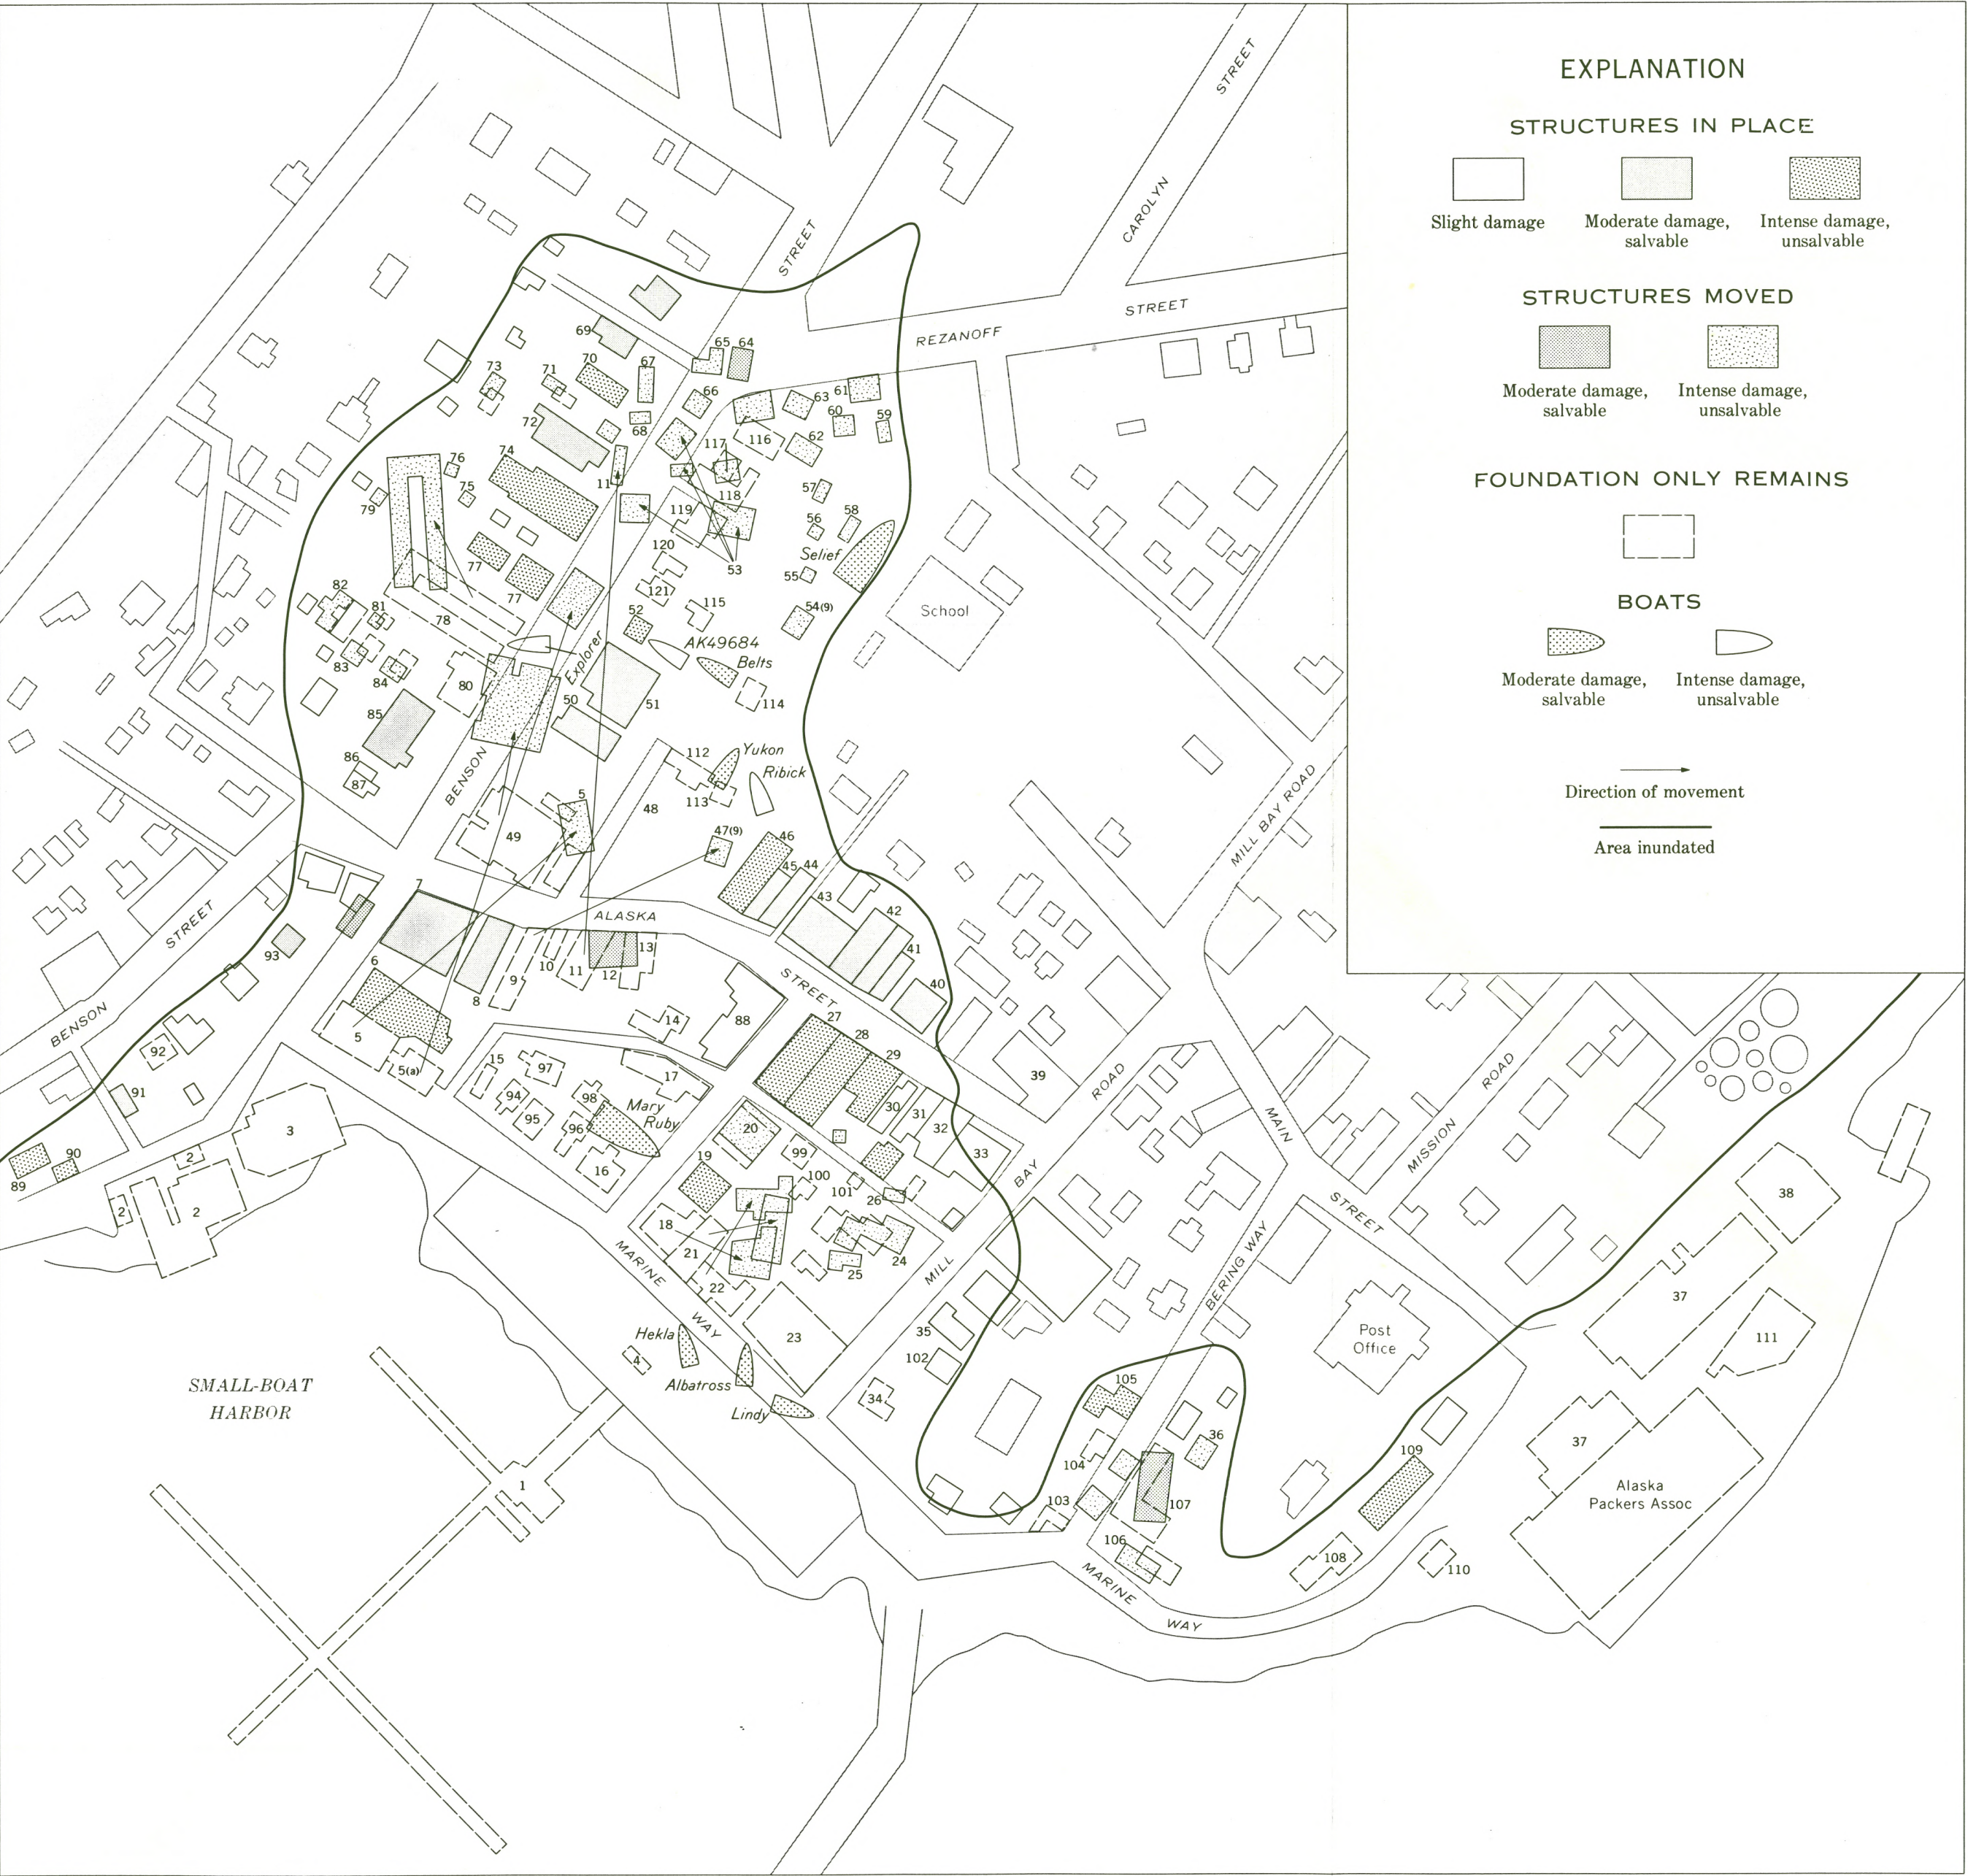
- STRUCTURE OR OWNER OF STRUCTURE
- | | |

| 1. Small-boat harbor docks | 92. Residence |
