# Effects of the Earthquake Of March 27, 1964 In the Copper River Basin Area, Alaska

By OSCAR J. FERRIANS, JR.

*A description and analysis of the earthquake-  
induced ground breakage, landsliding, regional  
uplift and subsidence, and damage to manmade  
structures in the Copper River Basin*

GEOLOGICAL SURVEY PROFESSIONAL PAPER 543-E

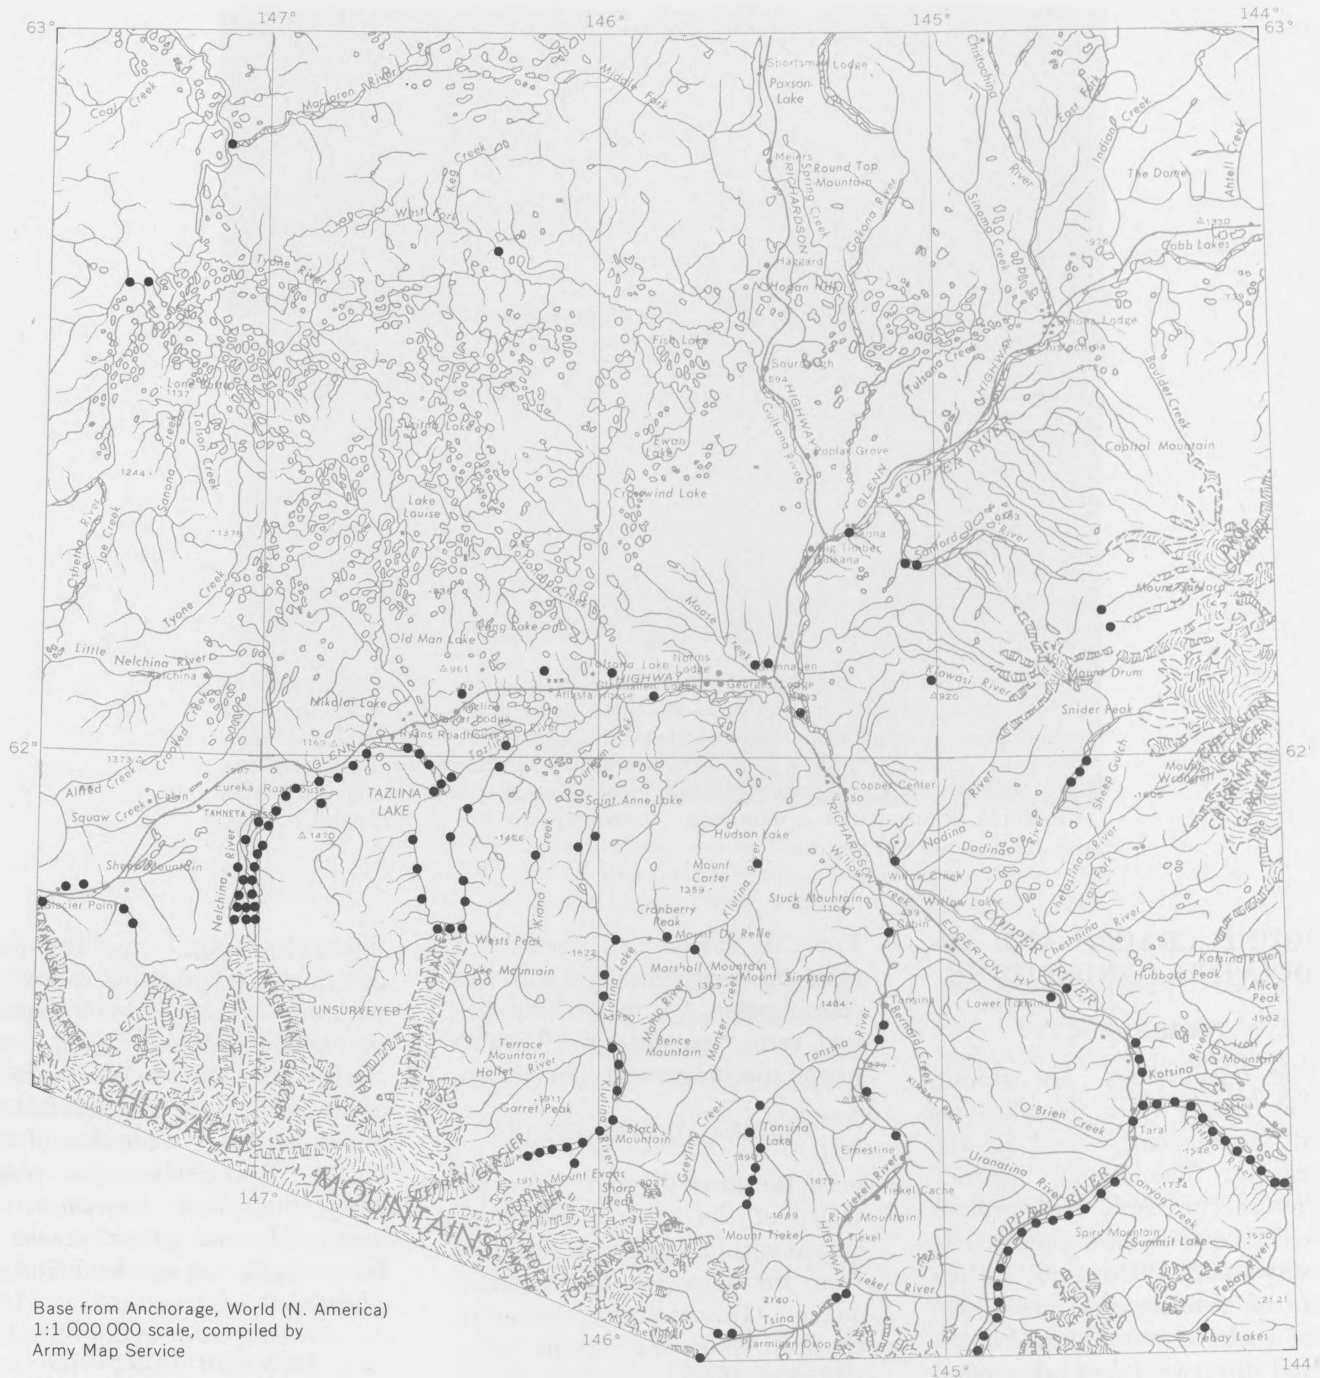
linear zones (fig. 7), and thus suggests that they were not caused by fault movement in bedrock beneath the unconsolidated deposits. Rather, the distribution pattern indicates that local geologic factors controlled the distribution of the cracks. Nevertheless, the possibility that fault movement at depth did cause ground cracks to form locally can not be definitely eliminated.

•  
Area where ground cracks were  
observed, July 1964

Permafrost which extends from near the surface to depths as great as 200 feet is widespread in the Copper River Basin area, but generally was absent in areas underlain by coarse-grained deposits in which ground cracks formed (see figs. 2, 7). Permafrost generally was absent also near large deep lakes, and consequently, ground cracks occurred locally along the shores. In areas where ground cracks formed in fine-grained deposits, the impervious permafrost table generally was from 10 to 20 feet below the surface; in flat-lying areas this situation permitted a water-saturated zone to exist between the permafrost table and the base of the seasonal frost at the surface.

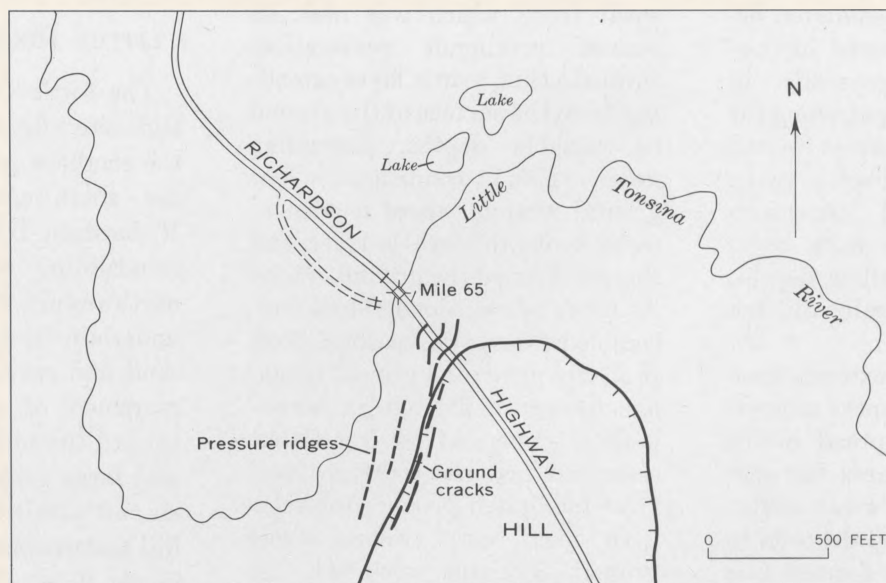
8. Sketch map of the Little Tonsina River landslide site.

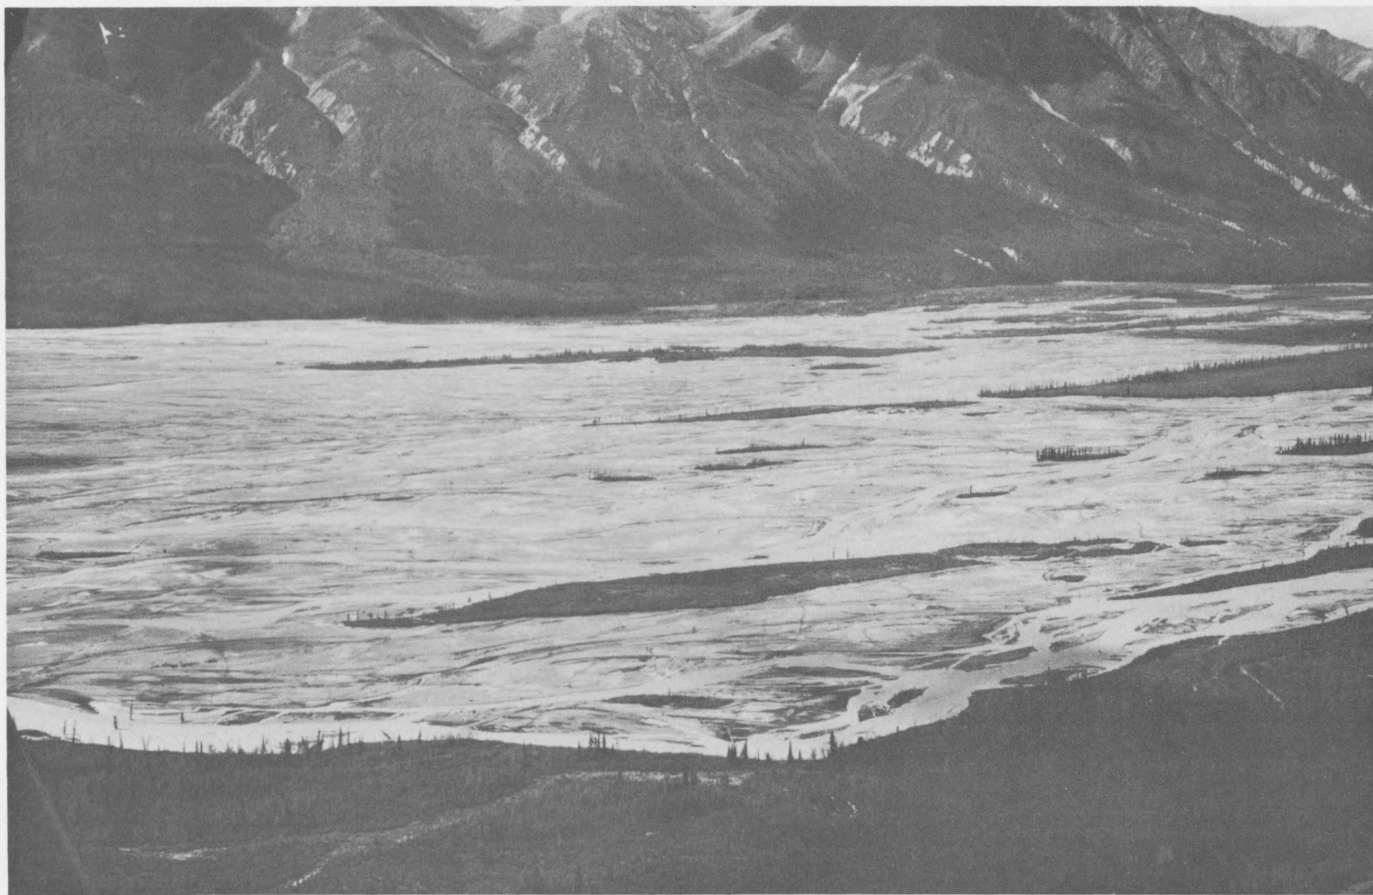
13.—View, to the east, of the large braided flood plain of the Nelchina River 8 miles north of the terminus of the Nelchina Glacier.

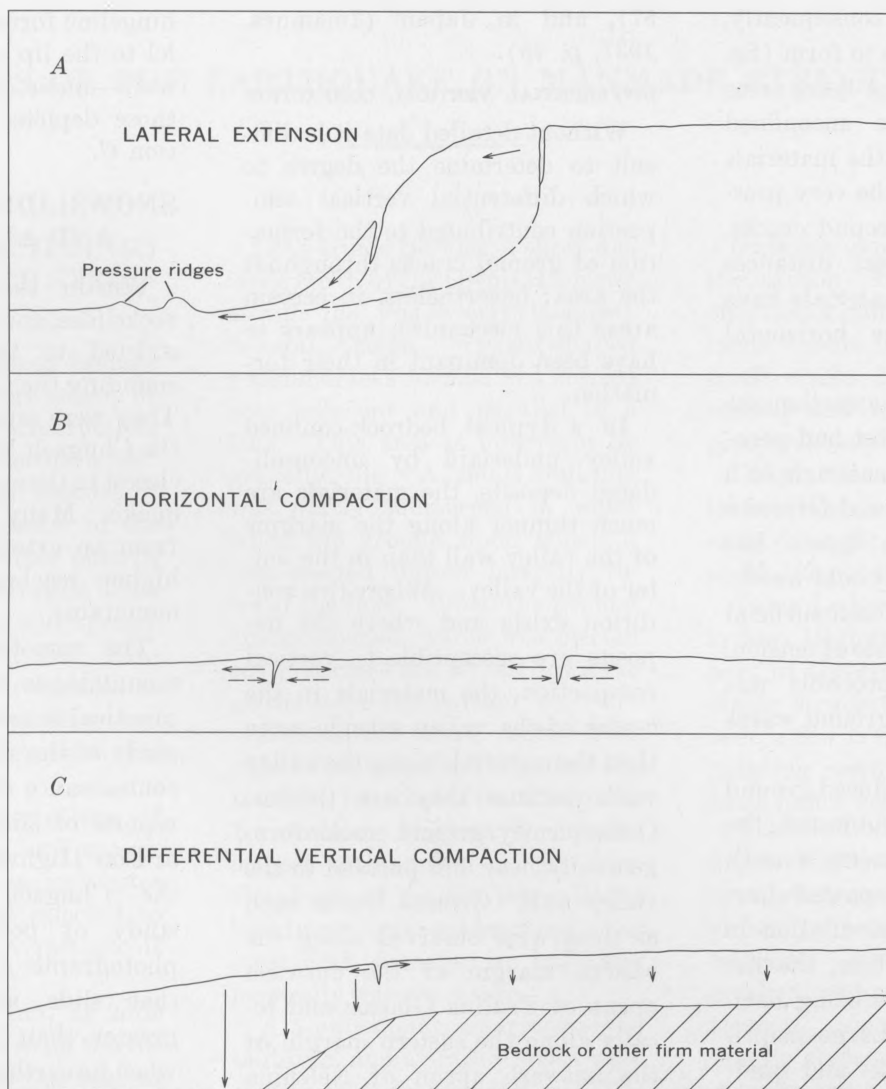
20.—Diagrammatic sections showing mechanism of formation of basic types of ground cracks in unconsolidated deposits in the Copper River Basin area.
