The Alaska Earthquake

Surface Faults
On Montague Island
Associated with the
1964 Alaska Earthquake

By GEORGE PLAFKER

GEOLOGICAL SURVEY PROFESSIONAL PAPER 543-G

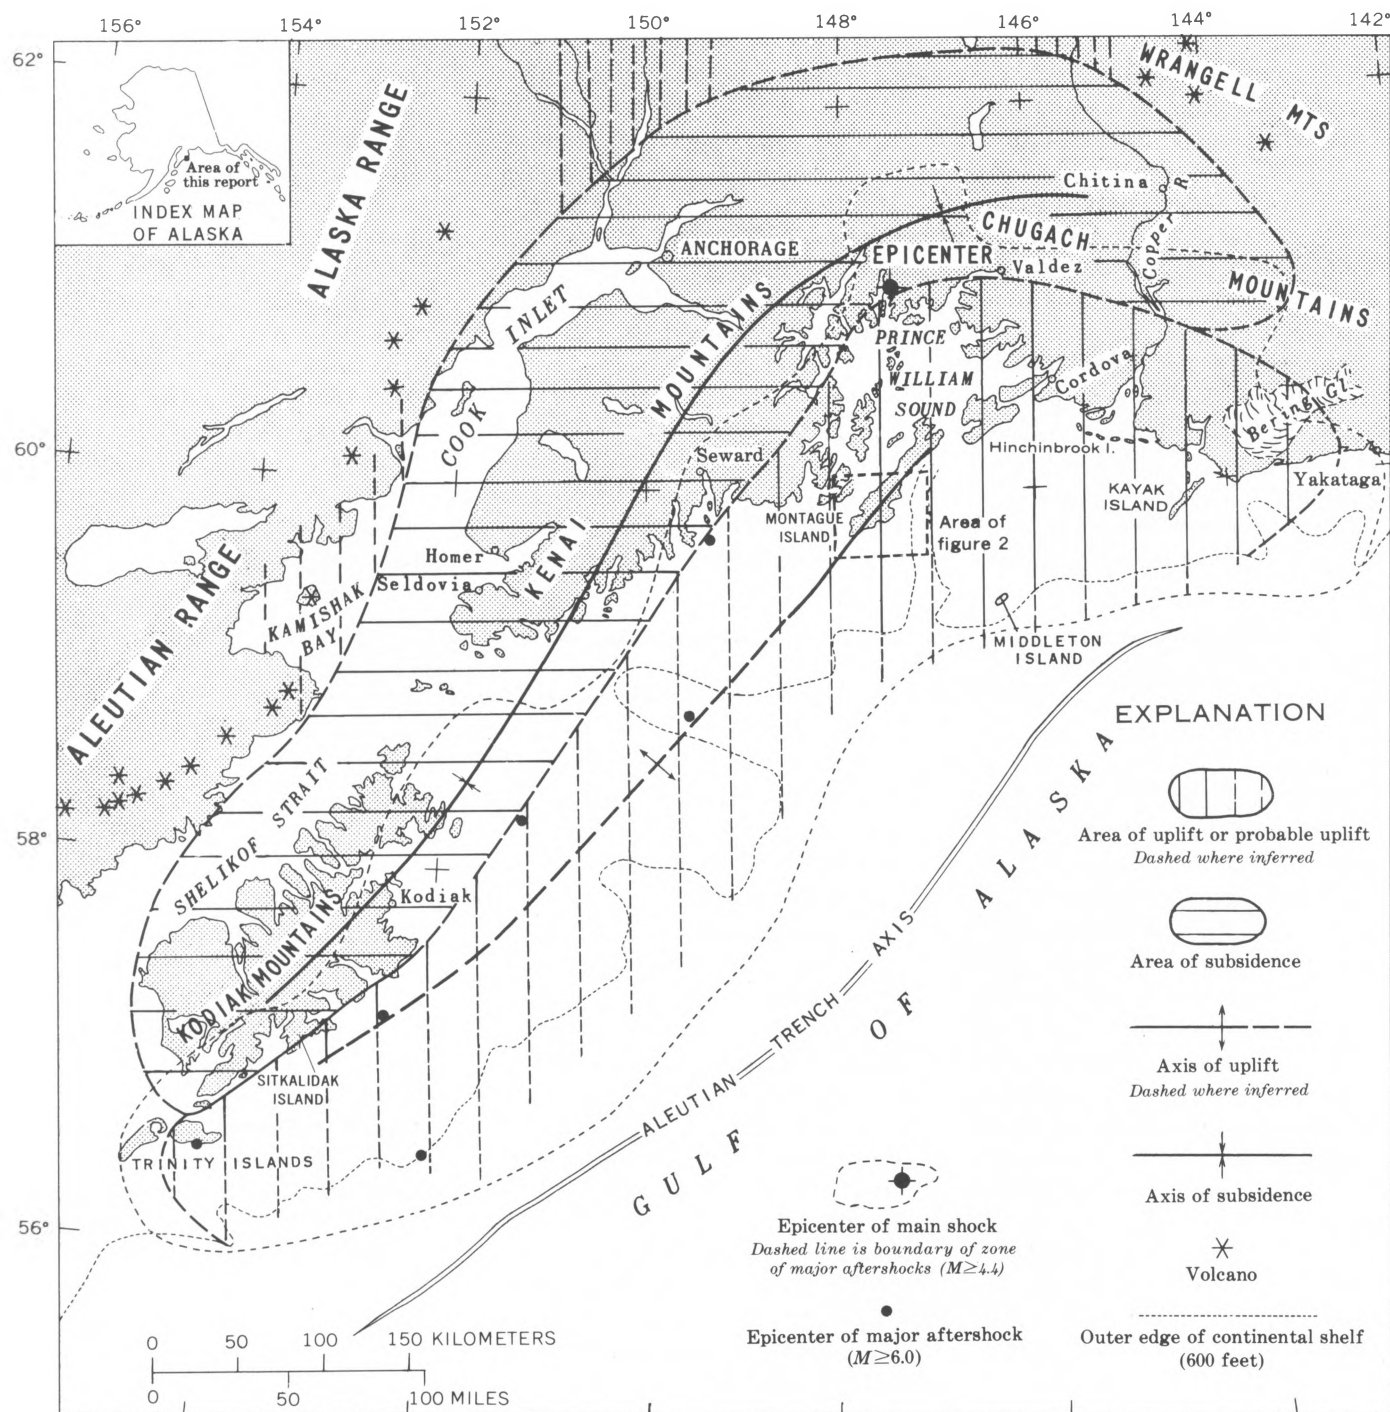
1.—Setting of Montague Island with respect to regional tectonic deformation and seismicity that accompanied the March 27, 1964, earthquake.

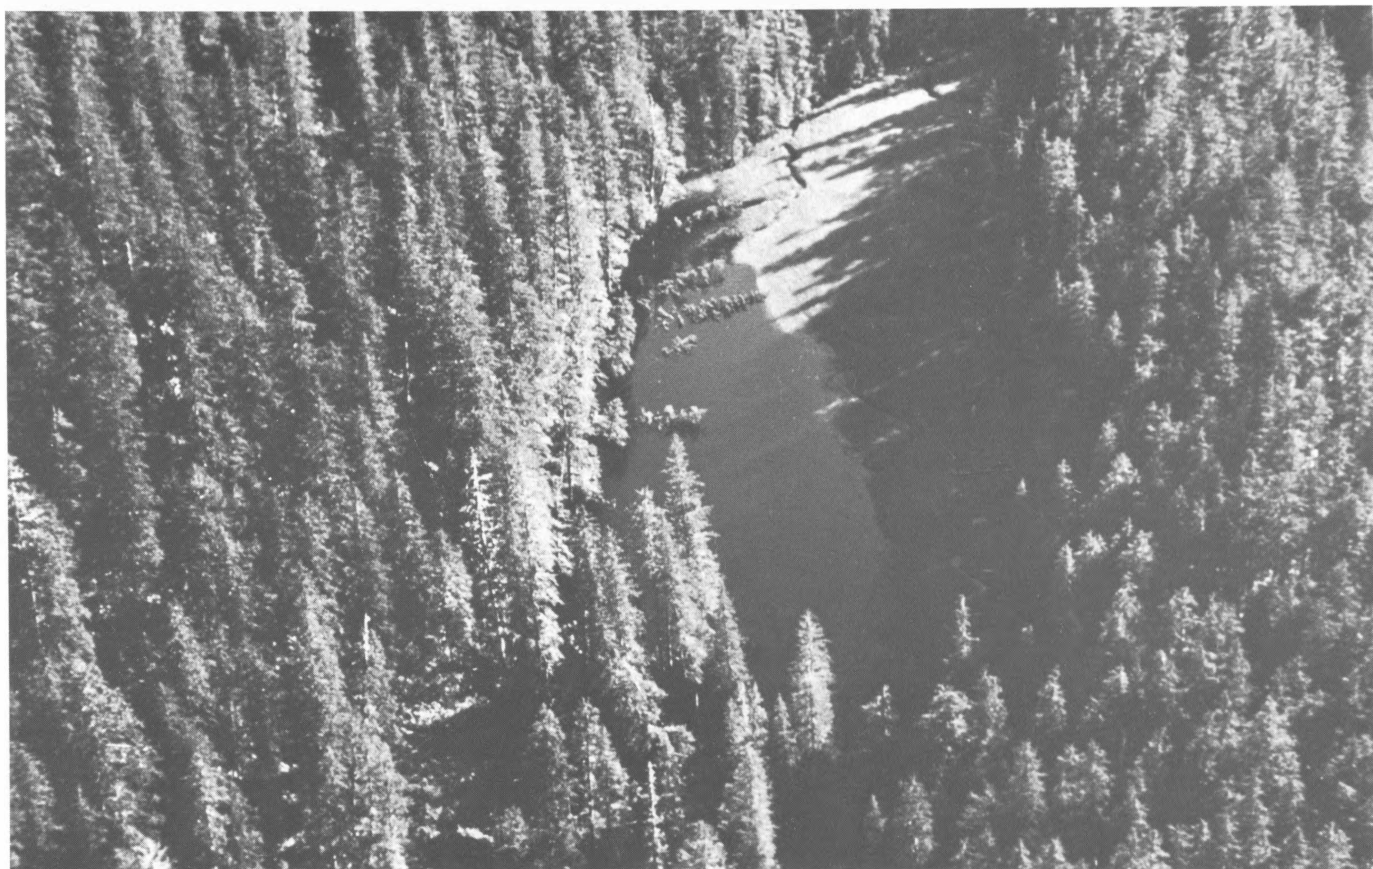
headwall scarps of enormous incipient landslide blocks that occur all along the upper part of the cliff. It reappears some 500 feet inland from the cliff where it coincides with the linear edge of a muskeg swamp. The fault trace here consists of a north-south trending zone of parallel surface fissures and flexures in glacial till and sphagnum peat. Individual fissures that parallel the trace are open as much as 3 feet (fig. 10) and have vertical offsets of as

much as 5 feet with the west (downhill) sides upthrown relative to the east sides. Net vertical displacement across the fissures is about 7 feet; the amount of vertical movement resulting from warping is not known. A possible left-lateral component of horizontal displacement is indicated by a 17-inch offset of segments of a log that had been frozen into the ground in a position almost normal to the trend of one of the larger surface breaks. A few gaping cracks that trend N. 15° W. at an oblique angle to the fault trace are also suggestive of some left-lateral strike-slip movement. No evidence for lateral offsets was found anywhere else along the fault trace.

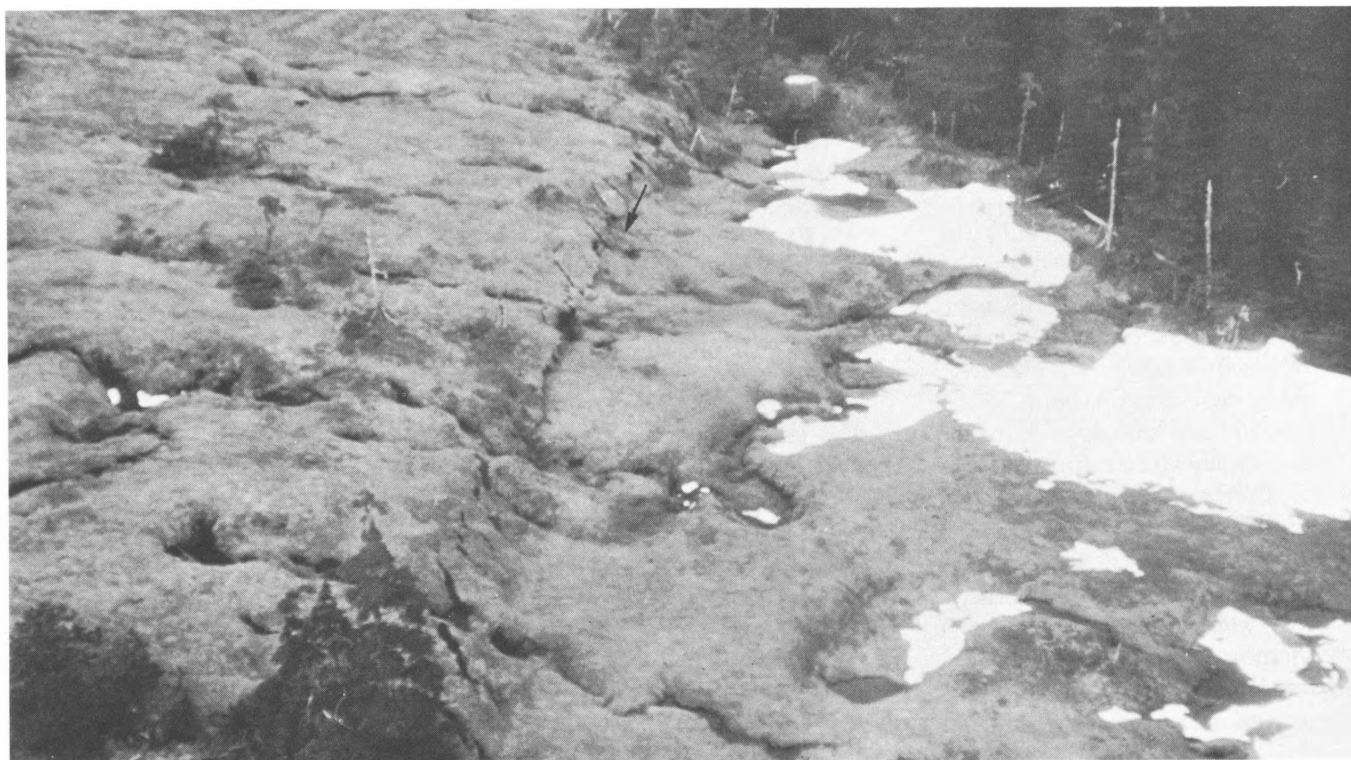
23.—Overhanging scarp of Hanning Bay fault in glacial till dipping 80° northwest. About 4 inches of left-lateral displacement is indicated by the rake of roots extending across the scarp. Scale is $6\frac{1}{2}$ inches long. Location shown in figure 27.

The displacement is entirely dip-slip except for about 4 inches of left-lateral strike-slip displacement near the south end of the fault. The lateral component of movement is indicated by rootlets that trend obliquely across the scarp (fig. 26), by the rake of striations in the fault plane, and by the regular right-handed en echelon arrangement of gaping fissures that follow the general course of the flexure but intersect it at an angle of about 15° (fig. 27). The absence of lateral displacements elsewhere along the fault, or of systematically offset drainage across the fault trace, demonstrates that the strike-slip component of displacement during this earthquake and during earlier movements was relatively minor.

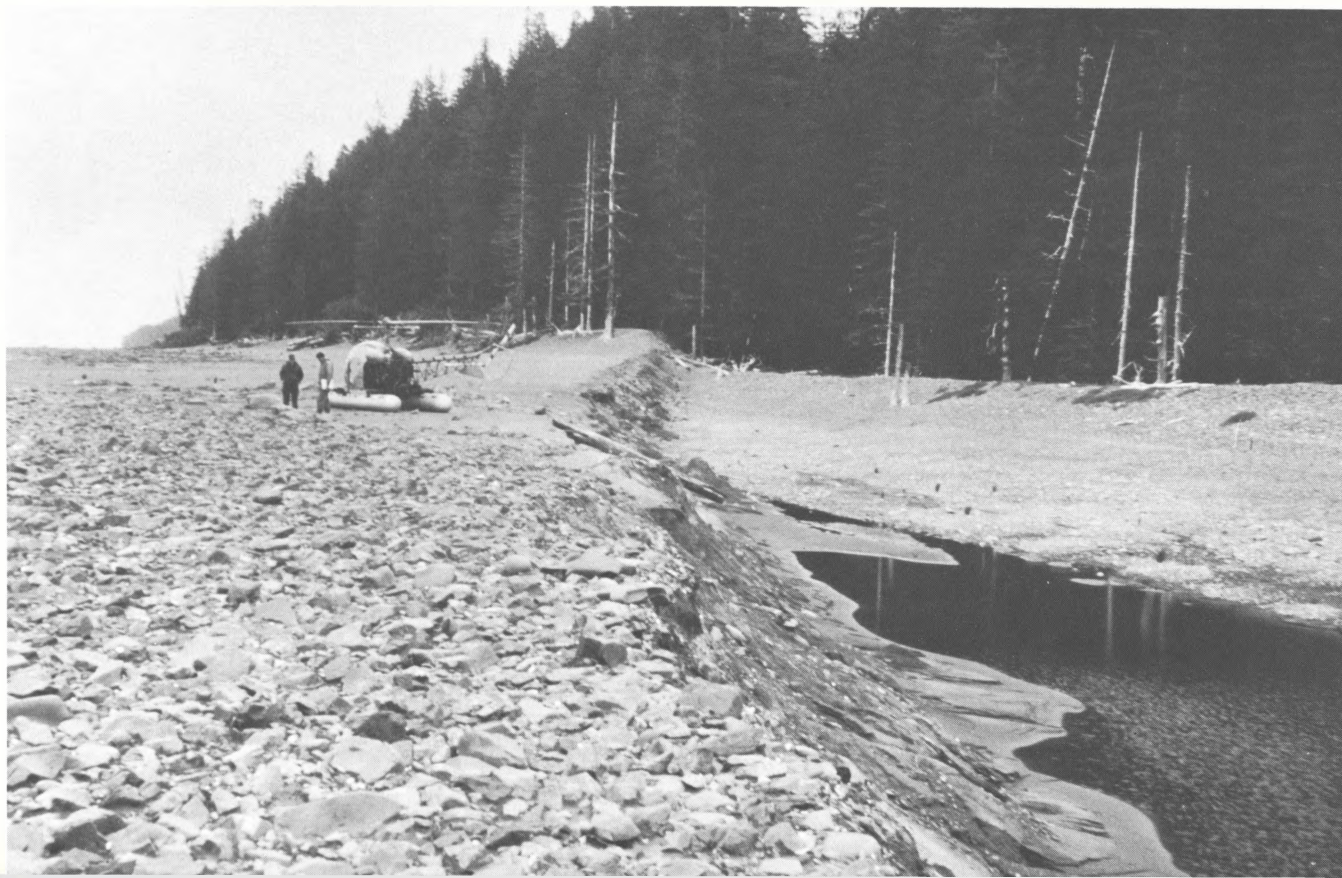
32.—View northwest toward cobble-gravel storm beach at north side of Fault Cove which was displaced $16\frac{1}{3}$ feet vertically across the Hanning Bay fault scarp. Pond at right occupies a shallow tectonic depression. Photograph by M. G. Bonilla.

cupies a tectonic depression along the scarp base immediately below the elevated beach berm.
